HOME INSPECTION REPORT

Address of Inspection: 123 Sample Drive

Monday, April 16, 2018

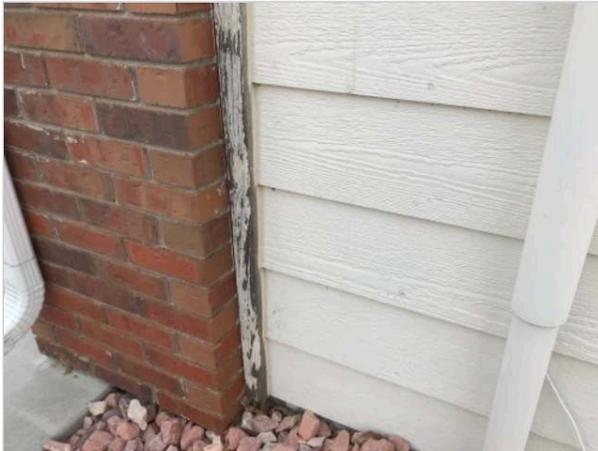
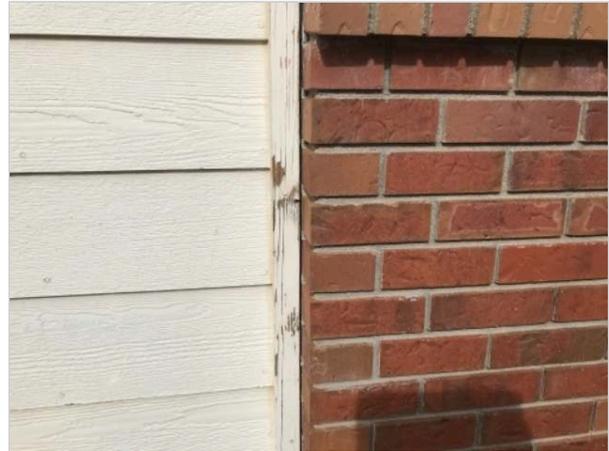
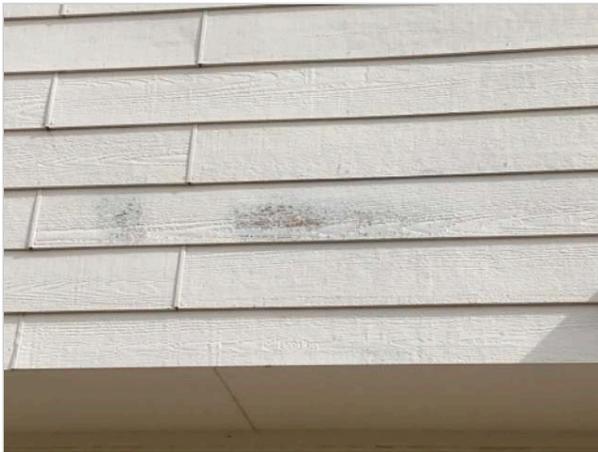
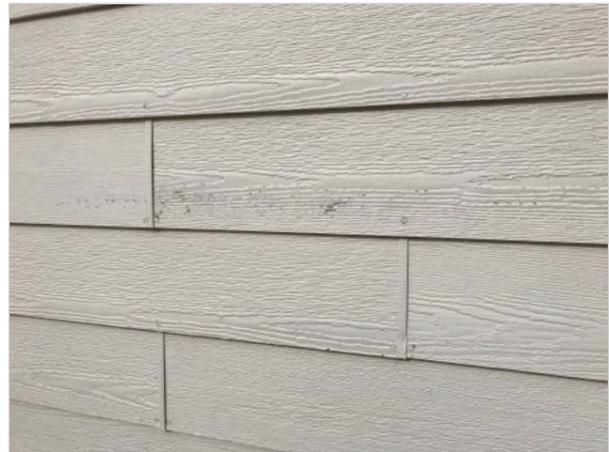
- **Some of the exterior siding and trim is in need of a coat of paint.** All exterior siding and trim should be kept well caulked and painted to prolong its useful life.

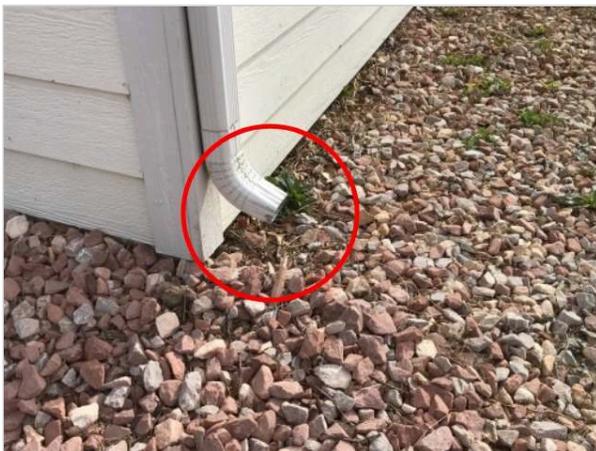
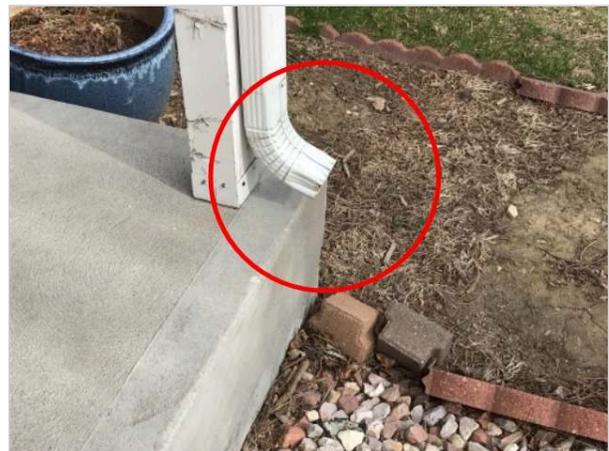
The roof drainage system consisted of galvanized metal gutters and downspouts which appeared to be functional at the time of the inspection. Gutters and downspouts should receive routine maintenance to prevent premature failure. There were no material defects observed on the visible portions of the gutters or downspouts.

- **NOTE:** *The addition of downspout extensions, where missing, should be considered to help direct rain water away from the foundation.*

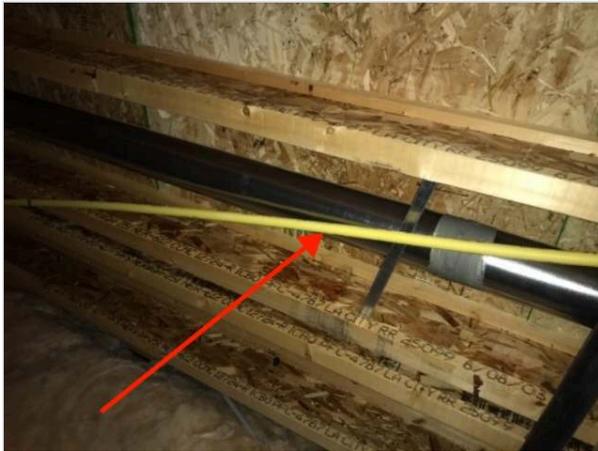
Photo 31

1. CSST gas piping (Corrugated Stainless Steel Tubing) was in use in this home. The potential exists for lightning strikes to cause arcing at the CSST gas piping that may result in perforation of the pipe, gas leaks and fire. Proper adherence to the manufacturer's bonding instructions should lower the risk of electrical arcing and related damage. Proper bonding and grounding of the product can only be determined by a licensed electrical contractor. More information is available at <http://www.csstsafty.com>. If this is a concern to you I recommend this installation be further evaluated and corrective action taken as needed.

- *CSST gas piping (Corrugated Stainless Steel Tubing) was in use in this home. The potential exists for lightning strikes to cause arcing at the CSST gas piping that may result in perforation of the pipe, gas leaks and fire. Proper adherence to the manufacturer's bonding instructions should lower the risk of electrical arcing and related damage. Proper bonding and grounding of the product can only be determined by a licensed electrical contractor. More information is available at <http://www.csstsafety.com>. If this is a concern to you I recommend this installation be further evaluated and corrective action taken as needed.*

CSST gas pipe

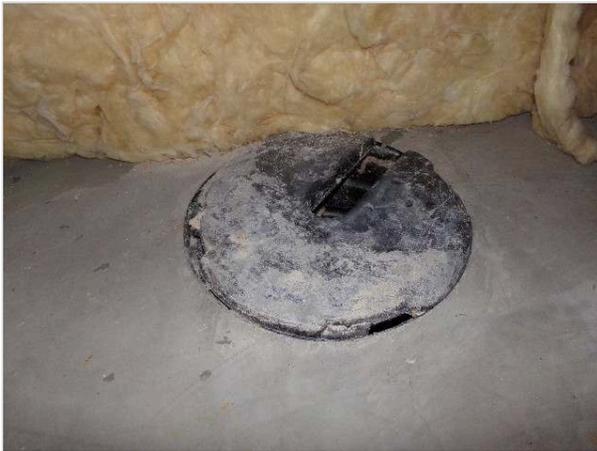
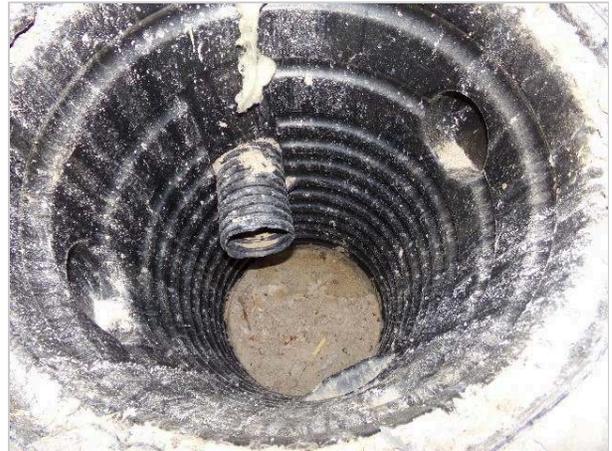
There was a sump pit located in the crawl space. The sump pit was dry. A pump has not been installed in the pit.

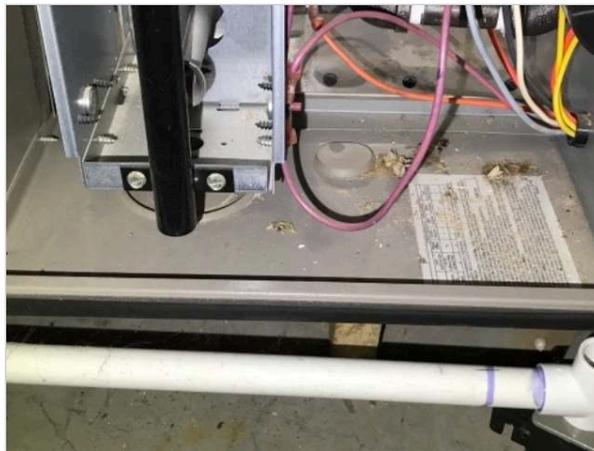
Photo 60

- The furnace is dirty and it should be cleaned and serviced.

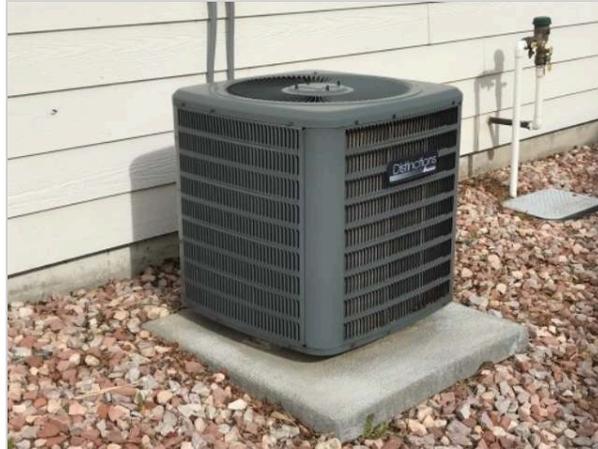
Photo 61

- **NOTE:** Due to the low ambient temperature the air conditioner could not be tested. Compressor damage can occur if air conditioner condensers are operated when the outdoor air temperature has been less than 60 degrees during the previous 24 hour period.
