### *HOME INSPECTION REPORT*

*This summary provides a simplified overview of the results of the Friday, June 29, 2018 inspection at 123 Main Street, Anywhere, VA 11111. Be sure to read the full body of the inspection report; it contains much more detail about the property. Any additional evaluations we've recommended must be performed prior to the conclusion of the inspection contingency period.*

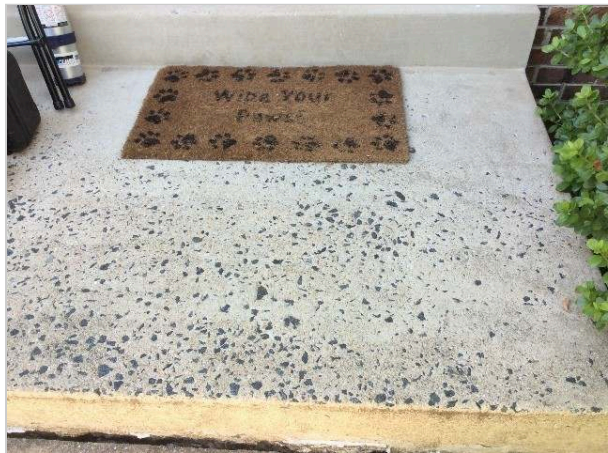
**Trip hazards were present on the walkways** around the house. The hazards can be repaired using a suitable or similar surfacing material to "feather" the out-of-level condition to make a smooth transition.

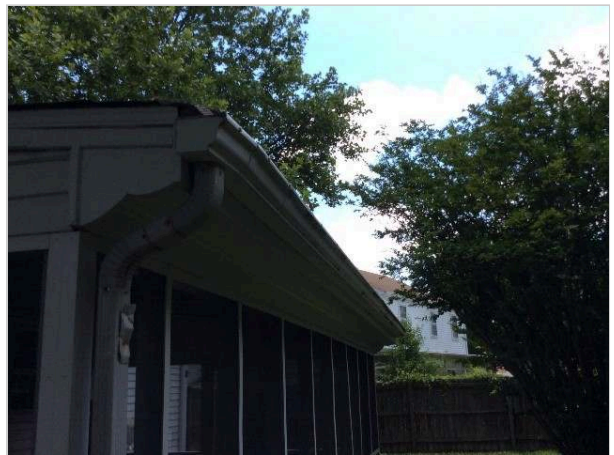
One downspout is draining directly onto the roof surface. This decreases the life of the roofing shingles dramatically. HomeTeam suggests extending the downspout to a lower gutter.

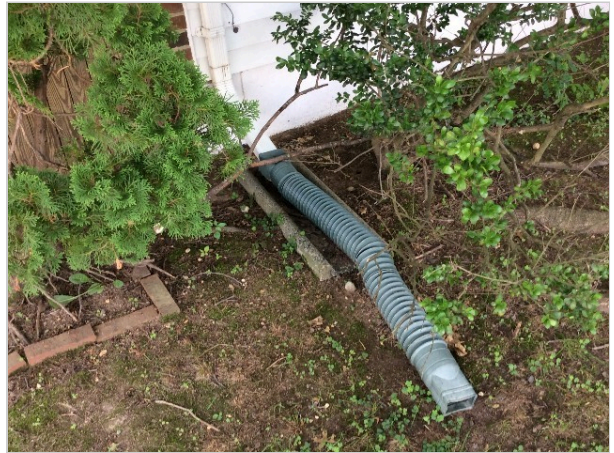
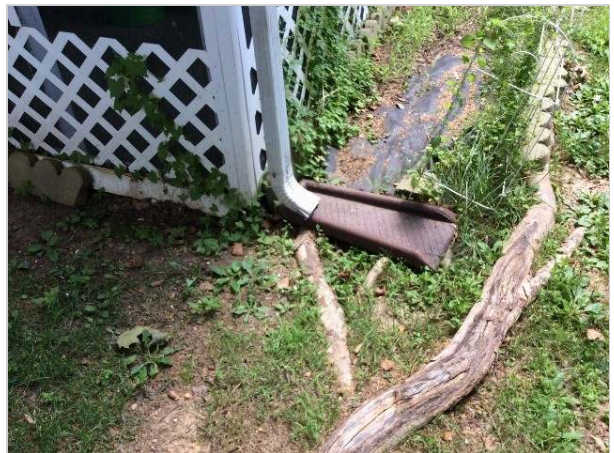
**At least one exterior downspout is not properly secured to the structure** and should be secured to prevent downspout and gutter damage.

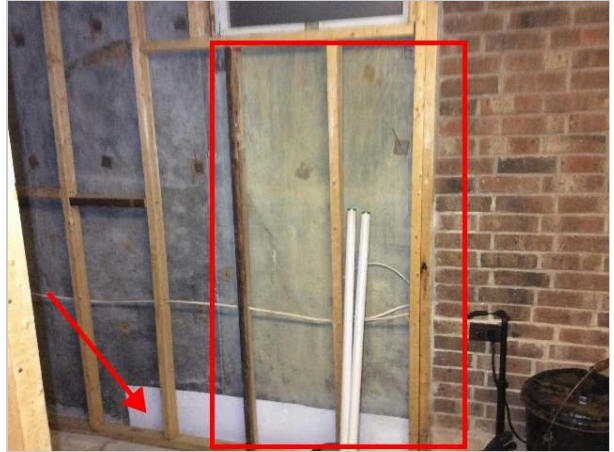
Evidence of water and mud infiltration to the basement was visible under all three basement windows.

Basement was dug out and a French drain system installed to counter the water issues.

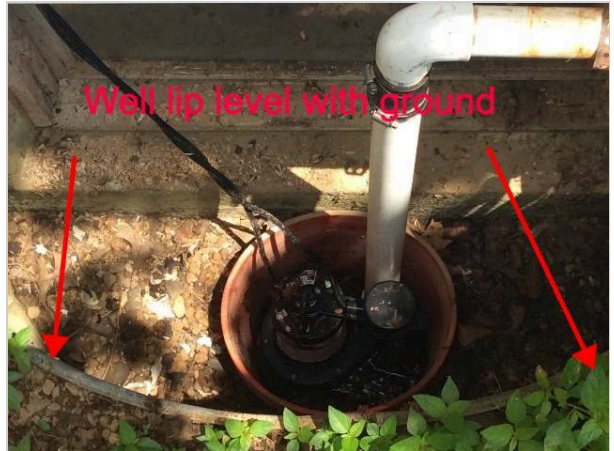
Water stains on the floor and mud and water stains on the wall below window

Small sump pumps were identified in the window well area to assist the removal of excess water

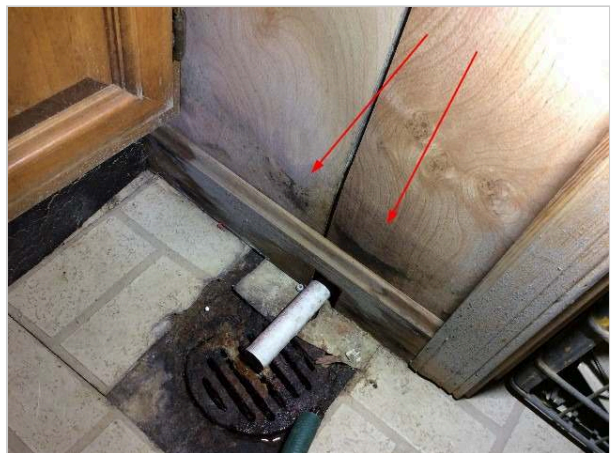
**Mold-like growth is visible in the structure.** The EPA has helpful information that may assist the buyer (<http://www.epa.gov/mold/moldresources.html>). HomeTeam recommends having the areas tested to determine presence, type and relative concentration of mold spores, and professionally remediated by a reputable mold remediation company, which may include removing and replacing affected segments. A mold remediation company may uncover additional areas or issues requiring repair or remediation.

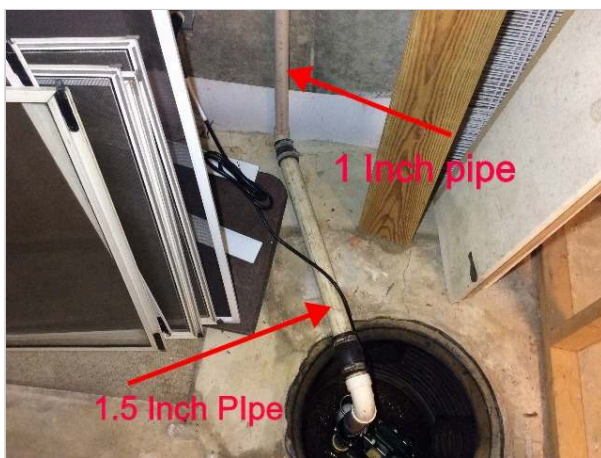
The sump pump primary pipe is 1.5 inches and flows into a reduced 1 inch pipe. This is contrary to sump pump operations and should be corrected by a licensed plumber or handyman. There is also excess loose sediment in the pump croc that should be removed to prevent damage to the pump.

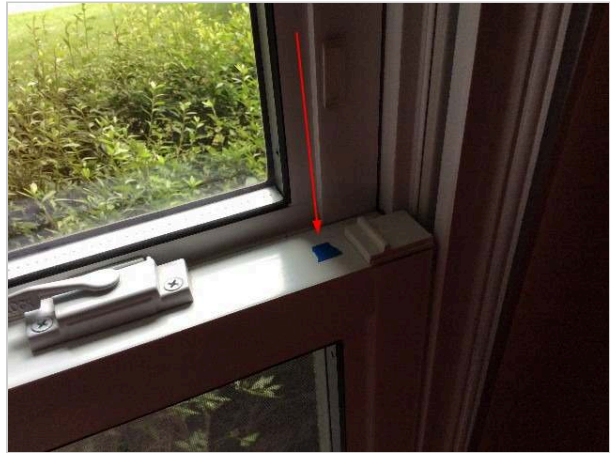
Corner Window - Front of Home

A minor crack was observed on the vinyl sash on one window in the living room, but did not appear to prevent the window from functioning properly. HomeTeam suggests monitoring the affected area for signs of continuous damage or consulting a handyman or licensed contractor for repairs. Marked with blue tape.

Hairline Crack

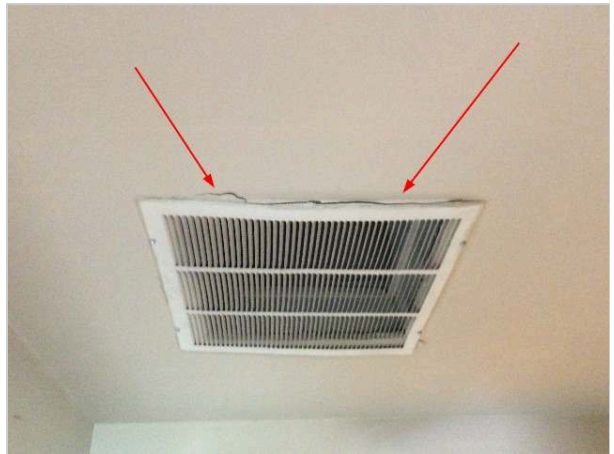
Minor cracks were noted on the ceiling around the return air duct. HomeTeam recommends consulting a handyman or licensed contractor for repairs to ensure the duct cover remains securely mounted.

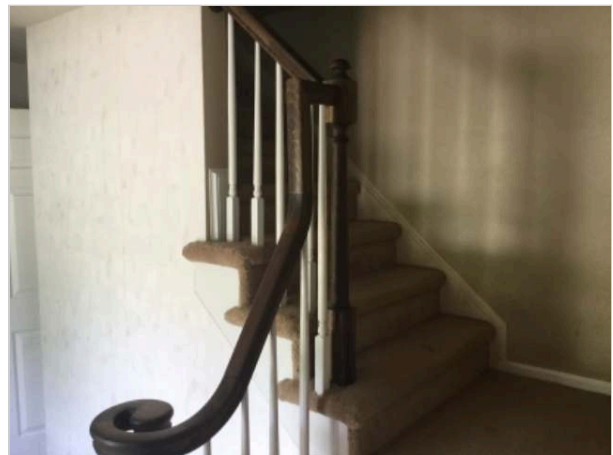
**The balusters on the second floor handrail were spaced greater than four inches apart, creating a potential safety hazard for small children.** Generally accepted construction techniques provide for balusters to be installed vertically and spaced no greater than four inches apart. Larger baluster spacing can also be a safety concern. Consult with a general contractor for cost estimates for additional balusters.

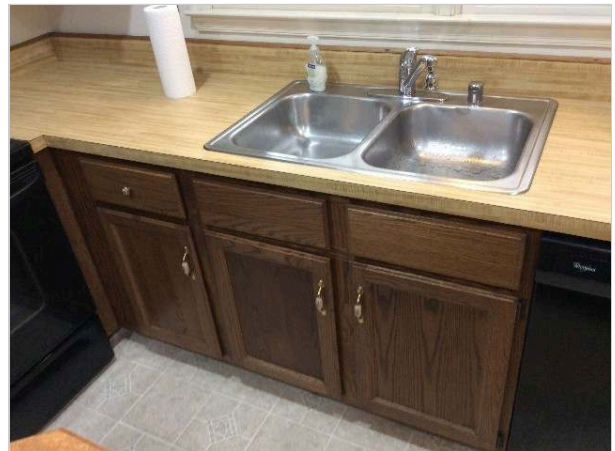
NOTE: Evidence of previous water intrusion is present under the kitchen sink.

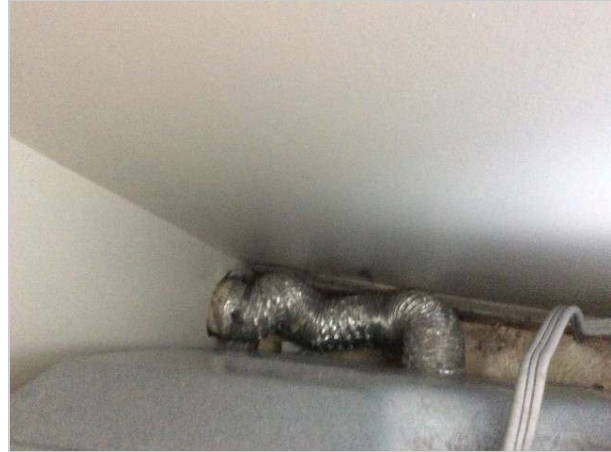
Dryer vent hose appears damaged and should be replaced

NOTE: Dryer vent hose appears to be damaged and may need to be replaced.

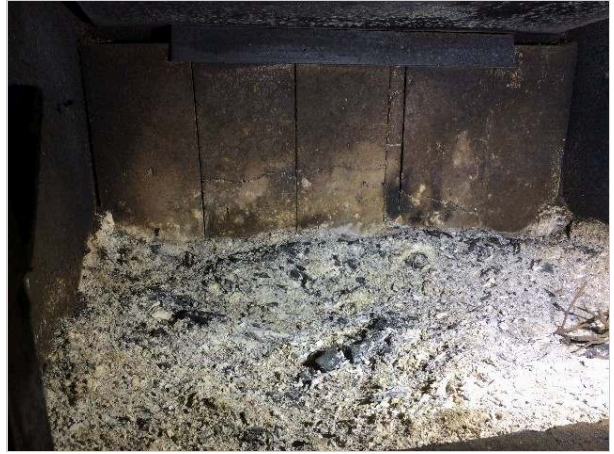
**Cracks were present in the firebox of the fireplace located in the basement.** Generally, firebox cracks are acceptable unless they are wide enough to fit a quarter into. The bricks and mortar inside the firebox are designed to act as a heat and spark shield and should be free of any voids. The firebox should be repaired and further assessed by a qualified chimney and fireplace service.

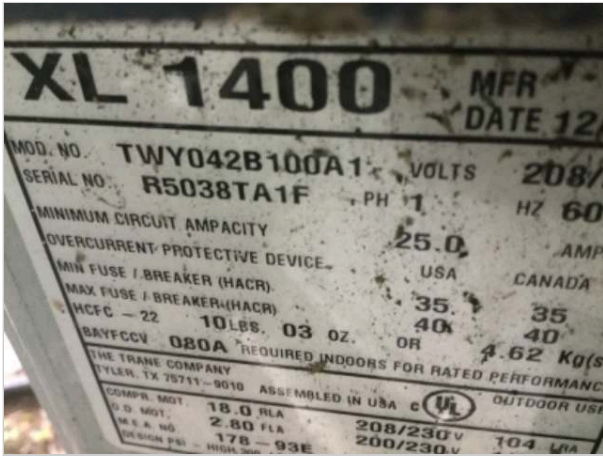
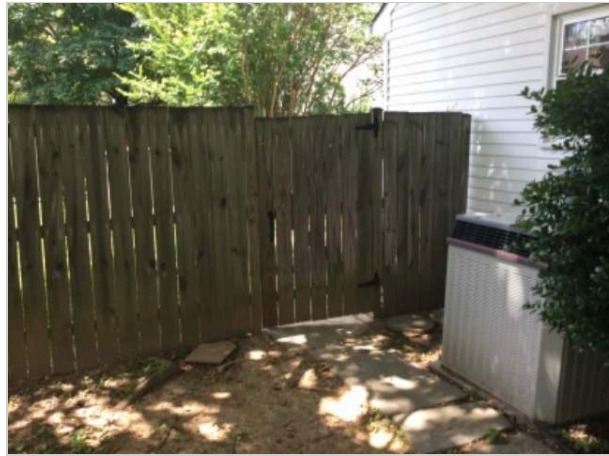
The air conditioner may be past its design life of 16-18 years. Unless noted otherwise, the system was functional at the time of the inspection. As with a light bulb that functions normally one day but the next may not turn on, a system's age is a helpful factor that assists in budgeting for eventual replacement.
