HOME INSPECTION REPORT

The inspected property consisted of a ranch wood-framed structure with plywood siding / cladding that was occupied at the time of the inspection. Minor, exterior type caulking and maintenance, painting are common on most homes and may be present but may or may not be specifically identified in this report. The approximate temperature at the time of the inspection was 70-75 degrees Fahrenheit, and the weather was sunny and clear. The utilities were on at the time of the inspection. The buyer was present during the inspection. The home was situated on a lightly sloped lot. The general grade around the home appeared to be mostly adequate to direct rain water away from the foundation. The age of the home, as reported by the building permits was said to be 37 years old.

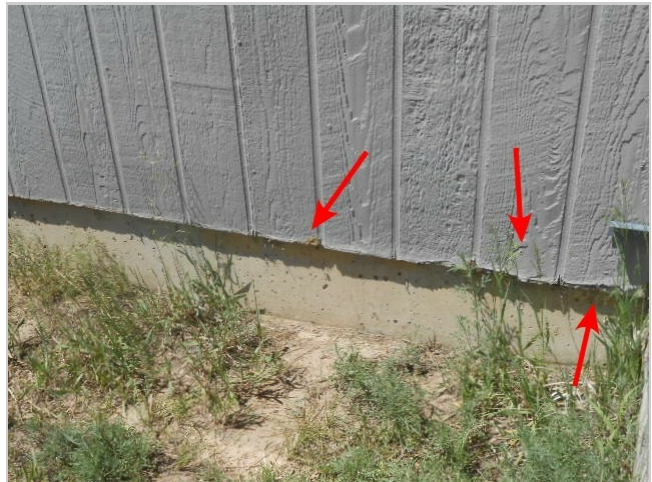
The siding and trim throughout the exterior of the home were in overall marginal condition. There were several areas throughout the exterior where the siding and trim was deteriorating and scraping, repairs, caulking and paint to match are needed. We recommend that a reputable contractor further evaluate the homes exterior and any recommendations for repairs and maintenance be completed prior to closing to prevent any further decay and to prevent possible water intrusion into the home or the homes structure.

- The siding and trim throughout the exterior of the home were in overall marginal condition. There were several areas throughout the exterior where the siding and trim was deteriorating and scraping, repairs, caulking and paint to match are needed. We recommend that a reputable contractor further evaluate the homes exterior and any recommendations for repairs and maintenance be completed prior to closing to prevent any further decay and to prevent possible water intrusion into the home or the homes structure.

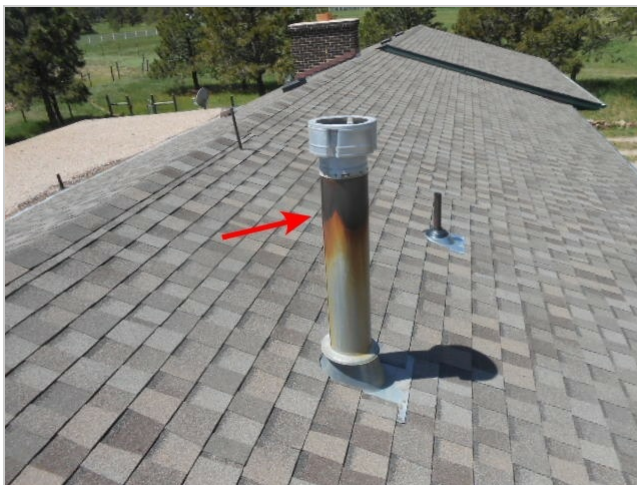
The furnace vent pipe (which penetrates the roof line) is rusted or deteriorated and is recommended to be replaced by a qualified HVAC contractor or roofer, prior to closing.

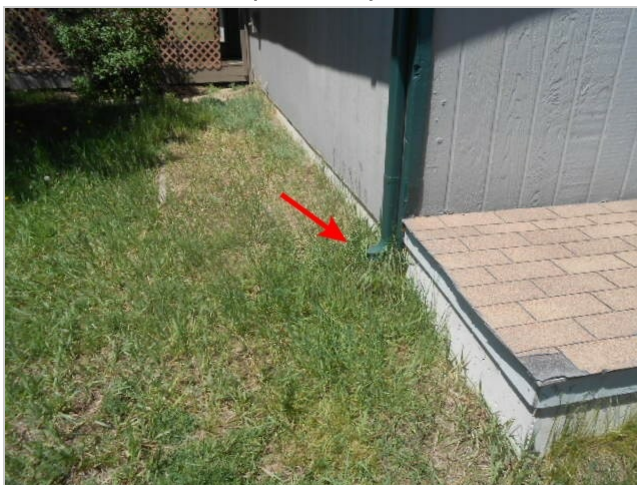
One of the downspouts on the left, rear of the home was missing the extension. This condition can allow for rain water to accumulate along the home and the possibility of water in the crawlspace if not repaired.

- One of the downspouts on the left, rear of the home was missing the extension. This condition can allow

for rain water to accumulate along the home and the possibility of water in the crawlspace if not repaired.
