HomeTeam[®]
INSPECTION SERVICE

HOME INSPECTION REPORT

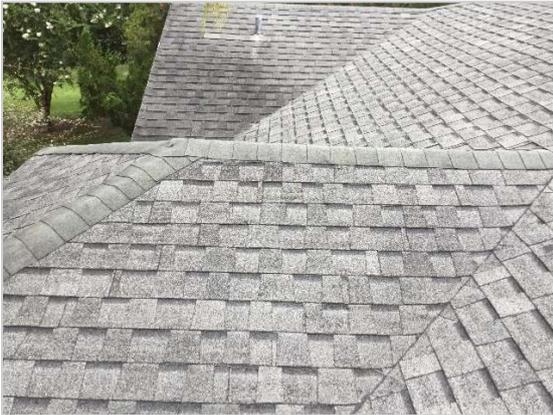
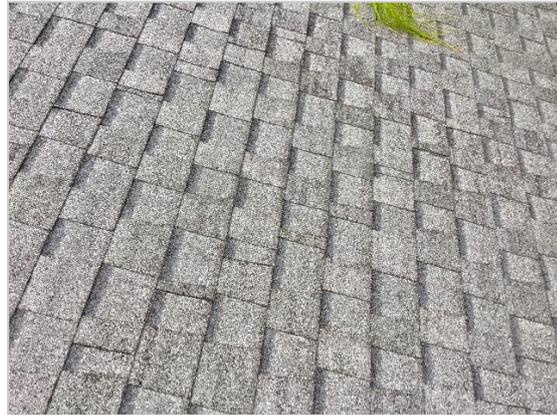
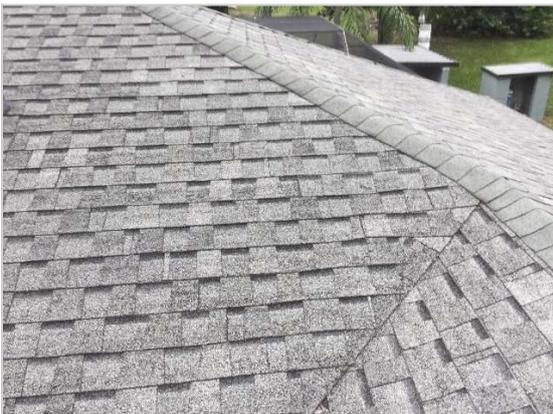
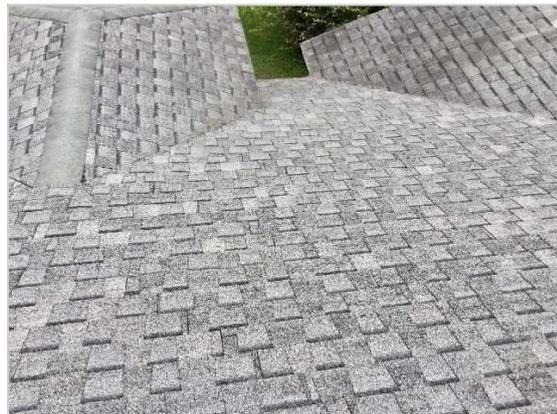
- **The age and physical condition of the shingles indicate they are nearing the end of their useful life. There were no active leaks observed in the attic space. A licensed roofing company should be called to evaluate the roof.**

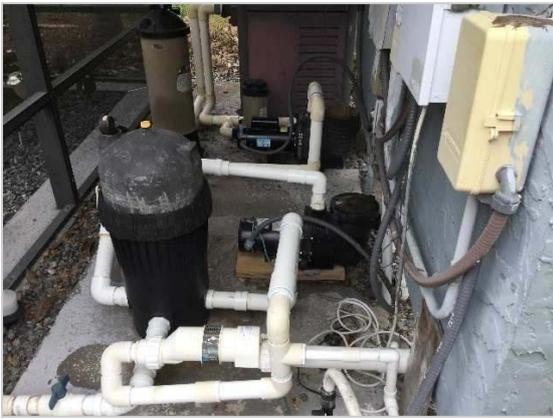
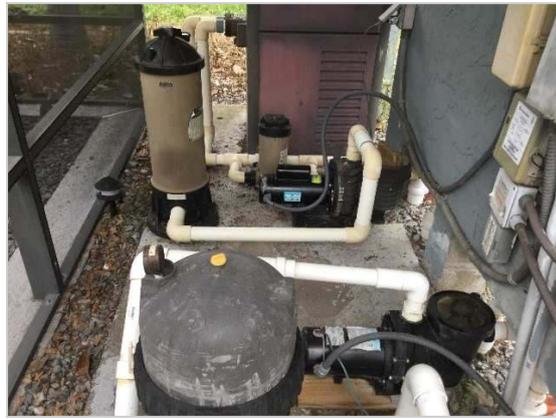
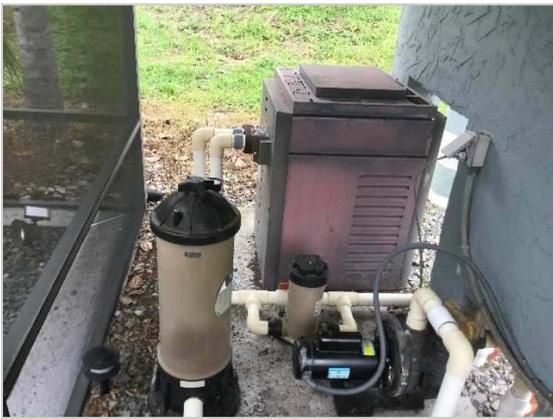
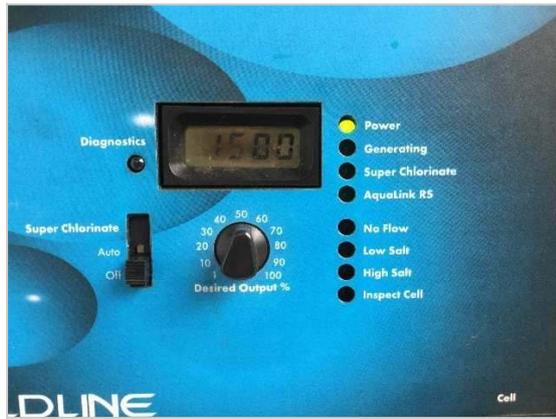
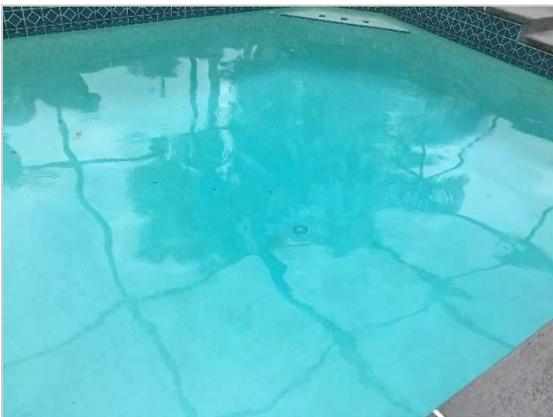
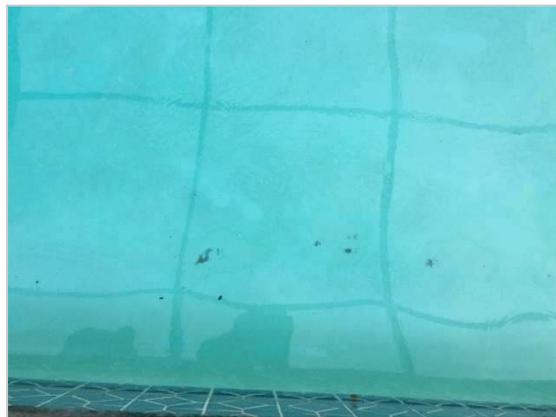
- The pool was originally designed to be used as a salt system but chlorine was being used. The salt equipment was disconnected and it is not known if it is functional. The pool surfaces were worn and pitted, indicating the pool will need to be re-surfaced later. A licensed pool company should be called to further evaluate the equipment.

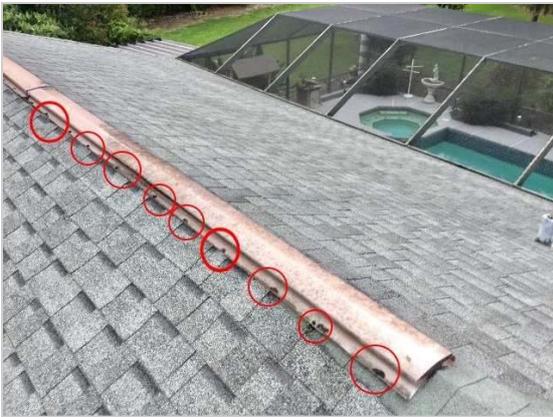
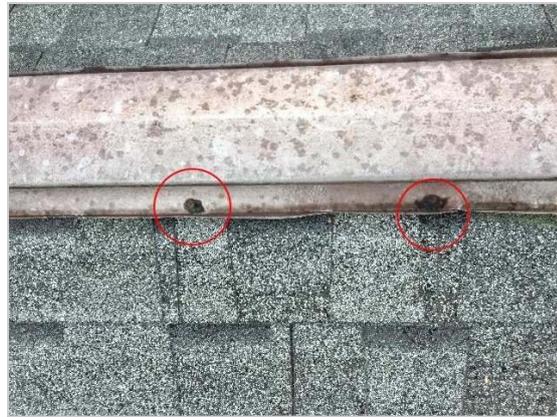
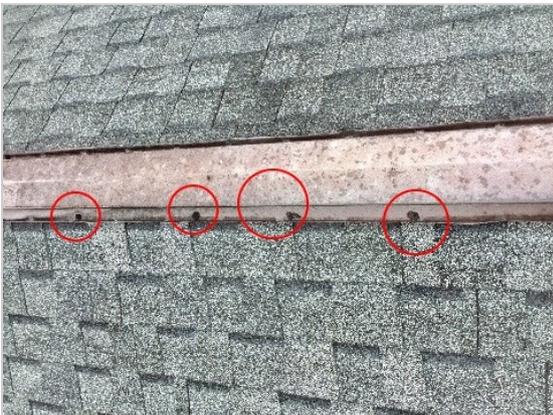
- The nails securing the ridge vents were very rusted and a few have pulled through the metal. This issue should be corrected ASAP to prevent water intrusions from blowing rains. A licensed roofing company should be called to address this issue.

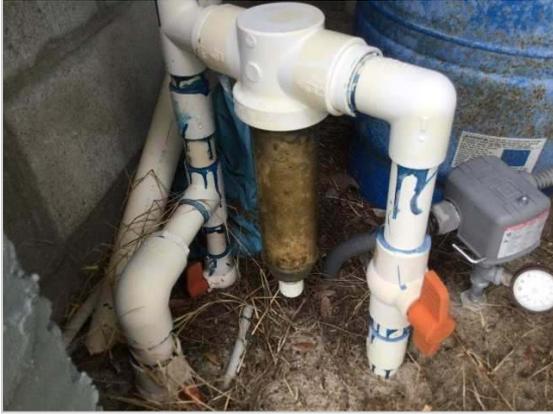
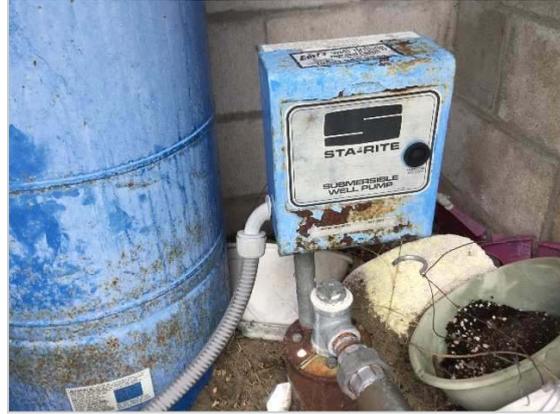
- There was a filter at the well that needs monthly maintenance. The power box at the well was very rusted and should be monitored for failure. The equipment at the well is older but functional at the time.

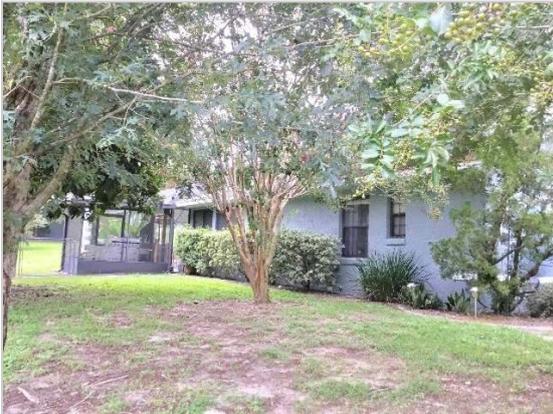
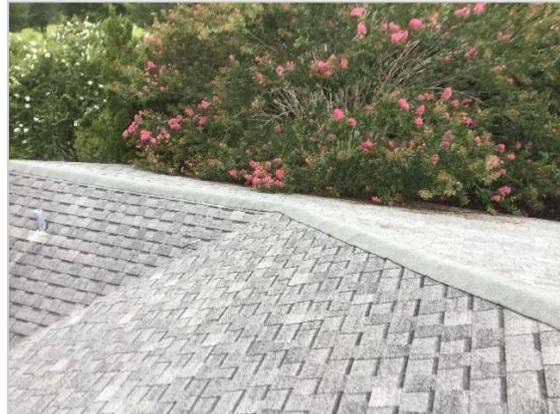
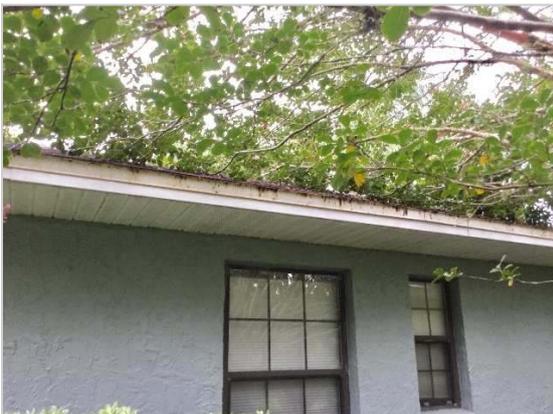
- There was a tree making contact with the home and/or roof. The tree should be removed before damage occurs to the home.

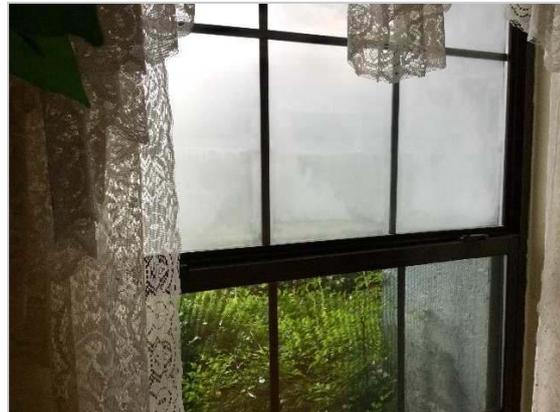
- One or more of the insulated window panes throughout the home had a defective thermal seal. A defective thermal seal can be identified when fogging is observed between the panes of glass. A defective thermal seal does not affect the performance of the window. Repair of the thermal seal can be accomplished by replacing the affected glass panel.

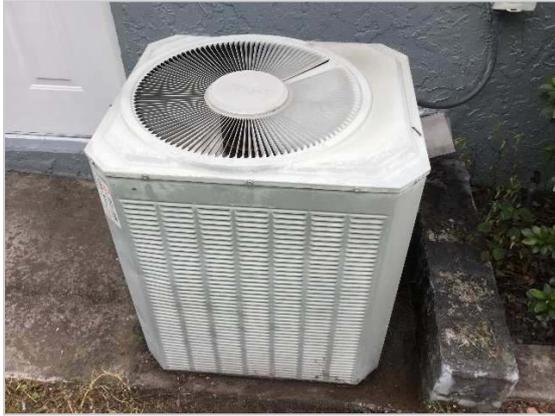
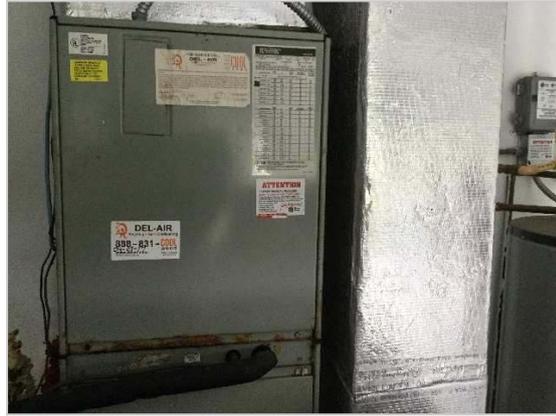
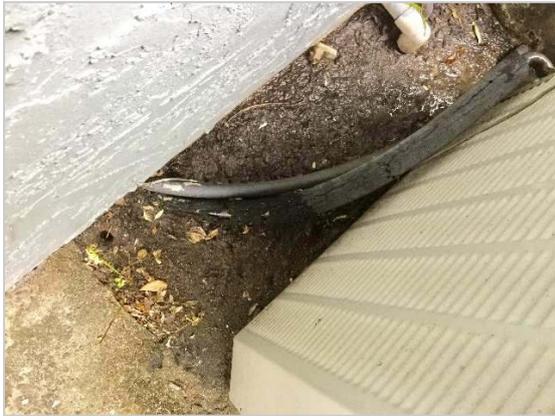
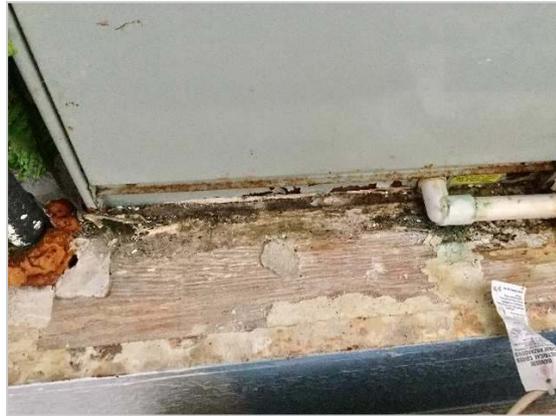
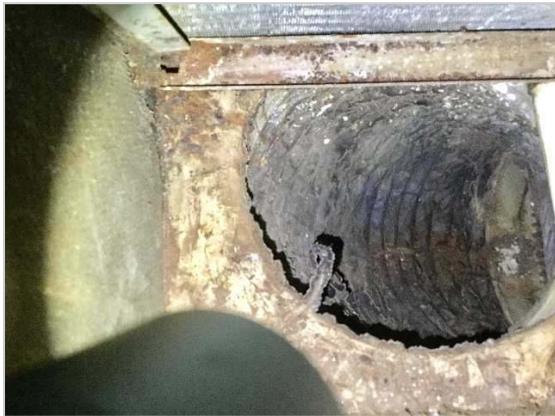
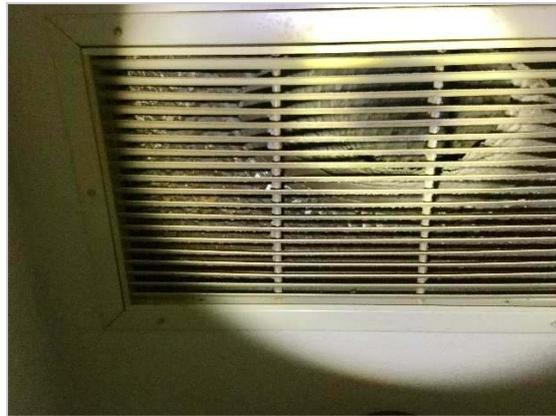
- Due to the age and physical condition of the entire HVAC system, a complete evaluation and

cleaning (including the air handler platform, ductwork and outside line set) of the system is recommended. The HVAC system is functional at this time but is nearing the end of its life expectancy.

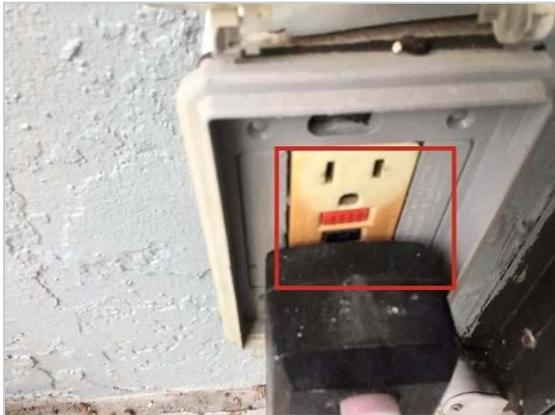
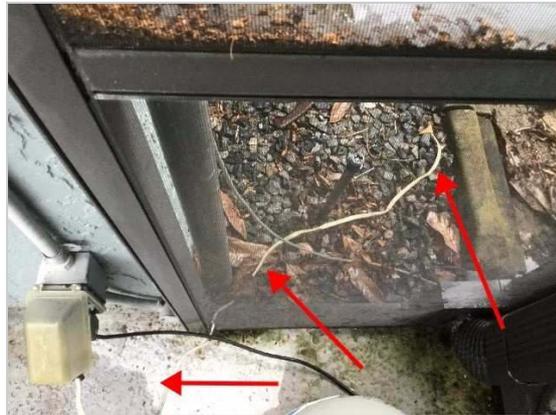
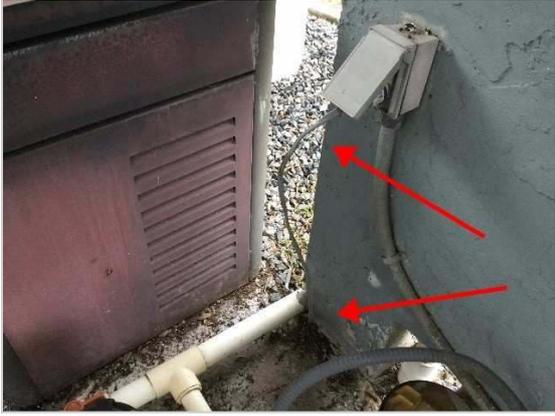
- Evidence of amateur wiring was noted at the exterior of the home. Amateur wiring does not conform to standards methods and could be a safety concern. Consult with a qualified electrician for evaluation and repairs as required.

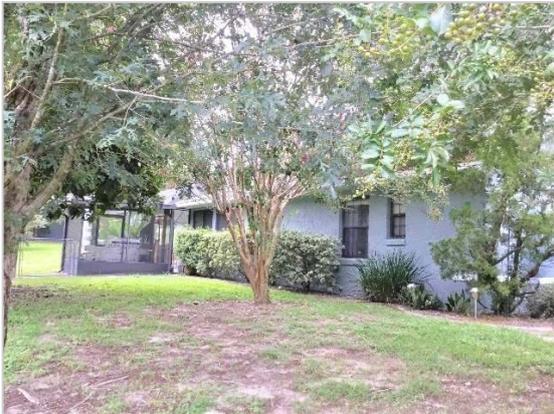
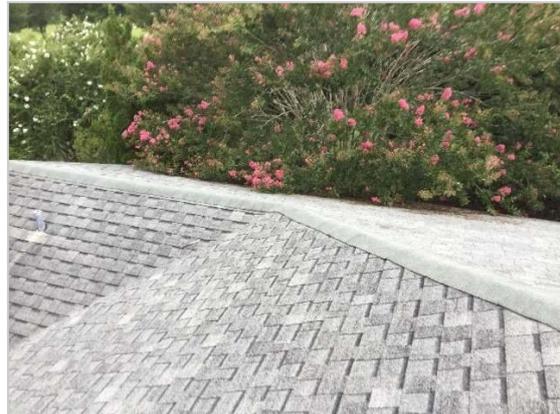
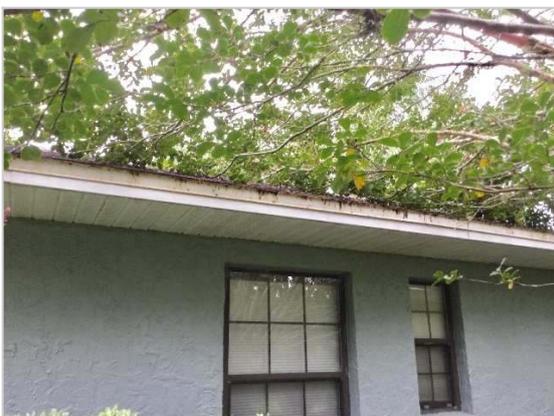
There was a tree making contact with the home and/or roof. The tree should be removed before damage occurs to the home.

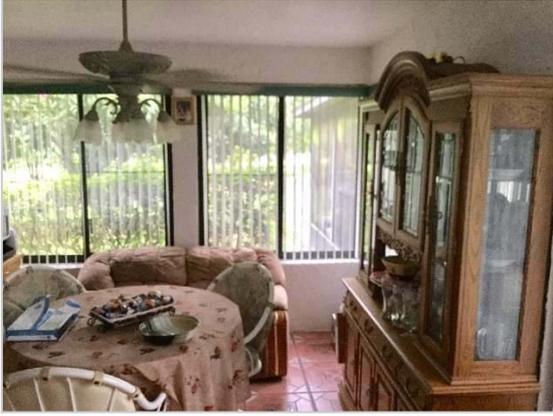
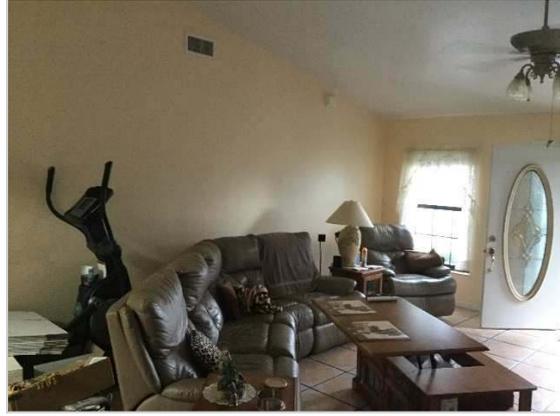
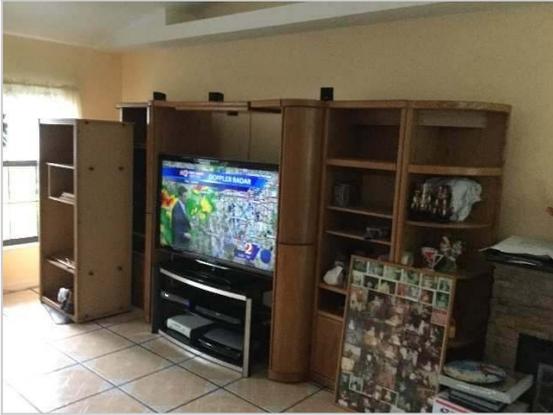
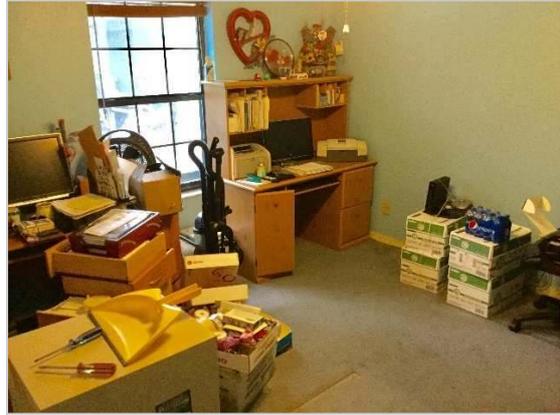
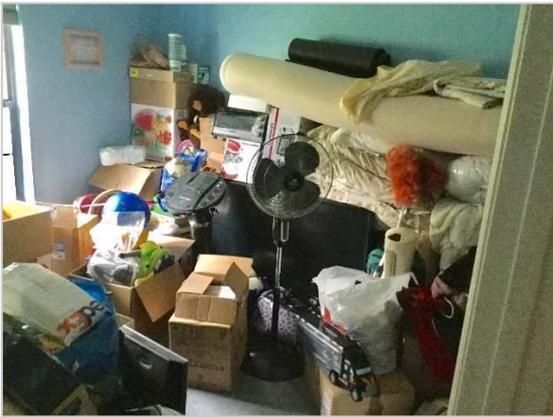
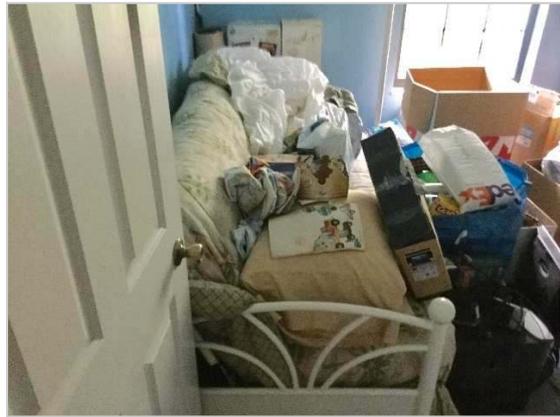
The living areas and garage were filled with many stored items and/or shelves at the time of inspection, therefore several areas were unable to be inspected.

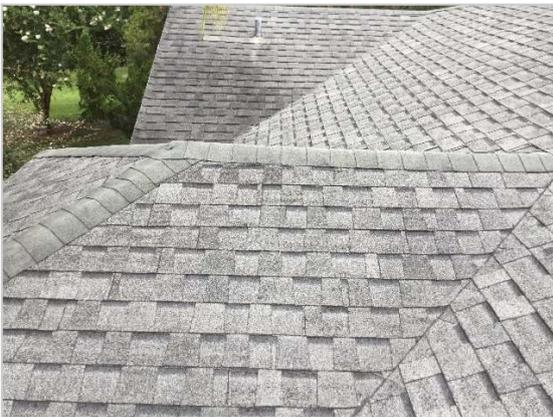
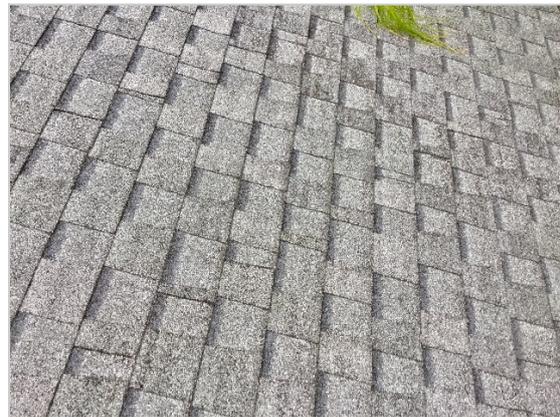
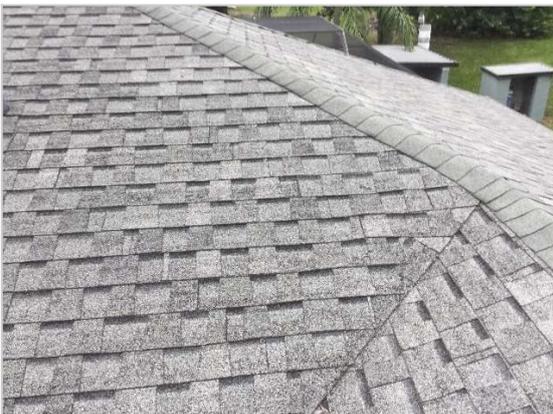
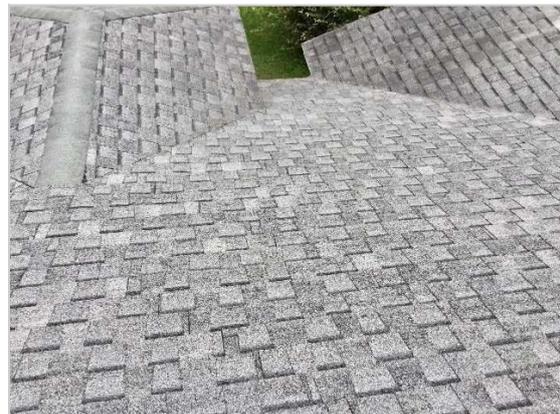
The age of the roof covering as reported by the county web site was 13 years old. There was one layer of shingles on the roof at the time of the inspection. There was moderate curling and substantial surface wear observed on the roof shingles at the time of the inspection. These conditions indicate the roof shingles were in the late second half of their useful life.

The age and physical condition of the shingles indicate they are nearing the end of their useful life. There were no active leaks observed in the attic space. A licensed roofing company should be called to evaluate the roof.

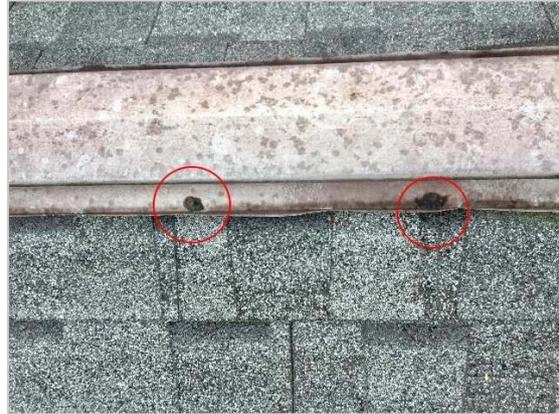
The nails securing the ridge vents were very rusted and a few have pulled through the metal. This

issue should be corrected ASAP to prevent water intrusions from blowing rains. A licensed roofing company should be called to address this issue.

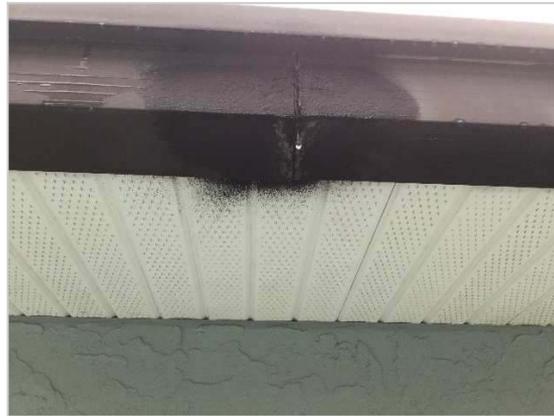
The gutters in the rear of the home was damaged and should be repaired.

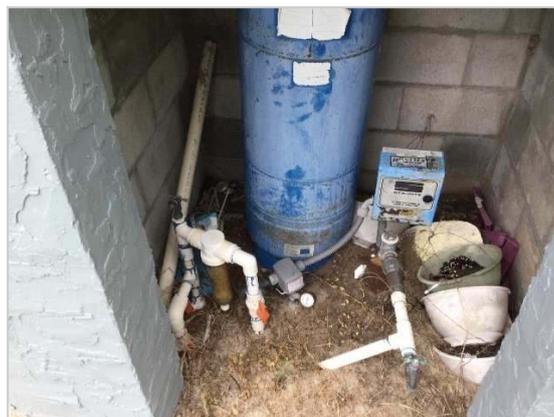
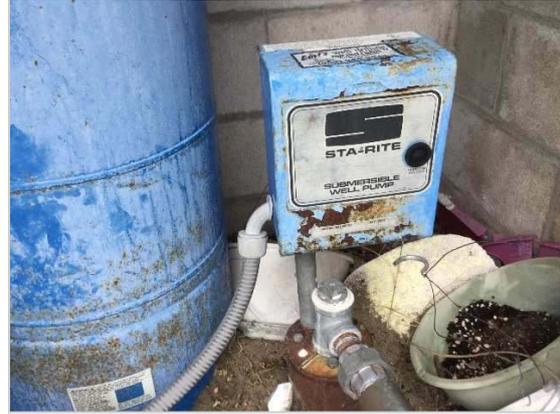
The well was located in the right rear of the home. The shut-off was located at the well. **Defects were observed at the well at the time of the inspection.**

There was a filter at the well that needs monthly maintenance. The power box at the well was very rusted and should be monitored for failure. The equipment at the well is older but functional at the time.

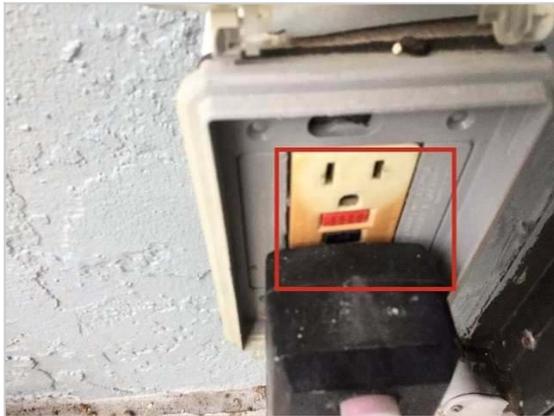
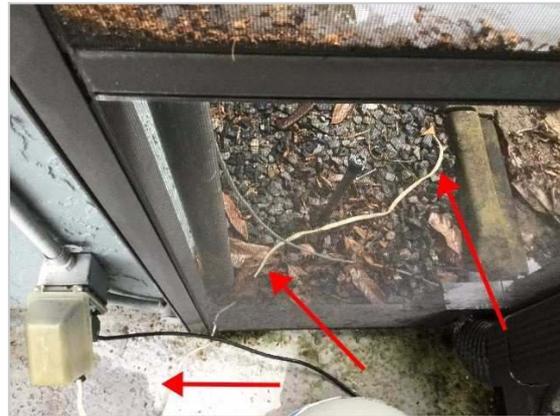
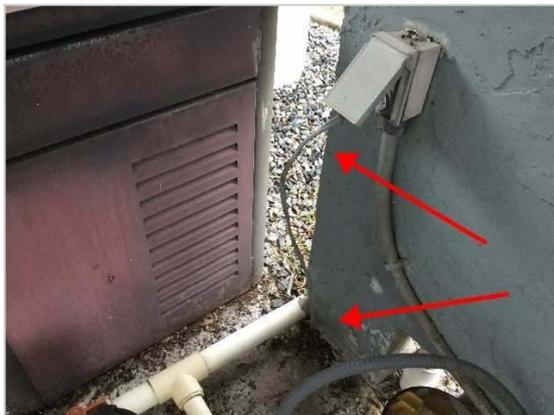
Evidence of amateur wiring was noted at the exterior of the home. Amateur wiring does not conform to standards methods and could be a safety concern. Consult with a qualified electrician for evaluation and repairs as required.

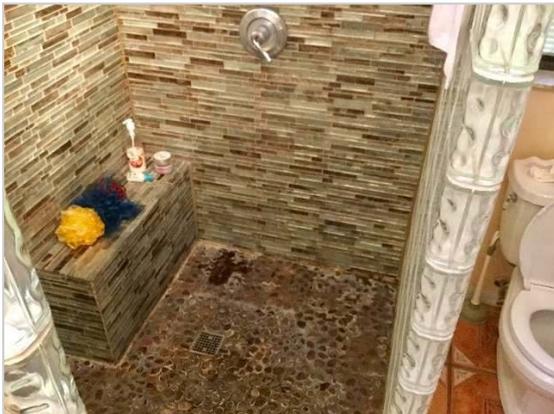
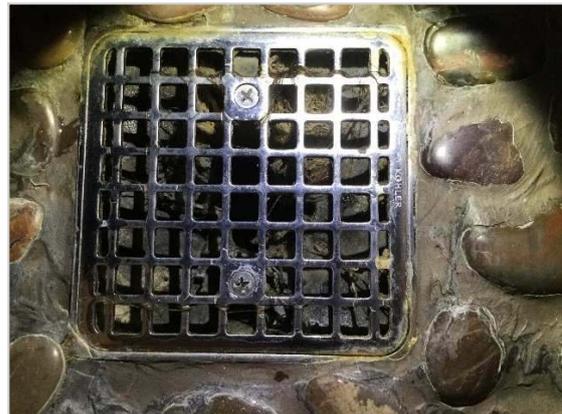
The rock floor in the master shower was not professionally done and not properly pitched. Although the shower appears to drain properly, caution should be used when entering the area.

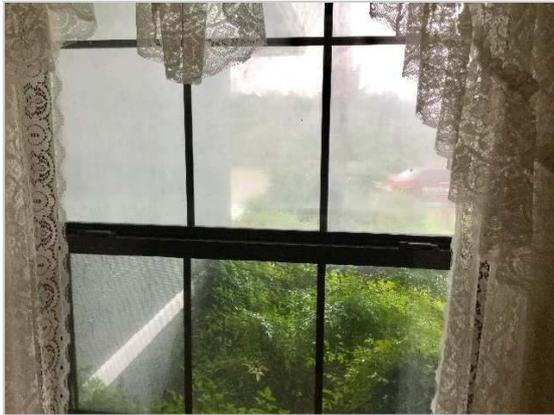
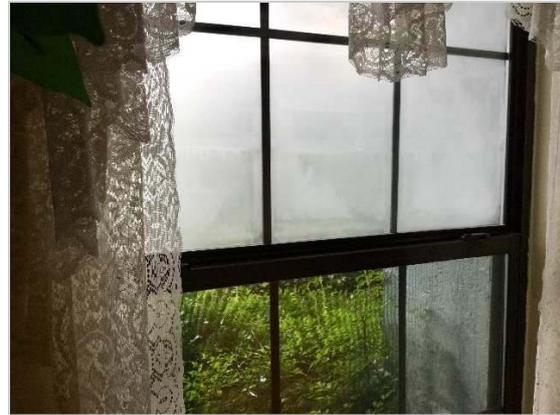
One or more of the insulated window panes throughout the home had a defective thermal seal. A defective thermal seal can be identified when fogging is observed between the panes of glass. A defective thermal seal does not affect the performance of the window. Repair of the thermal seal can be accomplished by replacing the affected glass panel.

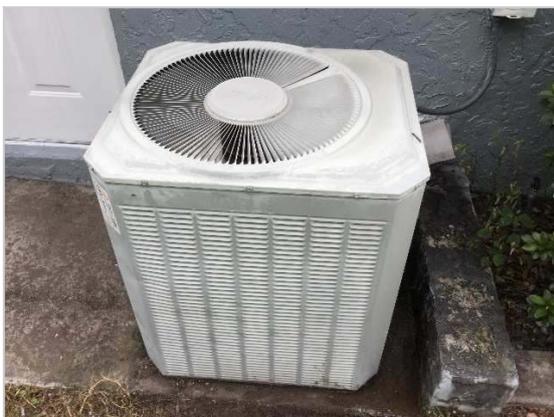
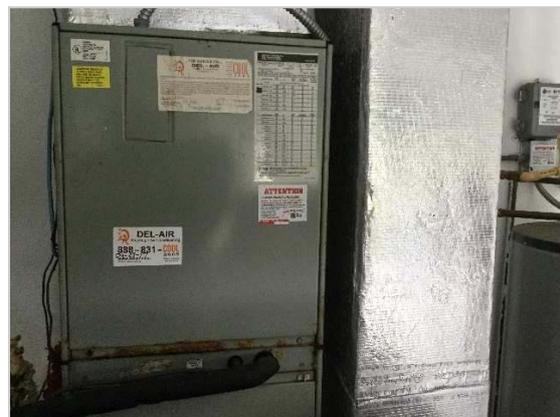
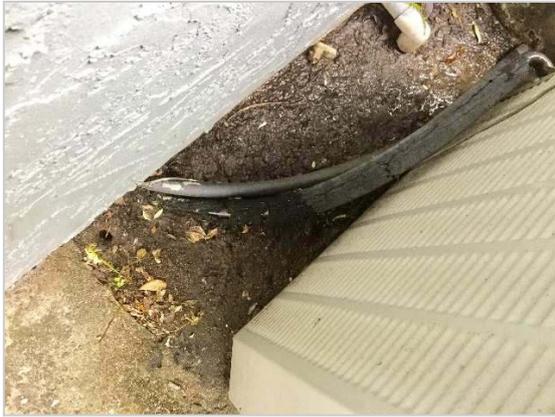
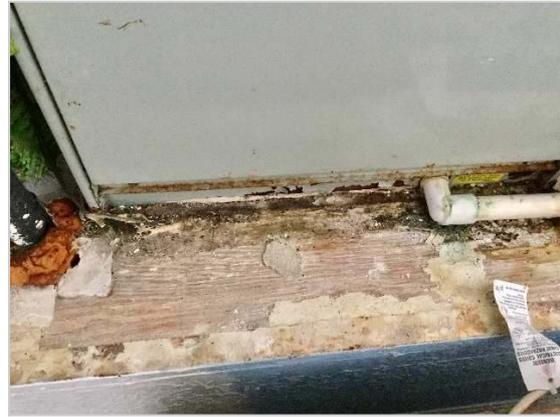
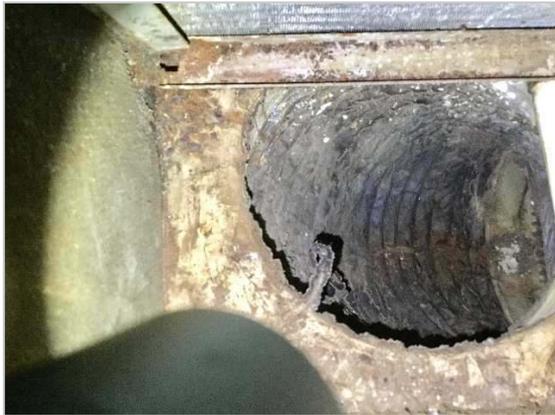
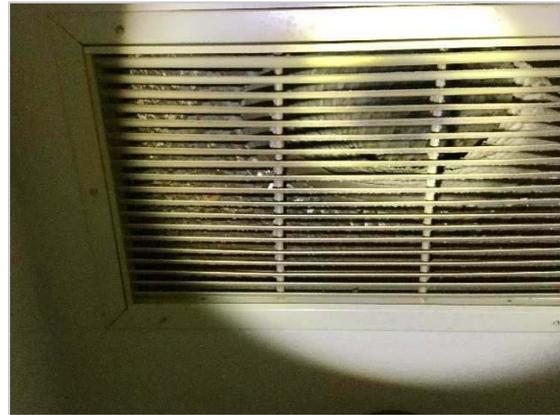
Due to the age and physical condition of the entire HVAC system, a complete evaluation and cleaning (including the air handler platform, ductwork and outside line set) of the system is recommended. The HVAC system is functional at this time but is nearing the end of it's life expectancy.

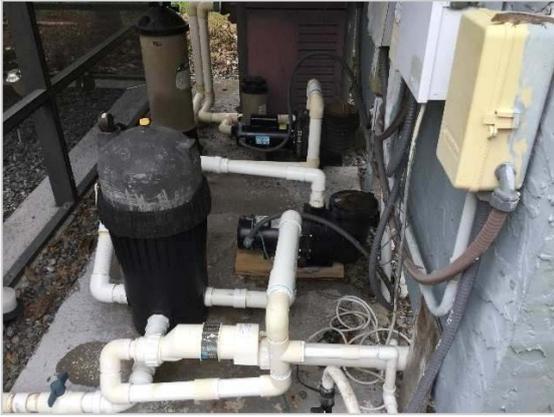
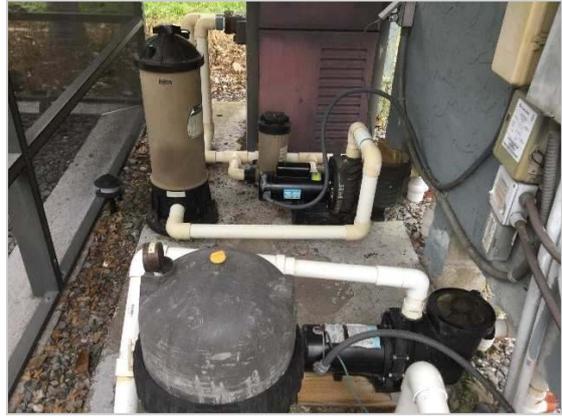
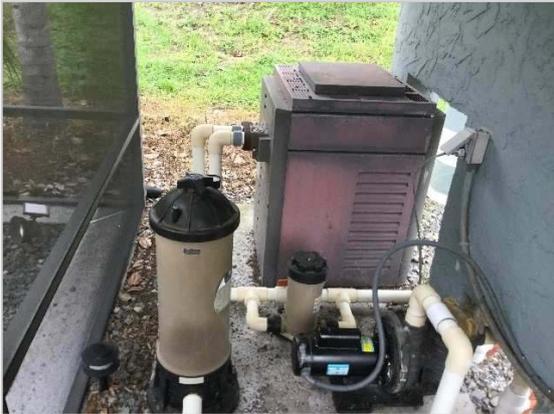
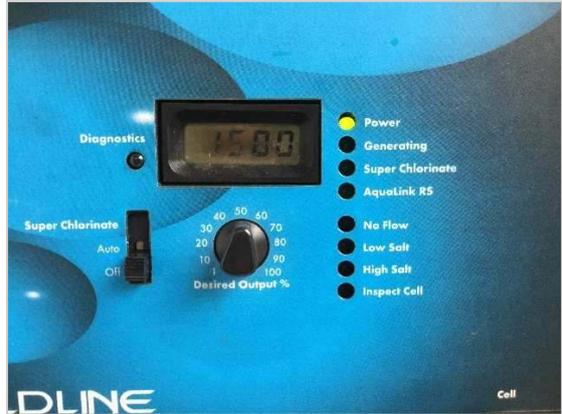
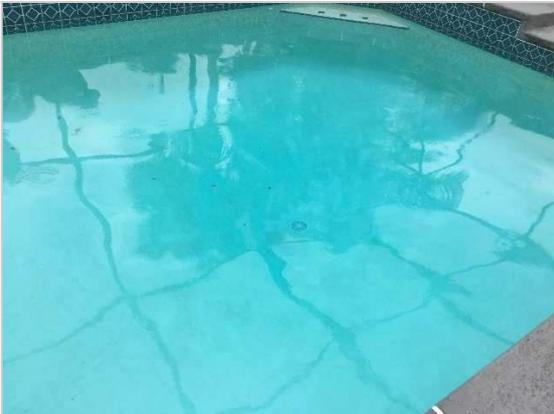
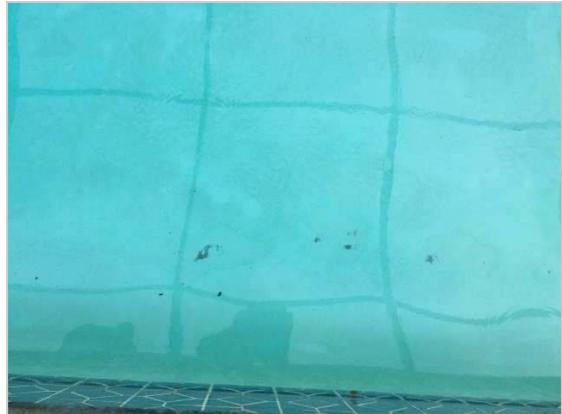
The pool was originally designed to be used as a salt system but chlorine was being used. The salt equipment was disconnected and it is not known if it is functional. The pool surfaces were worn and

pitted, indicating the pool will need to be re-surfaced later. A licensed pool company should be called to further evaluate the equipment.
