# HomeTeam<sup>®</sup>

### *HOME INSPECTION REPORT*

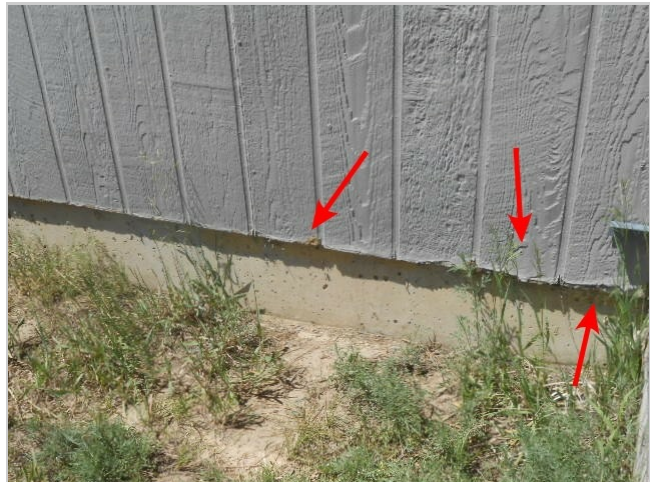
The siding and trim throughout the exterior of the home were in overall marginal condition. There were several areas throughout the exterior where the siding and trim was deteriorating and scraping, repairs, caulking and paint to match are needed. We recommend that a reputable contractor further evaluate the homes exterior and any recommendations for repairs and maintenance be completed prior to closing to prevent any further decay and to prevent possible water intrusion into the home or the homes structure.

- The siding and trim throughout the exterior of the home were in overall marginal condition. There were several areas throughout the exterior where the siding and trim was deteriorating and scraping, repairs, caulking and paint to match are needed. We recommend that a reputable contractor further evaluate the homes exterior and any recommendations for repairs and maintenance be completed prior to closing to prevent any further decay and to prevent possible water intrusion into the home or the homes structure.

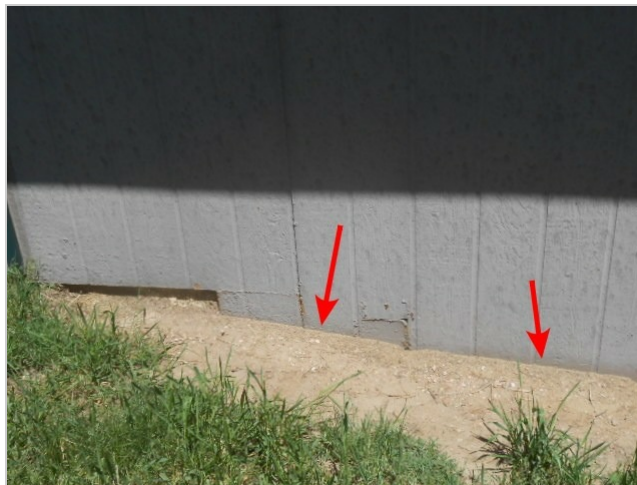
Some of the exterior siding on the rear of the home is in contact or is under the ground or earth. This condition can lead to wood rot or insect intrusion if not corrected. Further evaluation is recommended by a qualified contractor, prior to closing.

This section of siding on the rear of the home is in contact with the ground or earth.

- Some of the exterior siding on the rear of the home is in contact or is under the ground or earth. This condition can lead to wood rot or insect intrusion if not corrected. Further evaluation is recommended by a qualified contractor, prior to closing.

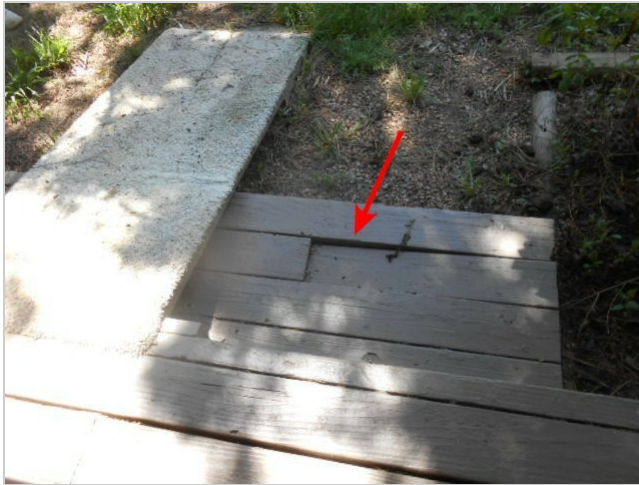
The underside of the deck was unable to be fully inspected due to the deck being very close to the ground or earth below. There were however several deck boards that were loose or were deteriorated indicating the need for further evaluation and repairs to the deck ( as needed ) by a qualified contractor, prior to closing.

Loose or deteriorated deck board on the rear deck.

- The underside of the deck was unable to be fully inspected due to the deck being very close to the ground or earth below. There were however several deck boards that were loose or were deteriorated indicating the need for further evaluation and repairs to the deck.
- Many of the older windows and both of the sliding glass doors in the home have a loss of vacuum seal and condensation is present between the window panes.
- All of the window screens and the sliding door screens in the home were found to be missing at the time of inspection.
- The water heater in this home will probably be in need of replacement within the next 1-5 years.

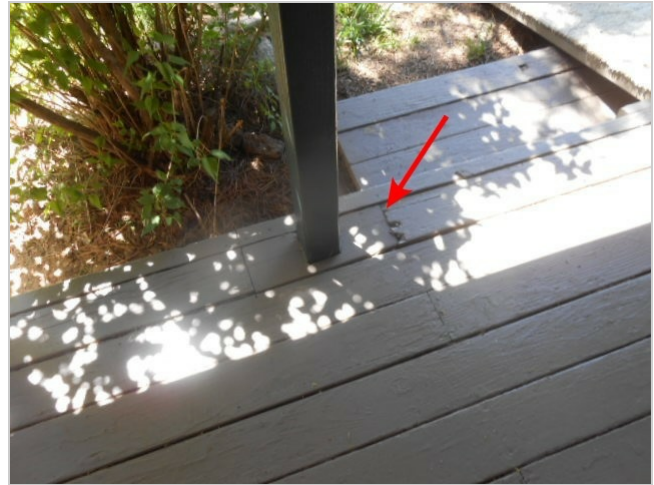
Loose or deteriorated deck boards on the rear deck.

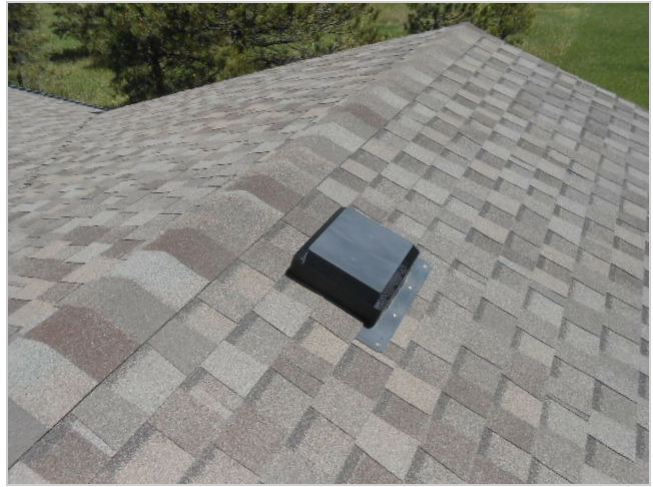
The transition roof flashing ( where the house roof meets the patio roof ) is loose or is unsecured indicating the need for further evaluation and repairs by a qualified roofer, prior to closing.

- The transition roof flashing ( where the house roof meets the patio roof ) is loose or is unsecured indicating the need for further evaluation and repairs by a qualified roofer, prior to closing.

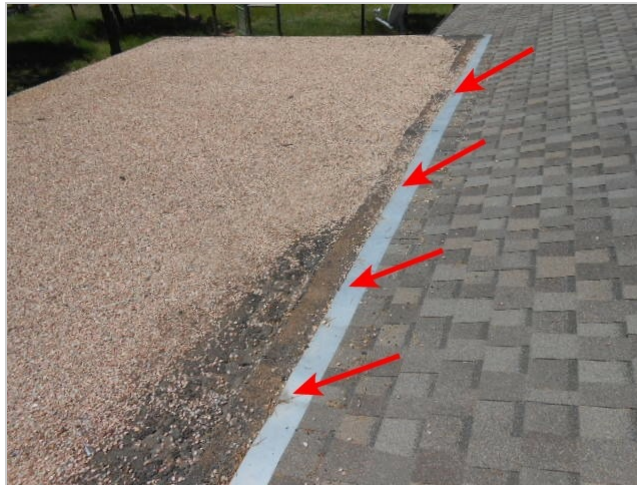
This transition roof flashing is loose or is not secured which can lead to roof leakage if not repaired.

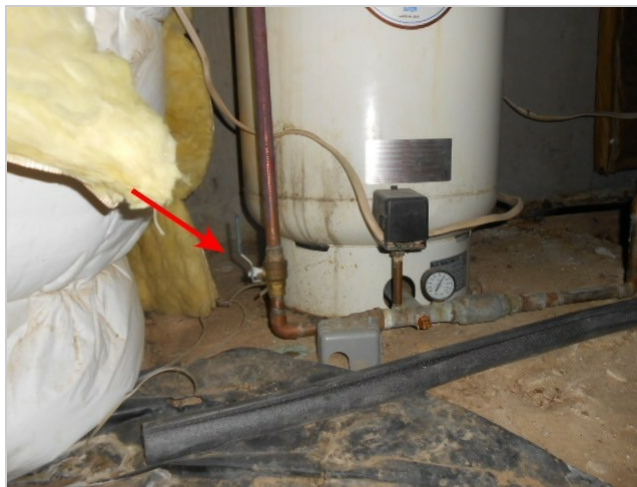
This is the main water shut off valve for the home.

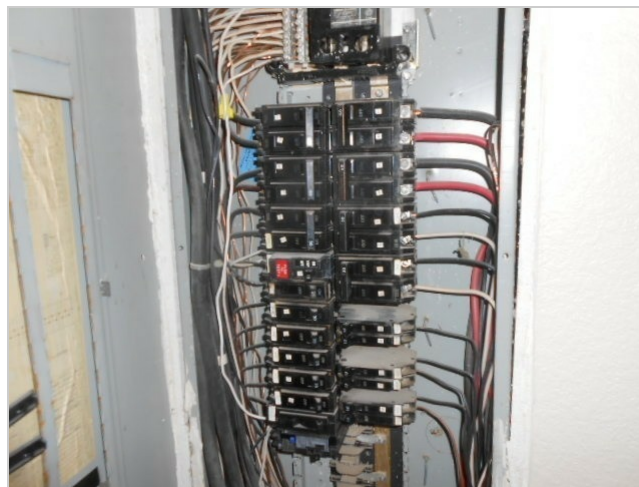
The electrical panel cover was removed for inspection of the house wiring, circuits and breakers.
