HOME INSPECTION REPORT

On November 19, 2016 The HomeTeam Inspection Service made a visual inspection of 123 Sample Road, Charlton, MA 01507. Enclosed please find a written, narrative report of our findings in accordance with the terms of our Inspection Agreement.

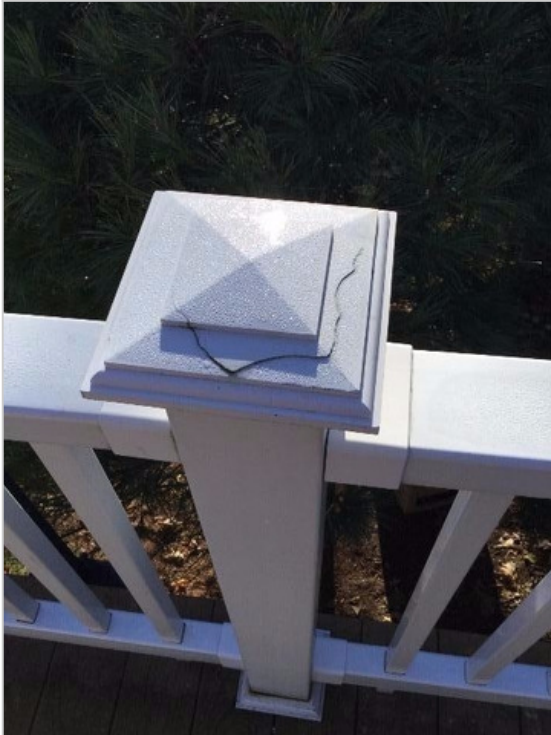
Photo 6

Crack in top cap of post. Non-structural - just visual impairment.

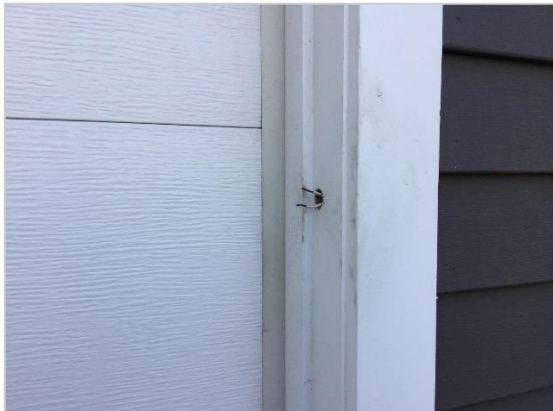
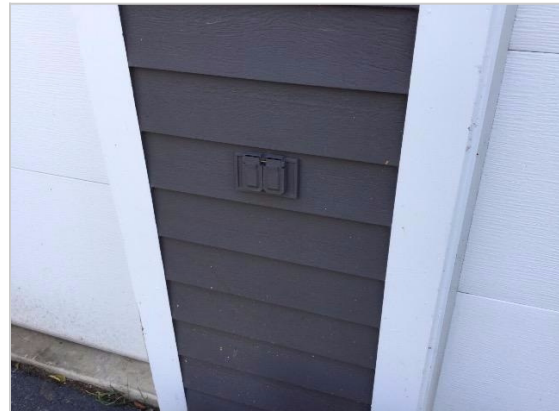
The automatic garage door opener was not functional at the time of the inspection. Consult with a

garage door service for evaluation and repair. Needs button replaced.

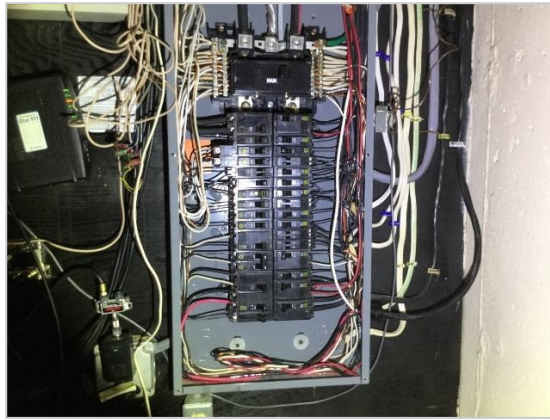
Photo 17

A circuit breaker in the electric panel had two attached circuits (wires). Each circuit should have its own dedicated breaker to prevent nuisance tripping and ensure good terminal contact, which may help prevent overheating. This situation is commonly referred to as a "double-tap". An electrician should repair this condition and further assess the panel for any additional required repairs.

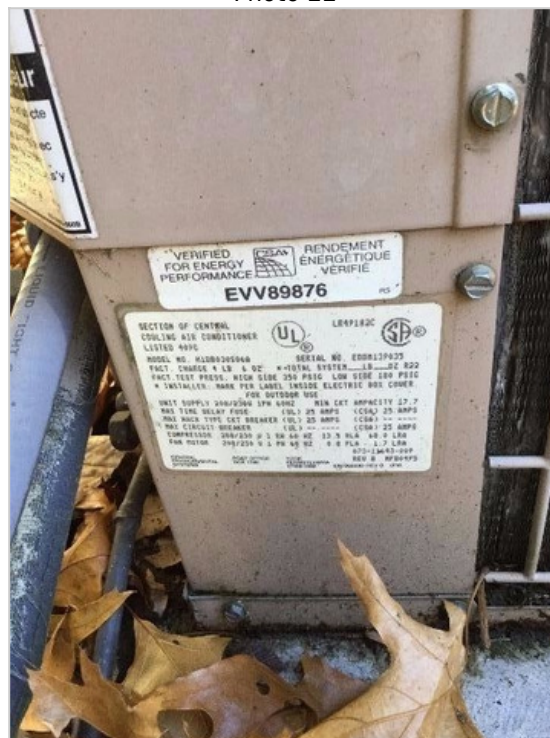
Photo 22

Because of its condition and performance at the time of the inspection, **the HVAC system requires cleaning and servicing by a professional HVAC technician.** At that time, the technician will test refrigerant levels, service the equipment to improve its performance, and perform other tests beyond the scope of the home inspection to assess and identify any additional areas that may require attention.

Gaps were observed around the HVAC air intake and refrigerant line. These gaps should be sealed to prevent moisture and pest intrusion.
