HomeTeam[®]

HOME INSPECTION REPORT

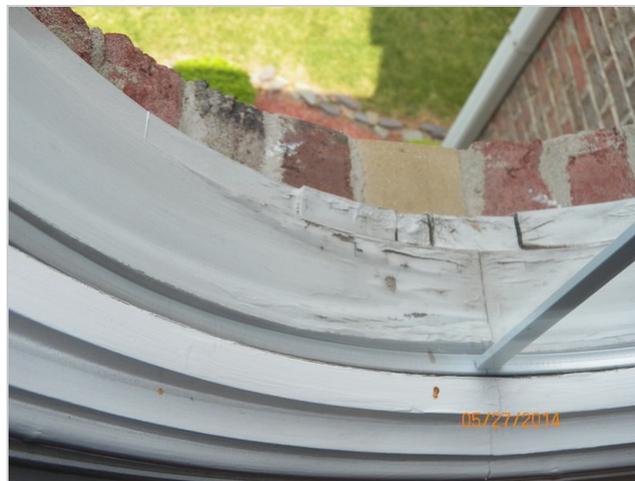
NOTE: The exterior wood trim at the second level oval window had minor wood deterioration at the bottom. We recommend consulting a qualified professional for repairs.

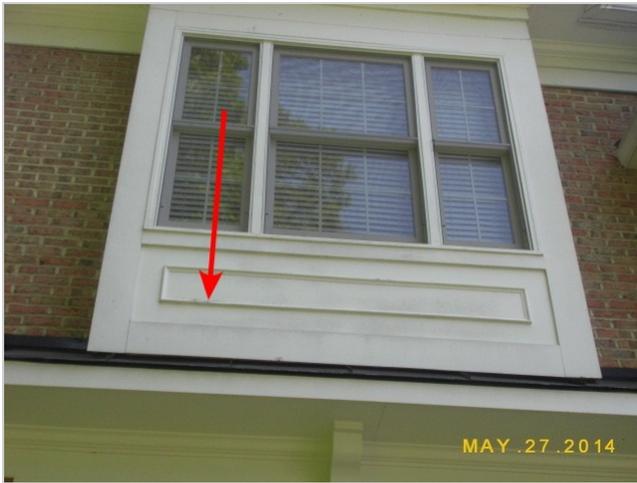
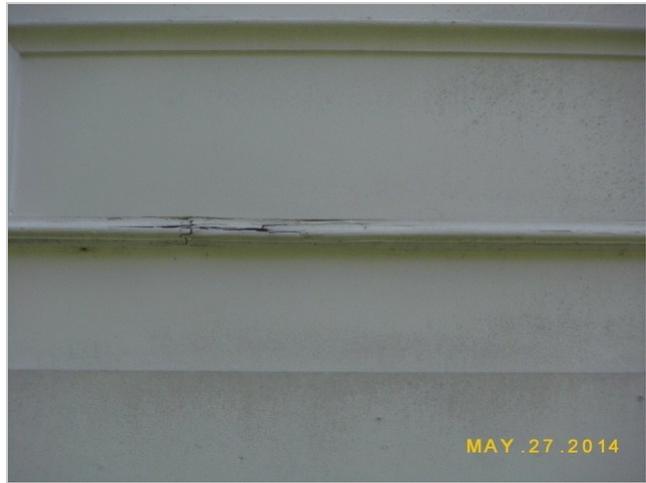
NOTE: The exterior wood trim at the front, second level window had minor damage. This damage can be easily repaired during routine maintenance.

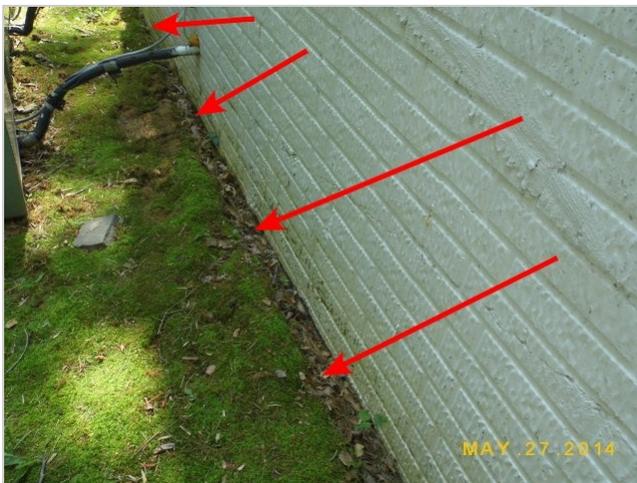
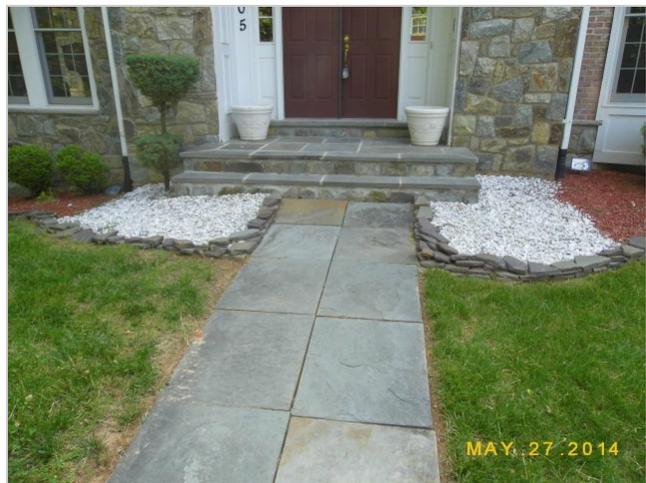
NOTE: The surface grading around the foundation is inadequate at the left side of the home. We recommend consulting a qualified professional for proper grading to prevent foundation damage and water penetration.

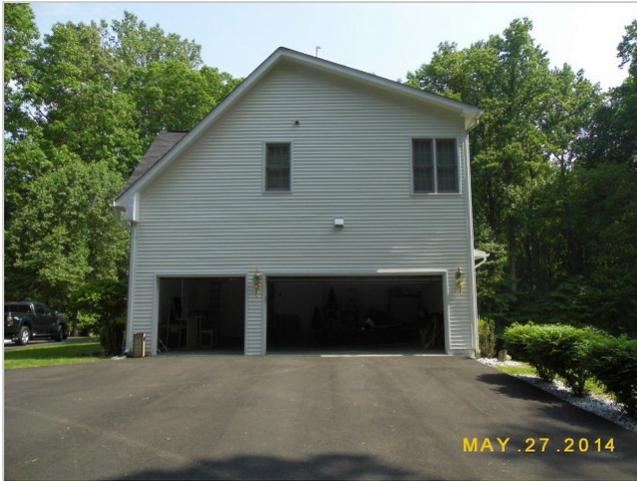
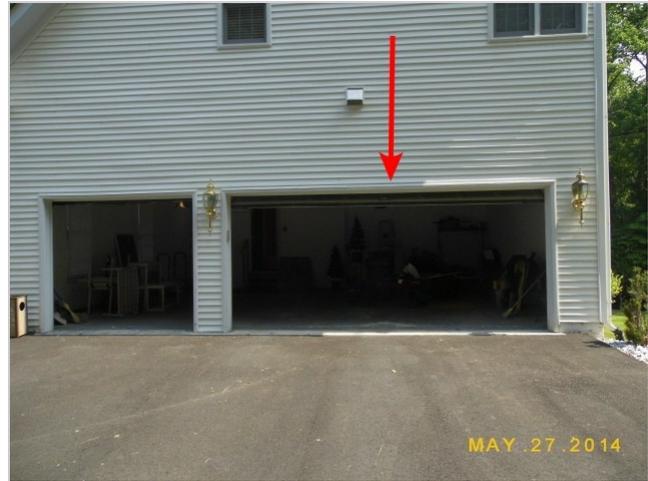
NOTE: The right garage door opener was nonfunctional. We recommend consulting a qualified professional to evaluate and repair or replace as need.

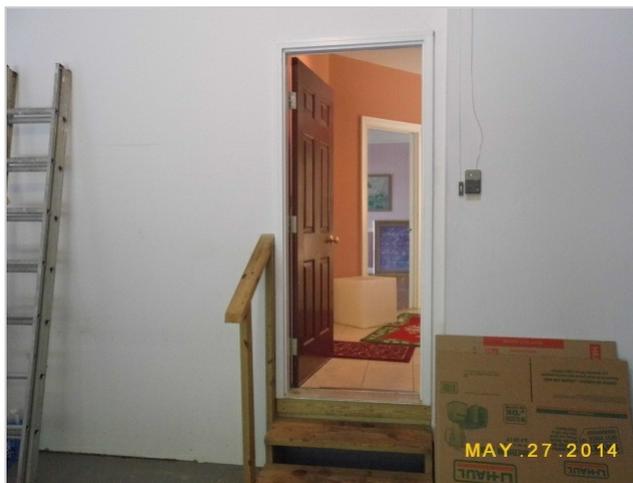
NOTE: The door between the garage and home was a wood door and not self closing. We recommend having the door replaced.

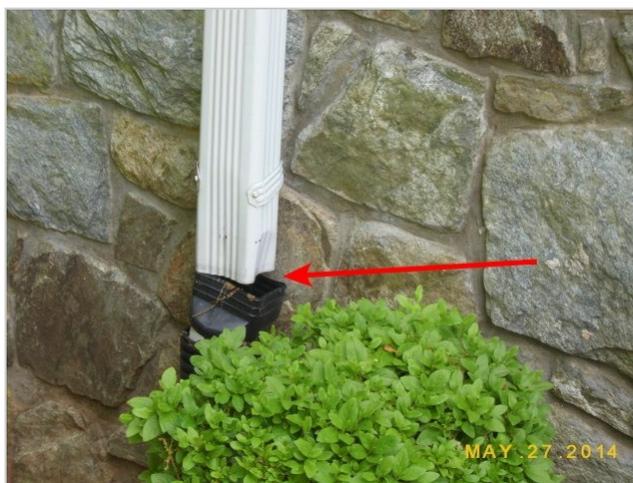
NOTE: The underground downspout was not properly attached. We recommend having the downspout properly attached.

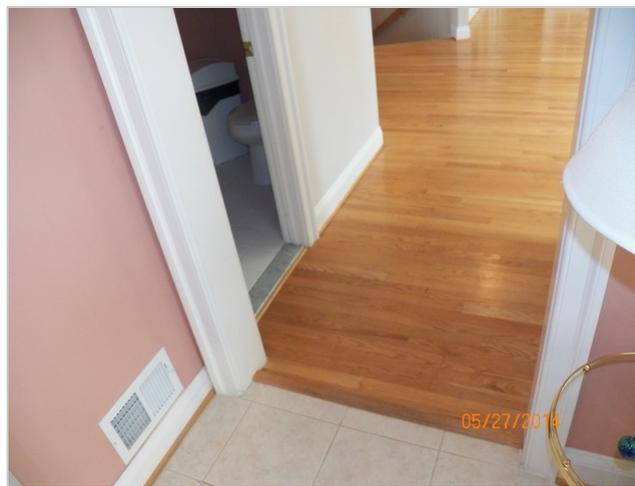
NOTE: The floor had a significant slope at the kitchen entryway by the first level powder room. Therefore, the powder room floor tile has cracked. We recommend consulting a qualified professional to evaluate the cause of the slope, correct the slope and replace the cracked tile.

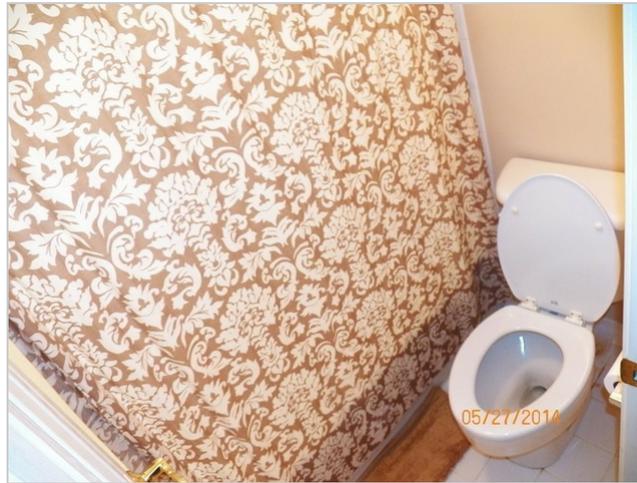
NOTE: The jack&jill bathroom toilet on the second level was nonfunctional. We recommend consulting a licensed plumber to evaluate and repair or replace the toilet as needed.

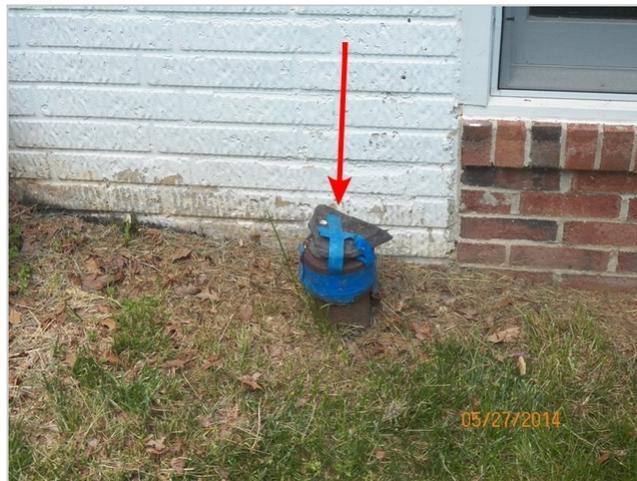
NOTE: The septic clean-out cover was damaged. We recommend consulting a licensed plumber for repairs.

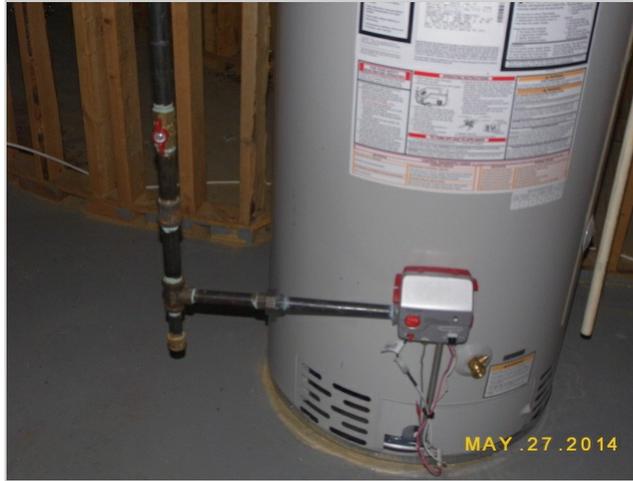
NOTE: There was a gas odor at the water heater. We recommend consulting a licensed plumber to evaluate and correct as needed.

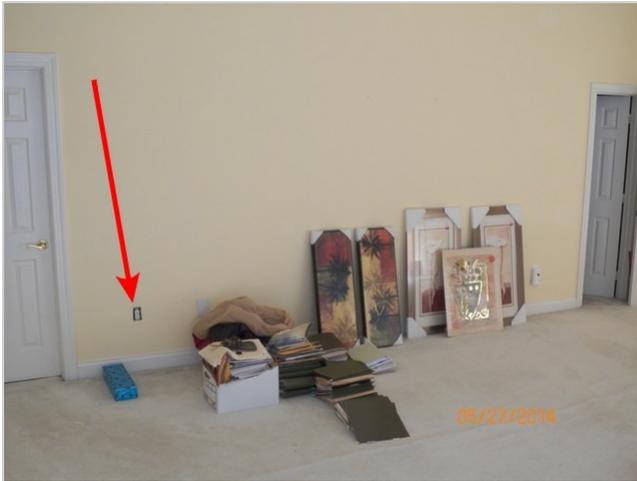
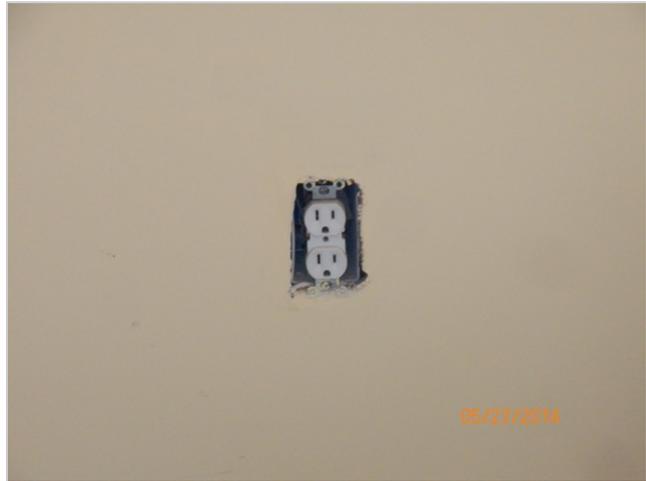
NOTE: The master bedroom front wall right outlet was missing a cover plate. For safety reasons, we recommend having a cover plate installed.

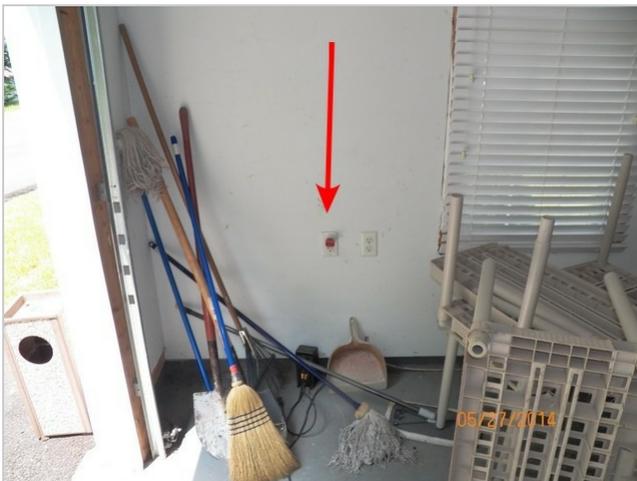
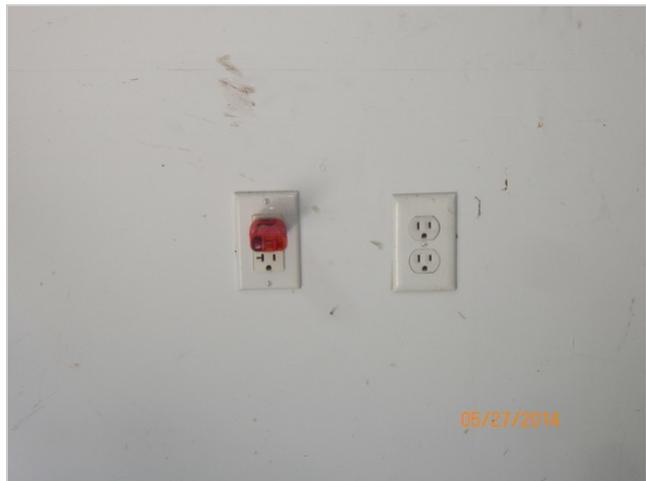
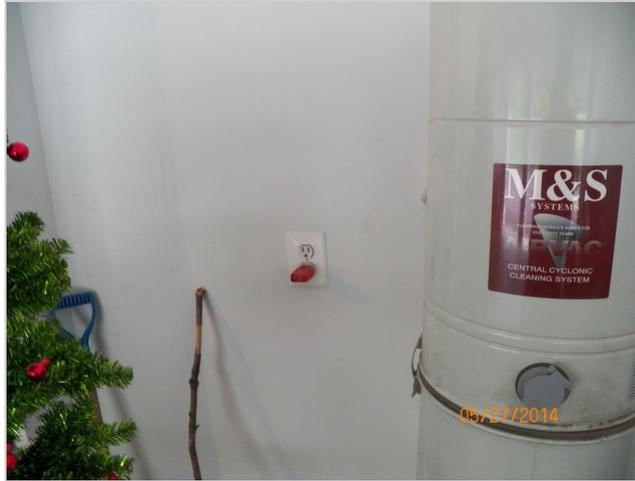
NOTE: The garage GFCI outlet would not reset, and therefore two garage outlets and all exterior outlets were nonfunctional. We recommend consulting a licensed electrician to evaluate and correct as needed.

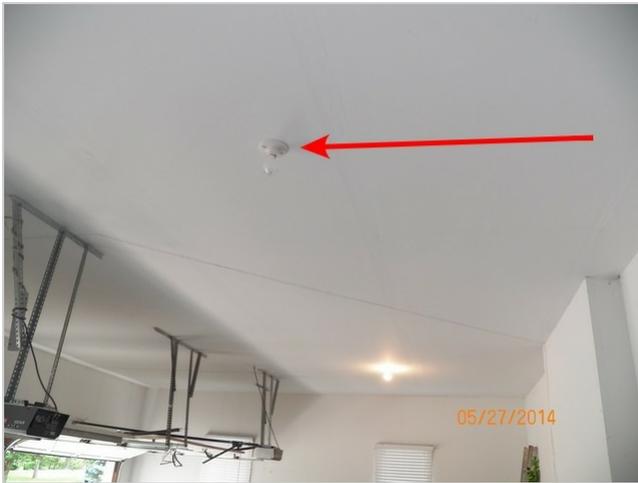
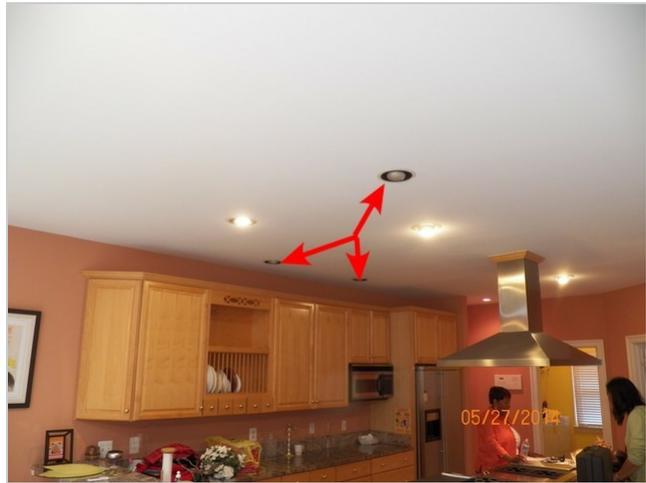
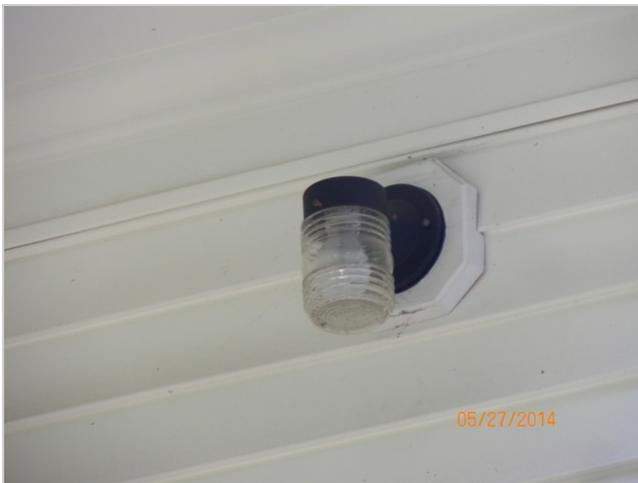
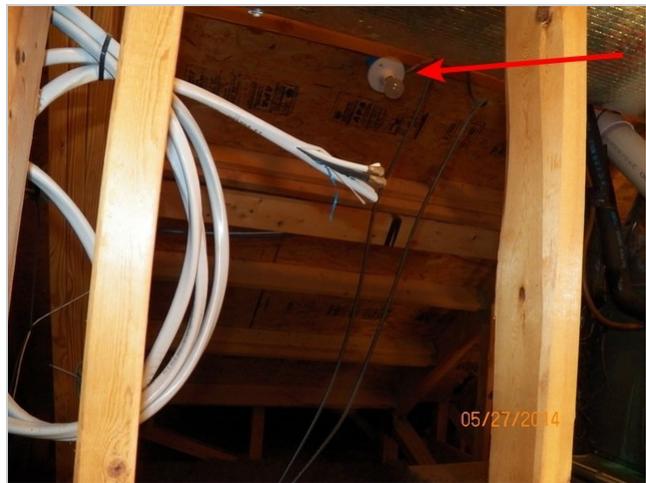
NOTE: One of the two garage lights, the light next to the attic furnace and three of the seven kitchen lights were nonfunctional. We recommend placing all nonfunctional light fixtures in working order.

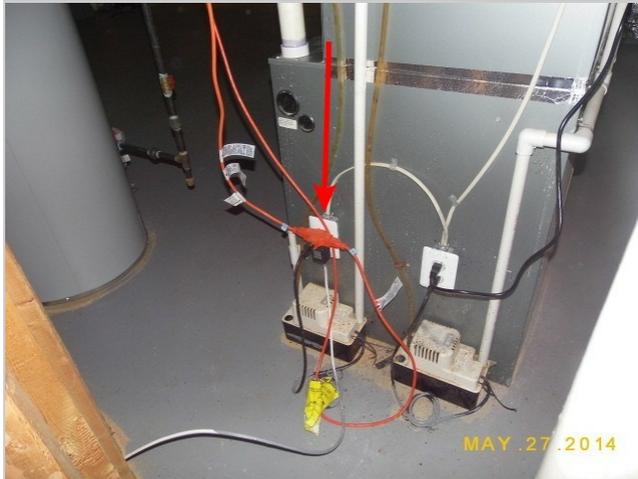
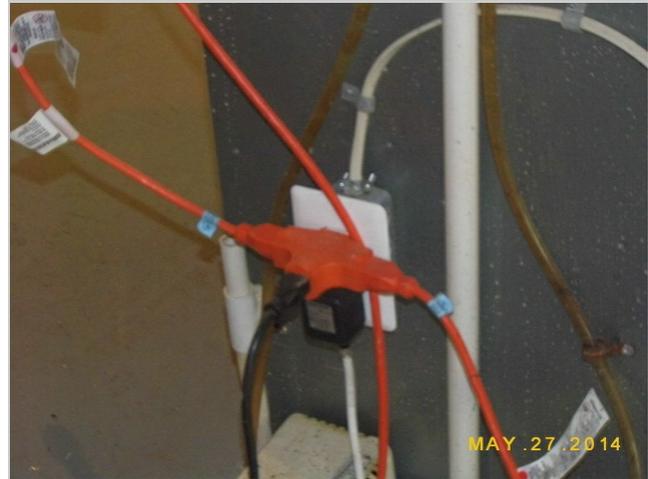
NOTE: There were excessive electrical connections plugged into one of the basement outlets. This condition could cause and overload the circuit breaker. We recommend consulting an electrician to install more outlets.

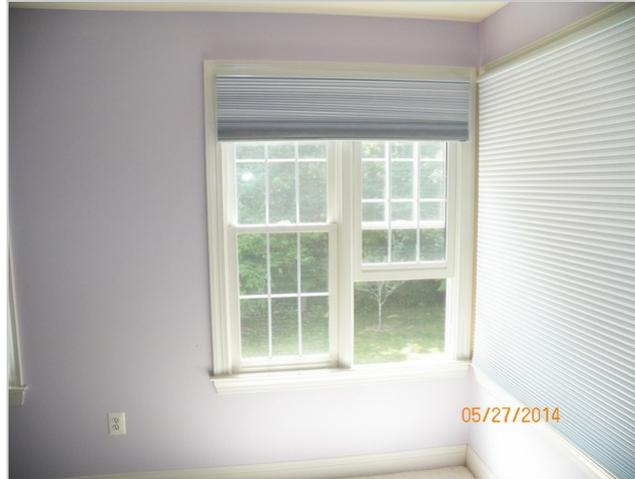
NOTE: The master bedroom rear/right window and the dining room front/left window would not stay in the up position. We recommend consulting a qualified professional to evaluate and correct as needed.

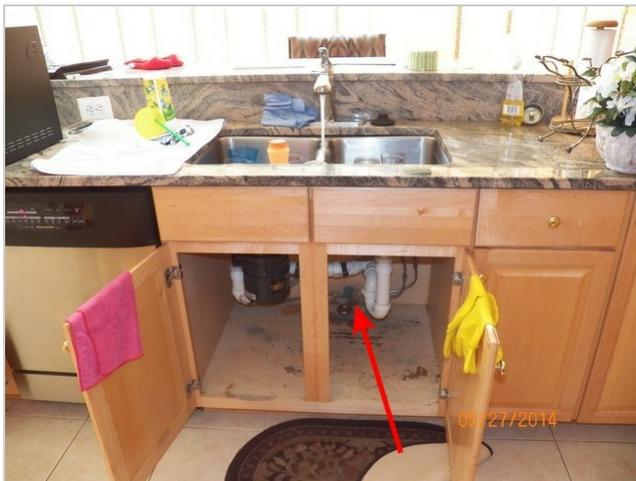
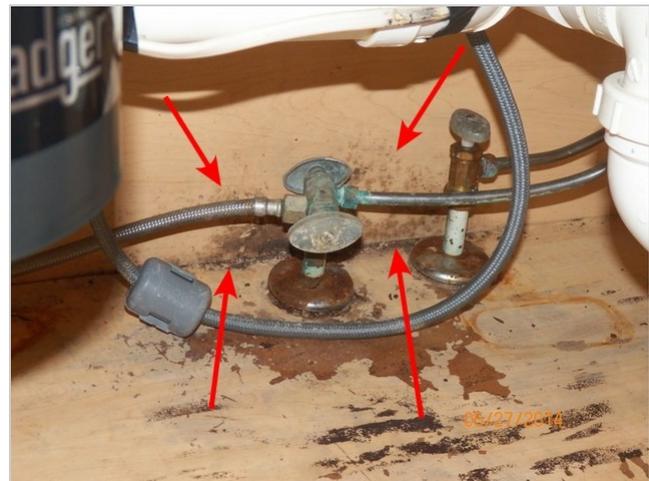
NOTE: There was mold observed underneath the kitchen sink. We recommend consulting a qualified professional to evaluate and remove the mold growth as needed.

NOTE: Certain types of mold growth may result in adverse health effects. If this is a concern to you, it is recommended to have this area tested to determine the type(s) of mold present. HomeTeam Inspection Service makes no warranty as to the current or future existence of mold in this property and is not liable for the potentially harmful effects thereof.

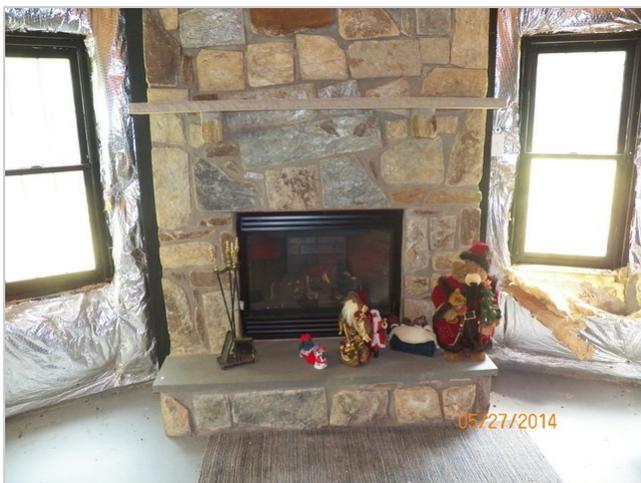
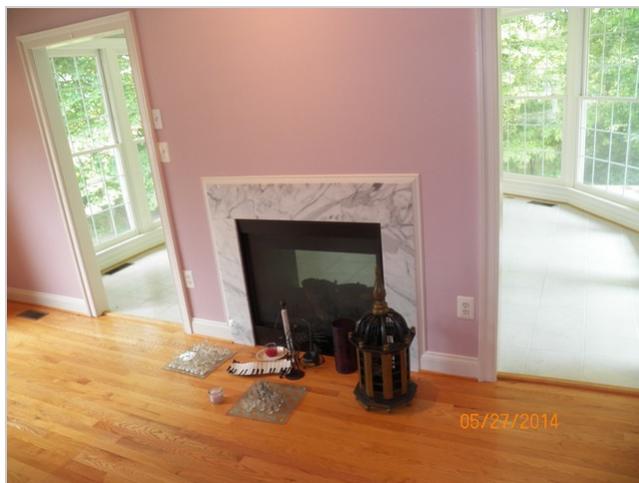
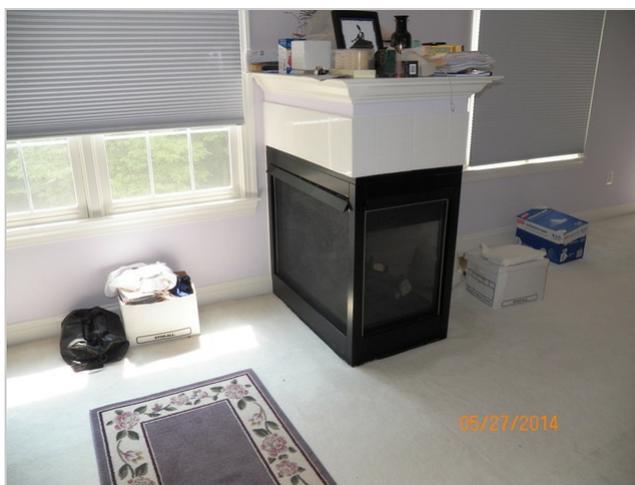
Propane gas-log fireplaces were located in the family room, living room and master bedroom. The fireplaces were tested and found to be nonfunctional.

NOTE: All three propane gas fireplaces in the living room, basement and master bedroom were nonfunctional and should be placed in working order.

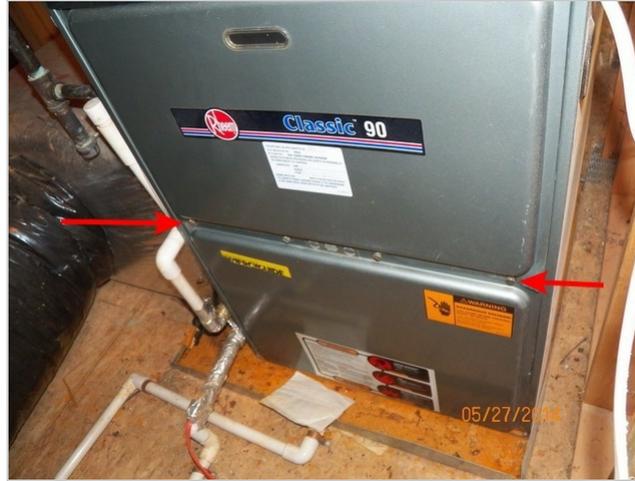
NOTE: The second level furnace cover could not be removed due to the screws not unscrewing. Therefore,

the data plate was not accessible and the unit could not be properly inspected. However, there were signs of rust in the pan and signs of a condensation leak at the top of the unit. We recommend consulting a HVAC technician to evaluate and correct as needed.

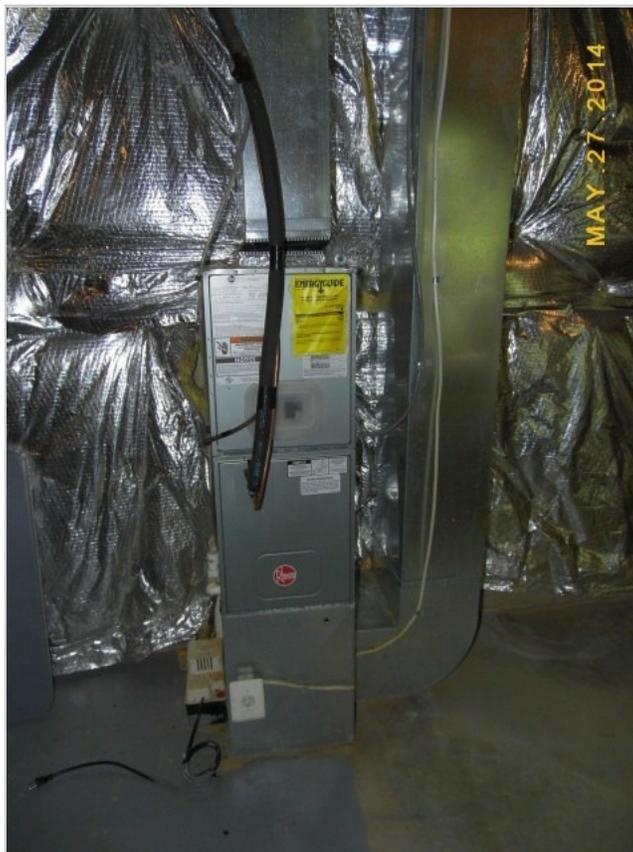
NOTE: The air handler was found to be nonfunctional. We recommend consulting a HVAC technician to evaluate the unit to determine the extent of repair required.

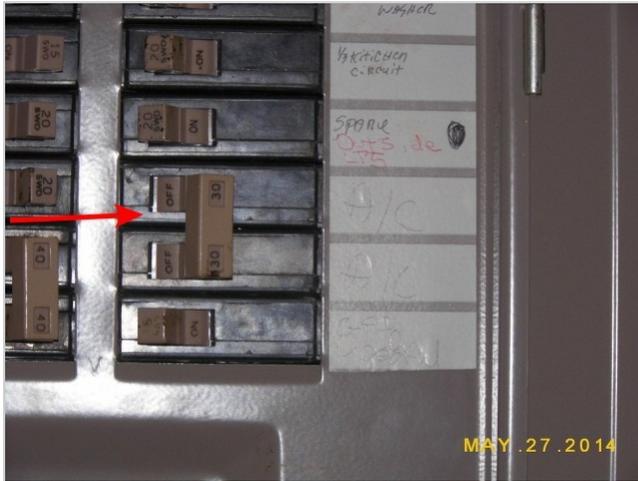
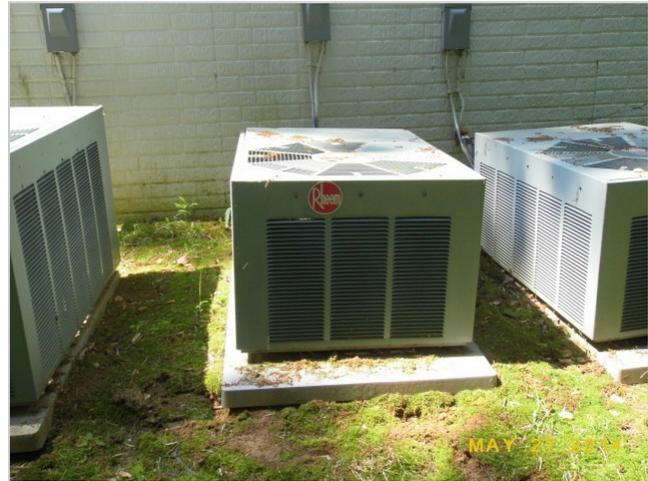
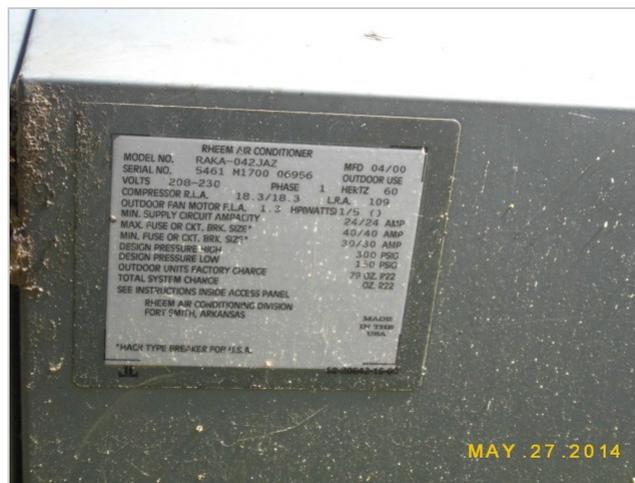
NOTE: The air conditioner was nonfunctional at the time of the inspection. The electric circuit breaker for the

air conditioner would not re-set. We recommend consulting a licensed electrician to evaluate and repair as needed. After the circuit breaker has been corrected we recommend having the air conditioner checked for function.

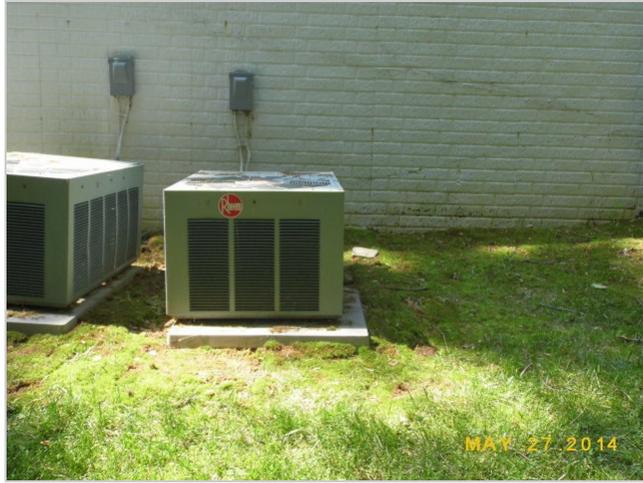
NOTE: The heat pump was nonfunctional at the time of the inspection. We recommend consulting a HVAC technician to evaluate and repair or replace as needed.
