HOME INSPECTION REPORT

SAMPLE REPORT

The inspected property consisted of a two story wood-framed structure, with a basement, that was occupied at the time of the inspection. The approximate temperature at the time of the inspection was 50 to 60 degrees Fahrenheit, and the weather was sunny and clear.

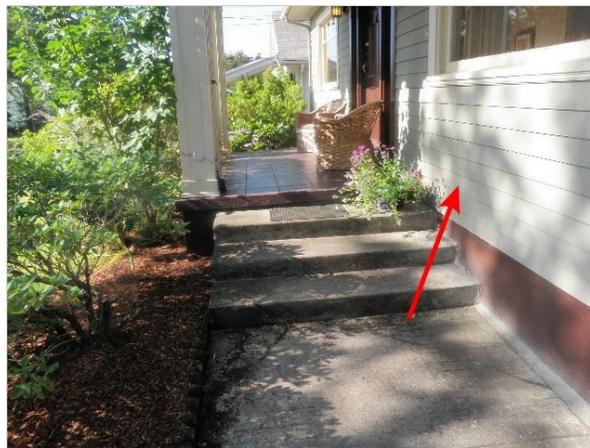
- **It is recommended to have handrails installed on the front exterior steps.**

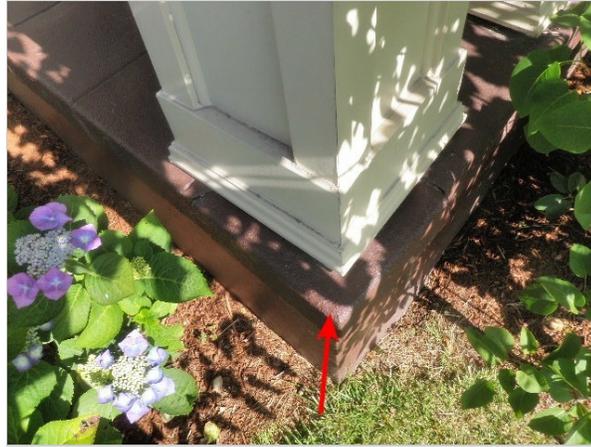
- **Plant growth was observed against the front and rear of the home.** All trees and bushes should be trimmed 6-inches to 12-inches from the home. It is recommended to remove this plant growth away from the siding to prevent possible damage including insect infestation.
- **The left front corner of the front porch was damaged and should be repaired.**

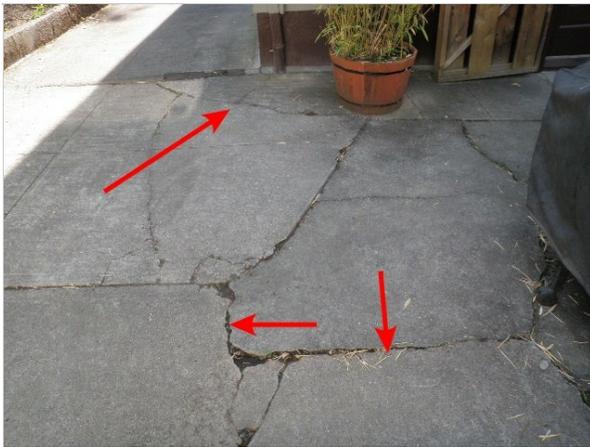
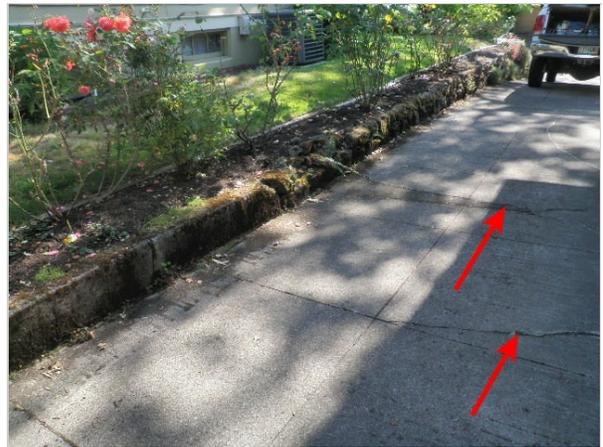
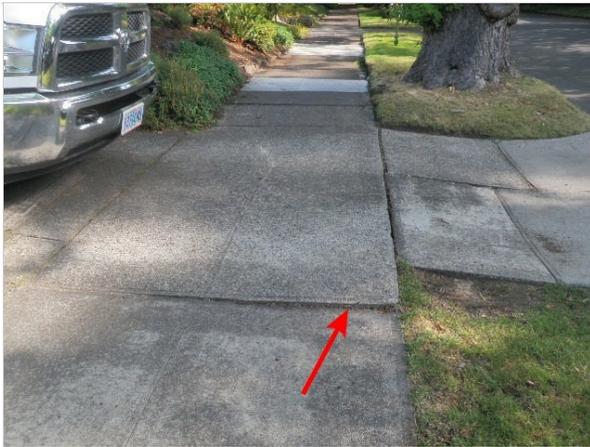
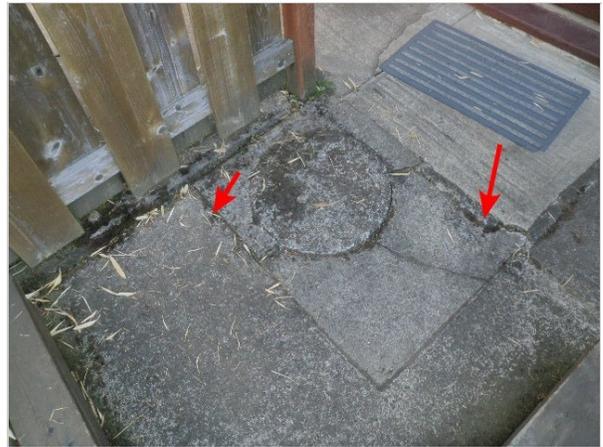
- There were trip hazards located on the property. They are the number one cause of accident and injury around the home. It is recommended to use caution in areas where trip hazards exist and to eliminate trip hazards in affected areas to help ensure safety of occupants. There damaged concrete or walkway located on the front sidewalk, driveway, and rear walkway.

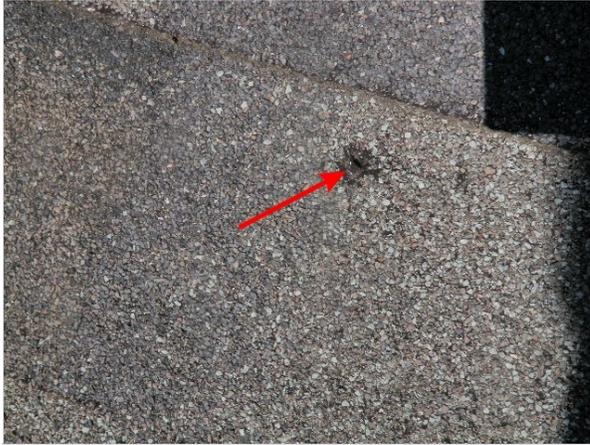
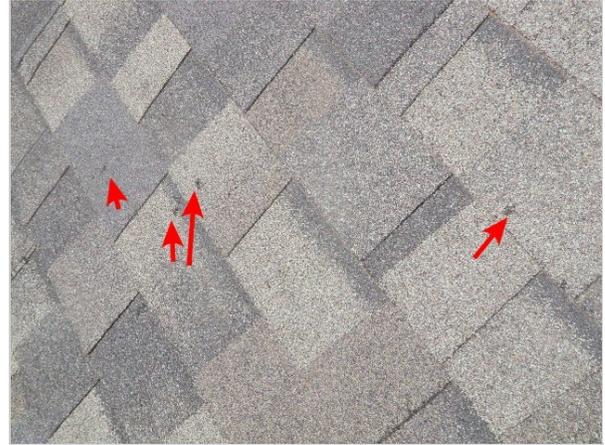
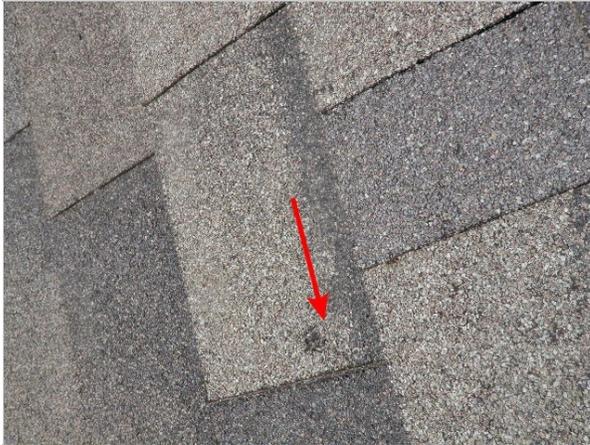
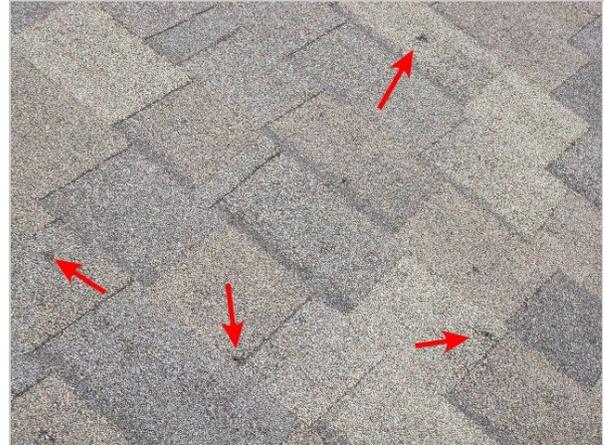
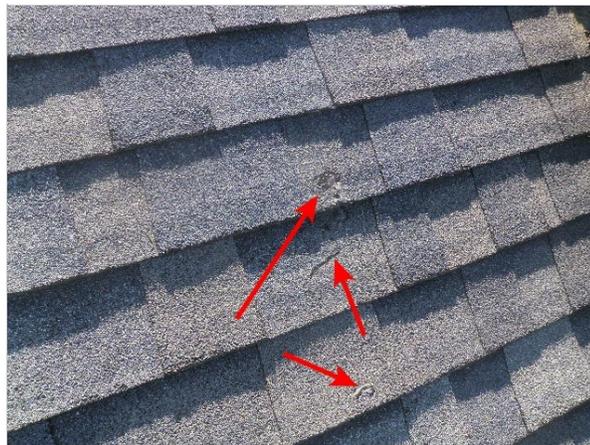
- **There were damaged shingles on the front and right rear of the home that should be repaired or replaced.**

- **There were visual defects noted on the roof that included but were not limited to the following items. It is recommended to have a licensed roofer examine and address all roofing issues noted or found on**

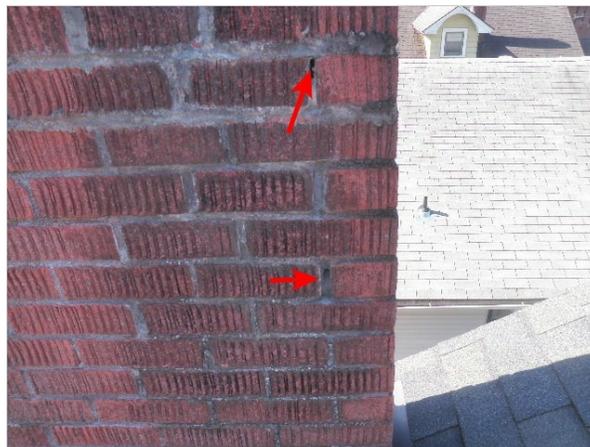
- **Tuck pointing is needed on the chimney.** The most common reason for tuck pointing brick masonry is to improve water penetration resistance. Tuck pointing deteriorated mortar joints is one of the most effective and permanent ways of decreasing water entry into brickwork. This is because the most common means of water entry into a brick masonry wall is through de-bonded, cracked or deteriorated mortar joints.

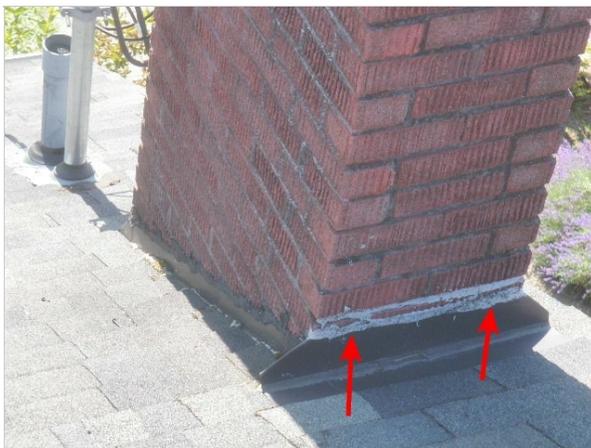
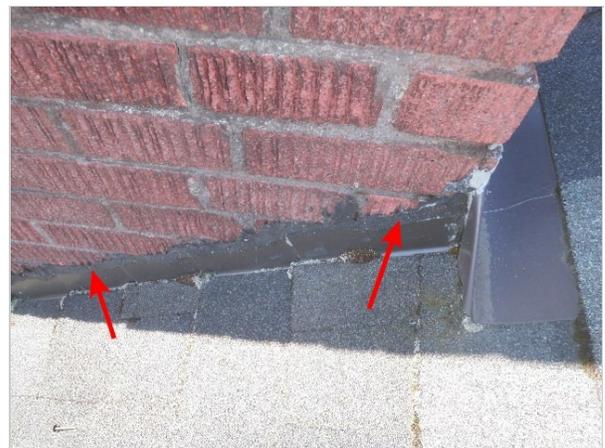
- **The flashing was caulked to the chimney. It is recommended to have it counter flashed to prevent leaking.**

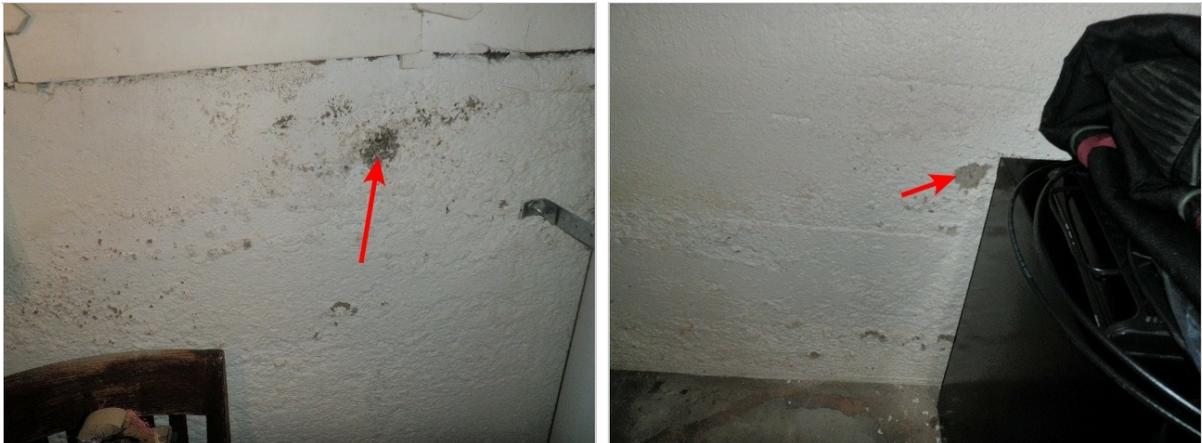
- **Skim coating is needed on the foundation wall in the utility room.**

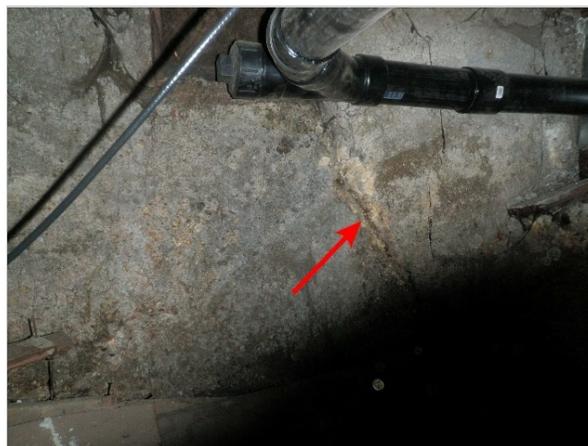
- **It is recommended to contact a licensed structural engineer to examine and address all foundation issues in the home. On the left side of the home behind the gas meter, there was a crack in the foundation which has been patched.**

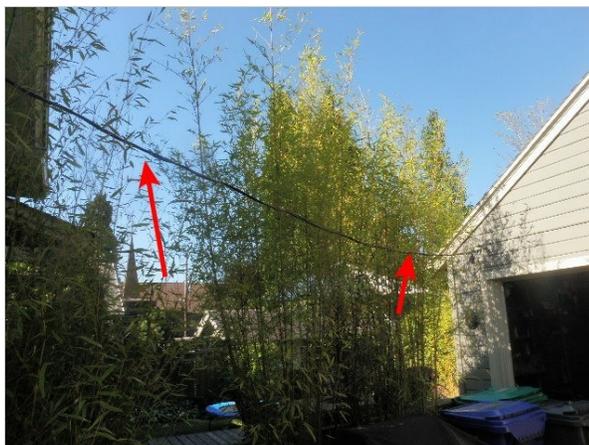
- **The main incoming power lines were too low and should be at least 12' above the driveway and 18' above the roadway.**

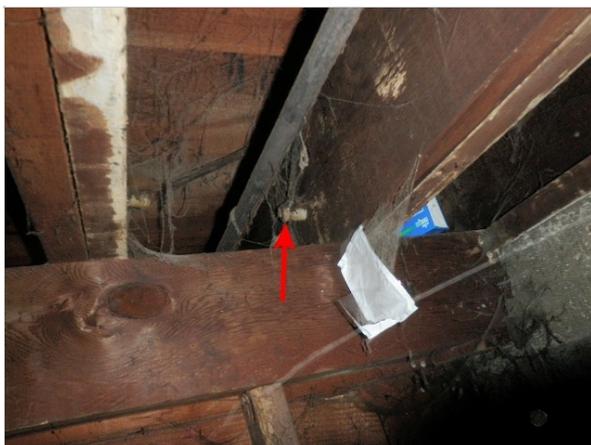
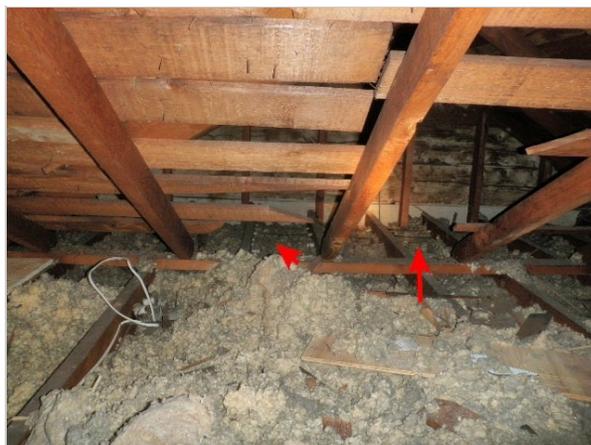
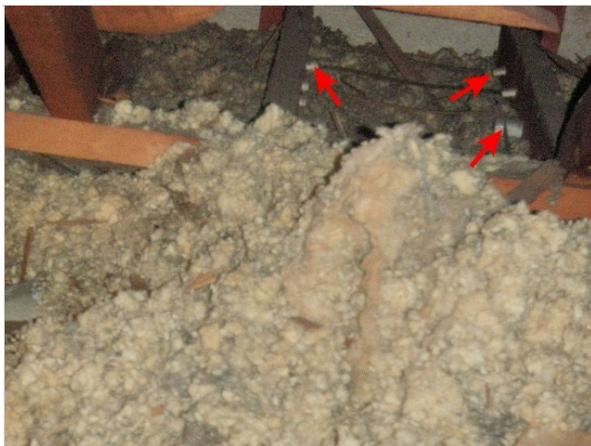
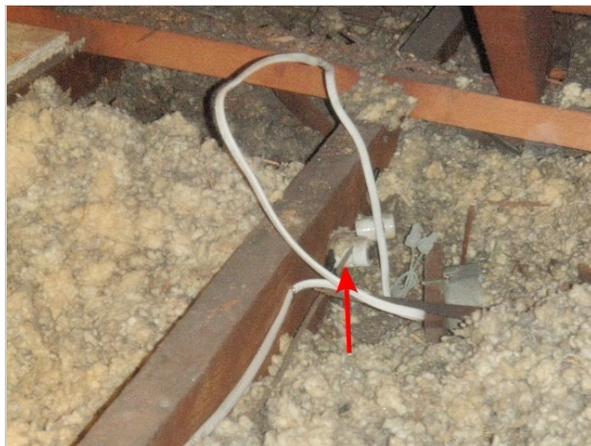
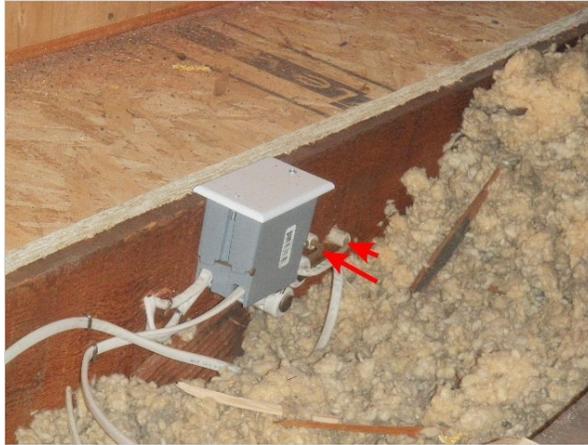
- **This home has visible Knob & Tube (K&T) wiring.** This is the original electrical system in the home and is outdated by today's safety standards. The major problem with this system is the insulation on the wires can become brittle and in some areas may be missing. It was also not designed to be covered with any material such as attic insulation. It should be noted that some insurance companies would not insure homes that have K&T wiring. For increased safety, it is recommended to have a licensed and qualified electrician evaluate the home for replacement of all K&T wiring in the structure. It is recommended to contact your insurance provider to determine if the home can be insured with this type of wiring.

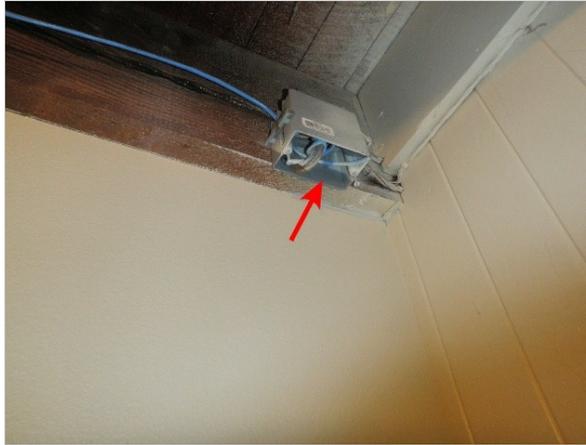
- **There was a junction box found in the laundry room that did not have a cover plate. These are required for safety.**

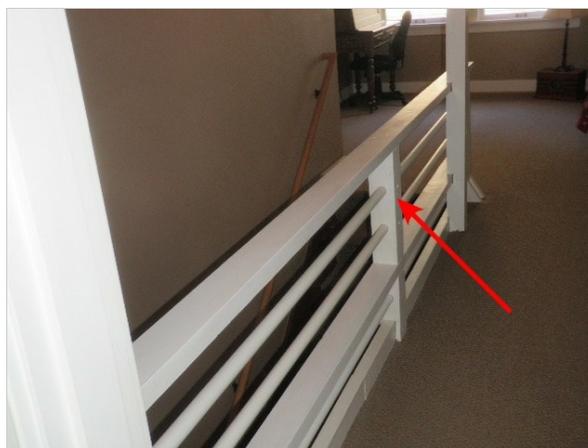
- **The guardrail was too low on the upstairs landing. It was approximately 30 ". It should be 34-38" high.**

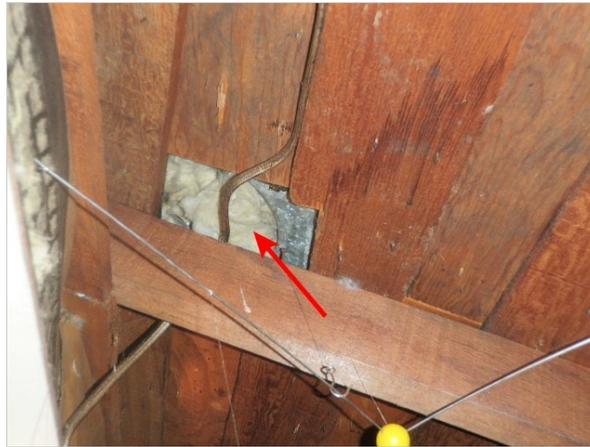
- **The static vents were plugged with insulation. It is recommended to have the insulation removed for proper insulation.**

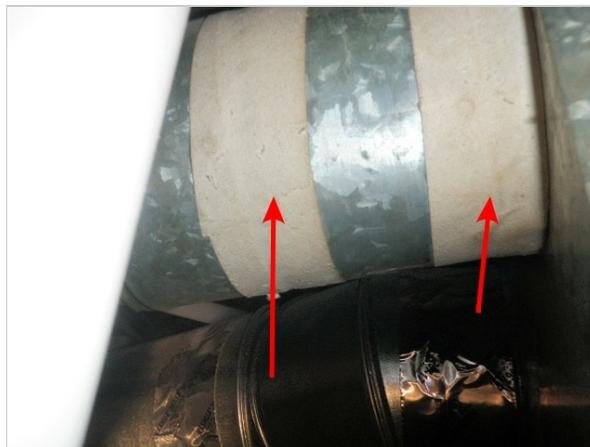
- **There appeared to be an asbestos type material on the heating ducts.** When it is necessary to disturb asbestos, you should contact a licensed asbestos contractor. You can also obtain a copy of "Asbestos in the Home", published by the U.S. Consumer Products Safety Commission. There is more information found on the Internet located on web site <http://www.cpsc.gov> or by calling (800-638-2772), which discusses the situation and makes recommendations. Remember, do not dust, sweep, or vacuum particles suspected of containing asbestos fibers.
