## **SAMPLE REPORT**

**SUMMARY:** The purpose of this summary is to provide a "quick view" of some results of the home inspection. **This summary is not intended to be comprehensive and does not include all findings of the inspection.** Please be sure to read the full body of the inspection report, as it contains much more detail about the home. The order in which the systems and components of the property are presented and the inclusion or absence of any defects from the summary is not intended to reflect the relative importance of any system or component of the property. Any recommendations for additional evaluation or estimates must be performed prior to the conclusion of the inspection contingency period. The following is a summary of the inspection performed at 1234 Fifth Street, HomeTown, ON A1B 2C3:

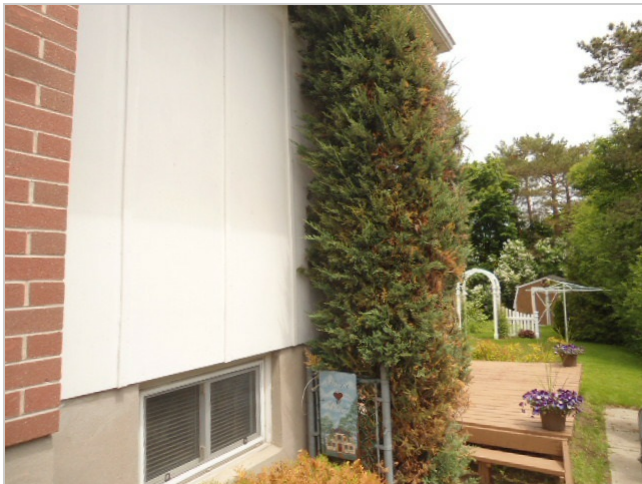
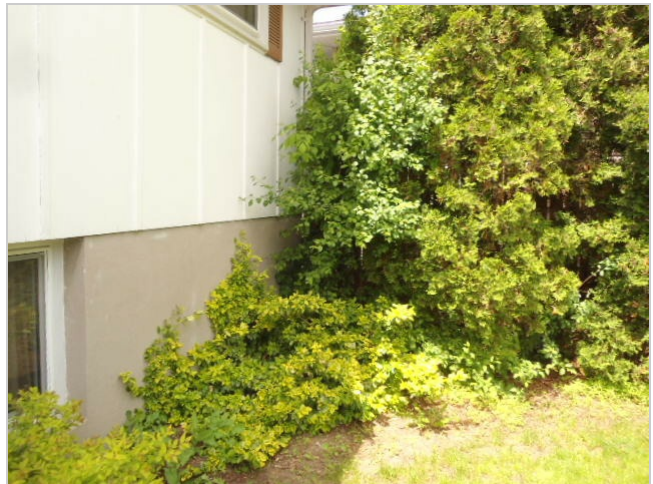
There was excessive plant growth observed against the siding on the back right and left corners. It is recommended to trim this growth away a minimum of six inches from the siding to prevent possible damage including moisture and insect infestation.

- There was excessive plant growth observed against the siding on the back right and left corners. It is recommended to trim this growth away a minimum of six inches from the siding to prevent possible damage including moisture and insect infestation.

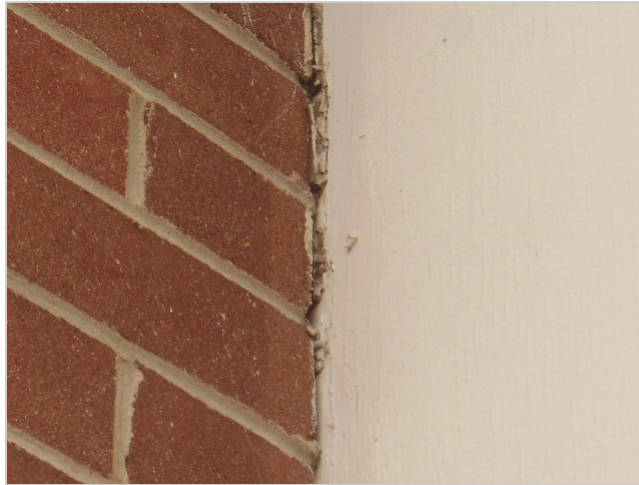
There were areas where the chimney meets the house that had gaps significant enough to allow water to penetrate. Recommend the openings be sealed or caulked to prevent damage caused by water intrusion.

- There were areas where the chimney meets the house that had gaps significant enough to allow water to penetrate. Recommend the openings be sealed or caulked to prevent damage caused by water intrusion.

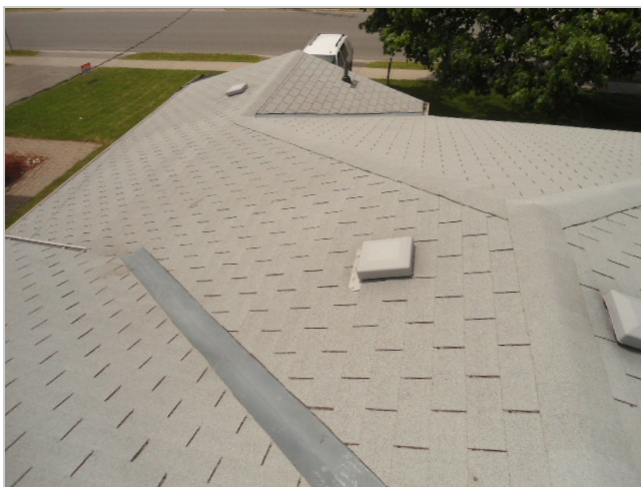
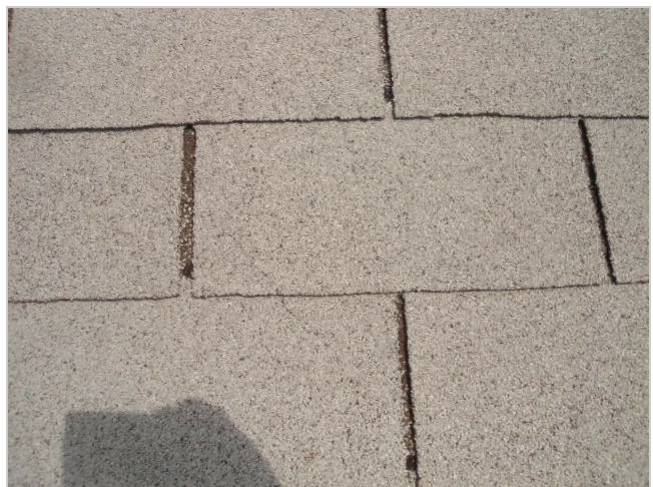
There was minimal curling and light surface wear observed on the roof shingles at the time of the inspection. Based on the observations made at the time of inspection the roof shingles appeared to be in the first half of their normal useful life.

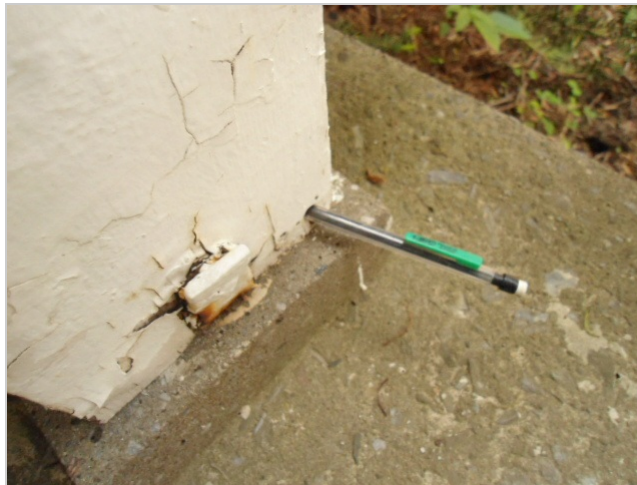
The front porch had a wooden support post that had some signs of wood rot on the bottom. This post should be monitored and may need replacement at some time in the future.

- The front porch had a wooden support post that had some signs of wood rot on the bottom. This post should be monitored and may need replacement at some time in the future.

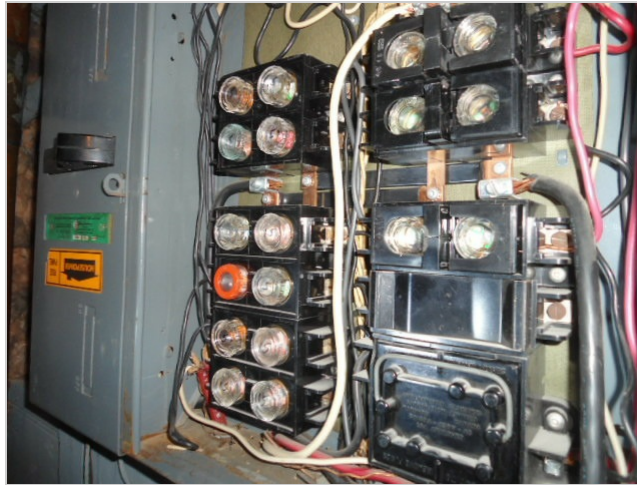
Fuse panels have not been installed in homes for many years and are considered to be outdated equipment. A service upgrade may be required at some point in the future.

There were several circuits in the electrical panel that had an inadequately sized wire matched with an oversized fuse. Proper sized fuses should be installed. Fuses are inexpensive and can be purchased at any home improvement store.

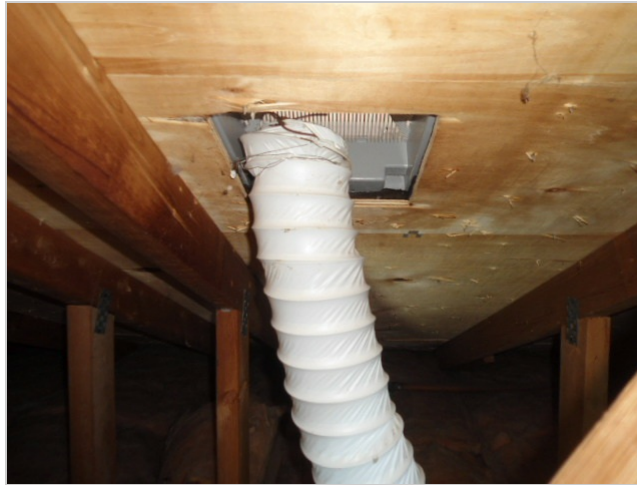
There was a bathroom exhaust vent that terminated in the attic. All exhaust vents should be directly vented to the outside by attachment of exhaust-vent ducting to appropriate through-wall or through-roof ventilation fixtures or grilles to keep excessive heat and moisture out of the attic.

- There was a bathroom exhaust vent that terminated in the attic. All exhaust vents should be directly vented to the outside by attachment of exhaust-vent ducting to appropriate through-wall or through-roof ventilation fixtures or grilles to keep excessive heat and moisture out of the attic.

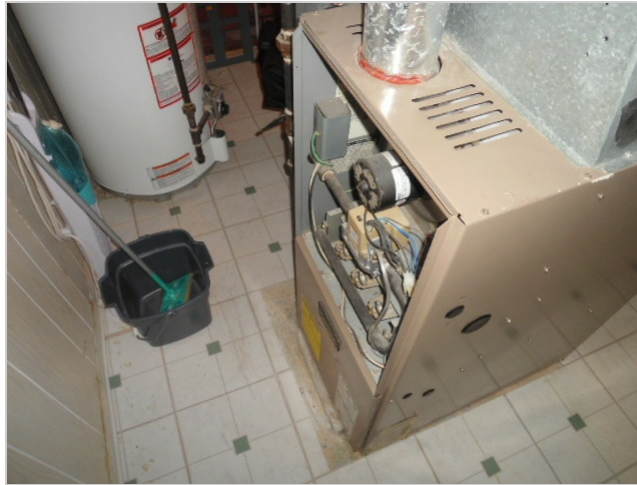
The life span of a furnace can vary greatly but the general accepted life expectancy of a furnace in this climate is fifteen to twenty years. Due to the age of the furnace in this home (19 years), failure is possible at any time. The furnace may need to be replaced in the near future.

- The life span of a furnace can vary greatly but the general accepted life expectancy of a furnace in this climate is fifteen to twenty years. Due to the age of the furnace in this home (19 years), failure is possible at any time. The furnace may need to be replaced in the near future.
