HOME INSPECTION REPORT

Friday, October 9, 2020

1234 Fifth Street
HomeTown, ON A1B 2C3
Inspection #: 647-122012-293

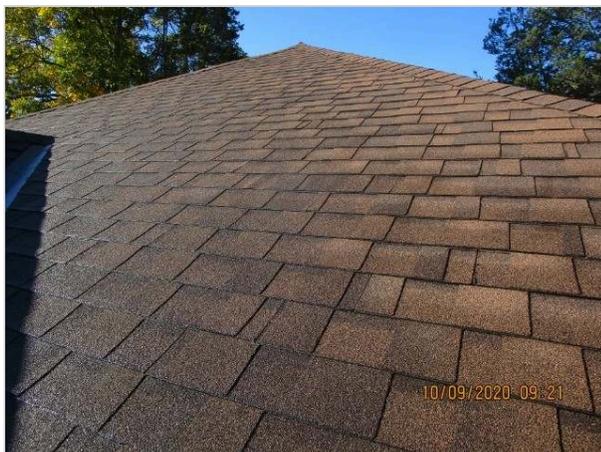
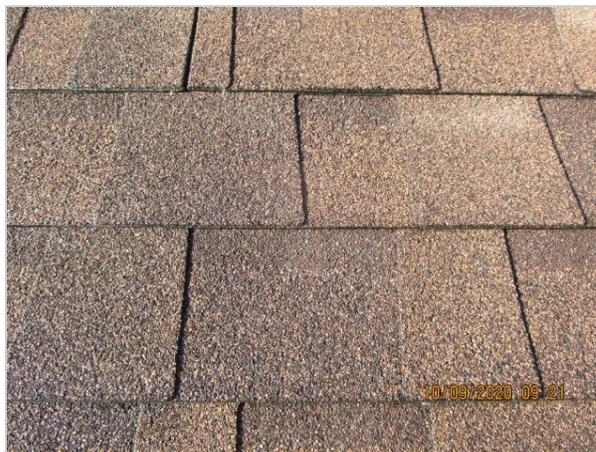
There was no curling and light surface wear observed on the visible roof shingles at the time of the inspection. Based on the observations made at the time of inspection the roof shingles appeared to be in the first half of their normal useful life.

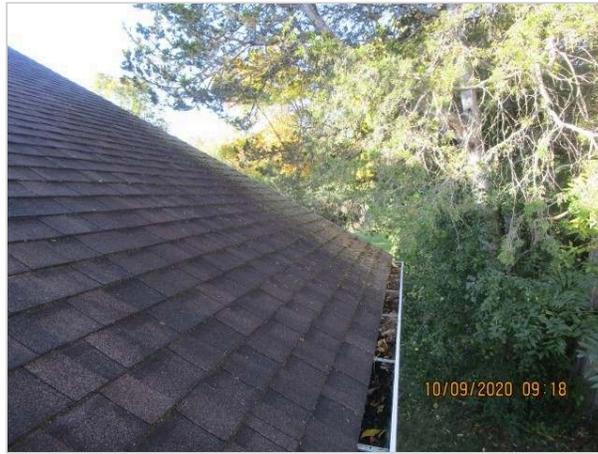
There were tree limbs near the roof surface on the right side of the home. Trimming tree branches away from the roof will greatly prolong the life of the roof surface.

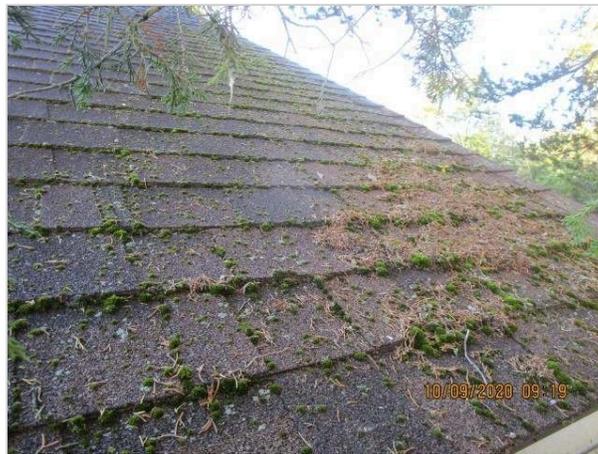
There was moss on the roof on the right side of the home at the time of inspection. A build-up of moss or algae can cause premature deterioration of the roof covering and can impede the flow of water off the roof and eventually build up enough water to divert it under shingles and into the building. It is recommended to keep the roof free from moss and algae to help prolong the life of the shingles. There are several products available at most home improvement stores designed to eliminate moss and algae. Roof moss can limit the visual inspection of the roof.

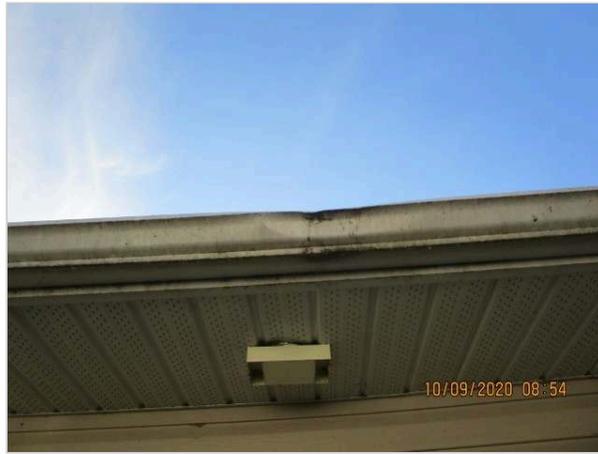
There was some damage to a section of eavestrough on the right side of the home. It is important to keep the roof drainage system in good working order and any damage to it is recommended to be repaired or replaced as needed.

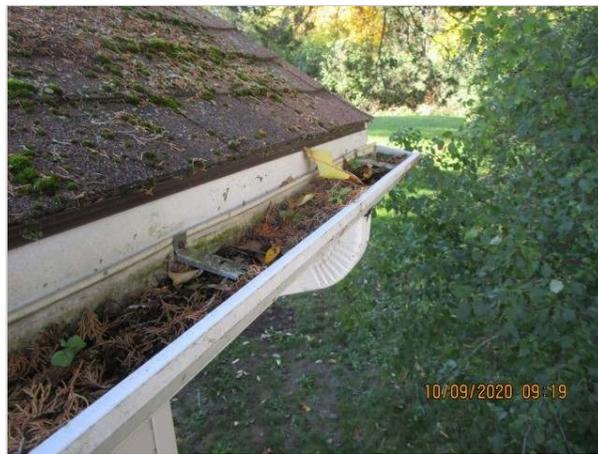
There were eavestroughs and downspouts on the home that were in need of cleaning to the extent that they were ineffective in their current condition. It is recommended that the eavestroughs be cleaned to prevent them from overflowing.

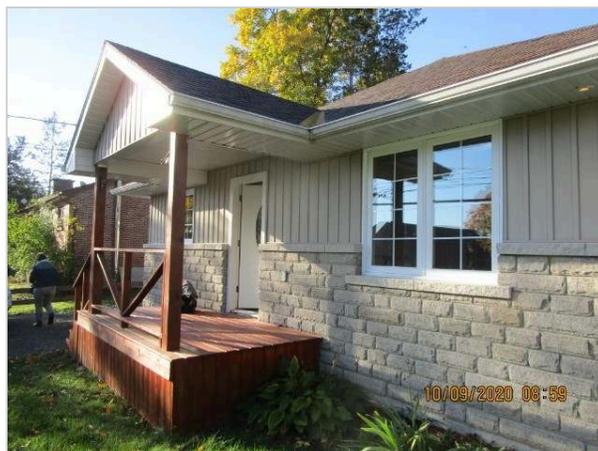
Part of the porch in the front was missing a railing. It is recommended to install a railing to prevent a fall injury.

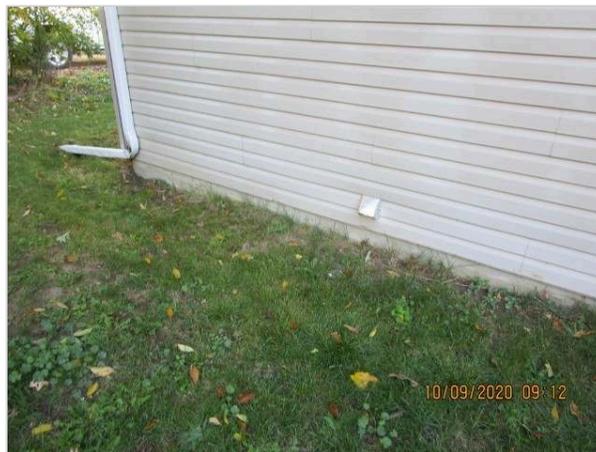
There was an area of the grading that did not appear to have an adequate slope to direct rain water away from the foundation on the back of the home. It is recommended to improve the grading and keep the landscaping sloped away from the home to protect the foundation and reduce the possibility of moisture or water in the crawlspace. Poor grading can allow water to enter the structure which can cause damage to structural elements, foundations and allow for mould growth. Therefore any defects in the grading should be considered a high priority remediation project.

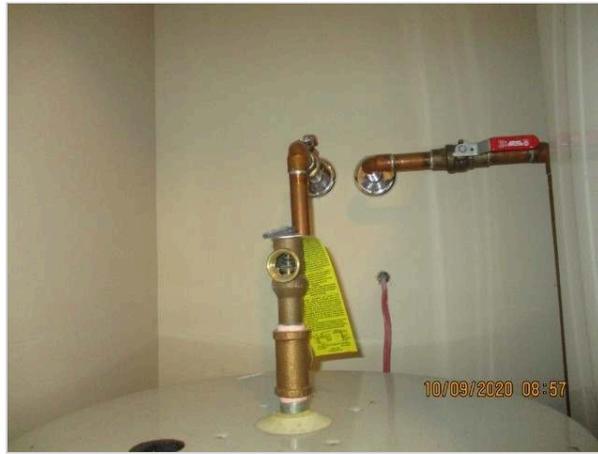
There was no T&P discharge pipe on the water heater. Because your safety depends on the presence of a T & P valve discharge pipe terminating close to the floor a discharge pipe should be installed. This is an inexpensive item available at most home improvement stores and is easy to install.

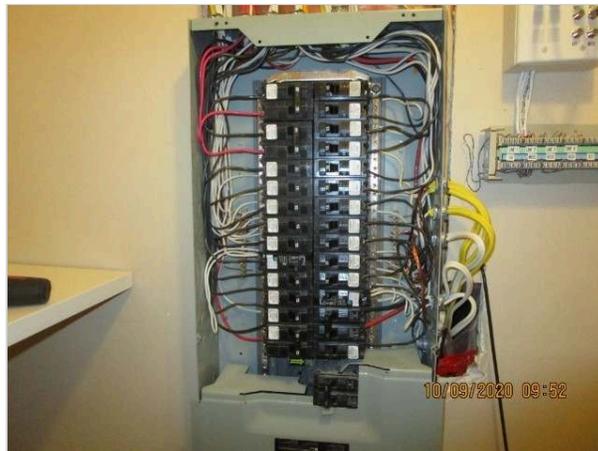
The service wire entered a Siemens circuit breaker panel, located in the kitchen pantry. The main disconnect and service panel had a 100 amps and 120/240 volt rated capacity. Any main disconnects are not opened and should only be opened by a licensed electrician. The branch circuits within the panel were copper. The visible house wiring consisted primarily of the plastic sheathed type and appeared to be in good condition. The ground conductor entered the ground on the homes exterior.

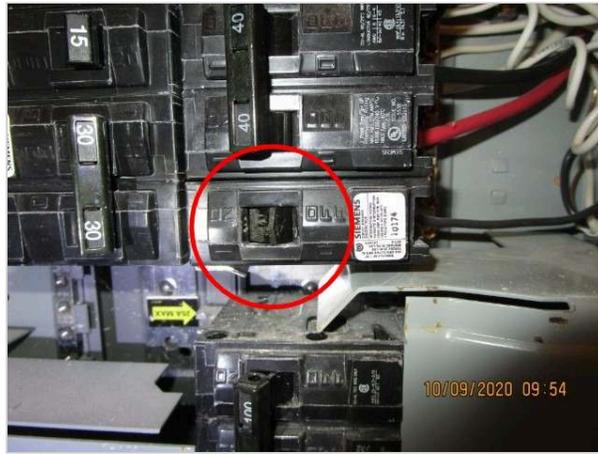
The service panel front cover was missing one of the screws .

There was a damaged breaker in the electrical panel. Recommend replacement.

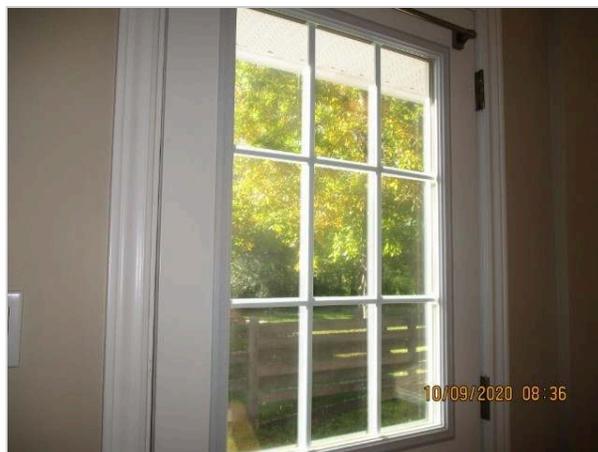
There was an exterior door window in the living room that had a failed seal causing a loss of vacuum between the panes. The most noticeable result of this failure is condensation and fogging between the panes of glass. When failed window seals are found in a home there is a possibility there are one or more others that have begun failing that could not be detected during the inspection.

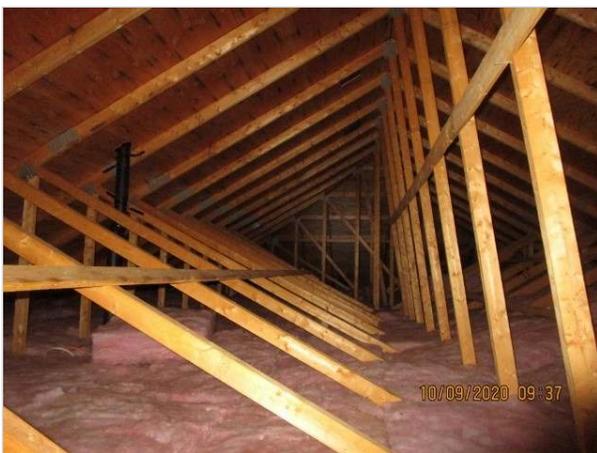
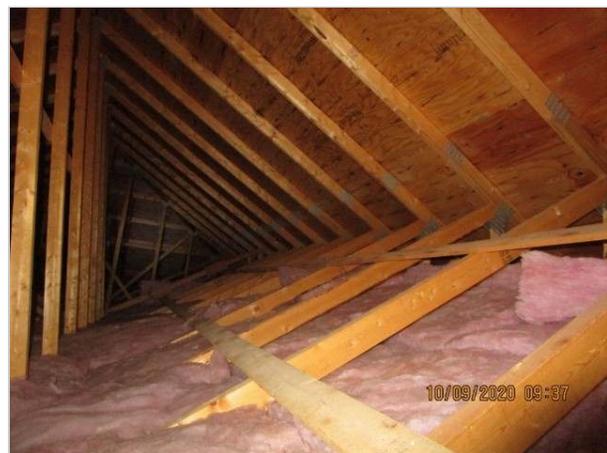
The attic was accessed through an access panel in a bedroom closet and inspected from this location. The attic above the living space was insulated with fiberglass batted insulation, approximately 12 inches in depth. Insulation behind finished walls was not visible. Ventilation throughout the attic was provided by soffit and roof vents. The roof structure consisted of two-inch by four-inch wood trusses spaced 24 inches on center and plywood sheathing.

Because of the configuration of the framing and insulation, which limited access, it was not possible to inspect all areas of the attic. It is important that the inspector does not disturb the insulation during the inspection. There was no moisture visible in the accessible attic space at the time of inspection. There were no major visual defects observed in the accessible attic.
