HOME INSPECTION REPORT

The inspected property consisted of a colonial wood framed structure with stucco that was vacant at the time of the inspection. There were no major visual defects on the visual portions of the siding.

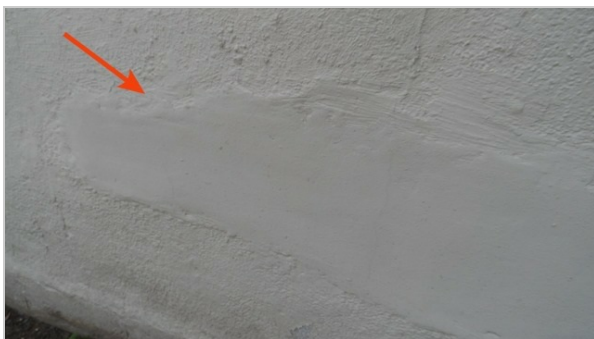
remediation of stucco

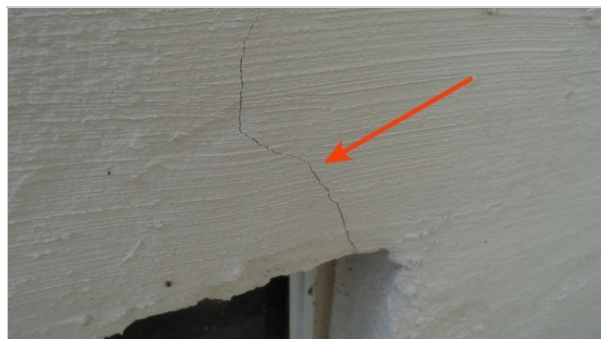
Minor cracking of stucco

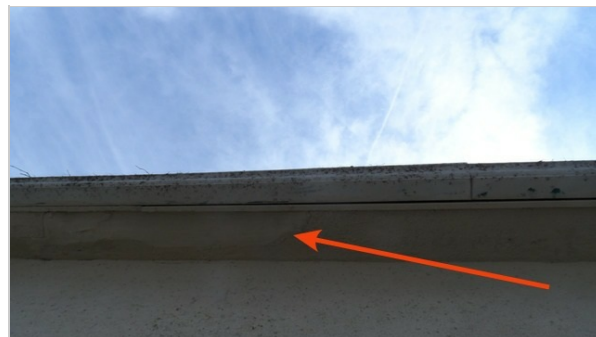
Remediation to siding/soffit

It was pointed out that there were signs of recent remediation to the siding and trim. Monitoring for cracks and repairing promptly was suggested to help prevent deterioration of the stucco.

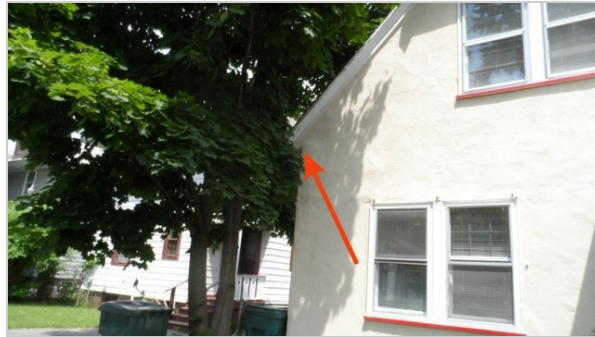
It was pointed out that there were trees and or vegetation near or in contact with the home at the time of inspection. Cutting back the growth was recommended.

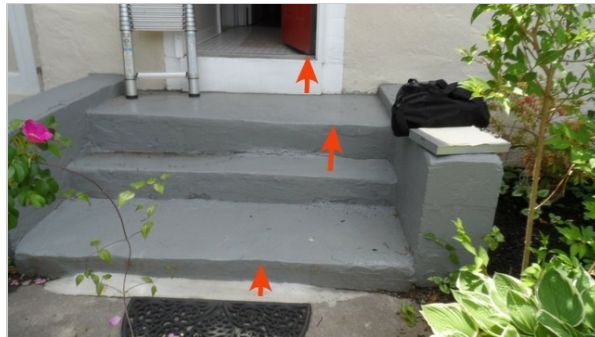
It was noted that the front steps were of different heights. This is a potential trip hazard. Repairs are recommended.

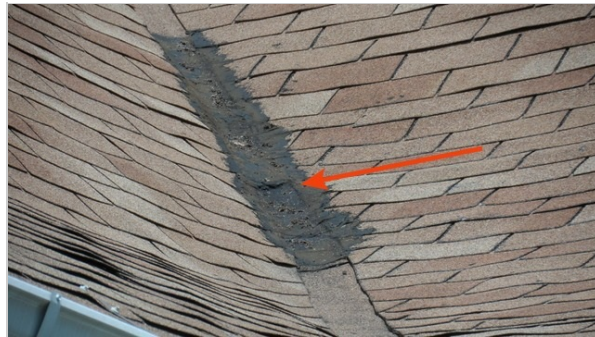
It was noted that there were repairs to the rear valley of the roof at the time of inspection. This area did not appear to be leaking. A roofer would be a good resource for advisement here.

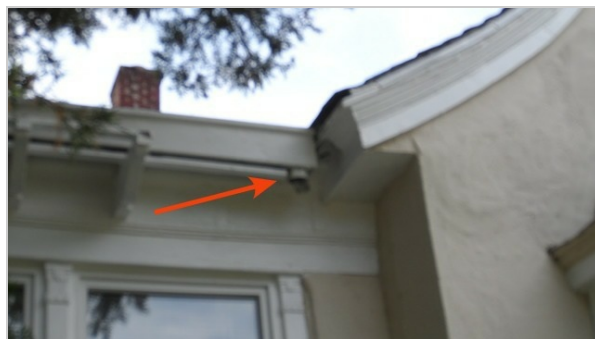
Missing downspout

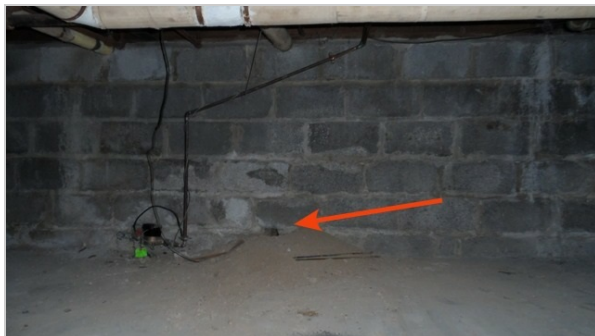
Critter den

It was noted that there was what appeared to be a past or present critter den on the front of the basement. Patching the hole in the wall was suggested.

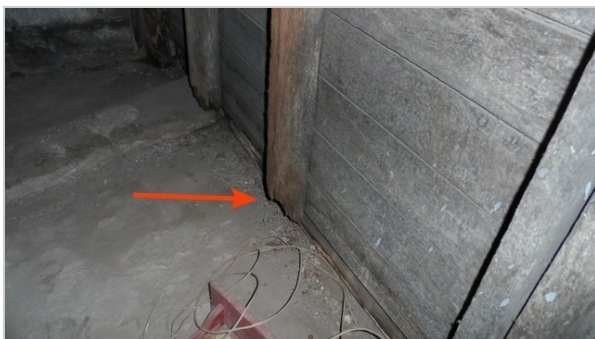
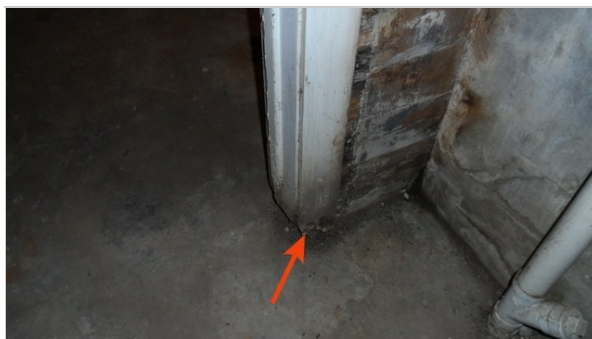
It was noted that there was evidence of wood rot on the basement walls. These wall are not structural.

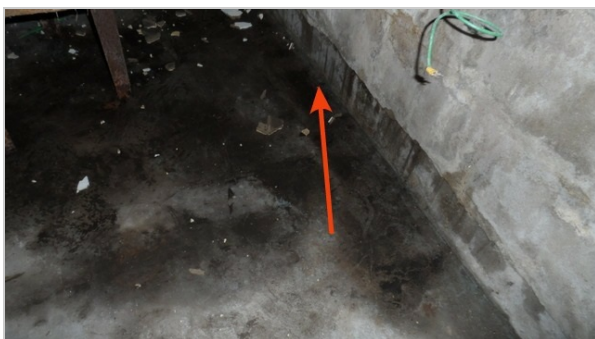
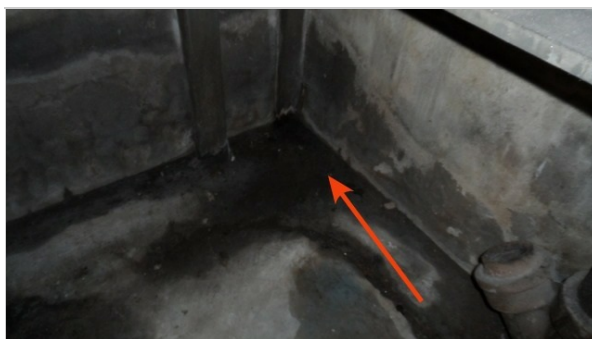
The basement was mostly dry at the time of the inspection. However, there were some signs of past moisture infiltration on the basement walls and floor, **especially in the corners**. Proper grading and gutter maintenance will help reduce moisture in the basement. Because the basement is below grade, there exists a vulnerability to moisture penetration after heavy rains. There were no major visual defects observed in the basement.

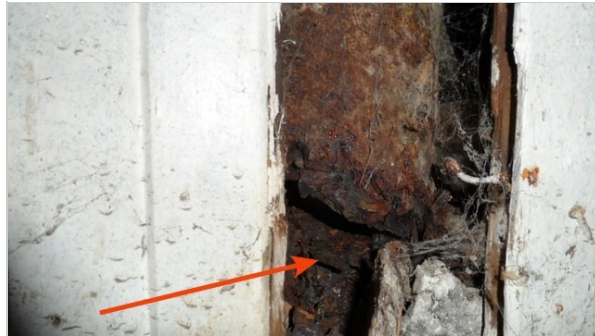
Support post

It was noted that there were corroded/rusted support posts in the basement. Replacement of the posts is recommended.

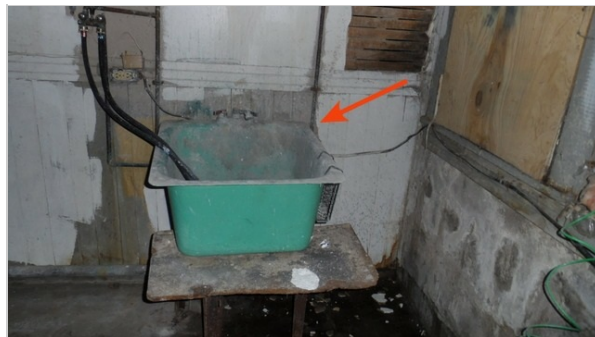
It was noted that the utility tub was not secure and in poor condition. Replacing the tub was discussed at the inspection.

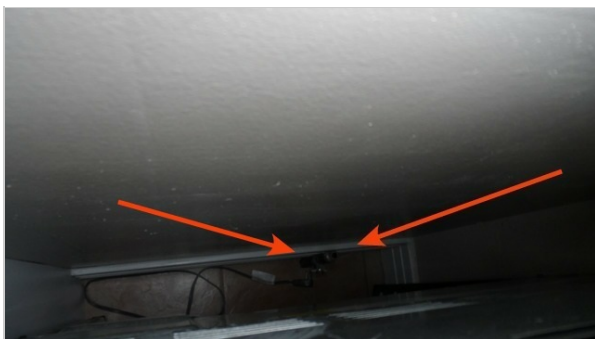
Behind stove

It was noted that there were open gas lines in the home. Capping the gas lines is recommended for safety reasons.

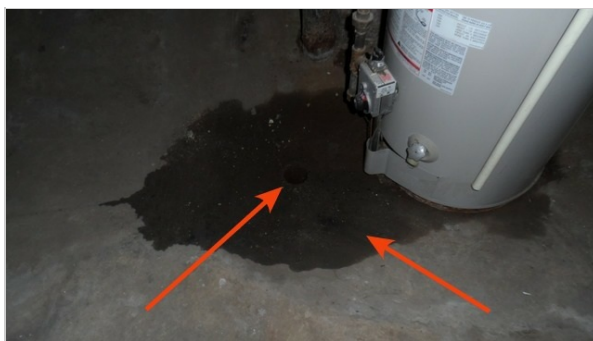
It was noted that there was water on the floor around water heater at the time of inspection. Further evaluation is needed as there was also a floor drain near the water heater. The source of the water could not be confirmed at the inspection. Contacting a plumber for advisement and repairs as needed was recommended.

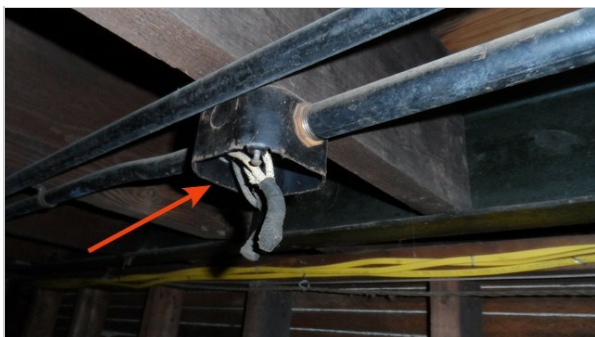
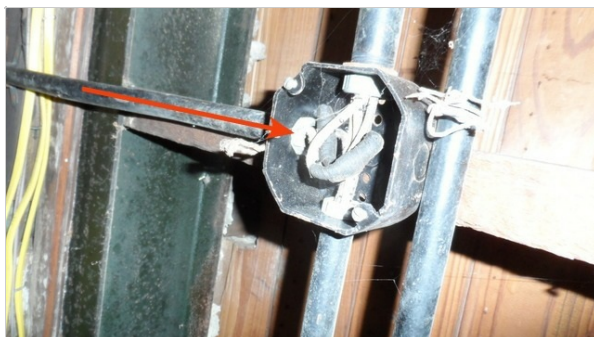
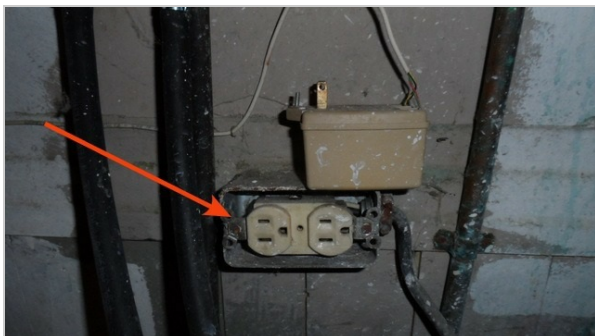
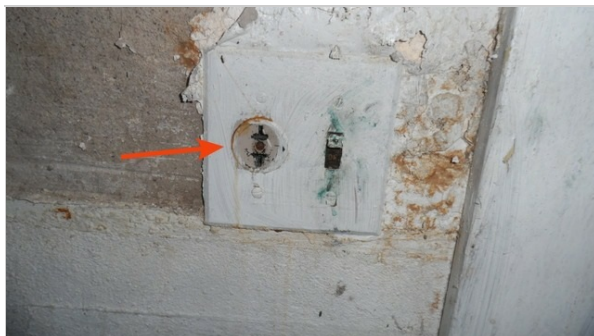
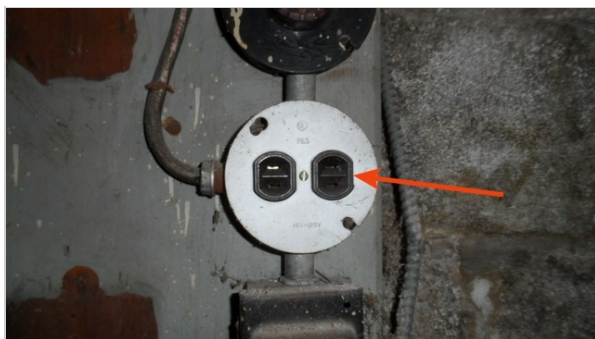
Any open electrical boxes should be covered for safety reasons. There were also two pronged electric receptacles in the home. These receptacles are considered outdated. Upgrading to grounded, three pronged receptacles is suggested.

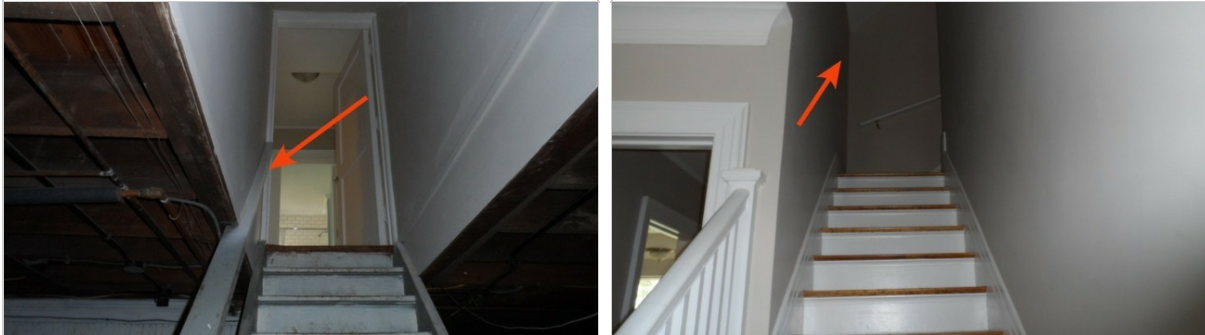
There were stairs in the home that did not have hand rails or proper handrails. All stairs should have hand rails for safety reasons.

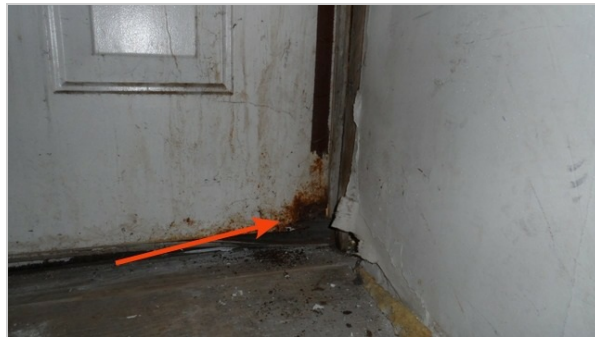
Basement door

It was noted that the exterior basement door was in poor condition at the bottom.

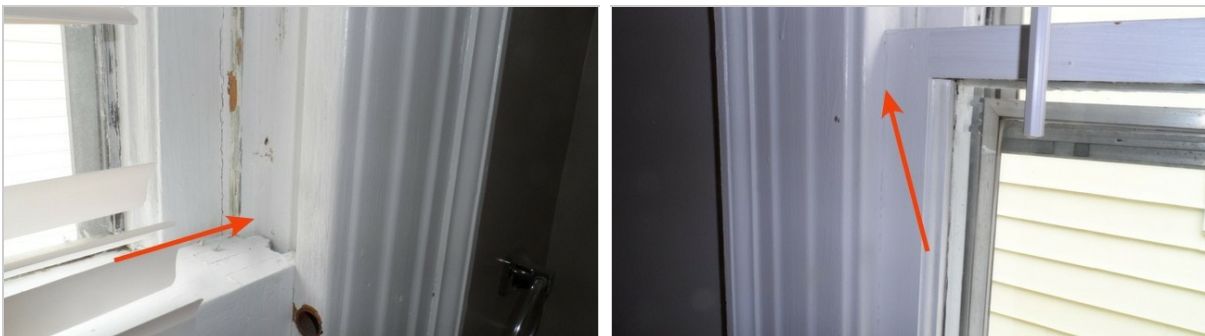
There were several windows in the home that were painted shut, hard to open or had missing or damaged counter weight mechanisms. This is a potential safety hazard. Repairs are recommended. A window company would be a good resource here.

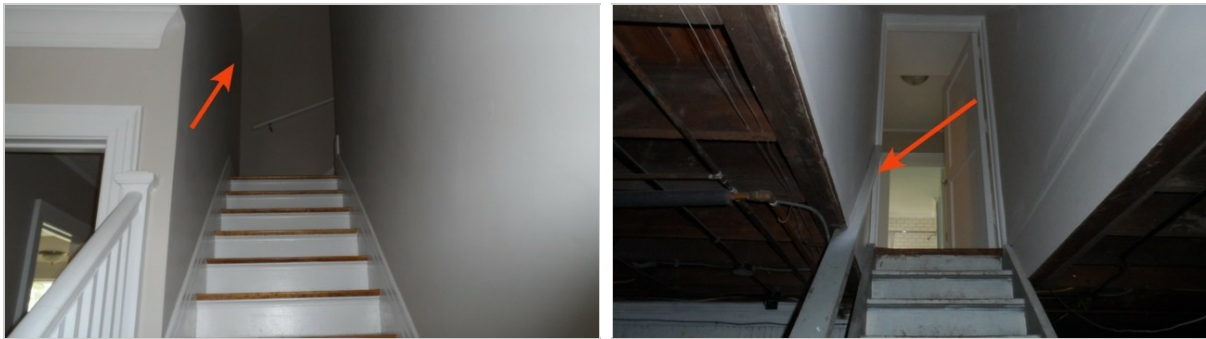
There were stairs in the home that did not have proper hand rails. All stairs should have hand rails for safety reasons.

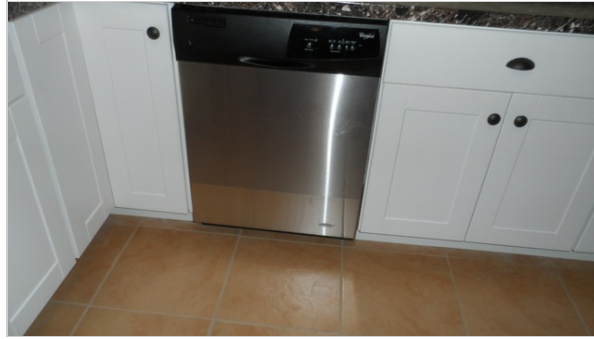
The Whirlpool dishwasher was observed through a cycle and **did not appear to be functional (No water) when set on the "wash" and "drain" cycle.**

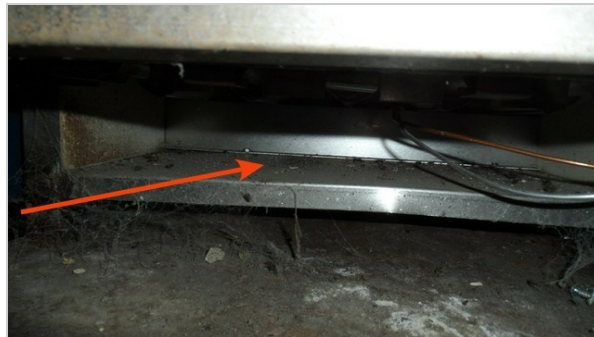
The heating system was found to be functional but dirty

Dirty bolier
