HOME INSPECTION REPORT

On Friday, June 7, 2019 The HomeTeam Inspection Service made a visual inspection of 123 Sample Drive, Anytown, NJ 08302. Enclosed please find a written, narrative report of our findings in accordance with the terms of our Inspection Agreement.

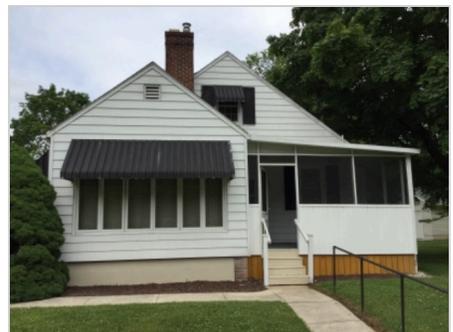
Photo 6

A hole was noted on the back of the structure's exterior. This condition does not have any effect on the structural integrity of the building. The areas should be repaired to prevent water intrusion.

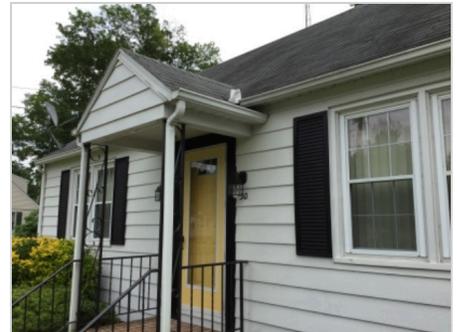
Photo 16

Some of the downspouts around the structure are draining into the ground with no conclusive termination point. HomeTeam recommends ensuring termination points for all downspouts is far enough from the structure and configured in such a way as to ensure water flows away from the foundation during periods of rain.

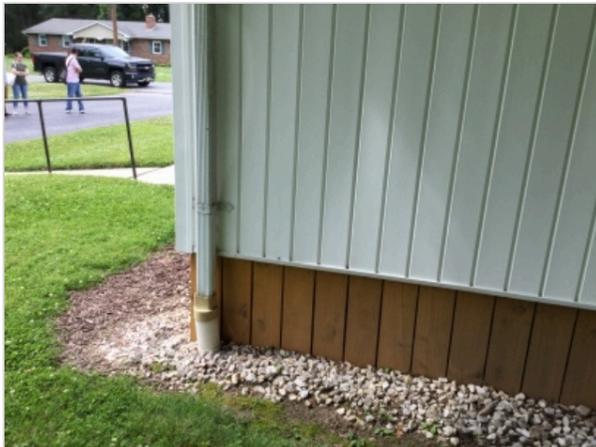
Photo 17

Gutters were in need of cleaning at the time of the inspection. Clogged gutters can cause roof drainage water to drain at the base of the foundation, causing basement water problems. Overflow from gutters can cause damage to fascia that is not visible or apparent at the time of the inspection. The gutters should be cleaned.

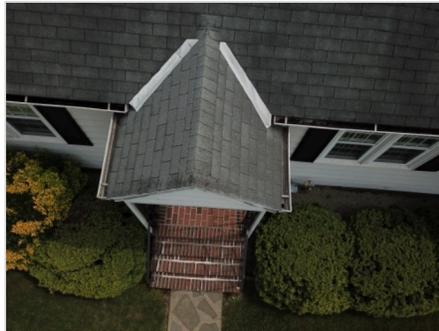
Photo 27

Previous repairs were evident on the roof. These signs may indicate exterior damage, problems with installation, age, previous water intrusion, or other factors, all of which should be considered when evaluating the health of the roof.

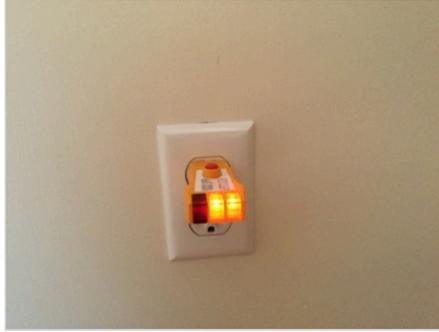
Photo 52

Two prong outlets were found in the structure. At the time this structure was constructed, two-prong outlets were the standard construction. Two-pronged outlets were not grounded (open-ground), and are considered to be outdated by today's standards. In many cases, the outlets can be easily upgraded to three-prong type. In cases where the outlets cannot be easily upgraded, the installation of GFCI's in kitchens, baths, garages, basements, outdoor receptacles, and any other high-risk areas, will increase the overall safety of the electrical system. A qualified electrician should be consulted when working on or updating the electrical system in your home.

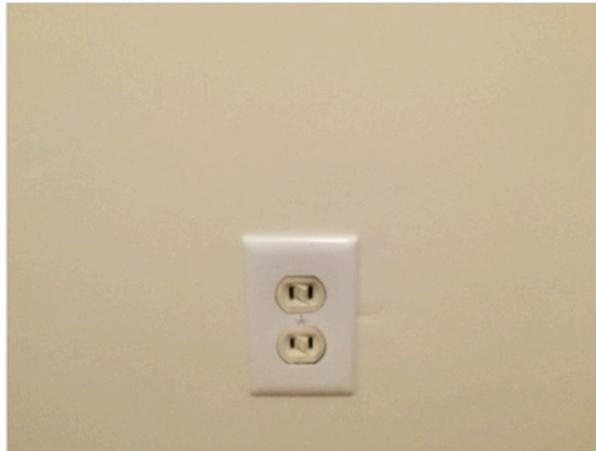
Photo 53

Multiple three prong type outlets in the structure had an open ground. The affected outlet(s) should be grounded, replaced with two-prong outlets, or connected to GFCI circuits to improve safety. This condition means that the third prong, also known as the ground prong, is not doing its job. This is often caused by a missing or disconnected ground connection at an electrical device in the circuit. Consult with an electrician for the best course of action.

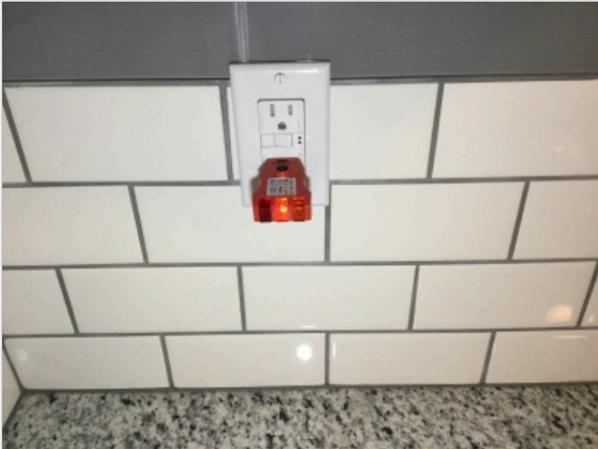
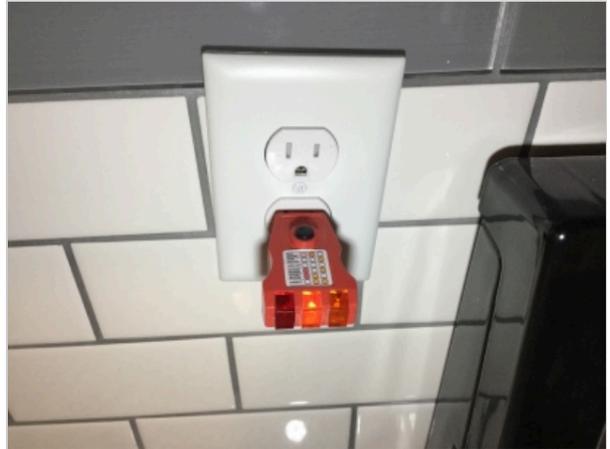
Kitchen sink left side

Kitchen sink right side

The GFCI outlet located in the kitchen is defective and should be replaced.

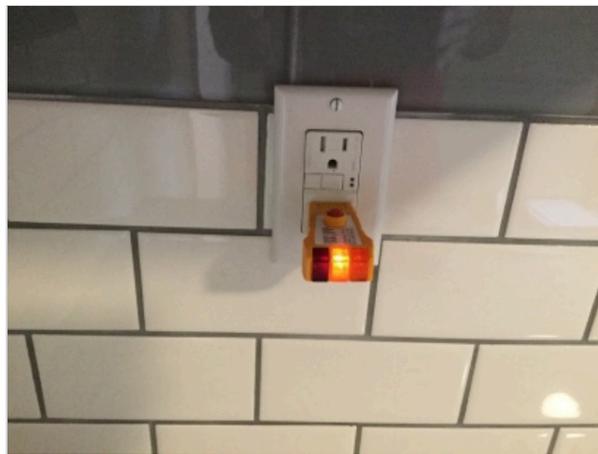
Photo 56

A loose outlet was observed in the kitchen. This could be a shock hazard due to exposed electrical contacts. The affected outlet(s) should be replaced by a qualified contractor.
