HomeTeam[®]

HOME INSPECTION REPORT

The HomeTeam Inspection Service made a visual inspection of 123 Main Street, Anytown, USA 55555. Enclosed please find a written, narrative report of our findings in accordance with the terms of our Inspection Agreement.

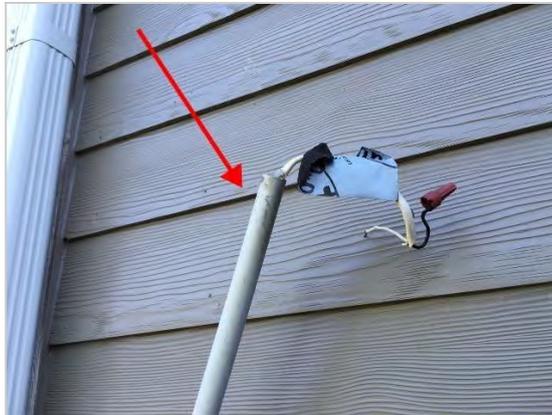
Photo 2

Exposed or un-terminated live wires were observed on the exterior. The wires should either be disconnected at the source or properly terminated in an approved, covered electrical box. Consult with a qualified electrician for repair and further assessment.

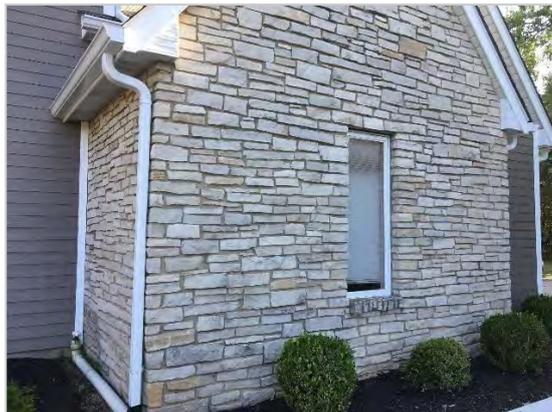
Photo 3

NOTE: The structure has a manufactured stone veneer (MSV) cladding. Structures with MSV can develop moisture intrusion problems even when properly constructed according to industry standards. The problem can develop because of moisture buildup behind the veneer that is unable to drain, and this moisture can cause significant structural damage that is not visible during a non-destructive test. Specific areas of concern include areas around the windows that may have been subjected to prolonged water exposure. Other areas of likely penetration are around chimneys, decks, and any other penetration points. Water intrusion is more likely at these points. In all cases, HomeTeam recommends having MSV-clad structures professionally inspected by an MSV-qualified technician prior to purchase and again each year. Typically, this type of test involves drilling several holes and inserting moisture meters to determine if any moisture is present behind the veneer.

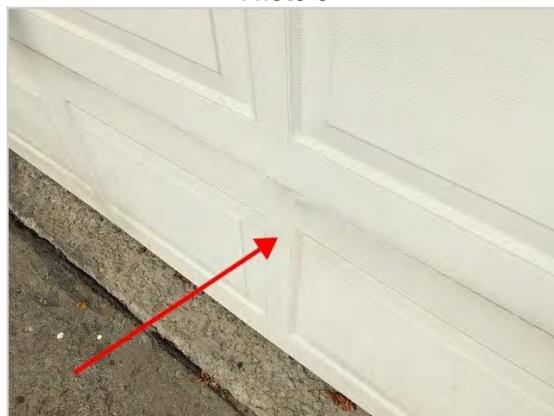
Photo 6

The widest of the three garage door is dented from what appears to be impact. The door was operating correctly at the time of the inspection. Care should be exercised to ensure that the door is not subjected to further impact, as the door may crack or fail.
