### HOME INSPECTION REPORT

XXXXXXXXXXXXXXXXXX  
2 Avenida La Promesa  
Coto De Caza, CA 92679

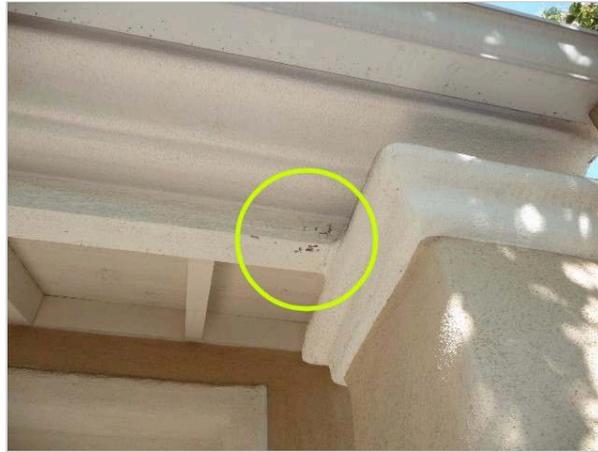
Soffit wood at the rear of the home exhibited damage by wood destroying organisms. Recommend Termite inspection to identify the organism treat and repair as needed. Note this may be an HOA function. consult your Realtor for information.

wood damage

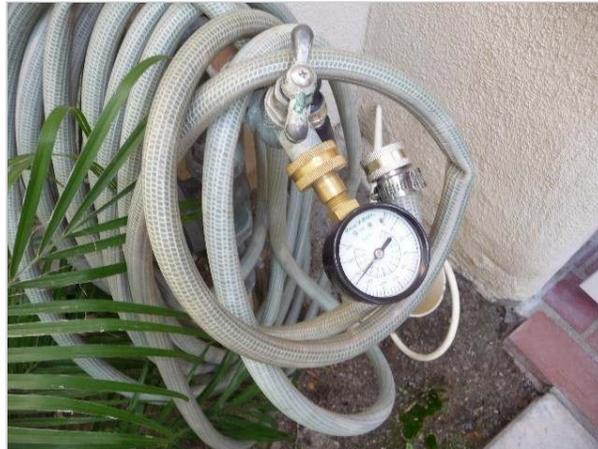
All plumbing fixtures not permanently attached to an appliance were operated and inspected for visible leaks. Water flow throughout the home was above average. Water pressure was tested at an outdoor sillcock and found to be 150

pounds per square inch. This report is not intended to be an exhaustive list of minor plumbing issues. Concealed, latent or intermittent plumbing issues may not be apparent during the testing period. There were no material defects observed in the visible portions of the plumbing system.

The water pressure in the home can be reduced by installing a pressure regulator on the main water service line in the home. In cases where a pressure regulator already exists, the device may be set for high water pressure or defective. High water pressure can place stress on the water fixtures throughout the home and shorten the life of the shut off mechanisms. Plumbing related repairs should be performed by a qualified plumber.

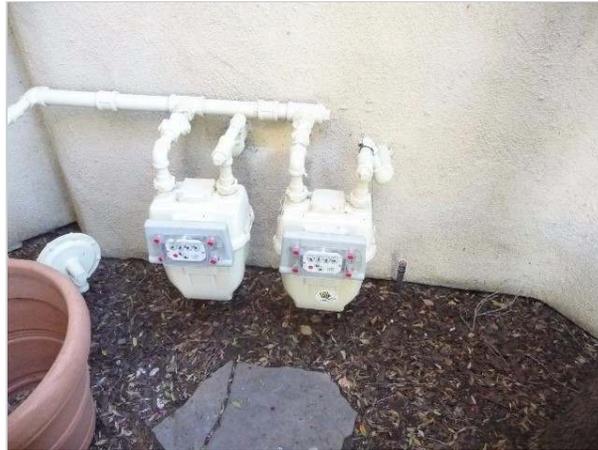
meter is not identified

The two meters were not labeled as to with unit the supplied. Recommend contacting the gas supply company for identification.

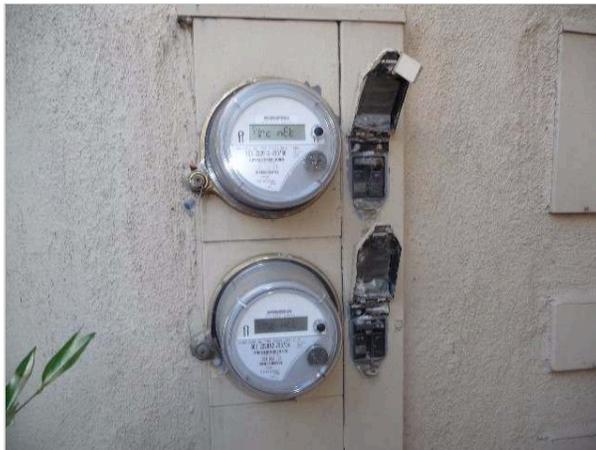
Electrical meter and main disconnect were not identified. Contact the electrical supplier for determination.

Main disconnect and meter lacking proper identification.

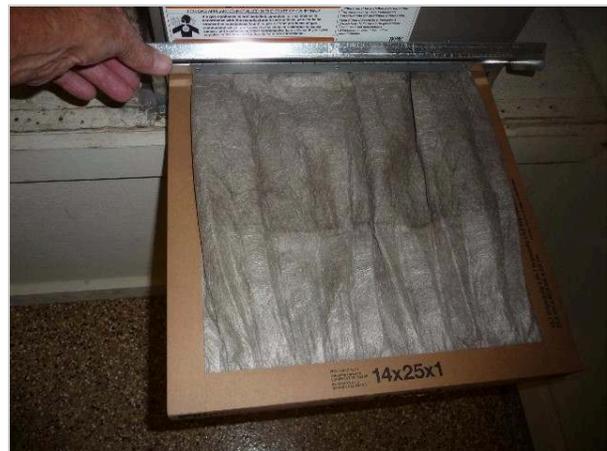
filter needs changing

The disposable filter should be replaced on a regular basis to maintain the efficiency of the system. The efficiency rating is not within the scope of this inspection.

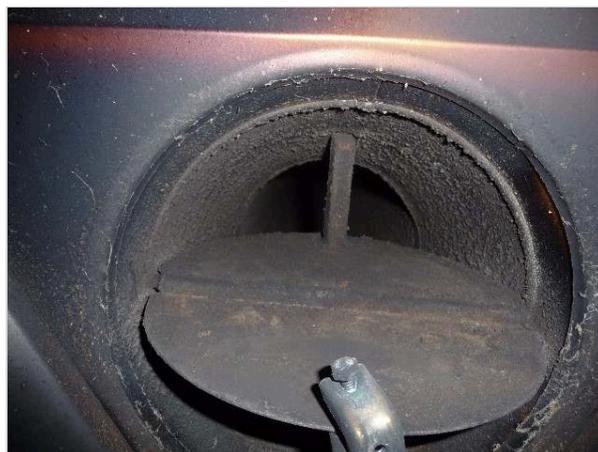
fireplace with restricting clamp installed

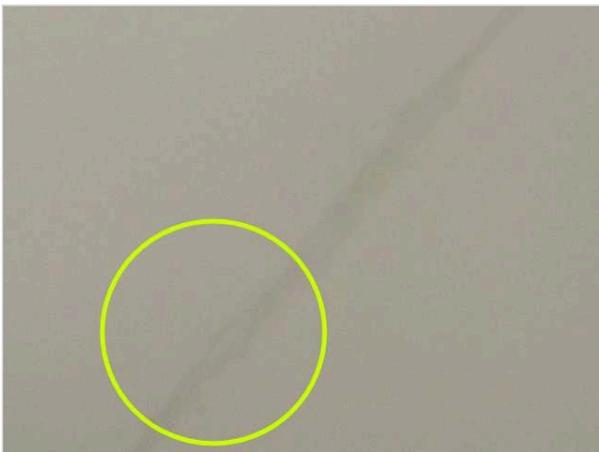
master bedroom ceiling previous repair

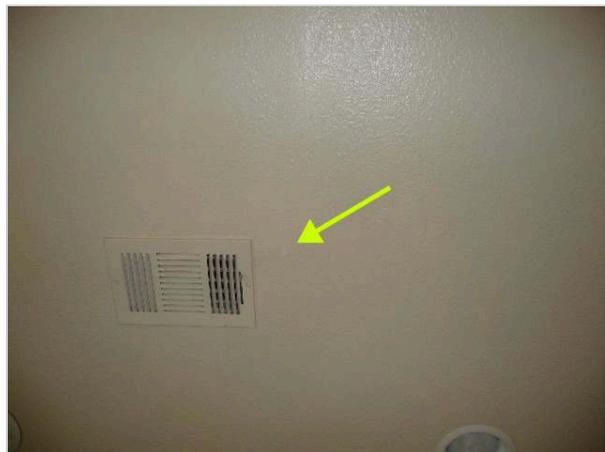
Evidence of previous water damage to the ceilings in the master bathroom were noticed. it was repored by the owner these repairs were made prior to her ownership.

master bathroom previous ceiling water damage.

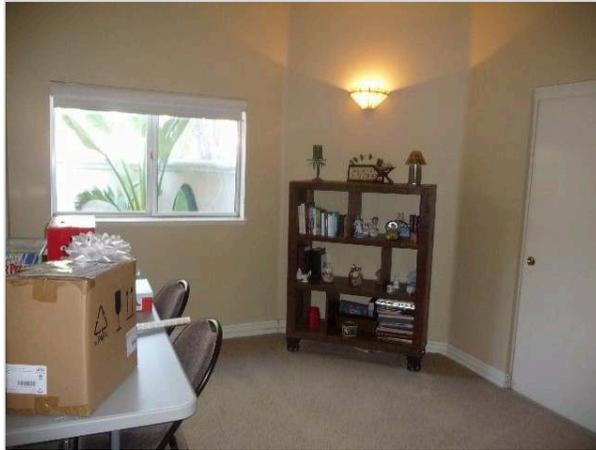
bedroom 1

One three prong type outlets in the home located in bedroom 1, left of the window tested as having an open ground. This means that the third prong, also known as the ground prong is not doing its job. This is usually caused by a missing ground connection at an electrical device in the circuit. This condition is usually easily correctable by an electrician. Open grounds in wet locations is considered a safety issue and should be corrected. Please note that we only test outlets that are visible and readily accessible at the time of the inspection.

- Representative number of receptacles were tested and found to be in need of repair.

Outlet to the left of the window was found to have an open ground condition. Recommend contacting a licensed electrical contractor for repair.

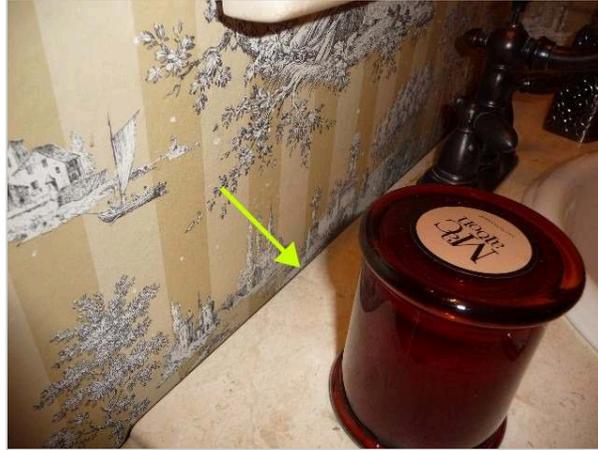
Vanity was installed approximately 1 inch from wall creating a gap the may be unacceptable. Recommend remounting vanity after removing baseboard so as to fit tight to wall.

vanity not installed tight to wall.

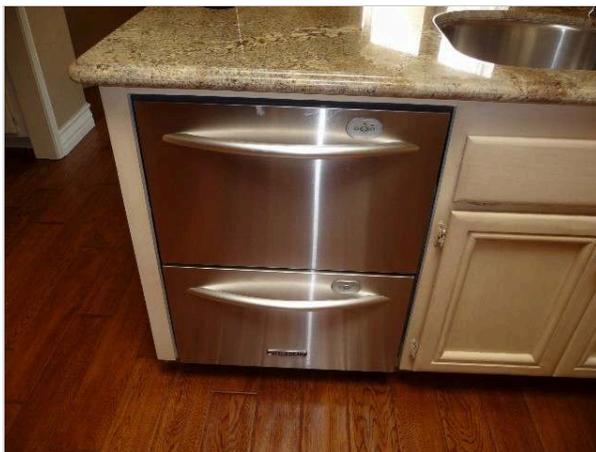
The dishwasher did not have an anti-siphon device (air gap) installed in the drain line. Anti-siphon devices are installed to prevent wastewater from the dishwasher from being siphoned back into the dishwasher and contaminating its contents. Recommend an anti-siphon device be installed by a qualified plumbing contractor.
