### HOME INSPECTION REPORT

## **GENERAL DESCRIPTION**

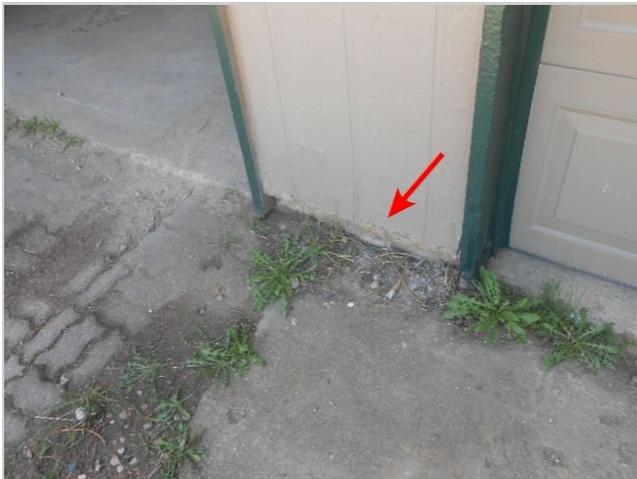
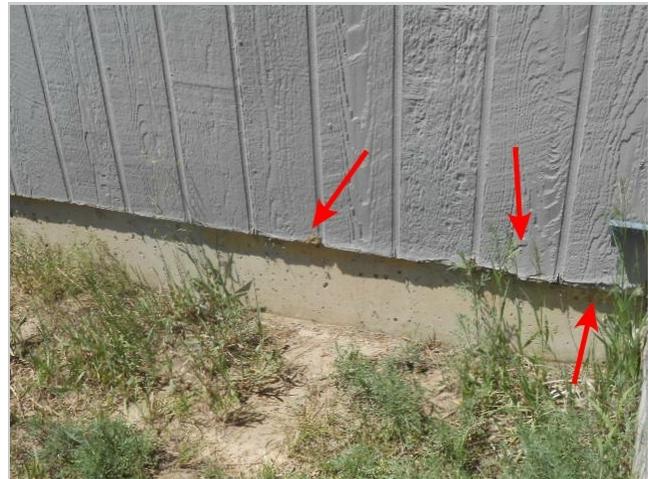
The siding and trim throughout the exterior of the home were in overall marginal condition. There were several areas throughout the exterior where the siding and trim was deteriorating and scraping, repairs, caulking and paint to match are needed. We recommend that a reputable contractor further evaluate the homes exterior and any recommendations for repairs and maintenance be completed prior to closing to prevent any further decay and to prevent possible water intrusion into the home or the homes structure.

- The siding and trim throughout the exterior of the home were in overall marginal condition. There were several areas throughout the exterior where the siding and trim was deteriorating and scraping, repairs, caulking and paint to match are needed. We recommend that a reputable contractor further evaluate the homes exterior and any recommendations for repairs and maintenance be completed prior to closing to prevent any further decay and to prevent possible water intrusion into the home or the homes structure.

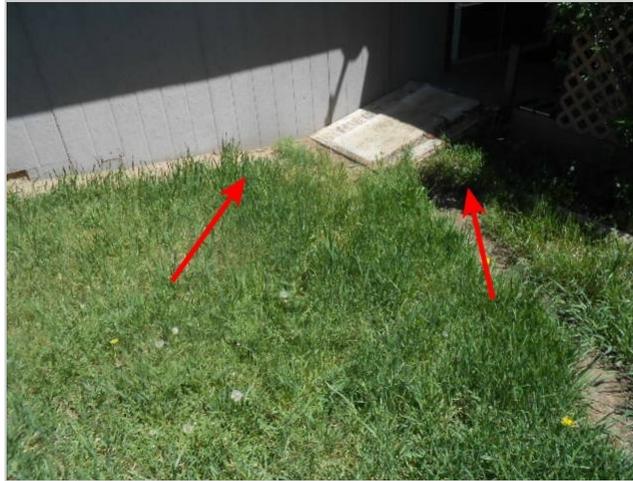
The exterior grading on the rear of the home was noted to be sloping towards the home and foundation. The grading in this area should be corrected to allow for proper drainage and to prevent water accumulation along the home and foundation.

This area of exterior grading on the rear of the home is sloping towards the home.

- The exterior grading on the rear of the home was noted to be sloping towards the home and foundation. The grading in this area should be corrected to allow for proper drainage and to prevent water accumulation along the home and foundation, basement.

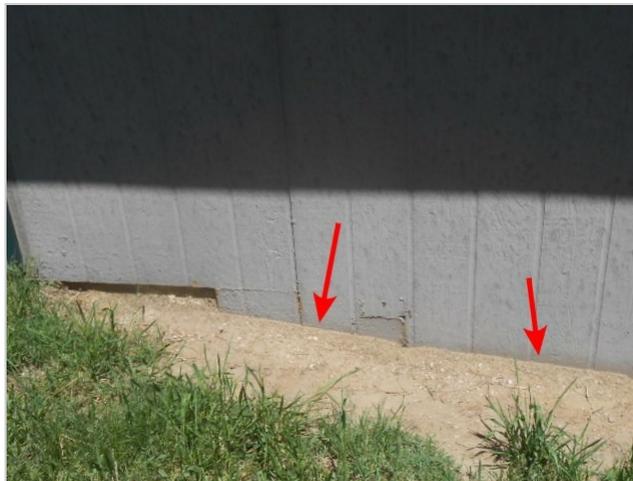
Some of the exterior siding on the rear of the home is in contact or is under the ground or earth. This condition can lead to wood rot or insect intrusion if not corrected. Further evaluation is recommended by a qualified contractor, prior to closing.

This section of siding on the rear of the home is in contact with the ground or earth.

- Some of the exterior siding on the rear of the home is in contact or is under the ground or earth. This condition can lead to wood rot or insect intrusion if not corrected. Further evaluation is recommended by a qualified contractor, prior to closing.

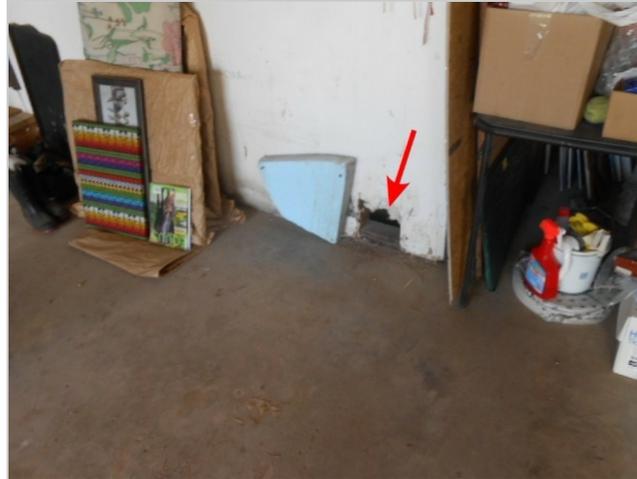
There was one firewall breach observed in the garage ( on the rear garage wall ) at the time of inspection. Firewall breaches are safety concerns which include holes or voids in the firewall separation between the

garage and home which should be sealed to prevent a garage fire from spreading easily into the home.

- There was one firewall breach observed in the garage ( on the rear garage wall ) at the time of inspection. Firewall breaches are safety concerns which include holes or voids in the firewall separation between the garage and home which should be sealed to prevent a garage fire from spreading easily into the home.

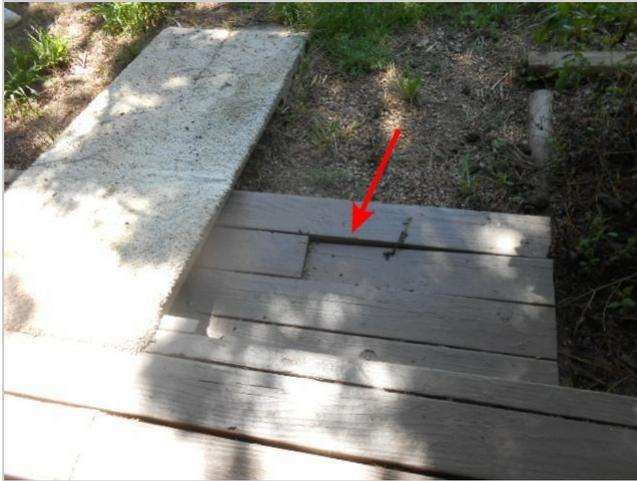
The underside of the deck was unable to be fully inspected due to the deck being very close to the ground or earth below. There were however several deck boards that were loose or were deteriorated indicating the need for further evaluation and repairs to the deck ( as needed ) by a qualified contractor, prior to closing.

Loose or deteriorated deck board on the rear deck.

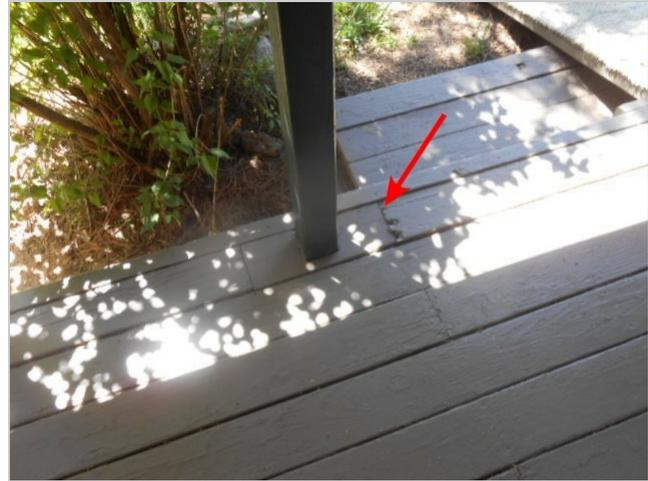
Loose or deteriorated deck boards on the rear deck.

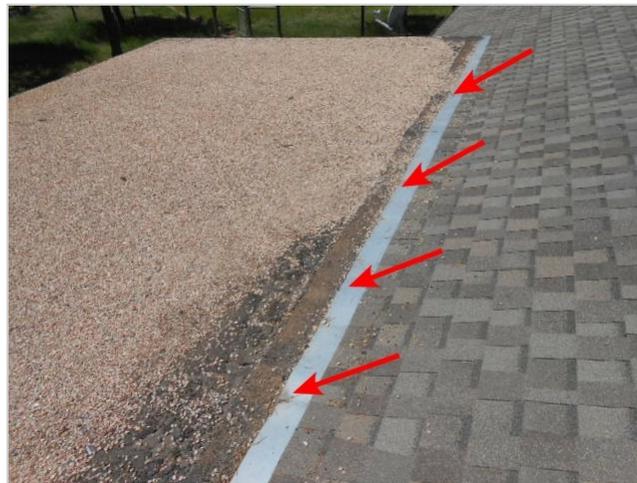
The transition roof flashing ( where the house roof meets the patio roof ) is loose or is unsecured indicating the need for further evaluation and repairs by a qualified roofer, prior to closing.

This transition roof flashing is loose or is not secured which can lead to roof leakage if not repaired.

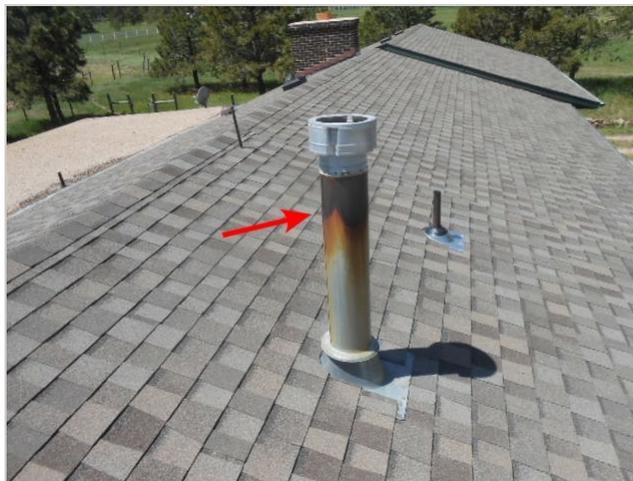
The furnace vent pipe ( which penetrates the roof line ) is rusted or deteriorated and is recommended to be replaced by a qualified HVAC contractor or roofer, prior to closing.

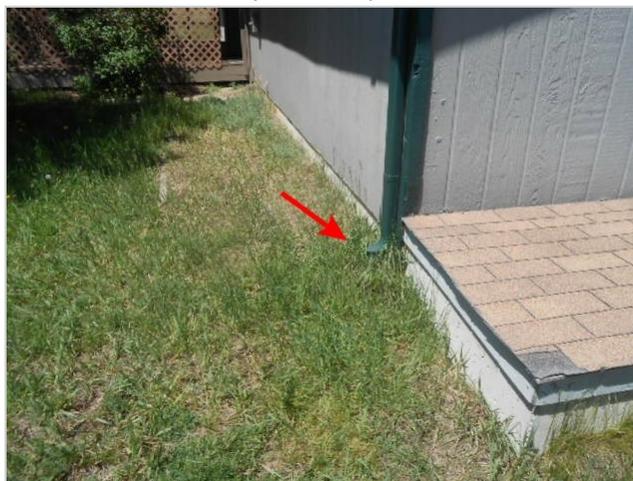
One of the downspouts on the left, rear of the home was missing the extension. This condition can allow for rain water to accumulate along the home and the possibility of water in the crawlspace if not repaired.

- One of the downspouts on the left, rear of the home was missing the extension. This condition can allow

for rain water to accumulate along the home and the possibility of water in the crawlspace if not repaired.

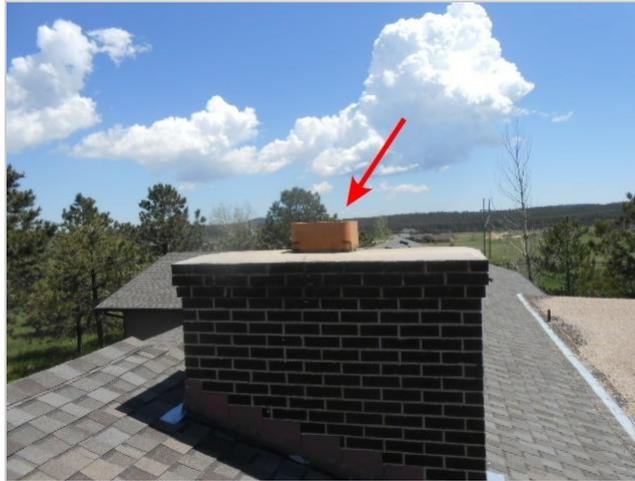
There was no rain hat on the chimney. This device is recommended to be installed by the seller ( prior to closing ) to prevent animals or rain water from entering the chimney and fireplace flue and causing damage to the home or to the metal flue damper inside the chimney.

- There was no rain hat on the chimney. This device is recommended to be installed by the seller ( prior to closing ) to prevent rain water from entering the chimney and fireplace flue and causing water damage to the home or to the metal flue damper inside the chimney.

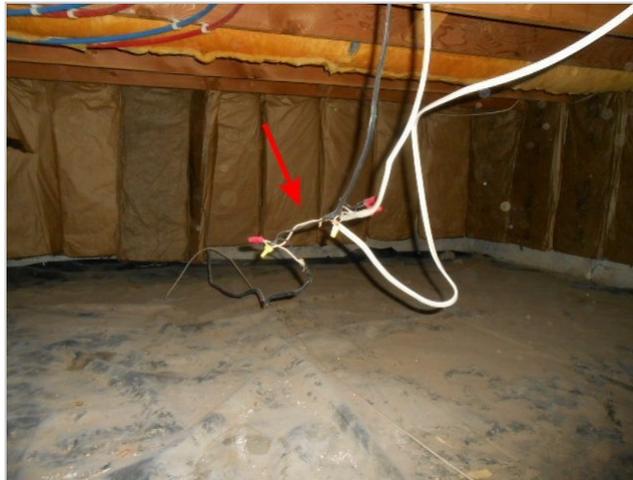
There were a few open splices noted throughout the crawlspace at the time of inspection. Open splices consist of wires joined together outside of a junction box or loose wiring. This is a safety concern which should be corrected by a qualified electrician prior to closing.

Open spliced wiring in the crawlspace.

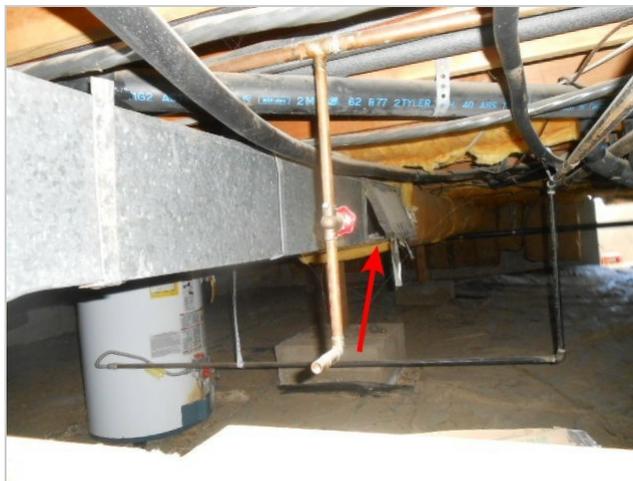
One of the heating supply or return ducts ( in the crawlspace ) has an opening which is recommended to be properly sealed to prevent heat loss into the crawlspace when the heating system for the home is in use.
