HOME INSPECTION REPORT

On Wednesday, August 1, 2018 The HomeTeam Inspection Service made a visual inspection of 123 Sample Drive, Anytown, MO 55555. Enclosed please find a written, narrative report of our findings in accordance with the terms of our Inspection Agreement.

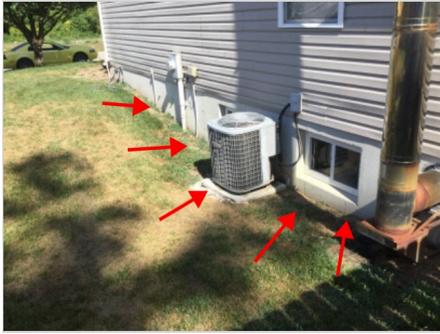
Photo 5

The structure was situated on a rolling lot. The general grade around the structure appeared to be inadequate on the back, left and right side to direct rain water away from the foundation, assuming normal drainage and downspout, gutter, and other systems are functioning properly.

Ground slopes toward foundation

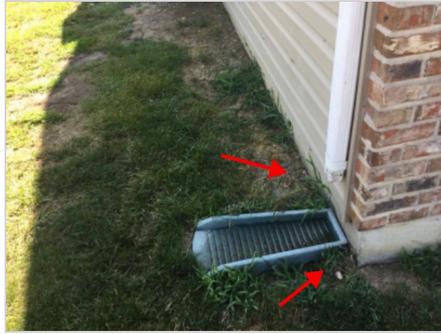
Photo 6

Ground slopes toward foundation

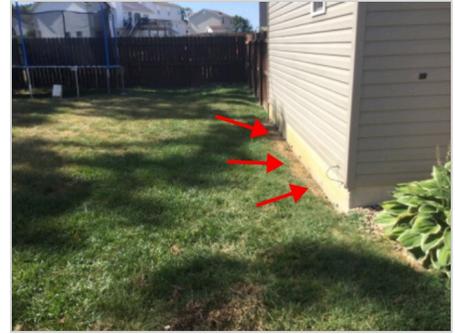
Photo 7

Ground slopes toward foundation

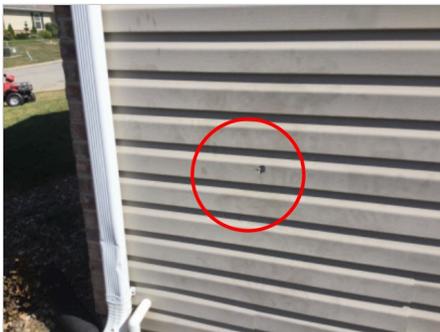
Photo 15

Holes were noted on the right, rear and left side of the structure's exterior. This condition does not have any effect on the structural integrity of the building. The areas should be repaired to prevent water intrusion.

Right side

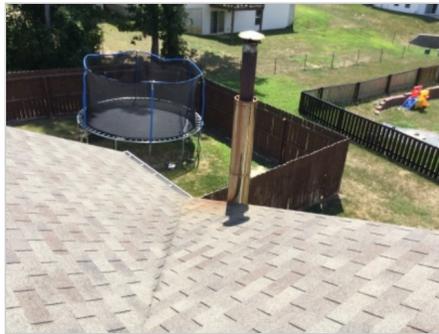
Photo 23

Evidence of a hail event is present on the roof (dents in metal materials and/or bruised shingles on or near roof). Consult with a professional roofer and/or the current owner to determine if the roof has been assessed or replaced since the hail event, and if not, have the roof assessed for replacement or repair by a professional roofer. Depending on the results of this consultation, this may be a material defect.

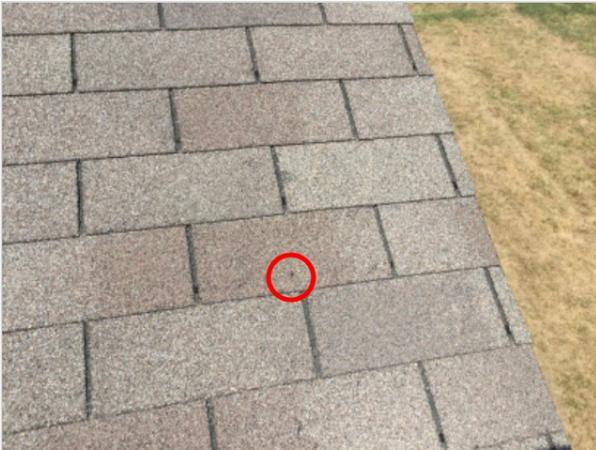
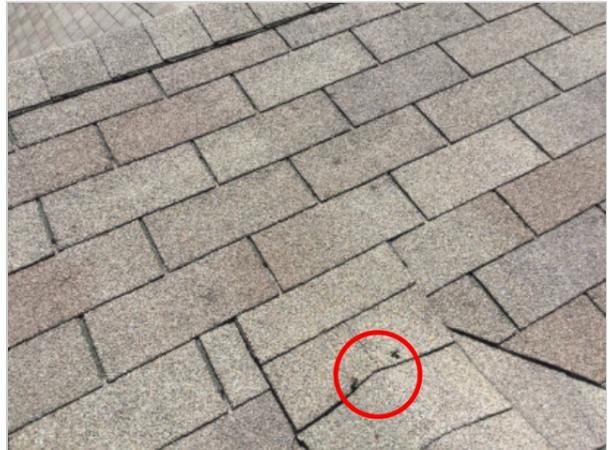
One or more popped nails were noted on the roof at the time of the inspection. A popped nail can be identified by a lifted corner on a shingle. The heating and cooling of the roof will often cause roofing nails to lift under the shingles, causing the corner to lift. While it is not likely that the condition is causing a leak, the nails should be reset and sealed to prevent wind from getting under the shingle and possibly lifting the shingle off the roof. Consult with a qualified roofer for repair.

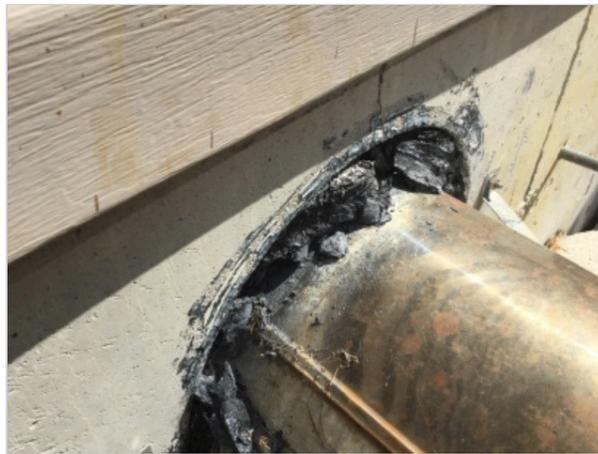
Photo 31

The flashing around the chimney requires repair. Flashing is a critical component that helps prevent water intrusion. At the time of repair, the technician should investigate the area for any previous water intrusion or damage.

Right side , base of chimney

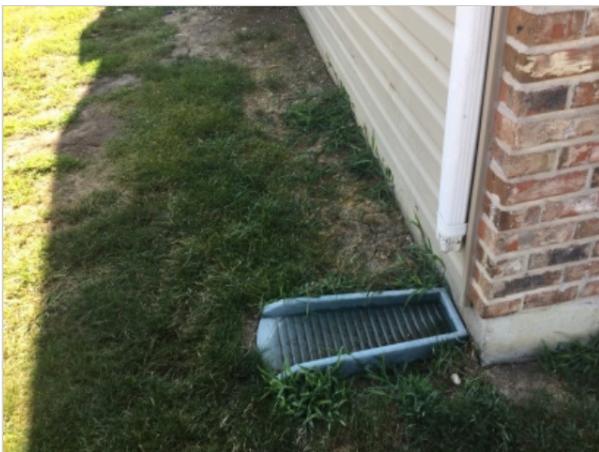
Photo 33

Several downspouts were draining at or too close to the base of the foundation. To reduce the likelihood of water problems at the base of the structure, all roof drainage should be directed at least six feet from the base of the foundation.

Left front

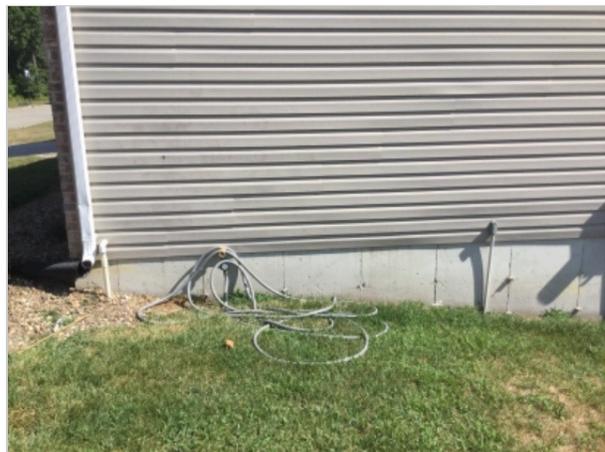
Photo 34

Right front

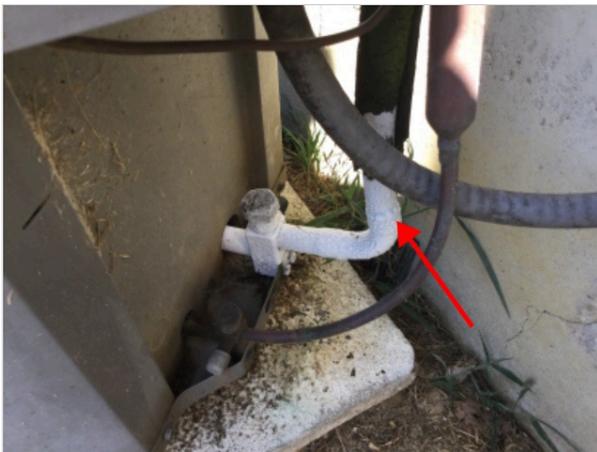
Photo 38

Because of its condition and performance at the time of the inspection, **the HVAC system requires cleaning and servicing by a professional HVAC technician.** At that time, the technician will test refrigerant levels, service the equipment to improve its performance, and perform other tests beyond the scope of the home inspection to assess and identify any additional areas that may require attention.

Low pressure line freezing

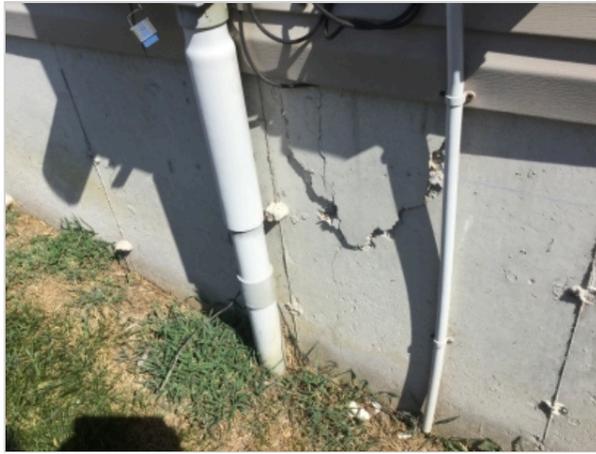
Photo 42

There were several minor, vertical cracks and spalling observed on the foundation. The cracks were 1/16-inch or less in width. These cracks are common and usually insignificant. All buildings experience some settlement. Settlement cracks most often occur within the first few years after construction as the soil under the structure accommodates itself to the load of the structure. However, the significance of cracks cannot always be judged by a single inspection. All cracks should be monitored for significant changes in characteristics. Consult with a company specializing in foundation repair if there is a marked change in the size or dimension of a crack.

One or more areas on the foundation were found to have spalling. One of the causes of spalling is from moisture

entering behind the surface of concrete, brick or stone, freezing, and eventually causing a portion of the surface to be pushed away and break off from the foundation or siding. Although not a structural concern at this time, it is recommended that large spalling areas be patched and monitored, to prevent further damage.

Right side

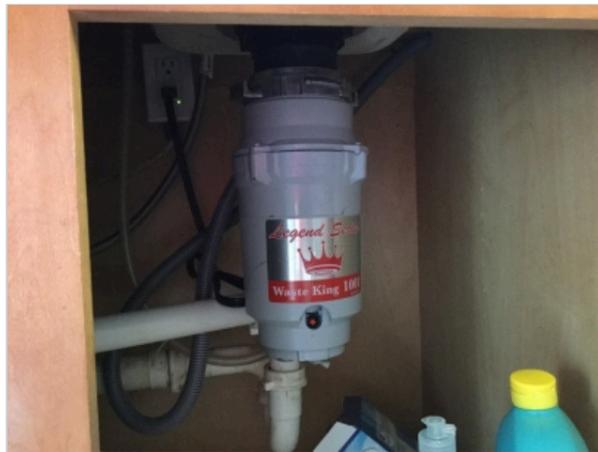
Photo 60

The garbage disposal is lacking a cable connector at the base of the unit. The purpose of the connector is to prevent pressure from the actual wire connection, which if disconnected, can lead to shock hazard.

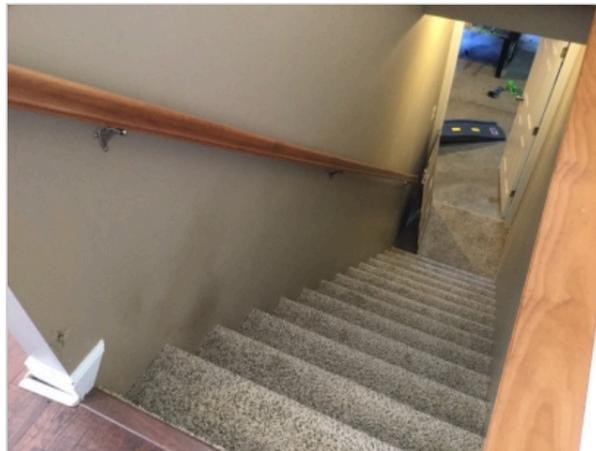
Photo 71

The stairs leading to the basement have a handrail that is loose or otherwise not secure. The handrail should be properly secured for safety.

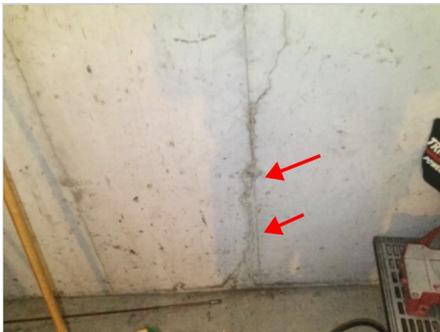
Photo 76

Cracks in the basement show signs of previous water intrusion. Below grade cracks are highly susceptible to water intrusion during times of heavy rain. The cracks should be monitored to determine if they are active. If a waterproof basement is required, HomeTeam recommends having the cracks sealed to prevent water intrusion.

Right basement wall

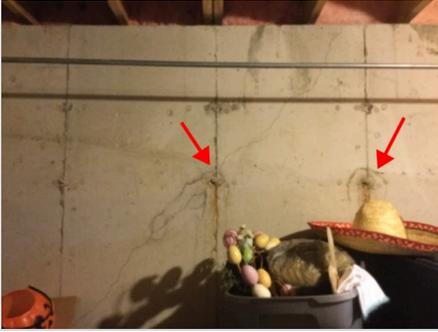
Photo 79

Rear left

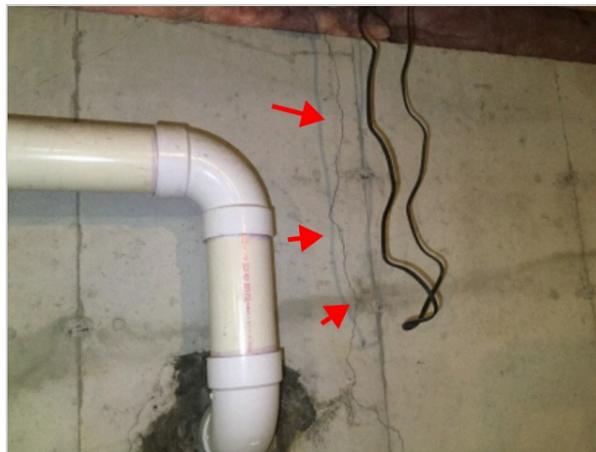
Photo 80

A crack or several cracks in the foundation were found in excess of 1/16th of an inch. Though there is no water penetration noted, it is recommended that routine monitoring of the cracks be conducted to see if cracks widen, become offset or develops water penetration. If it is found that the condition worsens, consulting with a foundation specialist is recommended.

Right front wall

Because of the items discussed in the foundation, it is recommend that you consult a structural specialist for further evaluation.

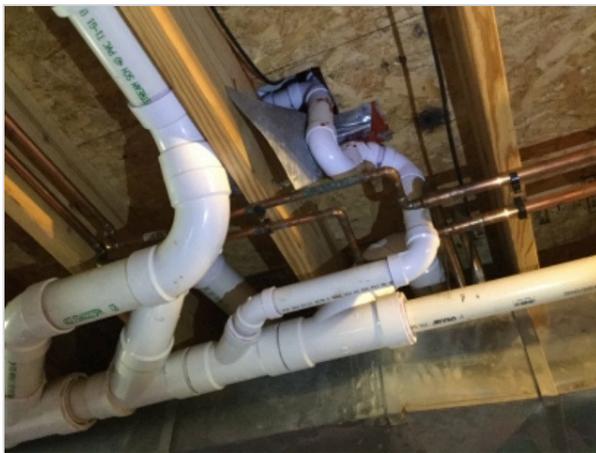
Photo 81

Plumbing firebreak is missing/damaged

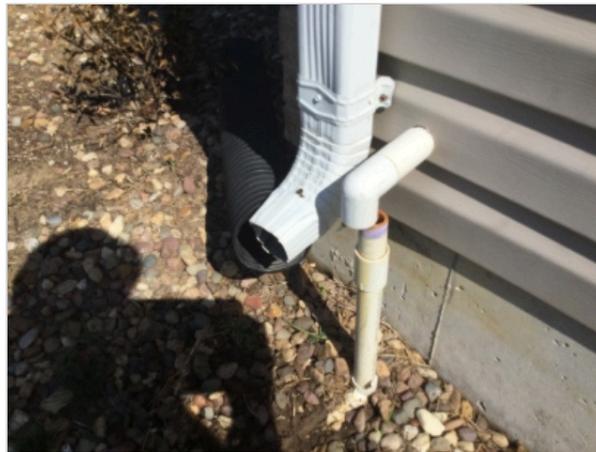
Photo 90

The sump pump drains too close to the foundation. The purpose of the sump pump is to reduce the possibility of basement flooding by collecting water that is gathering near the foundation and move it away from home. The discharge pipe should terminate at least 5 to 6 feet away from the foundation, dependent upon landscaping slope.
