HomeTeam® INSPECTION SERVICE

HOME INSPECTION REPORT

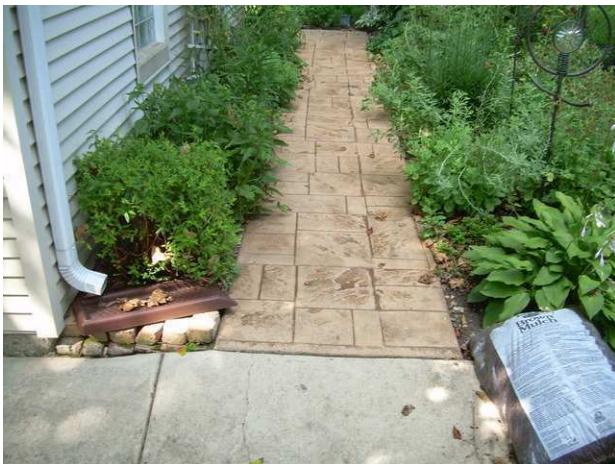
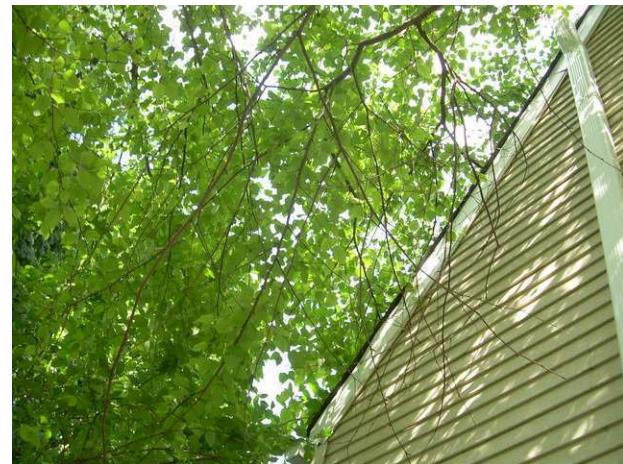
Extensive plant growth was observed aroundt the home and over the left rear of the roof. Recommend removing this growth away from the siding to prevent possible damage including insect infestation.

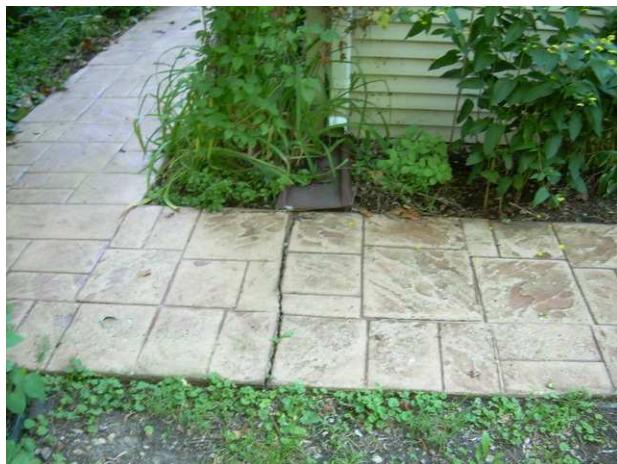
There was one or more cracks with trip hazards found on the walkways around the house. These are defined as two surfaces with at least a 1/4 inch deflection. The hazards can be repaired using a suitable or similar surfacing material to "feather" the out-of-level condition to make a smooth transition.

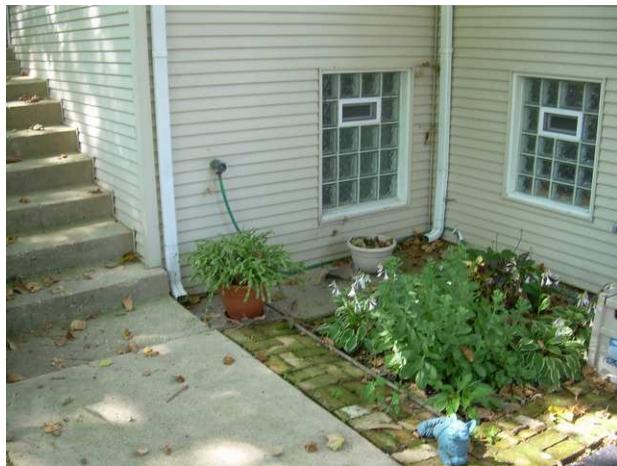
There was poor drainage and a negative slope present towards the patio; the bricks were deflected or in need of adjustment or repair; recommend grade adjustment and improved drainage repairs to avert further deterioration or moisture allowance or aggregation towards or around the house and its foundation.

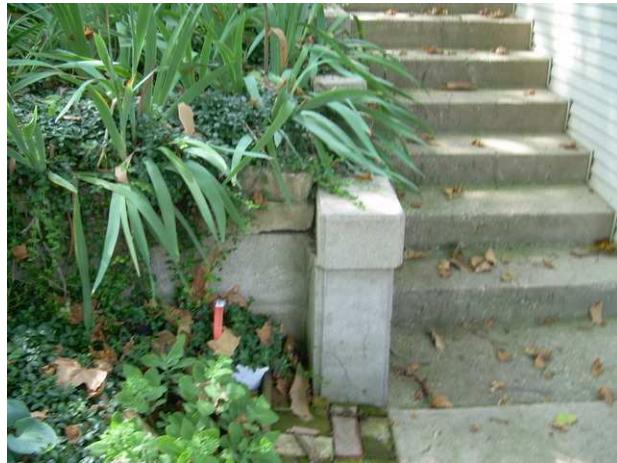
The area way retaining wall at the steps leading to the right front entry way is subtly leaning inward with cracks present. There were some vertical earth pressure type cracks observed in the wall. This condition is most often associated with soil and / or water pressure. The displacement occurs incrementally as the wall yields to horizontal earth pressure. The wall was stable at the time of the inspection. Repairs to the wall should be considered with on-going monitoring for additional movement, deterioration, or a need for repairs..

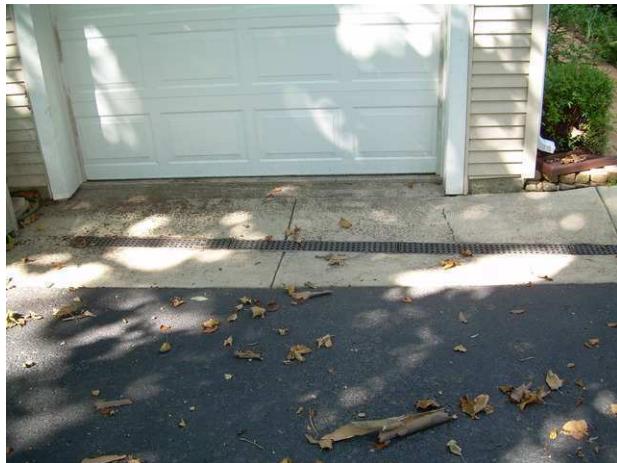
There was a drainage channel in front of the garage for improved drainage and moisture aversion or aggregation purposes which did appear to be in good condition at the time of inspection; it is recommended that on-going cleaning or checking for any blockage or debris be part of routine homeowner maintenance.

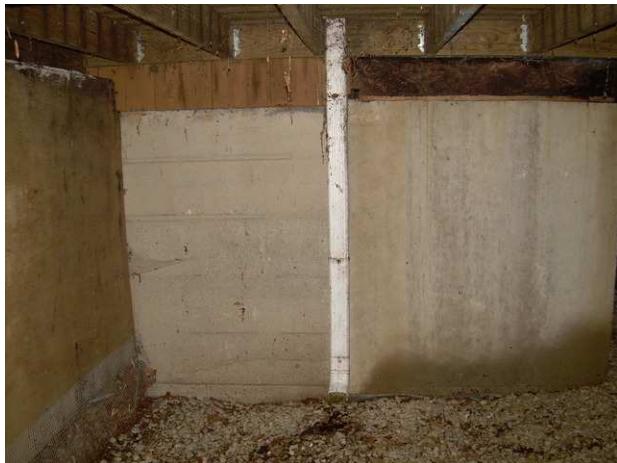
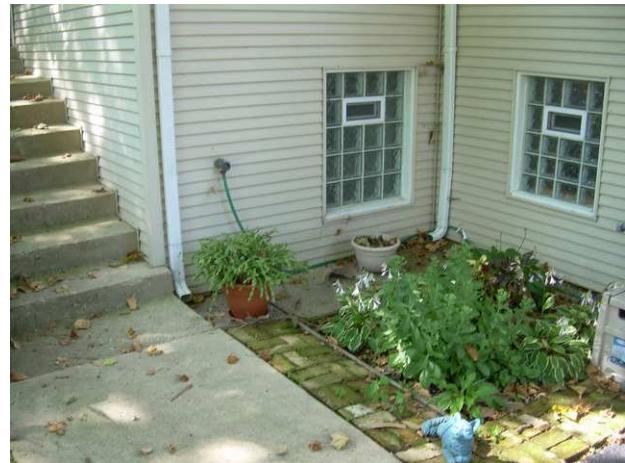
All the downspout (s) were draining at or too close to the base of the foundation. All roof drainage should be directed at least four to six feet from the base of the foundation.

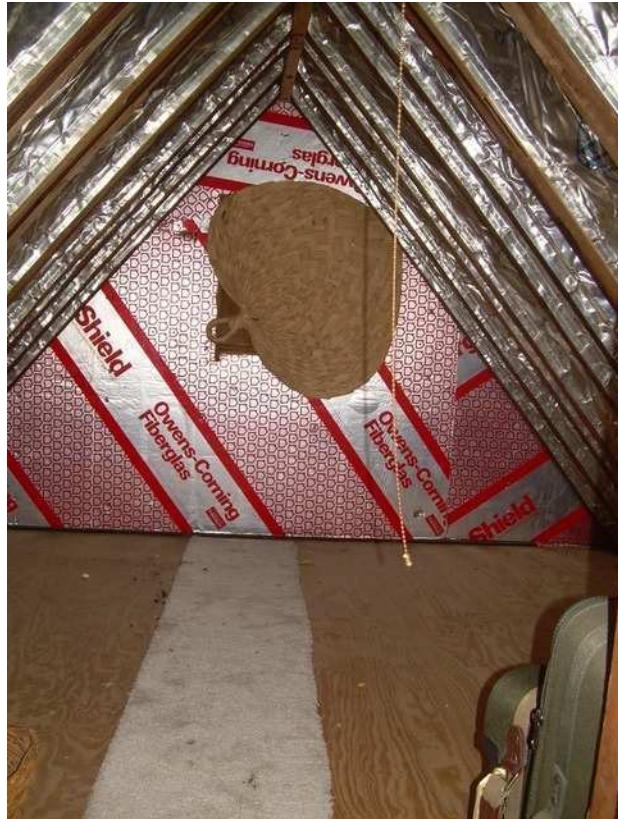
Insulation has been applied directly to some of the roof rafters in the attic storage or converted closet areas. Insulation applied directly to the roof deprives the roof deck of proper ventilation and can cause the roof to overheat resulting in shortened roofing life. Additionally, condensation can form between the insulation causing damage to the roof deck. The insulation should be removed from the roof rafters. Walls adjacent to or below

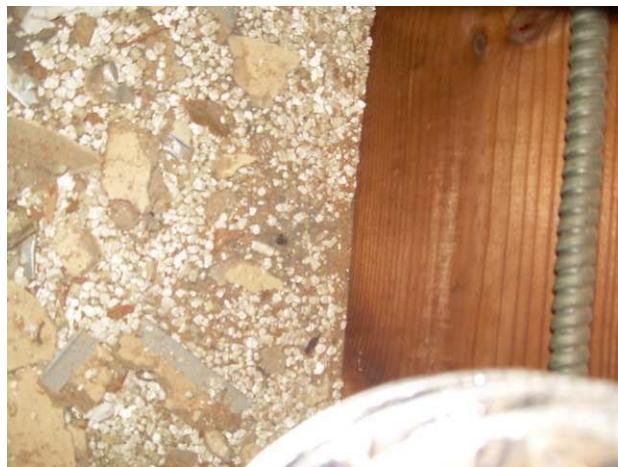
Vermiculite type insulation was noted in the attic. Vermiculite ore from some sources is known to contain asbestos minerals however, not all vermiculite type insulation contains asbestos. The presence of asbestos cannot be confirmed without professional testing. The EPA recommends that you do not disturb the insulation. Any disturbance has the potential to release asbestos fibers into the air. Limiting the number of trips you make into the attic and shortening the length of those trips can help limit exposure. The EPA strongly recommends that homeowners make every effort not to disturb the vermiculite insulation in their attics. If you plan to remodel or conduct renovations that would disturb the vermiculite, hire professionals trained and certified to handle asbestos and safely remove the material. More information on vermiculite can be found on the EPA web site: <http://www.epa.gov/asbestos/pubs/verm.html>

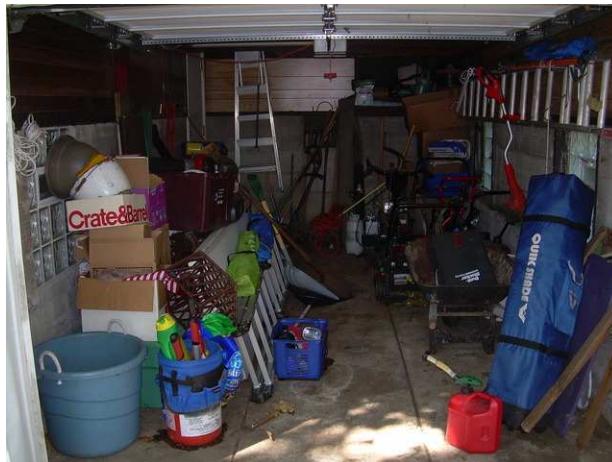
The garage was cluttered with many stored items and/or shelves at the time of inspection, therefore several areas were unable to be inspected.

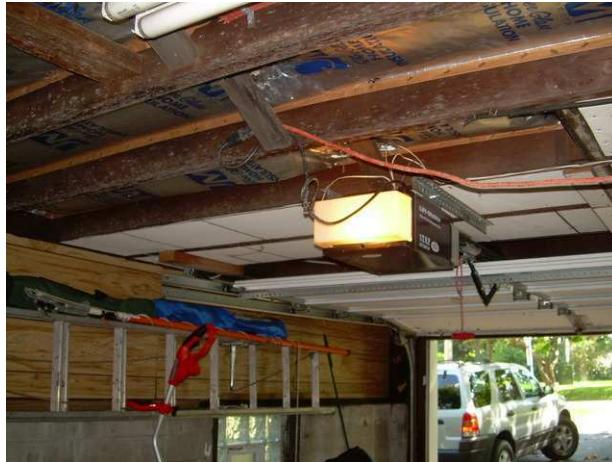
The electric power to the door opener consisted of temporary or inappropriate wiring. The door opener should be powered by a permanently wired electrical outlet located in close proximity to the door opener. Consult with a qualified electrician to correct this issue.

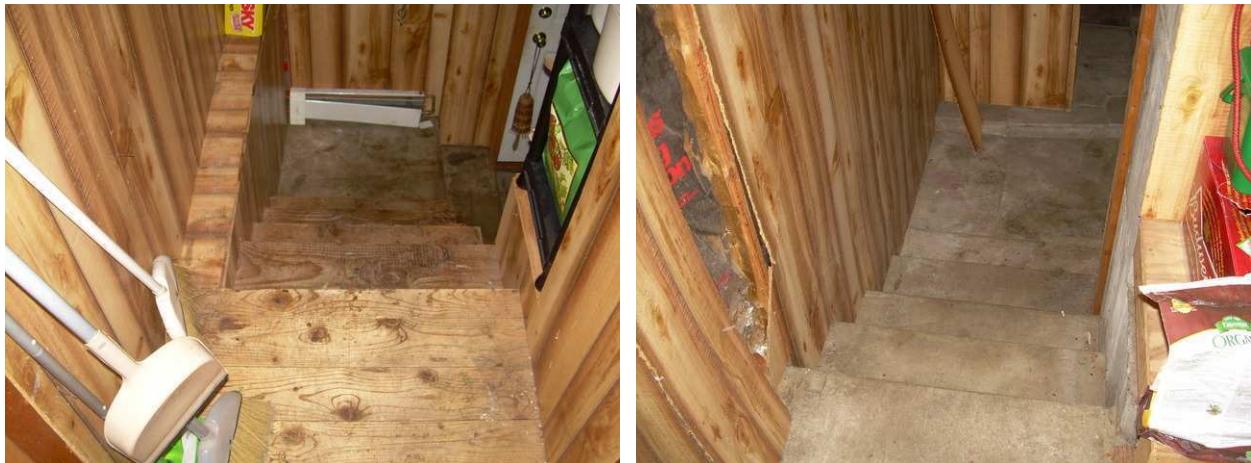
There was no handrail on the stairs leading to the basement. This can be a safety concern. Local building codes may also require the installation of a handrail.

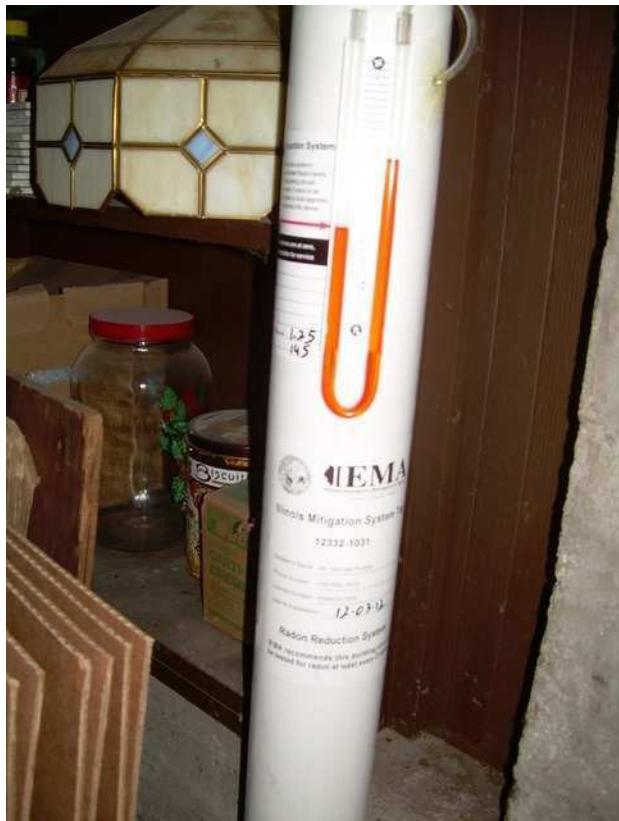
A Radon mitigation system was present in the basement and routed to the left exterior for dissipation purposes; the system appeared to be functional; any questions or concerns should be directed to the contractor or a reputable Radon mitigation system licensed certified contractor.

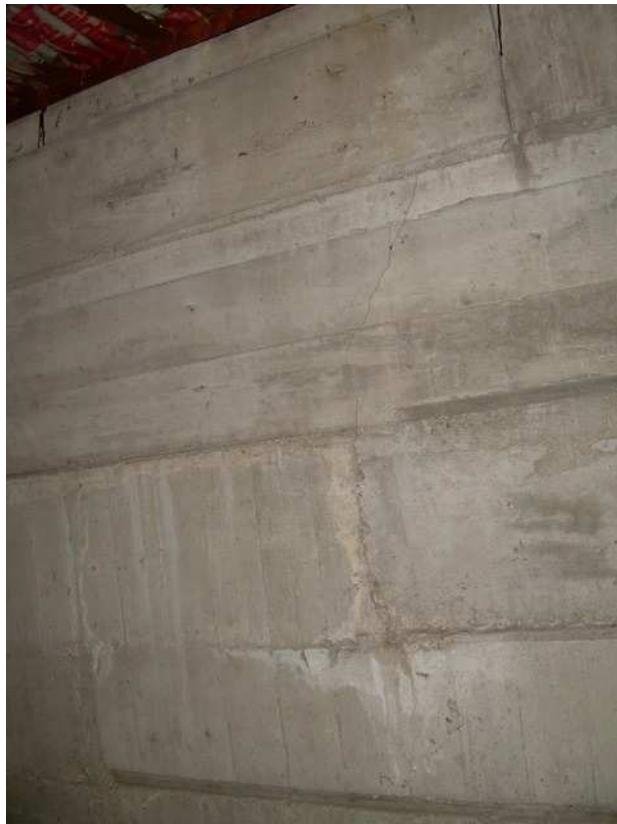
There was a small vertical hairline settlement crack noted on the left wall was stains or potential previous signs of seepage; there was also some efflorescence present along the front wall to floor sections, indicative of high levels or moisture or humidity presence; while there were no active signs of moisture intrusion or penetration; recommend on-going monitoring for seepage or leakage; recommend placement and use of a dehumidifier in the basement and crawlspace for improved dampness and humidity control; additional consultation or advisory is recommended from a reputable concrete or water proofing contractor.

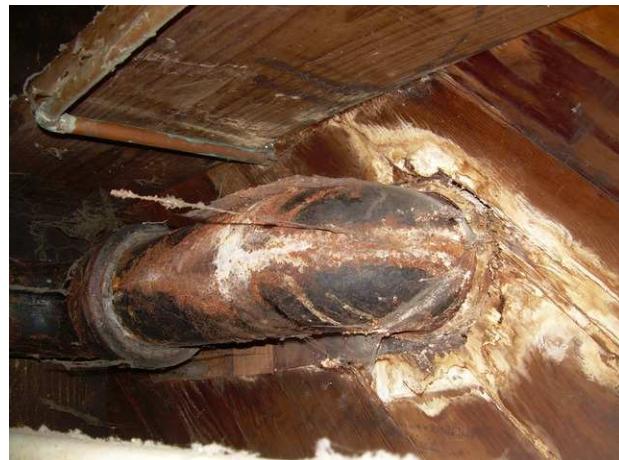
The upper section of a main drain stack in the rear basement ceiling was rusted at the time of the inspection. Consult with a qualified plumber for repair.

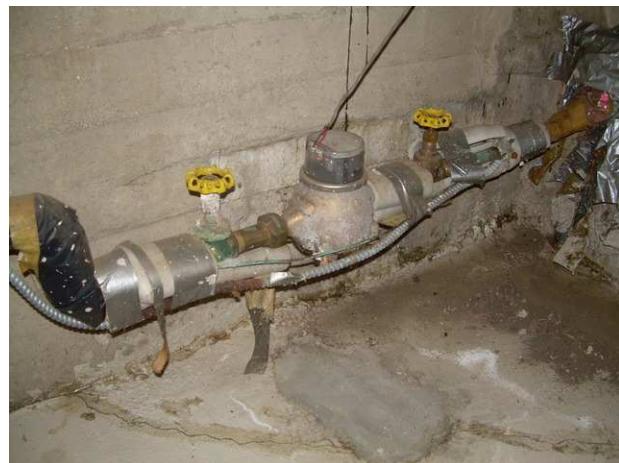
Generally accepted wiring methods, as well as some local codes require the installation of a ground jumper from one side of the water meter to the other. The purpose of the jumper is to ensure the integrity of the cold water ground connection. The water meter ground jumper was not installed at the time of the inspection. Installation of a ground jumper is recommended. Consult with a qualified electrician.

Recommend placement of an 8 Awg jumper wire around the water meter for safety and precaution purposes.

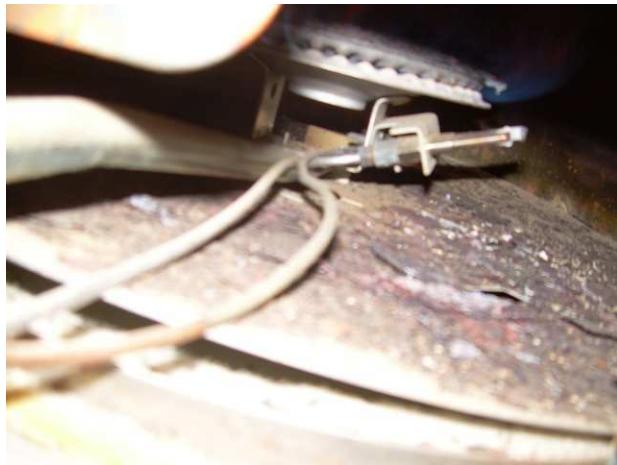
There was dirt and some rust in the burn chamber and on the burner with higher than normal orange flame presence during ignition and burn cycles; recommend a clean and check service by a licensed plumber or HVAC contractor.

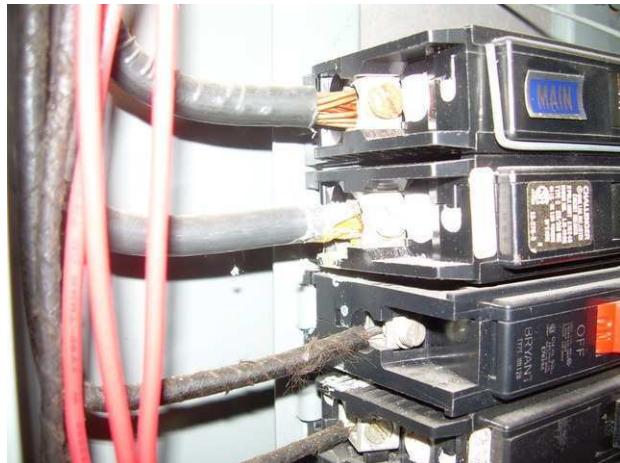
Corrosion was observed in the main electric panel on one of the main service wires from the meter. Corrosion on terminal screws can result in overheating of terminals and possible arcing problems in the panel. It is recommended that a licensed electrician evaluate the condition of the service panel.

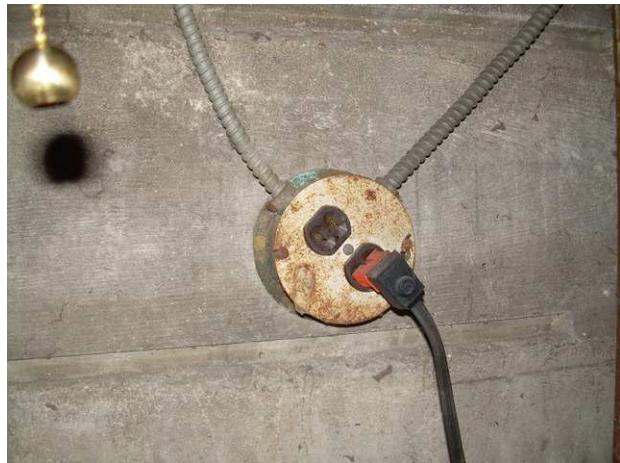
Two prong outlets were found in one or more locations in the home. At the time this home was constructed, two-prong outlets were the standard construction. Two-pronged outlets were not grounded (open-ground), and are considered to be outdated by today's standards. In many cases, the outlets can be easily upgraded to three-prong type. In cases where the outlets cannot be easily upgraded, the installation of GFCI's in kitchens, baths, garages, basements, outdoor receptacles, and any other high-risk areas, will increase the overall safety of the electrical system. A qualified electrician should be consulted when working on or updating the electrical system in your home.

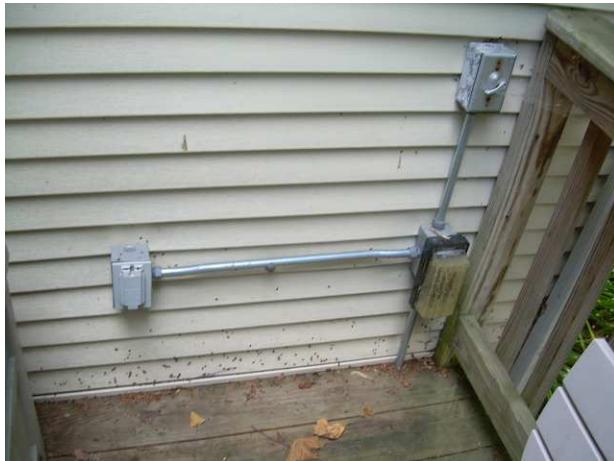
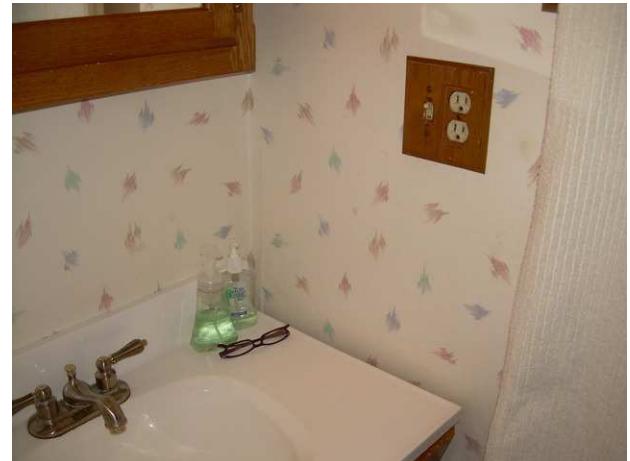
There was a switched covered 20 Amp receptacle on the deck that wasn't GFCI protected; recommend GFCI protection repair or placement of safety and compliance purposes.

There weren't any GFCIs in the bathroom, kitchen, or by the basement utility sink; recommend GFCI placement or repairs for safety and compliance purposes.

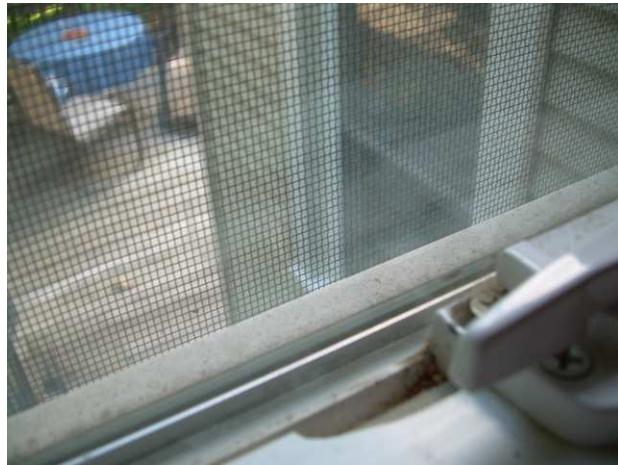
One of the first level windows had a small crack or gap around the lock or latch that was damaged and in need of repair.
