HOME INSPECTION REPORT

On Monday, February 18, 2019 The HomeTeam Inspection Service made a visual inspection of 123 Sample Drive, Tacoma, WA 55555. Enclosed please find a written, narrative report of our findings in accordance with the terms of our Inspection Agreement.

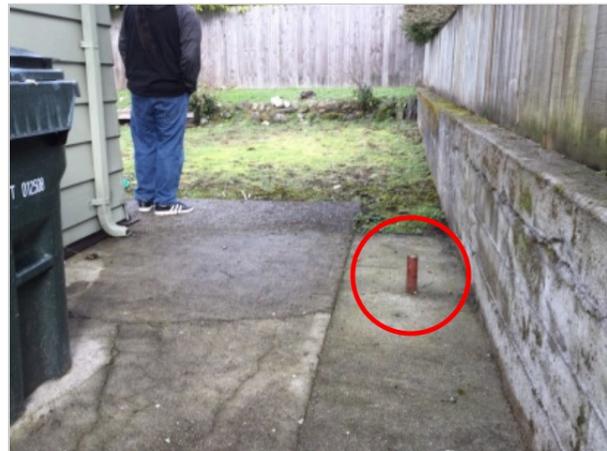
Photo 2

Right side yard

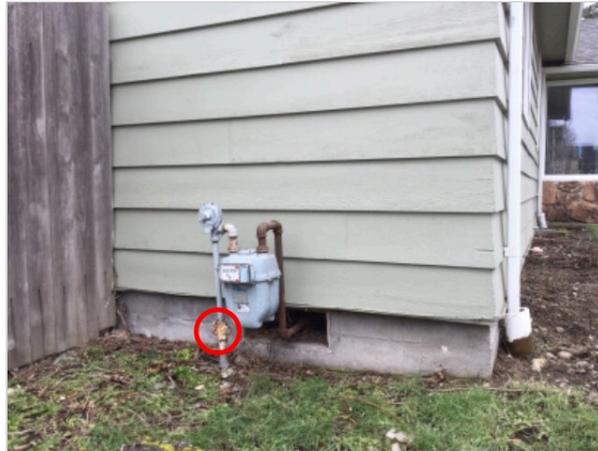
Photo 3

Main gas shut off valve

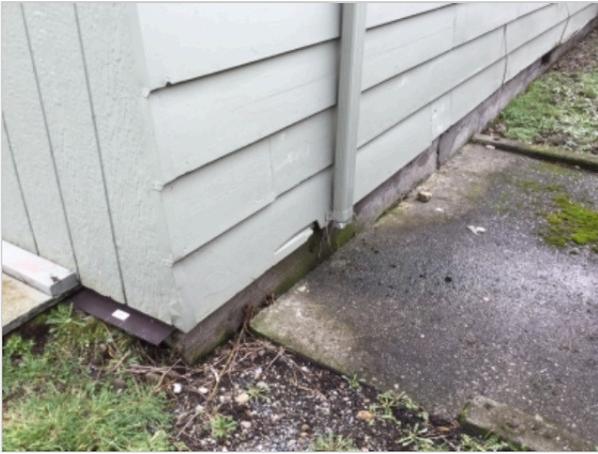
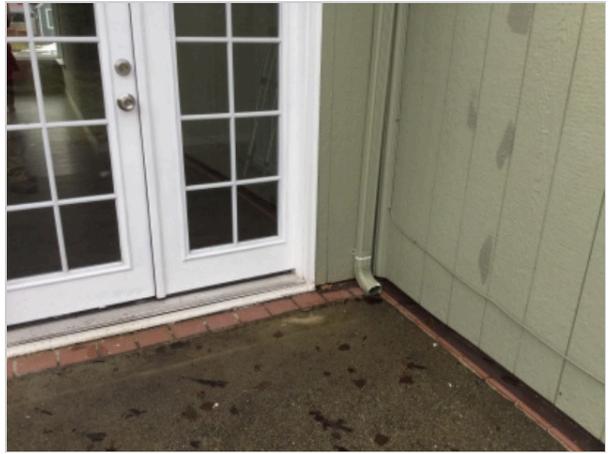
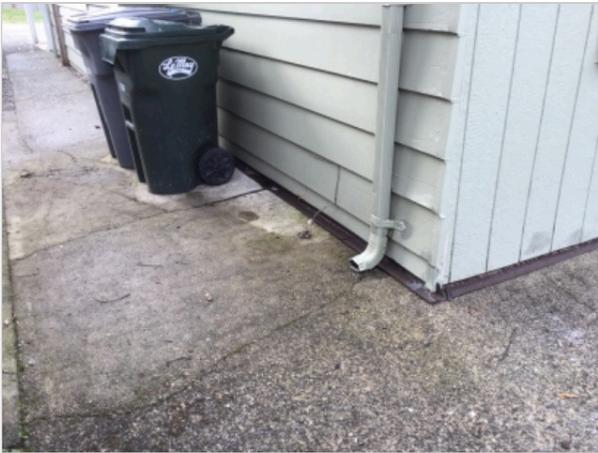
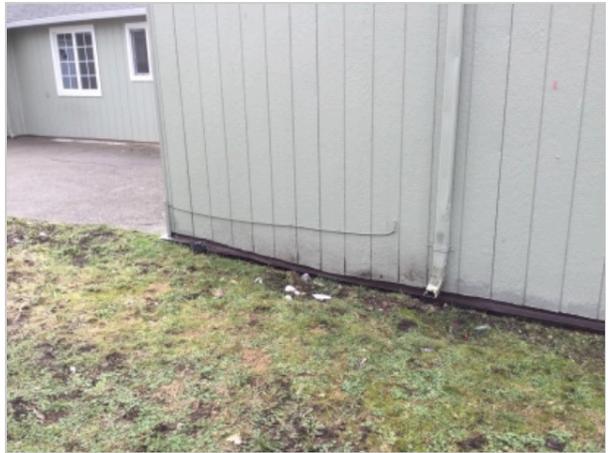
Some of the downspouts around the structure are draining into the ground with no conclusive termination point. HomeTeam recommends ensuring termination points for all downspouts is far enough from the structure and configured in such a way as to ensure water flows away from the foundation during periods of rain.

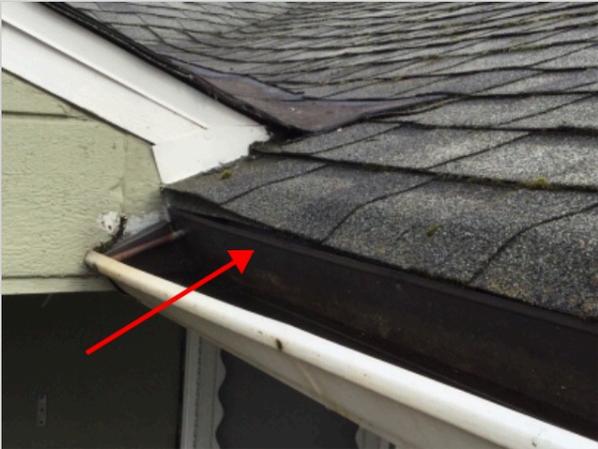
Photo 9

A loose gutter mount was observed at the time of the inspection. This is a common condition and is caused by expansion and contraction, along with the freeze thaw cycles that we experience in this area. The mounts should be re-secured and the underlying fascia checked for damage.

Carport gutter

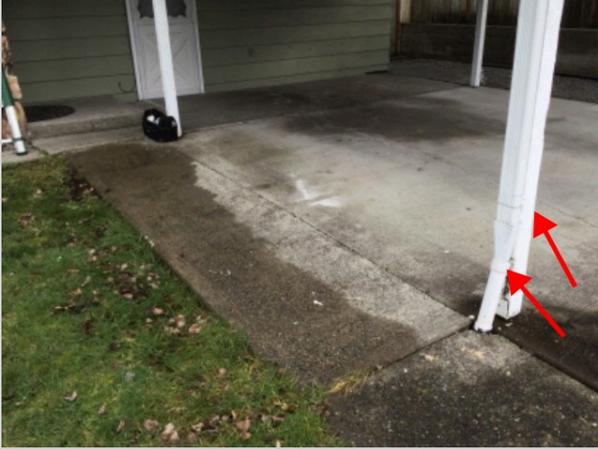
Photo 10

Gutters appear to be leaking at the seam. The seams should be sealed with an appropriate gutter sealant.

Carport downspout

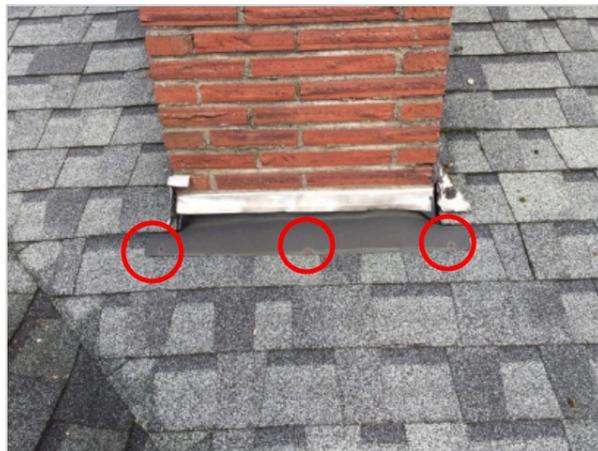
Photo 12

Nails securing shingles and/or roof ventilation flashing are uncovered. Any nails that penetrates the roof should be covered with shingles or roof tar in order to prevent possible water penetration into the sheathing of the roof structure.

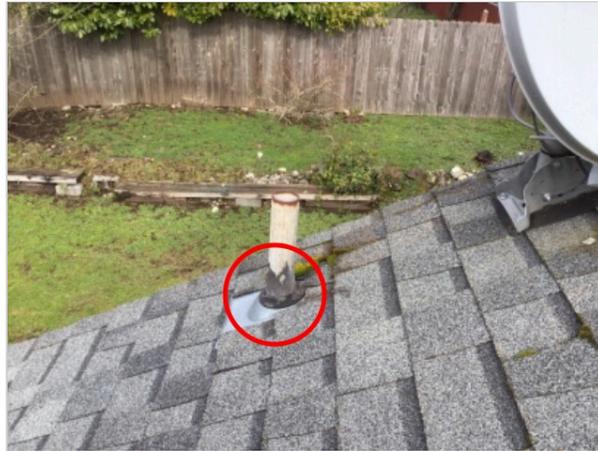
Photo 13

The flashing boot collar for the drain vent on the back roof is deteriorated. The boot collar should be repaired or replaced to prevent water intrusion, and any others should be further assessed at that time.

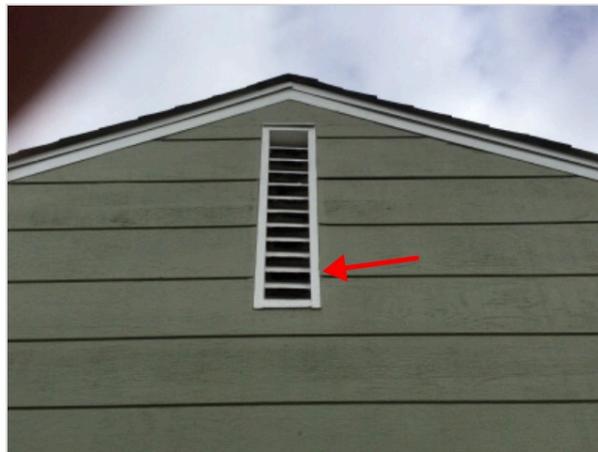
Photo 14

Gable vent cover is damaged. Without a proper vent cover rodent and insect entry is possible.

Front of the house

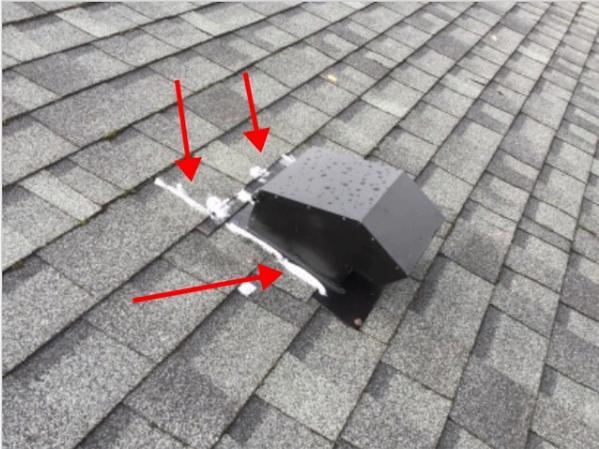
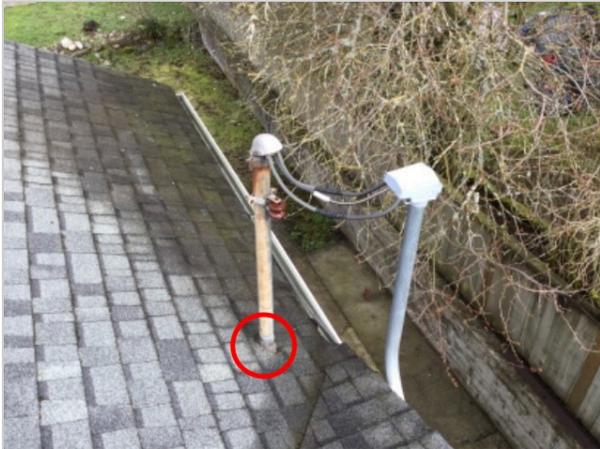
Multiple roof penetrations were previously repaired with substandard sealing material. These sealing methods may keep water from penetrating the roofing material for a short amount of time, but are not long-term fixes. Recommend repairs be made by a licensed roofing professional.

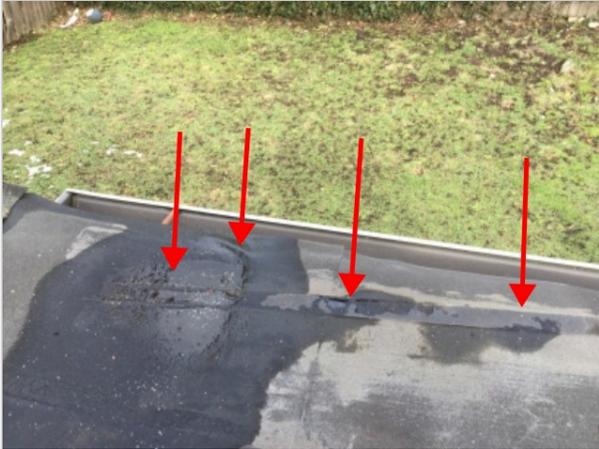
Photo 17

The roll type roof requires repair to prolong its life. At the time of the repairs, the roof and its components should be further assessed for any additional needed repairs, longevity, and serviceability.

Rear of house

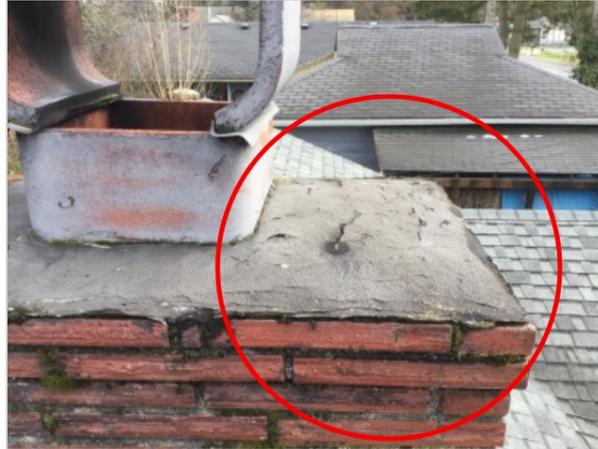
Photo 18

The chimney cap has several cracks. The cracks should be repaired to help prevent water intrusion and deterioration, and the chimney assessed for any additional repairs.

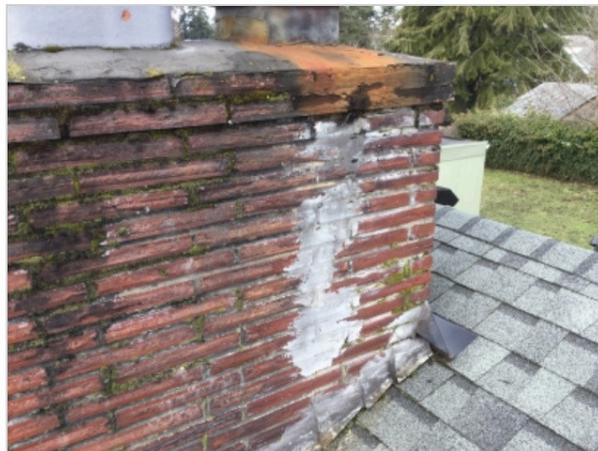
Photo 19

Spalling is present on the chimney's brickwork. Spalling of the brick is usually caused by moisture accumulation behind the brick. In cold weather, the moisture freezes and pushes the face off the brick. To help reduce spalling, the brick faces can be sealed. Some or all of the bricks may need to be repaired or replaced. Additionally, ensure the chimney cap is properly sealed. At the time of repair, the chimney should be further evaluated for any additional damage or required action. Depending on the results of that assessment, this may lead to a material defect.

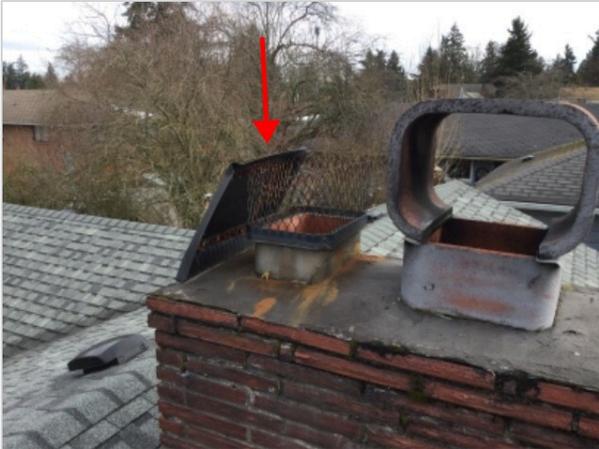
Photo 20

The chimney is missing a rain cap. A rain cap should be installed to prevent excessive water intrusion and deterioration of the chimney and its components.

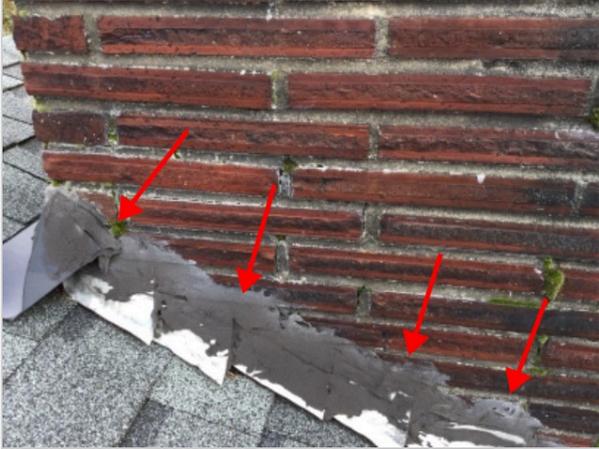
Photo 21

The flashing around the chimney requires repair. Flashing is a critical component that helps prevent water intrusion. At the time of repair, the technician should investigate the area for any previous water intrusion or damage.

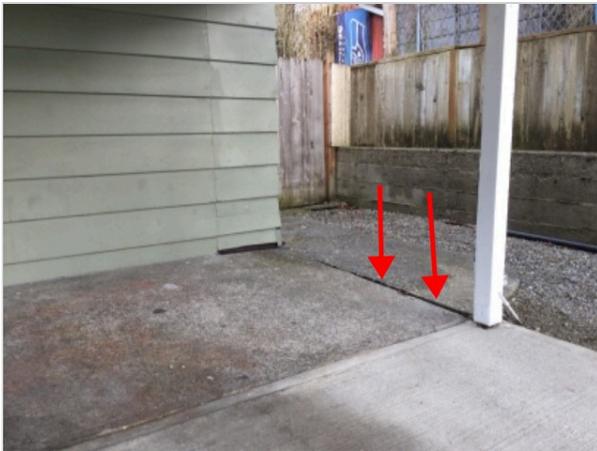
Photo 23

Areas of the driveway have settled. This condition indicates a possible void under the driveway. Driveway settling has led to potential tripping hazards. The areas should be monitored and repaired as needed.

Front right walkway

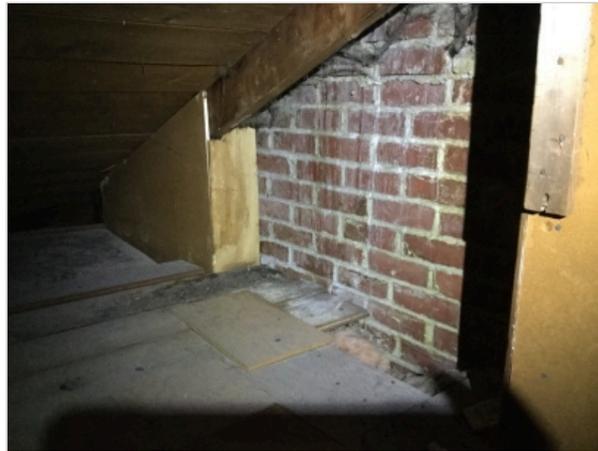
Photo 26

Evidence of an active roof leak was observed in the attic. Consult with a qualified roofer for evaluation and repair recommendations.

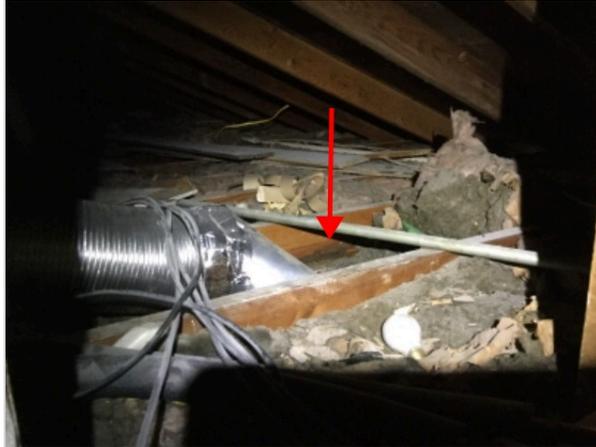
Photo 27

Areas of the attic were not properly insulated. This can lead to excessive energy bills and undesirable temperature variations within the structure. Insulation should be added to the affected areas.

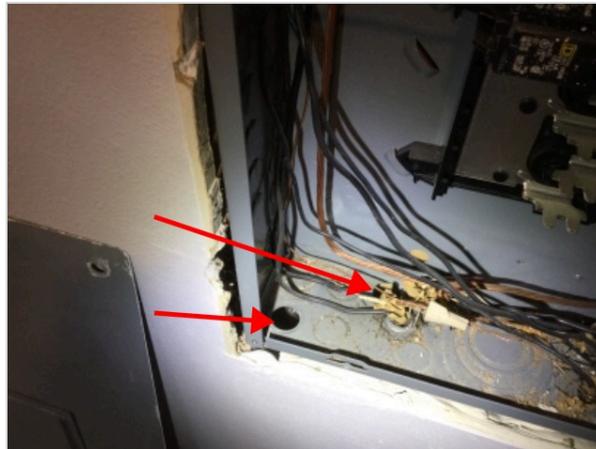
Photo 35

An open knockout was observed in the electric service panel, creating the potential for electric shock. All service panel openings should be covered to prevent access to high voltage and risk of electrical shock. Electrical related repairs should be performed by a qualified electrician.

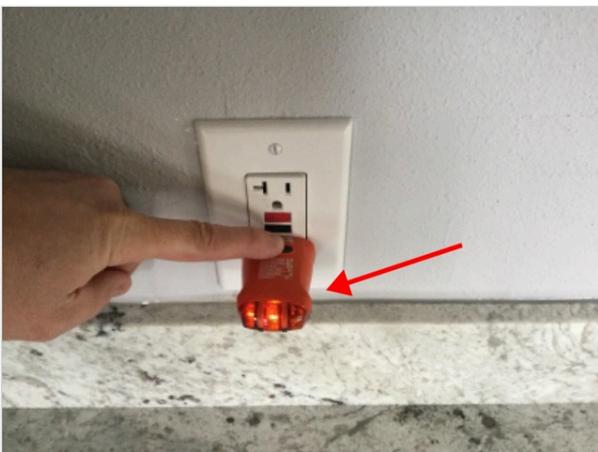
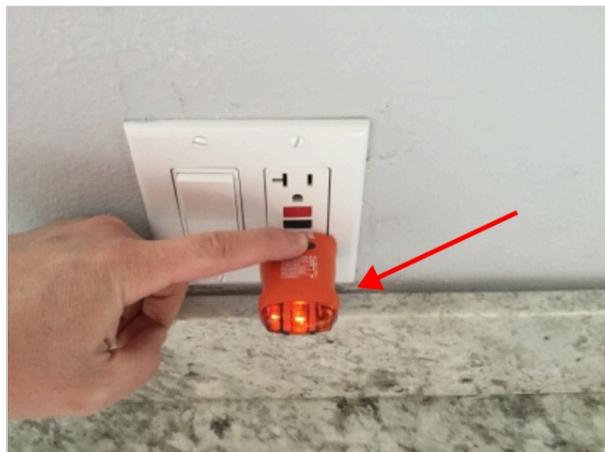
Multiple receptacles have hot and neutral wires reversed. This is a safety concern and should be repaired and further assessed by a licensed electrician. Please note that we only test outlets that are visible and readily accessible at the time of the inspection.

Kitchen GFCI

Kitchen sink GFCI

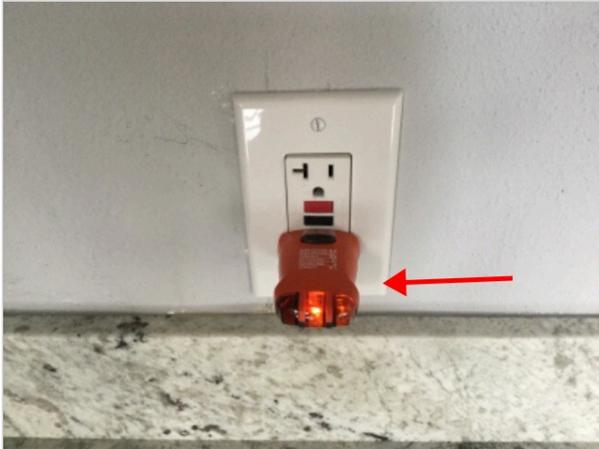
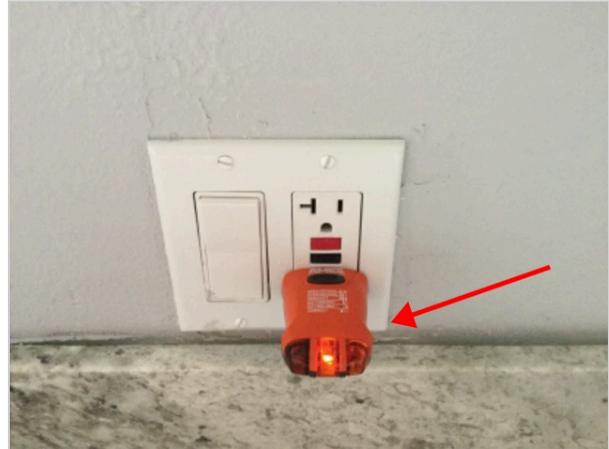
Multiple three prong type outlets in the structure had an open ground. The affected outlet(s) should be grounded, replaced with two-prong outlets, or connected to GFCI circuits to improve safety. This condition means that the third prong, also known as the ground prong, is not doing its job. This is often caused by a missing or disconnected ground connection at an electrical device in the circuit. Consult with an electrician for the best course of action.

Kitchen GFCI by range

Kitchen GFCI by sink

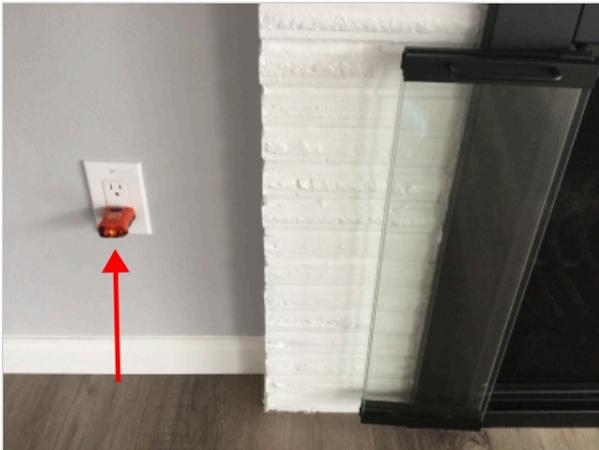
Photo 42

Living room next to fireplace. One of many examples

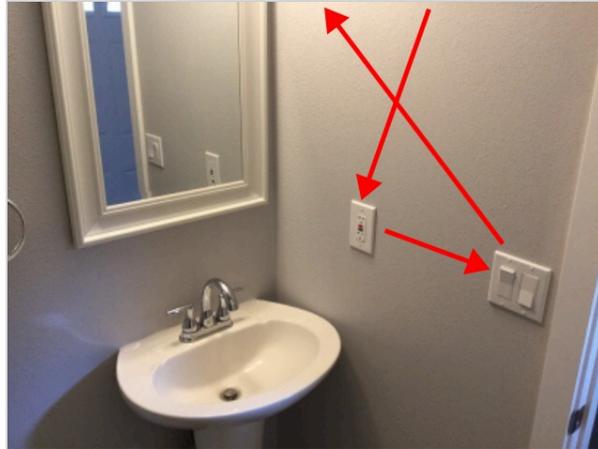
Photo 43

Evidence of amateur wiring was observed in many areas. Amateur wiring may not conform to standards methods and could be a safety concern. Consult with a qualified electrician for repairs and further evaluation.

Back right bedroom next to laundry area

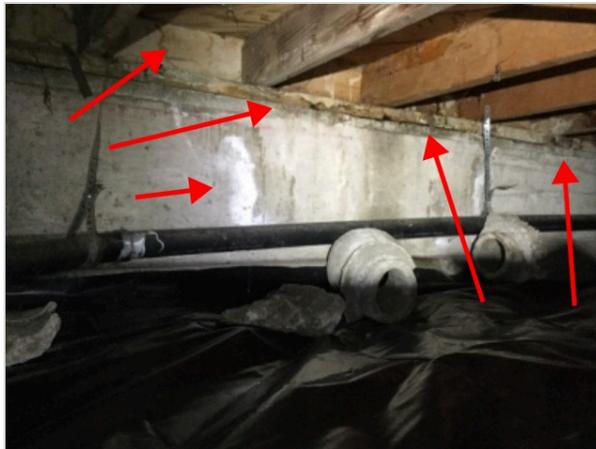
Photo 49

A section of floor structure is damaged from previous water intrusion. It was not clear whether the water intrusion has ceased. Monitor the area for any additional water intrusion, and repair as needed.

Along kitchen wall adjacent to back porch

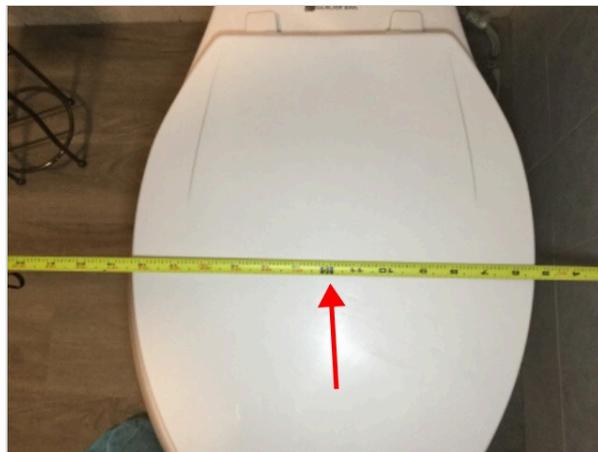
Photo 53

Toilet is situated too close to wall. Recommend re-situating, so that center of the toilet to the wall is at least 15 inches.

Master bathroom toilet

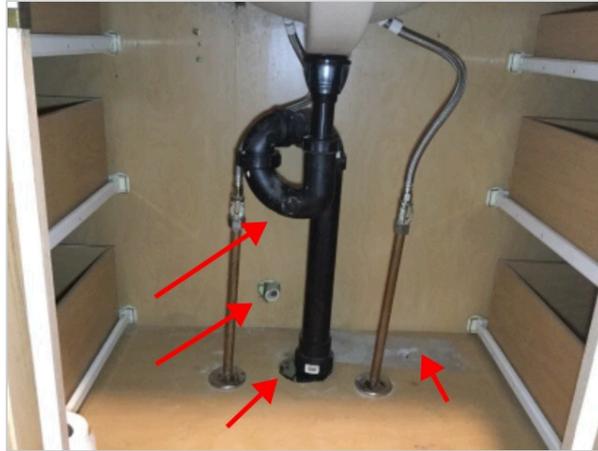
Photo 54

An S-style trap was observed under the sink in the master bathroom. Recommend replacing with a P-style trap.

S trap -master sink

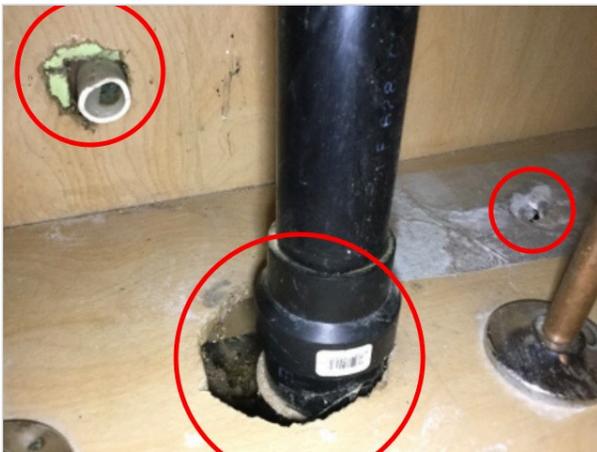
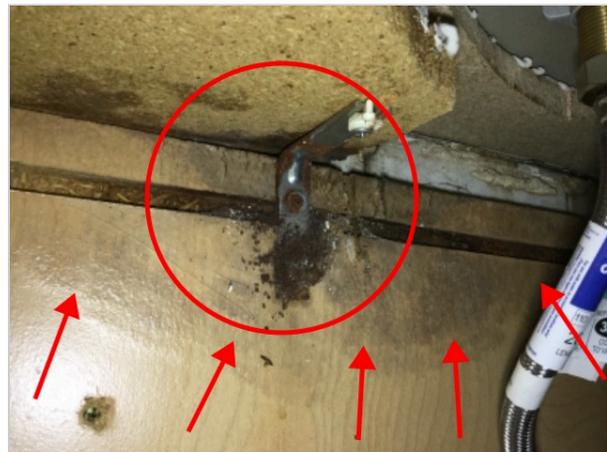
A significant dank smell was noticed under the master bathroom sink. Also observed were several unfinished penetrations and rust on metallic parts. Recommend evaluation by a licensed professional to ensure no persisting water intrusion that is not visible at time of inspection.

Master bathroom under sink

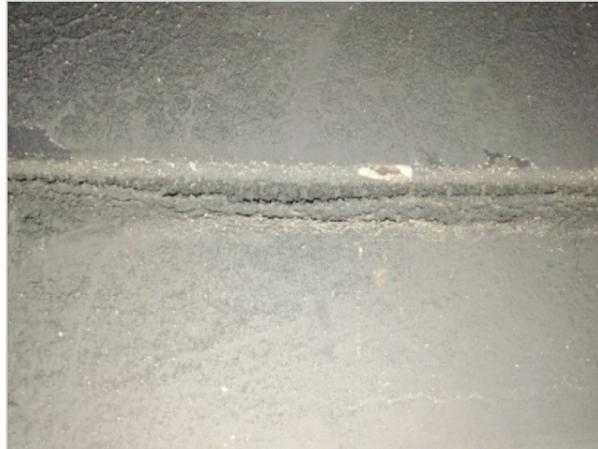
Photo 64

A buildup of soot and/or creosote was evident in the chimney in the living room fireplace. The unit should be cleaned and further assessed by a qualified fireplace service company.

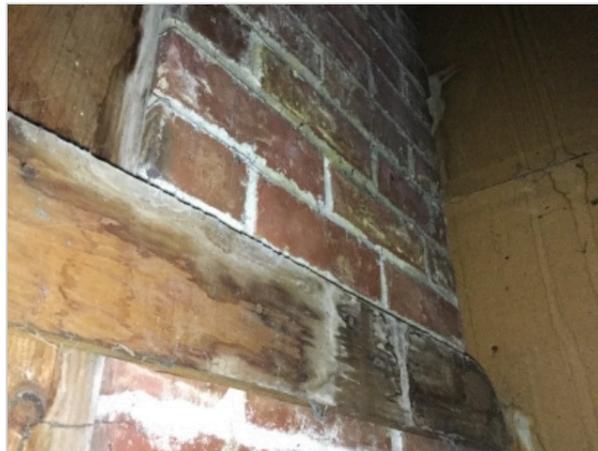
Photo 65

Evidence of water intrusion along the fireplace chimney next to the furnace. Current or past moisture evident on wood members as well as on brick. Recommend further examination by a licensed professional.
