### *HOME INSPECTION REPORT*

The inspected property consisted of a one and a half story wood-framed structure with hard coat stucco exterior and stone veneer that was vacant at the time of the inspection. The estimated date of construction, as reported by the seller was said to be 2007.

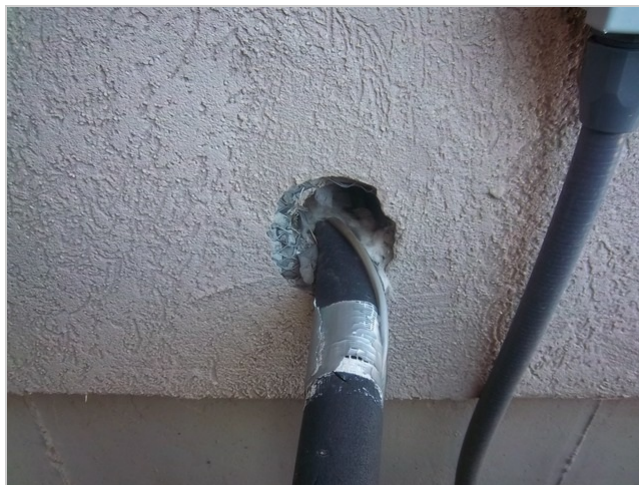
Minor abrasions and hairline cracks seen in the stucco are in need of maintenance attention to seal them against moisture infiltration.

Pipe and utility penetrations of the exterior are in need of maintenance attention to caulk and seal them to prevent moisture infiltration; especially at the AC condensing units.

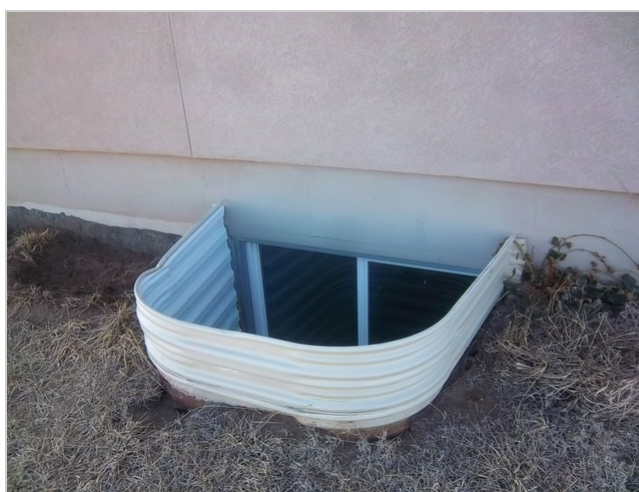
It is recommended that egress window wells be provided with a cover sufficient to keep personnel or critters from falling in.

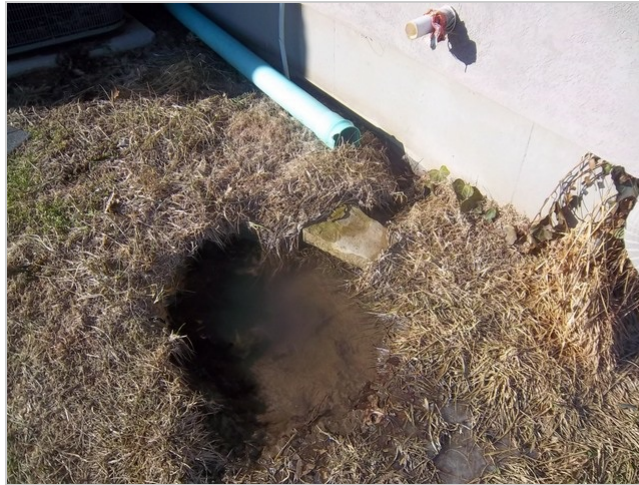
It is recommended that splash blocks and or extenders be provided beneath the downspouts of the gutter system. The splash blocks and extenders serve to prevent soil from washing away and creating depressions in which water can pool. The discharge pipe for the sump pump has dug a significant depression which needs filling and should be proved with a splash block and or extender.

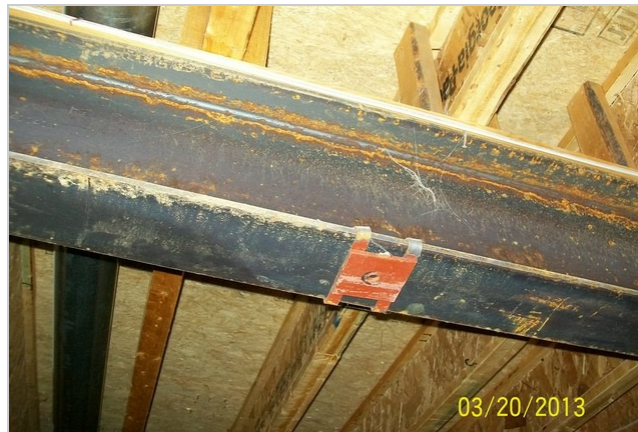
- *One of the steel support posts appears to have been removed and is leaning against the foundation wall. This should be replaced.*

The visible floor structure consisted of a waferboard sub-floor, supported by two by twelve inch TJI joists spaced sixteen inches on center. There was a 6x10 inch steel center beam and three inch steel posts or piers for load bearing support. There were no major visual defects observed in the visible portions of the floor structure. ***One of the steel support posts appears to have been removed and is leaning against the foundation wall. This should be replaced.*** One or more of the other support posts may have been relocated. We saw no evidence of any structural deflection or shifting.

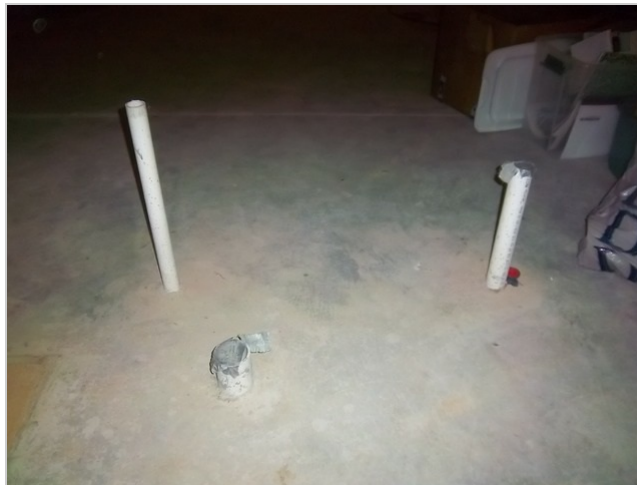
PVC pipes stubbed up through the basement floor are intended for the installation of plumbing fixtures for a future bath. Typically, these lines are tied into the active drain system at the time of construction. In this case, it is likely that the drain pipes are tied into the nearby sewage lift station.
