### HOME INSPECTION REPORT

File Number: **0000**  
Address of Inspection: **123 Sample Drive**

Monday, March 12, 2018

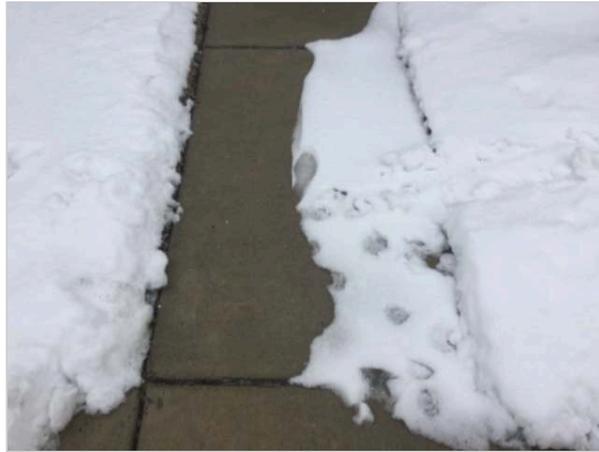
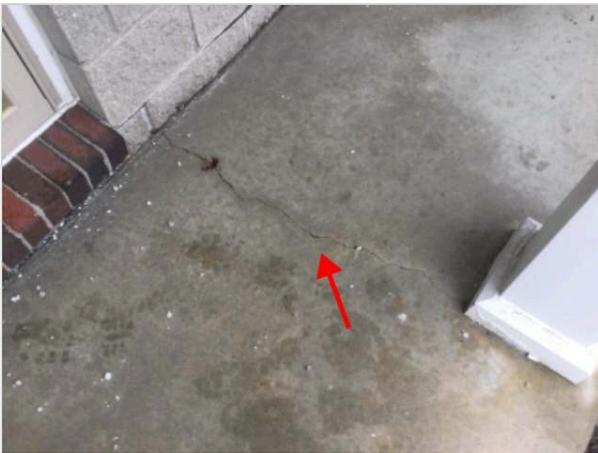
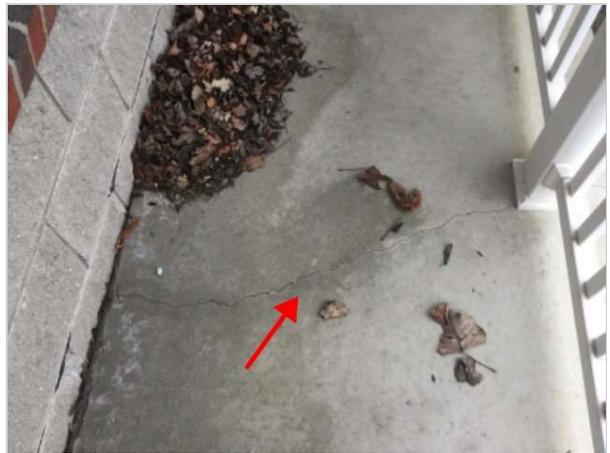
The walkway was partially covered by snow and not fully visible for inspection.

Any surface cracks should be sealed so the winter freeze does not start a new crack from forming.

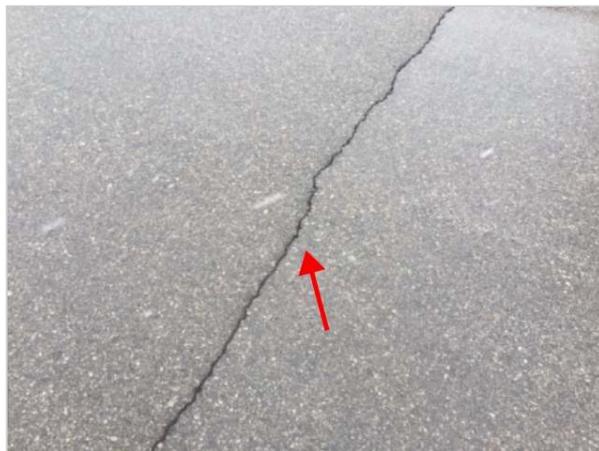
There was an asphalt driveway in the front and back of the home which led to the attached garage. There were many cracks noted on the driveway. Surface defects in driveways develop and progress with age and are considered normal as long as they do not create a safety hazard. There were no major visual defects observed in the driveway.

Caulking or sealing of cracks and joints will keep snow and ice from freezing in the open joints and prevent further damage.

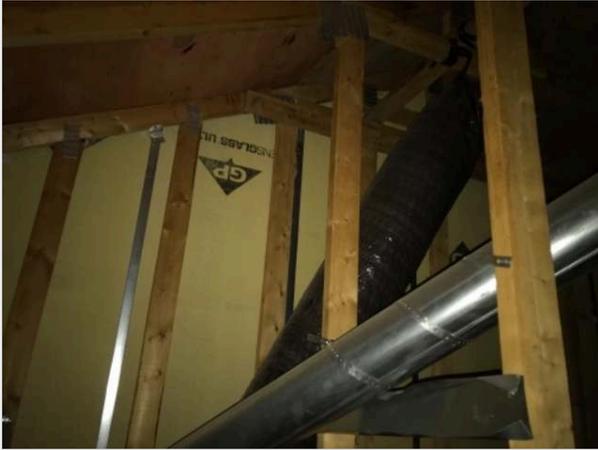
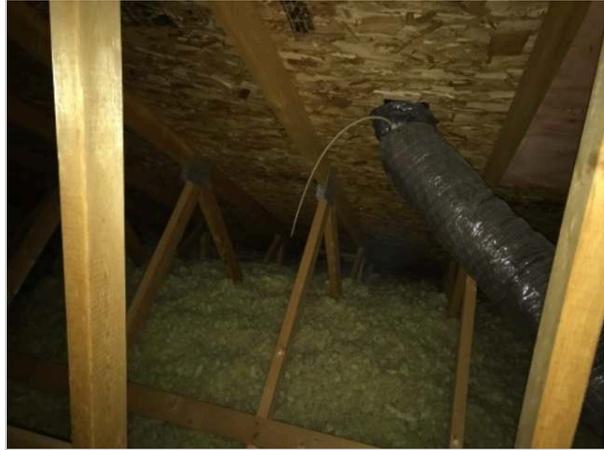
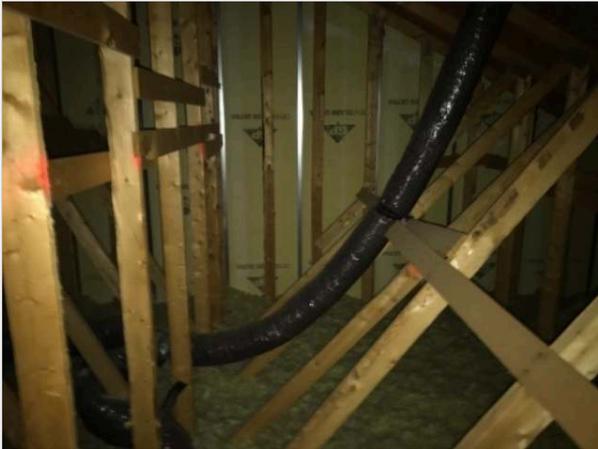
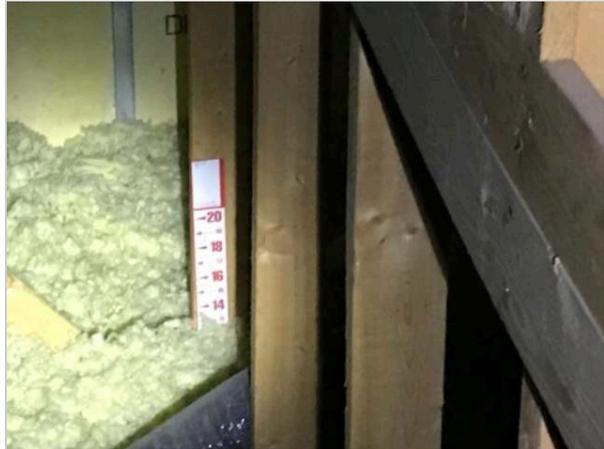
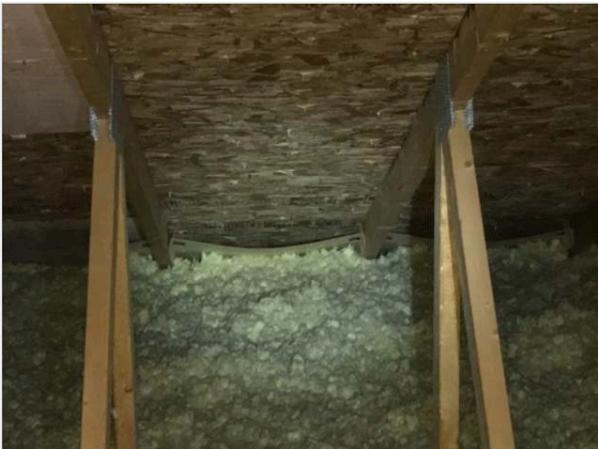
The attic above the living space was insulated with batted and loose fill insulation, approximately thirteen -inches in depth.

Ventilation throughout the attic was provided by soffit and ridge vents. The attic ventilation appeared to be adequate.

The roof structure consisted of two-inch by four-inch wood trusses spaced 24 inches on center and OSB (waferboard) sheathing.

There was no moisture visible in the attic space.

There were no major visual defects observed in the attic or roof structure.

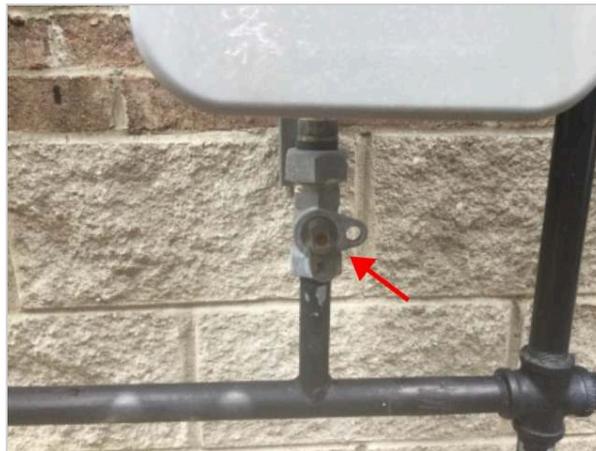
Main gas shutoff

The gas meter was located on the left exterior wall. The main gas valve is usually located at the gas meter and requires a wrench to operate. There was no noticeable odor of gas detected at the time of the inspection.

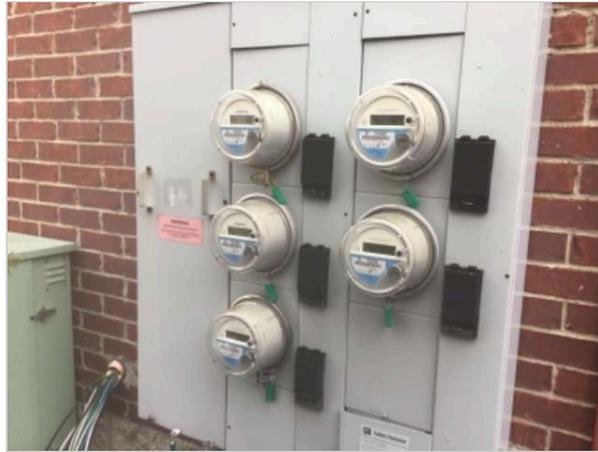
The underground electric service wire entered the home on the right side wall. The electric meter was located on the exterior wall. The service entrance cable consisted of stranded aluminum rated for 100 amps.

After moving in you, should ask the HOA which electrical meter and main disconnect is for your unit. They currently are not labeled.

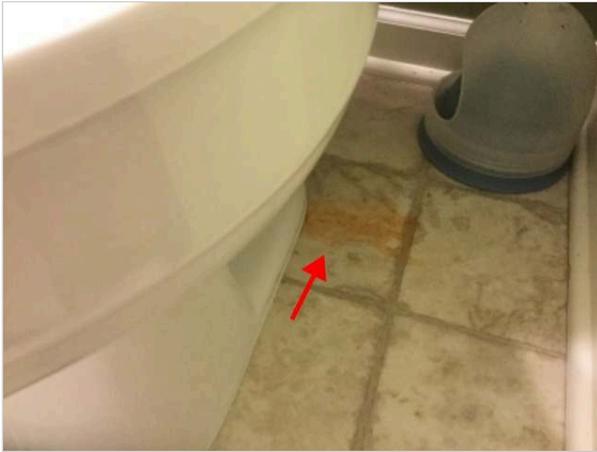
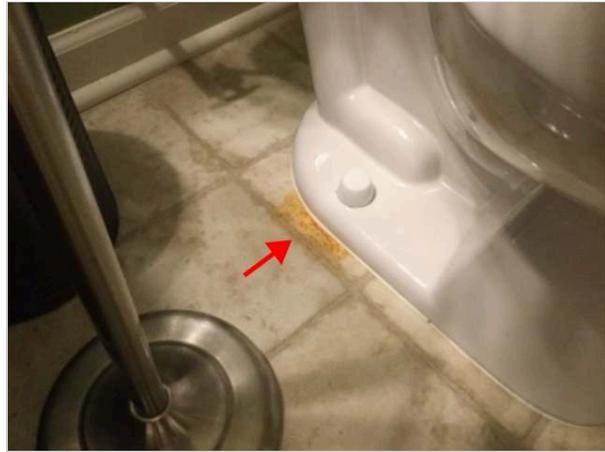
The master toilet may have a leak at the base.

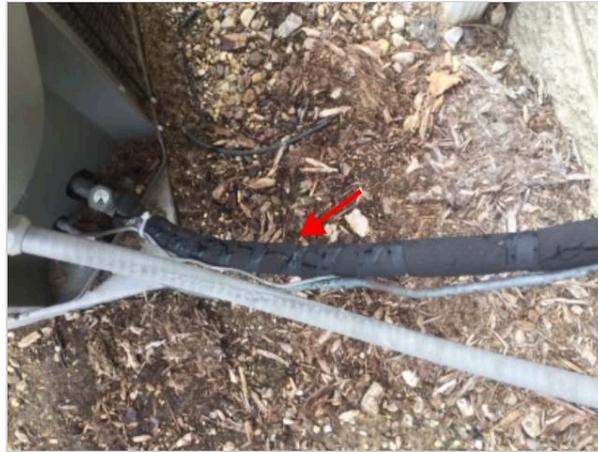
The insulation on the exterior air conditioning line set is damaged. This could affect the efficiency of the system and should be replaced.
