HomeTeam[®]

INSPECTION SERVICE

HOME INSPECTION REPORT

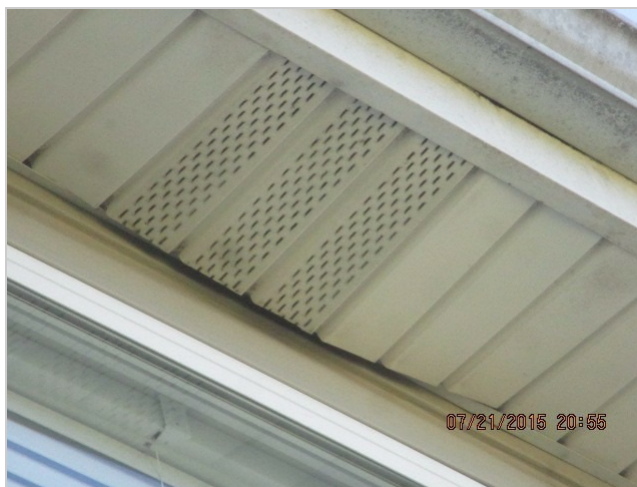
LOOSE SOOFIT: There were areas of the soffit that are loose on the rear of the home. Missing or loose soffit can also allow birds or rodents to enter the attic space. Recommend repair of the areas to prevent moisture intrusion.

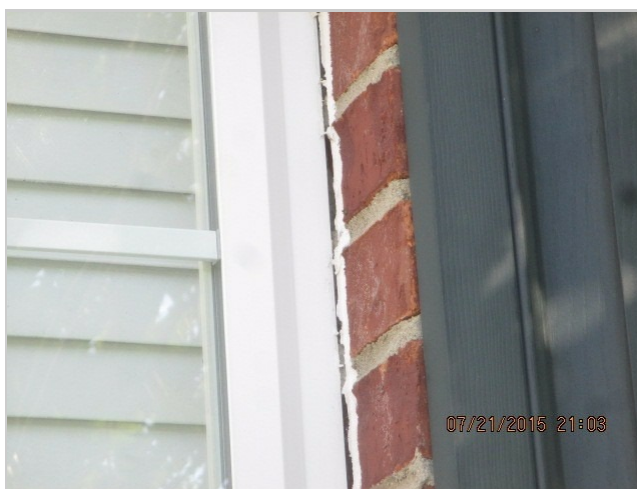
The windows on the front of the home need to be caulked. This will prevent water intrusion and help with energy efficiency.

Missing caulk on front window

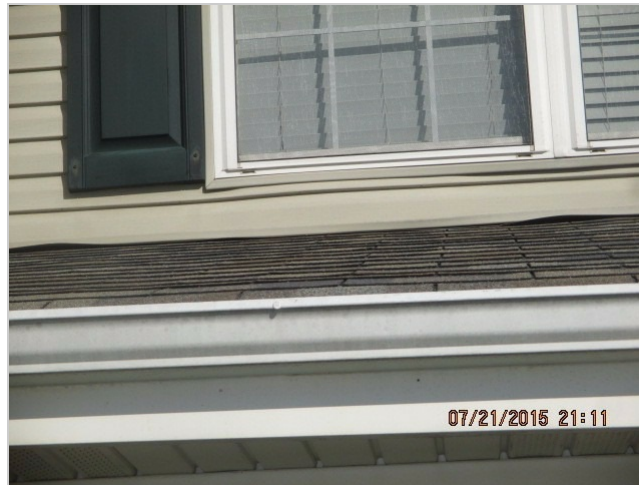
There was an area of loose flashing above the porch roof that should be secured to prevent water intrusion.

Loose flashing

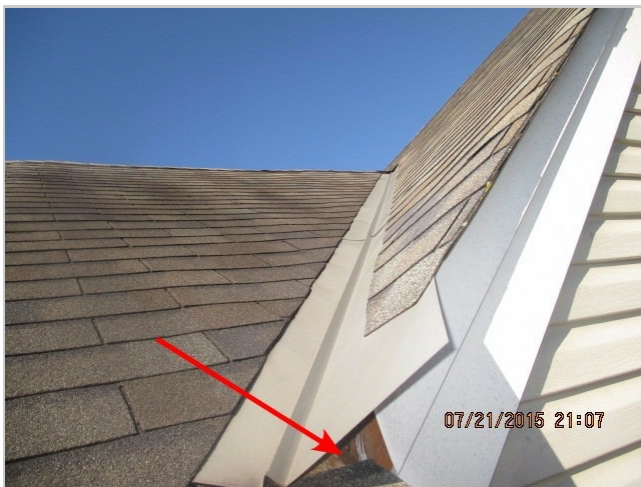
There was an open area where the front right gable roof meets the primary gable roof that should be sealed to prevent small animals or water intrusion.

Seal opening

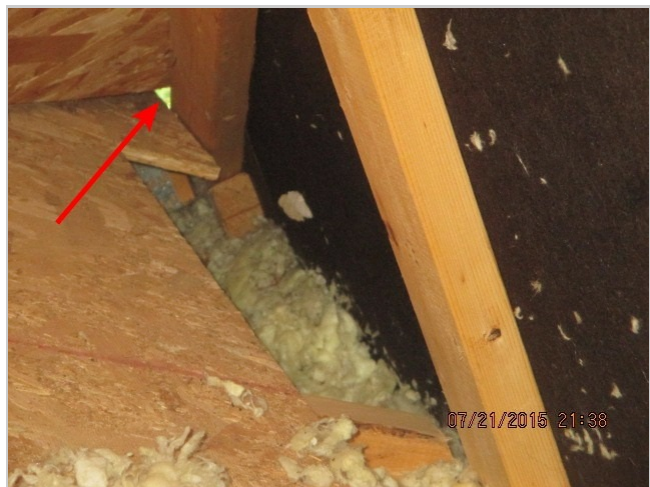
Opening from attic side

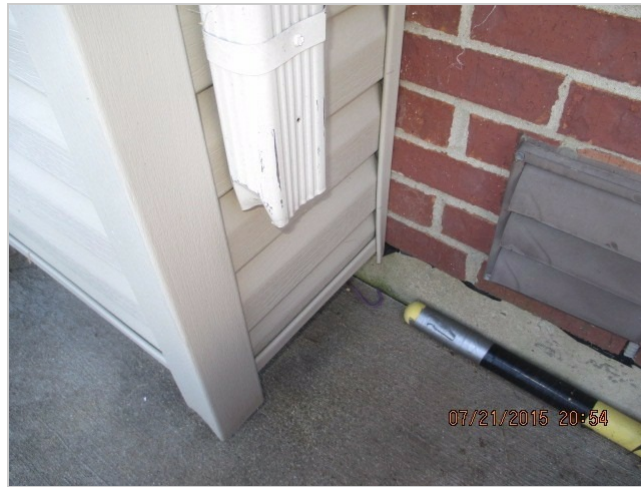
Rear downspout

The downspout on the rear were draining at or too close to the foundation. All roof drainage should be directed at least six feet from the base of the foundation. Downspouts that carry roof water far from the house are the most important part of the foundation drainage system. A properly-functioning drainage system is one of the most important items for extending the life expectancy of a house and its components. Recommend installing splash blocks or pipe extensions to help move water away from the foundation.

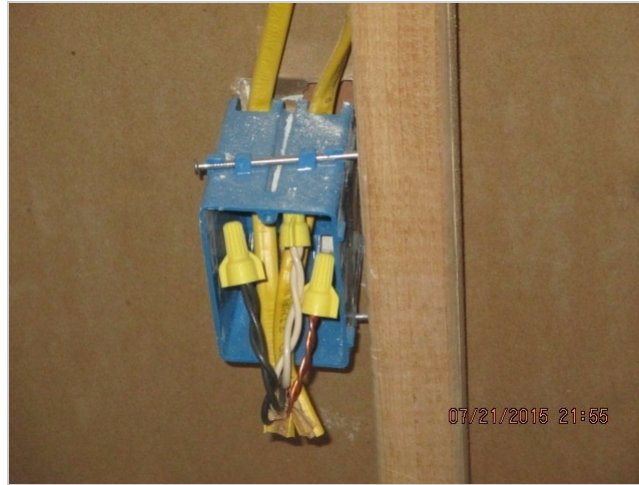
OPEN SPLICED WIRING: There was at least one open splice(s) noted in the basement level of the home. Open splices consist of junction boxes with missing cover plates, and wires joined together outside of a junction box. An open splice is unprotected joining of electrical wires and should be repaired by a licensed electrician. This is a safety hazard.

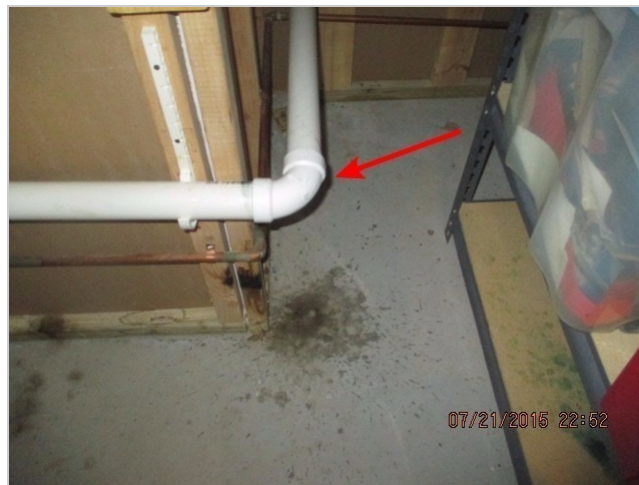
DRAIN PIPING LEAKS: There were leaks in the Lower-level bathroom sink drain piping at the time of the inspection. Water leaks can cause damage to the cabinet and/or floor and can be a source of mold growth. Recommend a qualified plumber to repair the drain pipe leaks to prevent water damage.

Bathroom sink drain line not glued and leaking

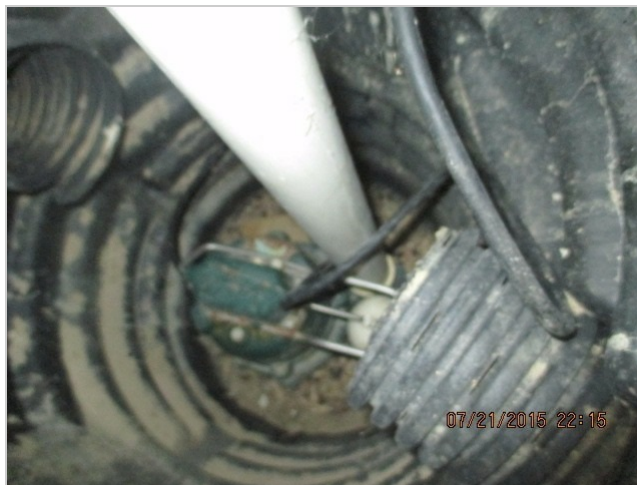
Sump pump

There was a sump pump located in the basement. The sump pump was functional. There was not a battery backup system in the sump pit. Recommend having a qualified plumber install a battery back up sump pump to help protect against water intrusion.

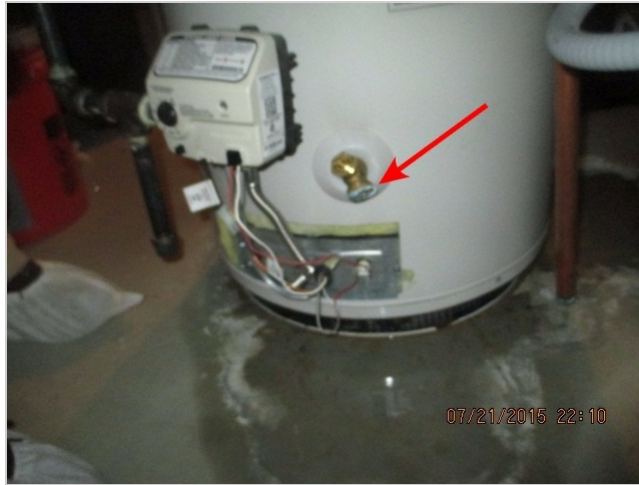
The drain valve on the water heater was leaking and should be repaired by a qualified plumber.

Leaking drain valve on water heater

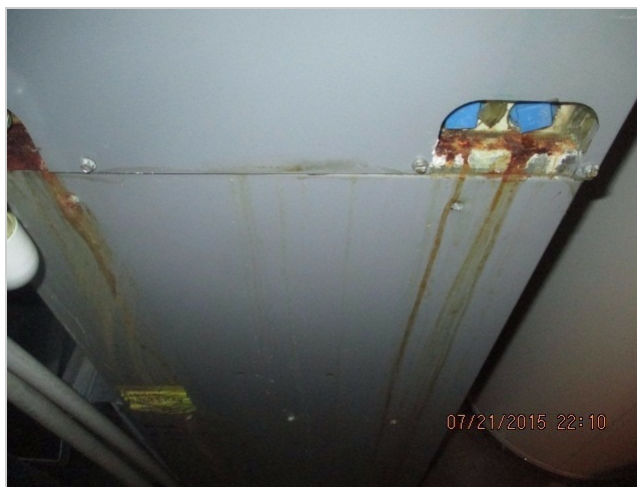
Rear furnace

Water was noted leaking on the outside of the furnace compartment. The water is most likely caused by a condensate leak in the furnace and/or air conditioning condensate drain lines. The water can also be caused by a leaking humidifier if one is installed. Water inside the furnace compartment can damage the furnace cabinet or other operational components and should be repaired. Consult with a qualified heating contractor to determine the source of the water and correct the issue.

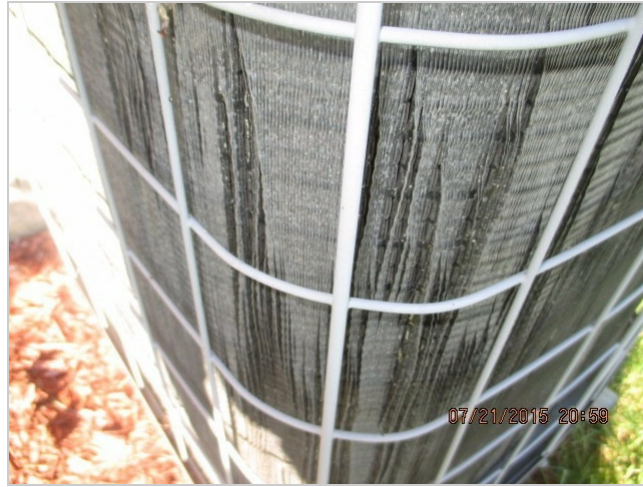
DAMAGED AC UNIT: The cooling fins on the air conditioner condensing unit are damaged which will restrict proper air flow across the unit. Recommend a qualified HVAC contractor to evaluate and repair or replace the unit as necessary.

Damaged A/C fins
