### *HOME INSPECTION REPORT*

The inspected property consisted of a ranch wood-framed structure with plywood siding / cladding that was occupied at the time of the inspection. Minor, exterior type caulking and maintenance, painting are common on most homes and may be present but may or may not be specifically identified in this report. The approximate temperature at the time of the inspection was 70-75 degrees Fahrenheit, and the weather was sunny and clear. The utilities were on at the time of the inspection. The buyer was present during the inspection. The home was situated on a lightly sloped lot. The general grade around the home appeared to be mostly adequate to direct rain water away from the foundation. The age of the home, as reported by the building permits was said to be 37 years old.

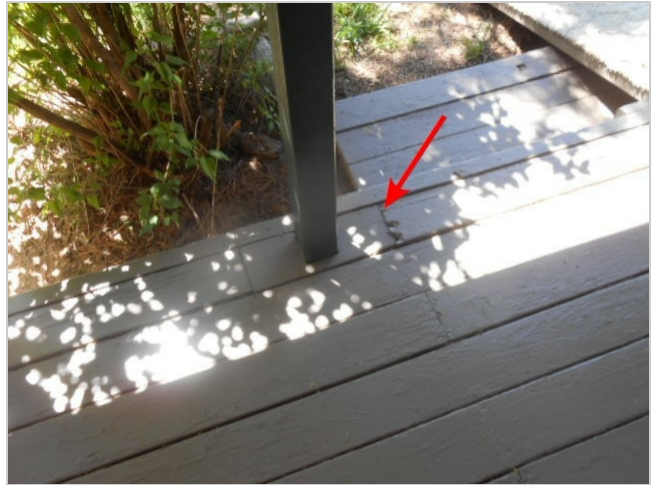
The underside of the deck was unable to be fully inspected due to the deck being very close to the ground or earth below. There were however several deck boards that were loose or were deteriorated indicating the need for further evaluation and repairs to the deck ( as needed ) by a qualified contractor, prior to closing.

Loose or deteriorated deck boards on the rear deck.
