# HomeTeam<sup>®</sup>

### HOME INSPECTION REPORT

**GENERAL DESCRIPTION**

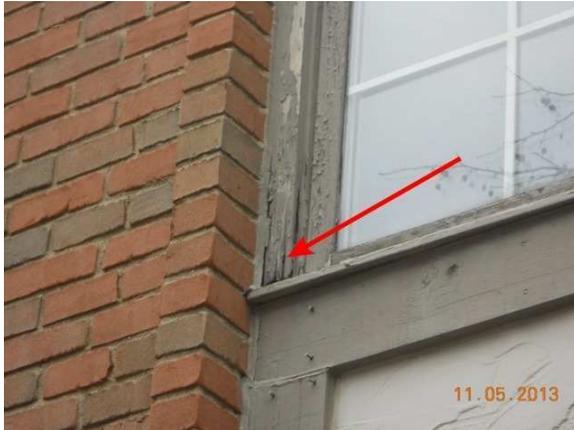
Peeling paint/deteriorated wood

- Peeling paint and weathered/deteriorated wood was noted in multiple areas of the windows, trim and siding. Recommend consulting with a qualified contractor to gain an understanding of options and costs for repair or replacement.
- The exterior caulking around the is cracked or missing in one or more areas. The caulking should be replaced to ensure the exterior of the home remains weather and water tight.
- One or more of the steel lintels above the windows on the exterior of the home were noted to be rusting. lintels support masonry materials above the doors and windows. keeping the lintels sealed and painted will prevent rusting and expansion. expanded lintels lead to cracks ion the masonry on the outside of the home.
- One or more outlets were not properly covered. Outlet covers designed for use in wet locations should be installed on all exterior outlets.

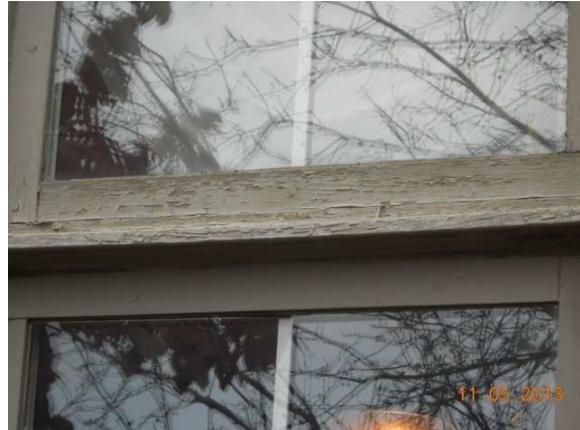
Peeling paint

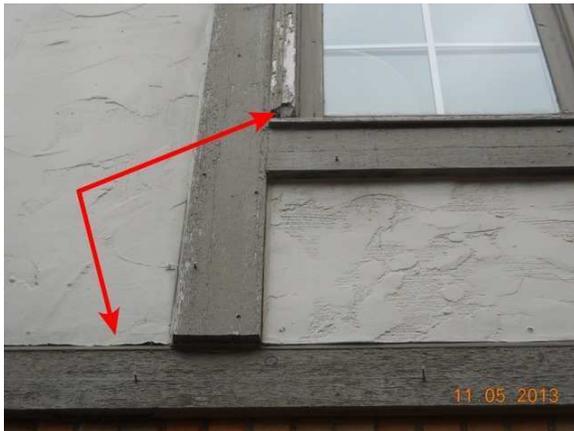
Moisture damage

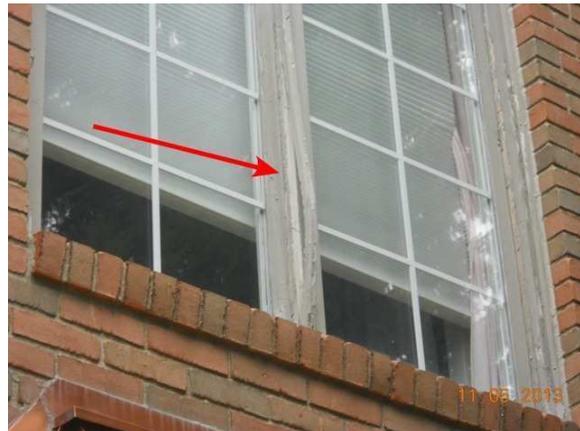
Damage (typical)

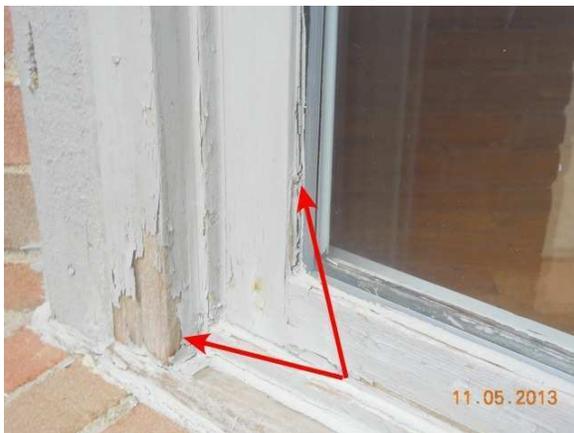
Deterioration

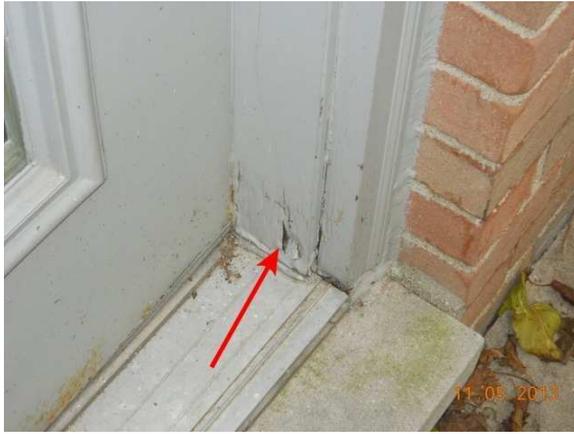
Moisture damage

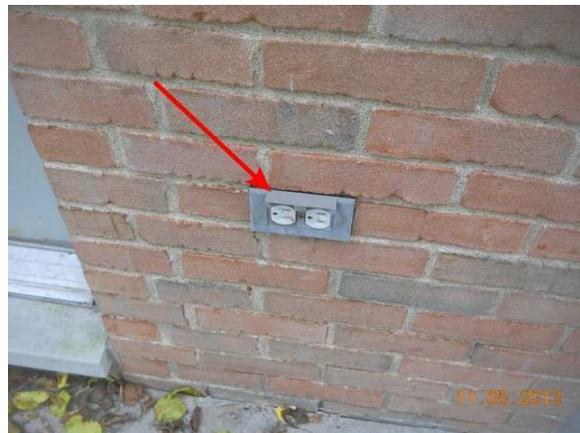
Missing cover

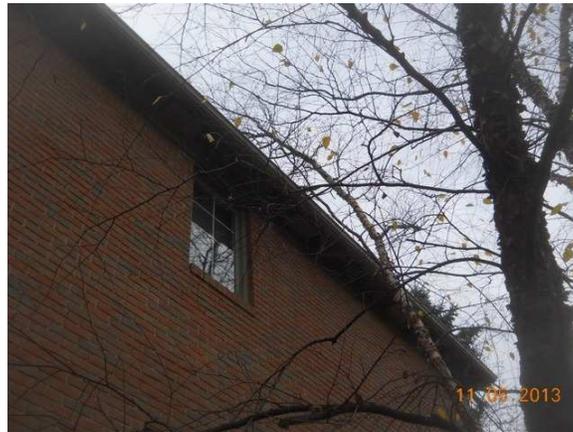
Overgrowth

- Tree branches were observed against the home, on the left side area of the house. Recommend removing this growth away from the siding and roof to prevent possible damage including insect infestation.

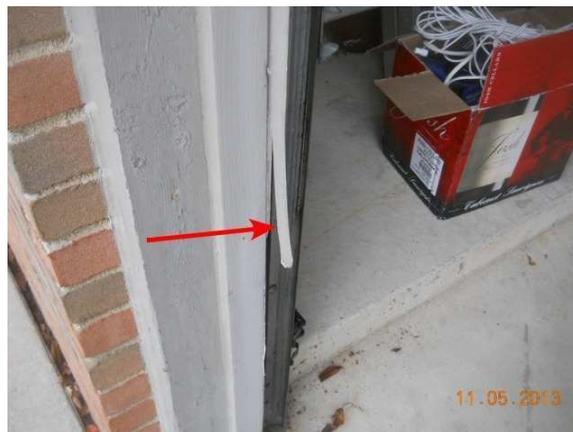
Damaged weather-strip(s) typical

- Automatic garage door opener remote controls, keyed or keyless entry systems are not tested.
- The vertical weather-strips on the door frames were damaged and in need of replacement.
- The concrete garage floor contained floor cracks. However, this condition does not appear to compromise the serviceability of the garage.

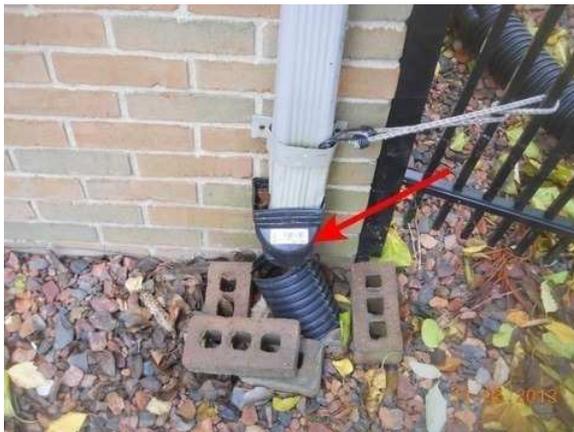
Not connected to drain

- The downspouts on the left side of the home terminated at or adjacent to the foundation. Installing downspout extensions to direct water away from the foundation is recommended.
- Water flow from downspout extensions or splash blocks should be carried several feet from the foundation and the downspouts should be securely attached to the property. Downspouts that carry roof water far from the house are the most important part of the foundation drainage system. A properly-

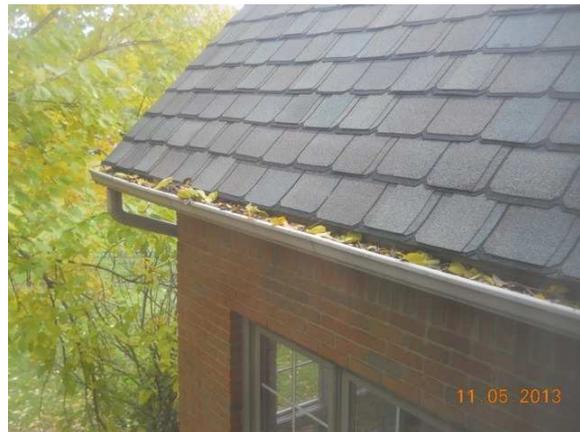
Gutters need cleaning

- The gutters were in need of cleaning at the time of the inspection. Clogged gutters can cause roof drainage water to drain at the base of the foundation, causing basement water problems. The gutters should be cleaned.

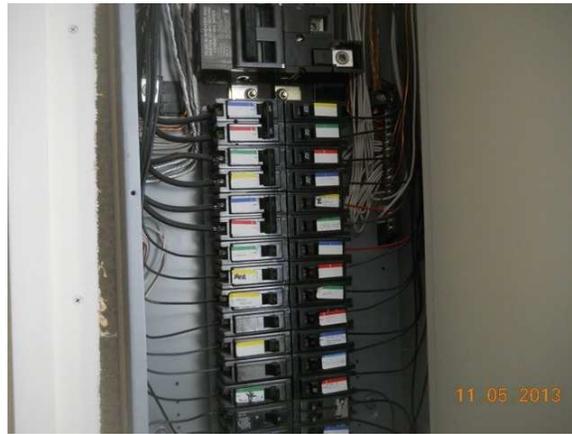
Panel cover missing

- There was no semi-permanent metal panel cover installed. For safety, the panel should be covered to prevent possible contact with an energized portion of the panel. Corrections are advised. Consult an electrician.

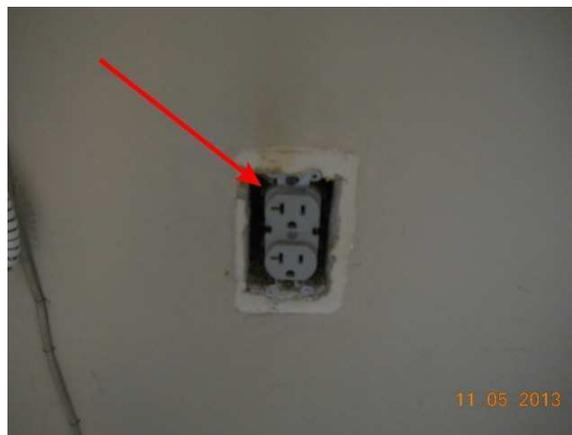
Missing cover (typical)

- Note: There were missing receptacle and/or switch plate covers. For safety, the receptacles and/or switches should be properly covered to prevent possible contact with an energized portion of the receptacle/switch.

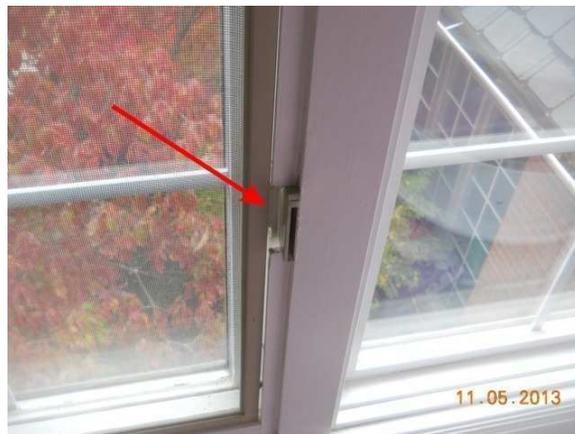
Latch missing

- Multiple windows showed signs of exterior deterioration, peeling paint and weathered wood. Recommend consulting with a qualified contractor to gain an understanding of options and costs for repair or replacement.
- The window crank mechanism in the Jack and Jill bathroom was defective. A window latch was missing from a front bedroom window.
