# HomeTeam<sup>®</sup>

### HOME INSPECTION REPORT

## **SAMPLE REPORT**

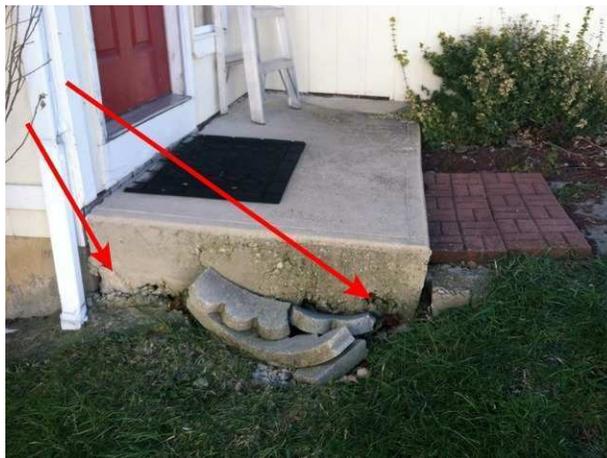
The left side of the front entryway has sunken slightly. Grading should be added to help prevent water intrusion to this area. Add sand /soil to fill in near the foundation and porch as needed.

fill in to where arrows are pointed to slope away from foundation

- The left side of the front entryway has sunken slightly. Grading should be added to help prevent water intrusion to this area. Add sand /soil to fill in near the foundation and porch as needed.

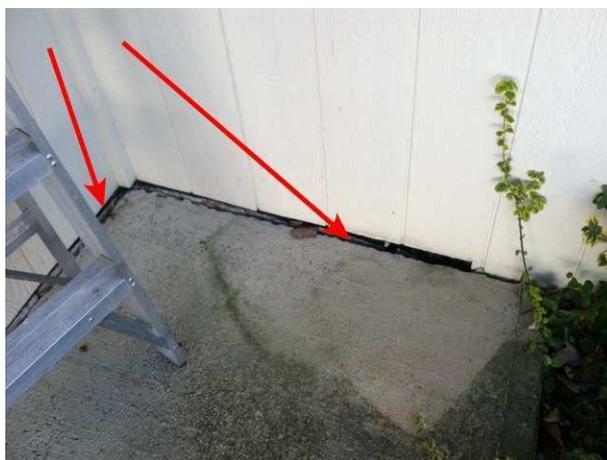
The area between the foundation and the front porch has some gaps. The gaps should be sealed as necessary to prevent water intrusion to these areas.

seal to prevent water intrusion

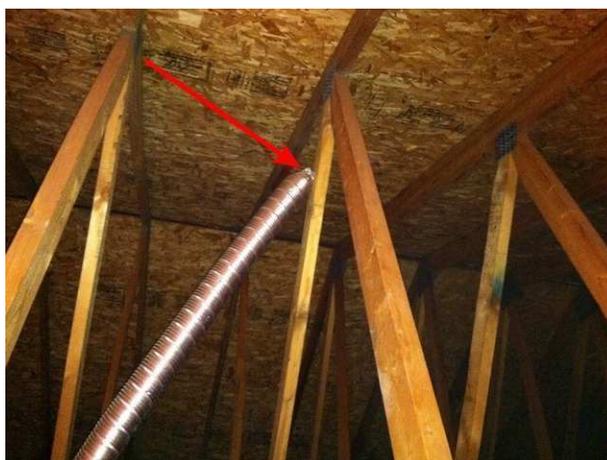
The two bathroom exhaust fans are discharging into the attic. Excessive moisture can build up in the insulation, creating a condition for mold growth. A duct should be installed from the fan exhaust to a roof vent.

extend to roof vent

- The two bathroom exhaust fans are discharging into the attic. Excessive moisture can build up in the insulation, creating a condition for mold growth. A duct should be installed from the fan exhaust to a roof vent.

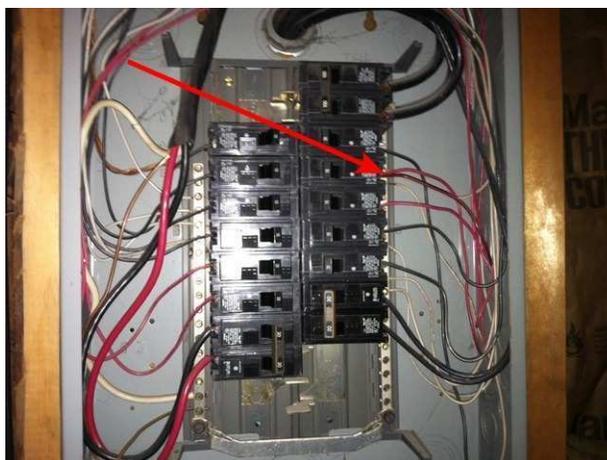
The circuit in position three right side of the service panel is double tapped. This means that more than one wire is attached to the overload protection device (fuse or circuit breaker). Double tapping can lead to nuisance tripping and should be avoided. Nuisance tripping occurs when the total amperage of the wires attached to the breaker exceed the rating of the breaker. For instance, if the double lugged breaker has a rating of 15 amps and the two wires attached are each drawing 10 amps, the breaker would trip. Neither one of the two wires is overloaded, but the total amperage flowing through the breaker is 20 amps. The breaker will trip even though no single wire is overloaded. Hence, the term, "nuisance tripping". Each circuit in the main service panel should have just one wire / circuit attached to the overload protection device. Consult with a qualified electrician for repair.

double tapped, add additional circuit breaker
