HOME INSPECTION REPORT

On November 19, 2016 The HomeTeam Inspection Service made a visual inspection of 123 Sample Road, Charlton, MA 01507. Enclosed please find a written, narrative report of our findings in accordance with the terms of our Inspection Agreement.

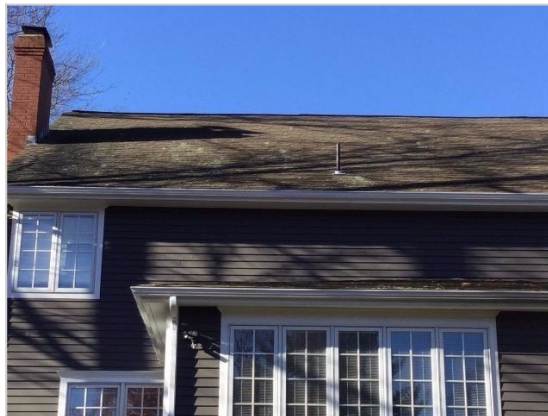
Photo 8

Gutters were in need of cleaning at the time of the inspection. Clogged gutters can cause roof drainage water to drain at the base of the foundation, causing basement water problems. Overflow from gutters can cause damage to fascia that is not visible or apparent at the time of the inspection. The gutters should be cleaned.

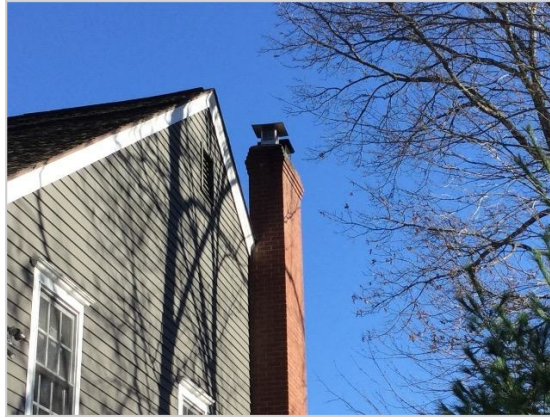
Photo 9

Although the roof condition is adequate and seems to be weathering well within its life expectancy; the age of the roof should be indication of a deferred expense to plan for within the next 5 years.

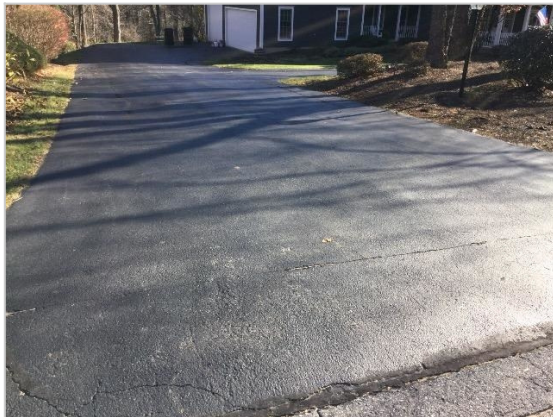
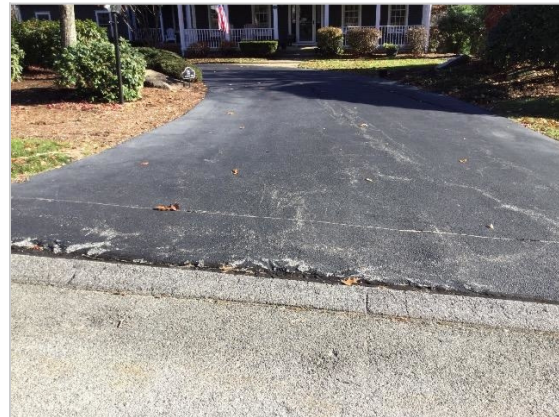
An asphalt driveway is present in the front of the structure. Cracks and spalling were observed on the driveway. Surface defects in driveways develop and progress with age and are considered normal as long as they do not create a safety hazard. Sealing defects may help slow the rate of deterioration.

Several areas of the driveway have settled. This condition indicates a possible void under the driveway. Driveway settling has led to potential tripping hazards. The areas should be monitored and repaired as needed.

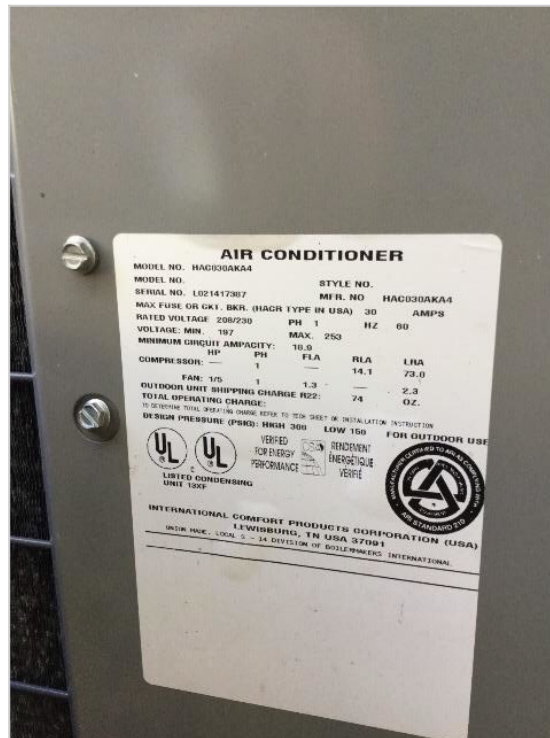
Photo 22

Because of its condition and performance at the time of the inspection, **the HVAC system requires cleaning and servicing by a professional HVAC technician.** At that time, the technician will test refrigerant levels, service the equipment to improve its performance, and perform other tests beyond the scope of the home inspection to assess and identify any additional areas that may require attention.

Gaps were observed around the HVAC air intake and refrigerant line. These gaps should be sealed to prevent moisture and pest intrusion.

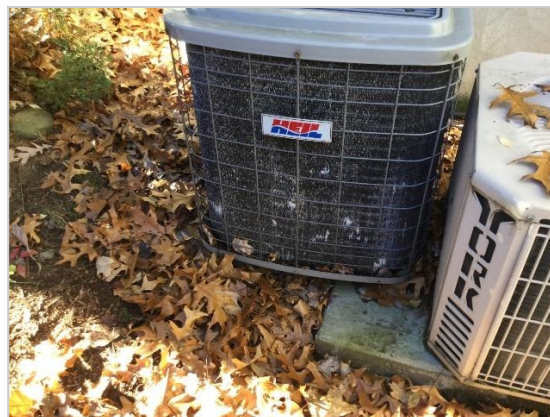
Photo 23

The fins on the outdoor compressor unit are bent. Combing or straightening the fins may improve the efficiency of the unit by aiding heat transfer.
