HOME INSPECTION REPORT

The HomeTeam Inspection Service made a visual inspection of 123 Anywhere St., City, ST 12345. Enclosed please find a written, narrative report of our findings in accordance with the terms of our Inspection Agreement.

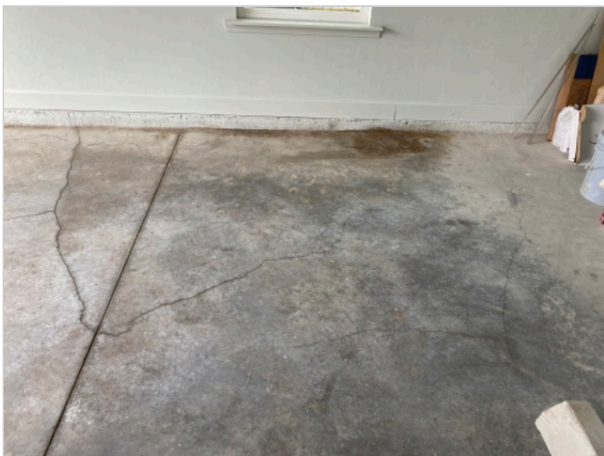
Photo 20

The garage floor had minor spider cracks observed. These cracks did not appear to be a structural issue. These cracks should be sealed and monitored.

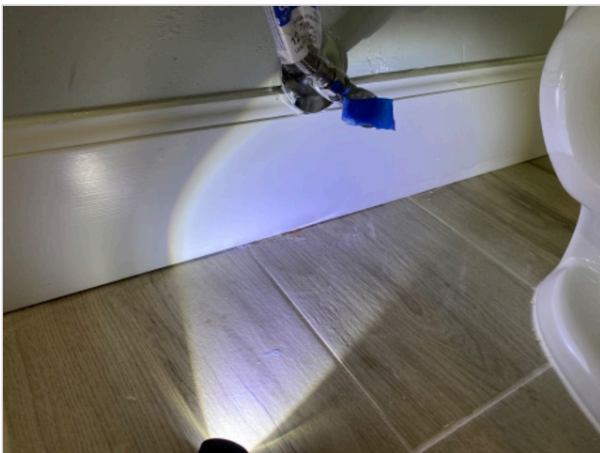
Photo 43

Leaks were observed at the toilet shut off in the Jack and Jill bathroom when in use. The tub and sink in the hall bathroom drain slowly. A licensed plumbing company should be called to evaluate the system and make any repairs.

The Jack and Jill toilet shut off is leaking.

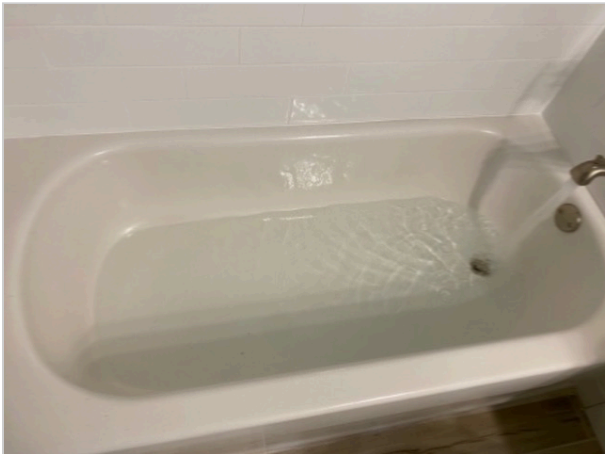
Photo 46

Hall bathroom drains slowly.

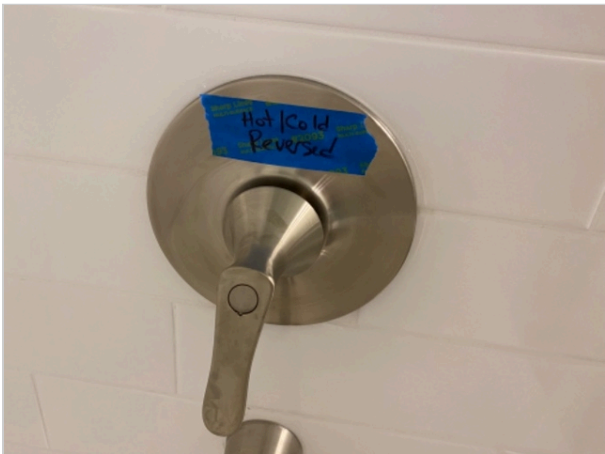
The shower controls in both guest bathrooms had the hot/cold reversed, which is a possible scald issue and should be corrected.

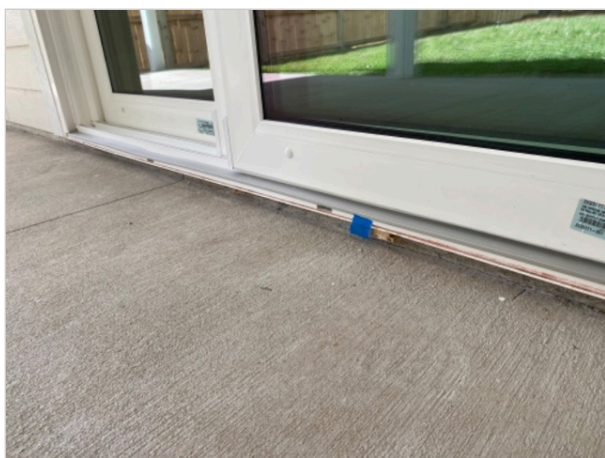
The rear sliding door threshold extends over the edge and is not supported properly. Recommend a qualified contractor to repair as needed.
