### *HOME INSPECTION REPORT*

The HomeTeam Inspection Service made a visual inspection of 123 Anywhere St., City, ST 12345. Enclosed please find a written, narrative report of our findings in accordance with the terms of our Inspection Agreement.

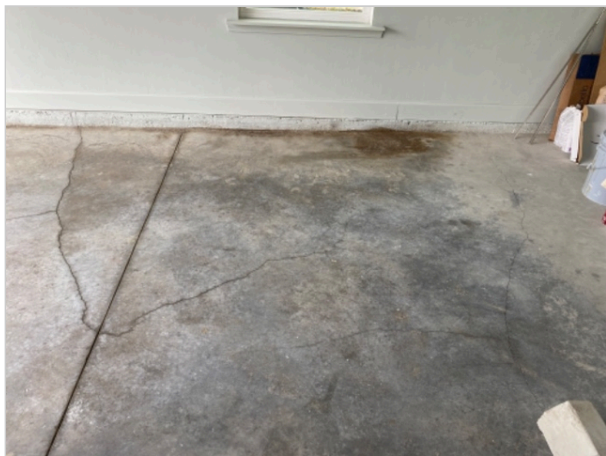
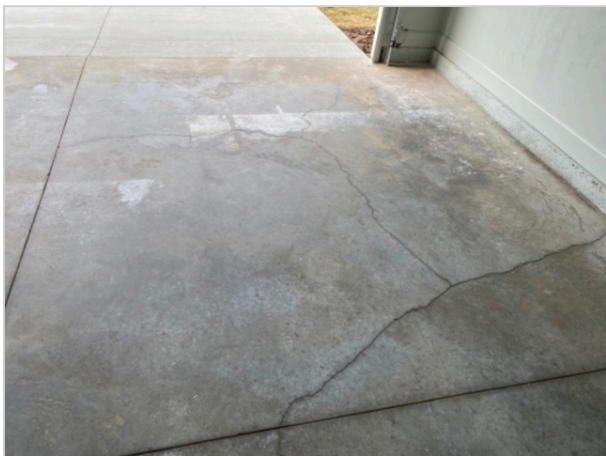
The garage floor had minor spider cracks observed. These cracks did not appear to be a structural issue. These cracks should be sealed and monitored.

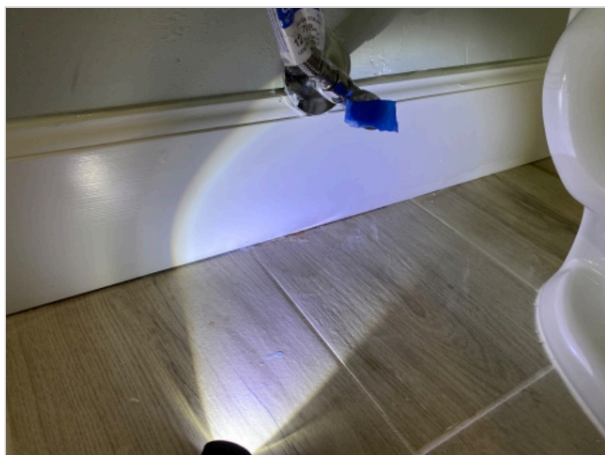
**Photo 43**

Leaks were observed at the toilet shut off in the Jack and Jill bathroom when in use. The tub and sink in the hall bathroom drain slowly. A licensed plumbing company should be called to evaluate the system and make any repairs.

The Jack and Jill toilet shut off is leaking.

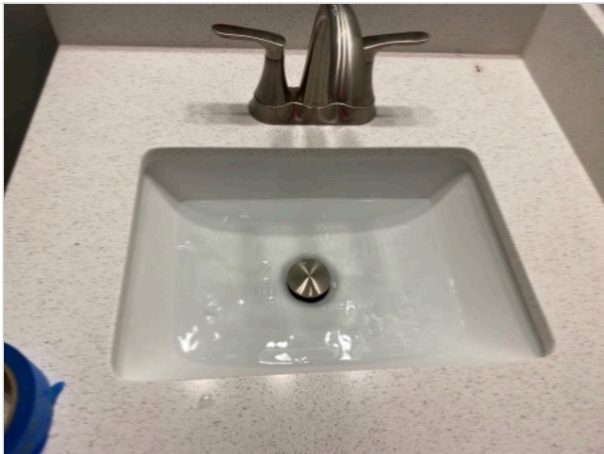
Photo 45

Hall bath sink drains slowly.

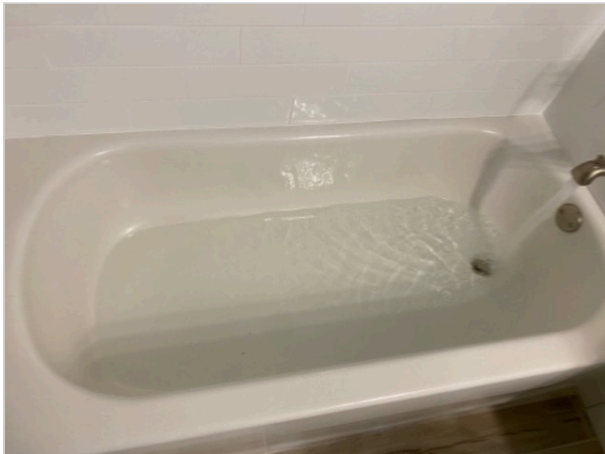
Photo 46

Hall bathroom drains slowly.

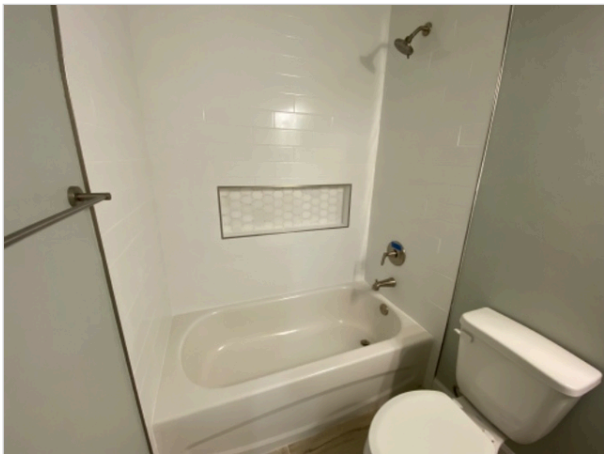
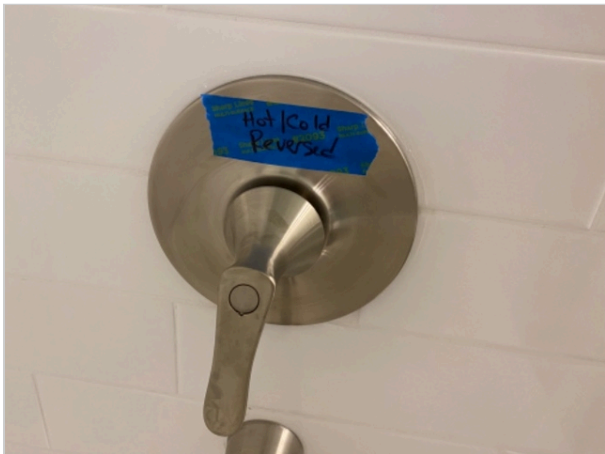
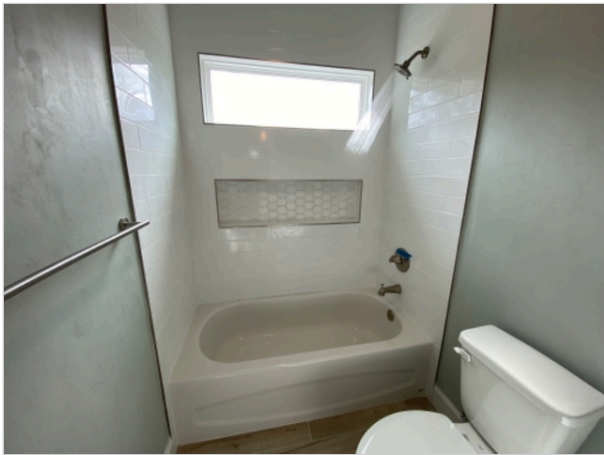
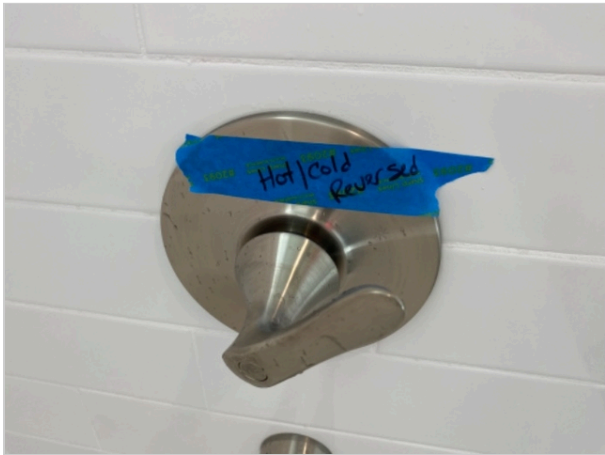
The shower controls in both guest bathrooms had the hot/cold reversed, which is a possible scald issue and should be corrected.

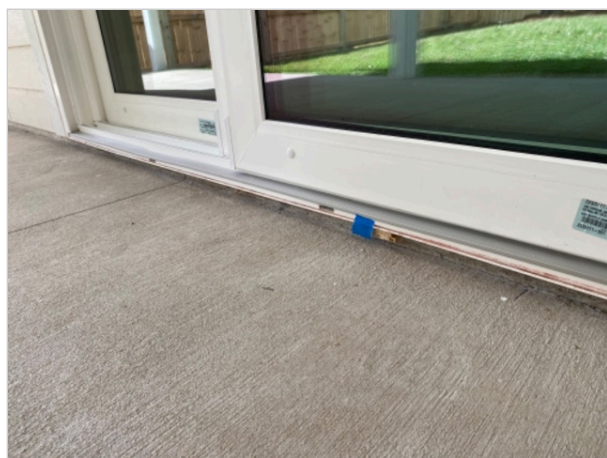
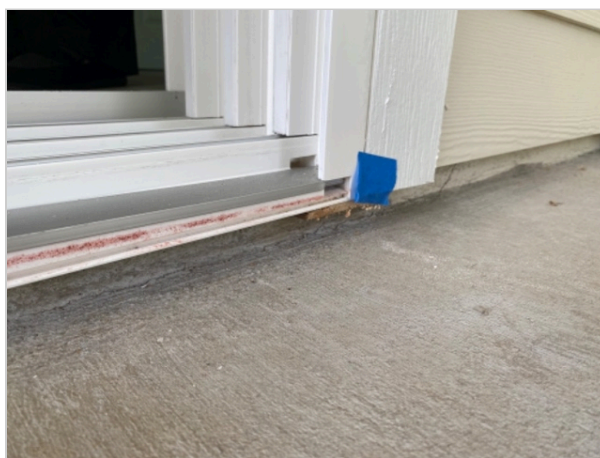
**The rear sliding door threshold extends over the edge and is not supported properly. Recommend a qualified contractor to repair as needed.**

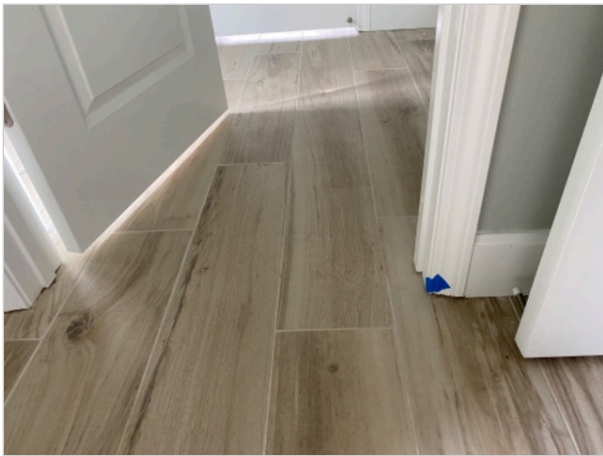
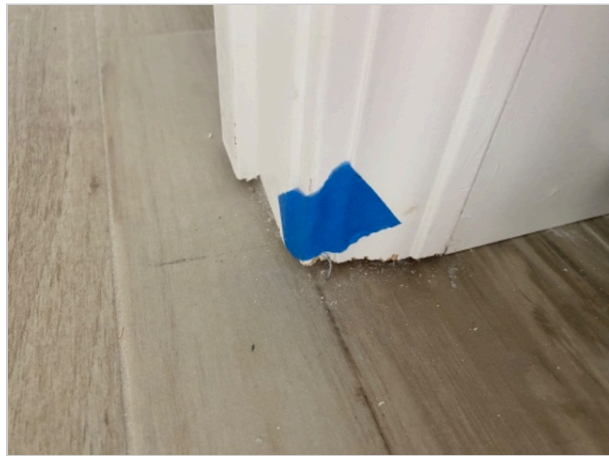
**An exposed nail was observed at the guest bedroom/ jack & jill bathroom door frame that should be removed**

**and has been marked with blue tape to help the builder and contractors identify said issues.**

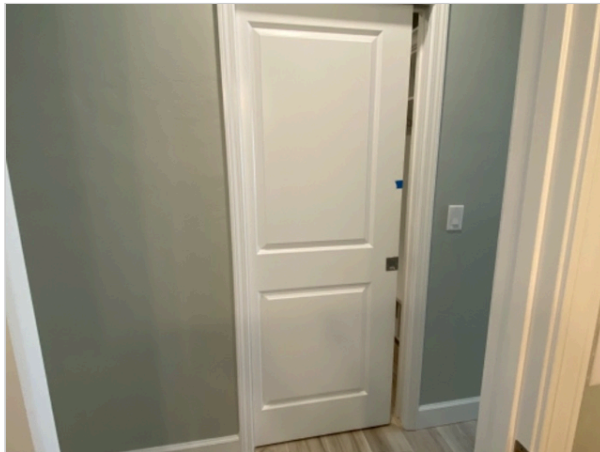
**Photo 61**

**The pocket door for the laundry room is difficult to open and should be adjusted.**

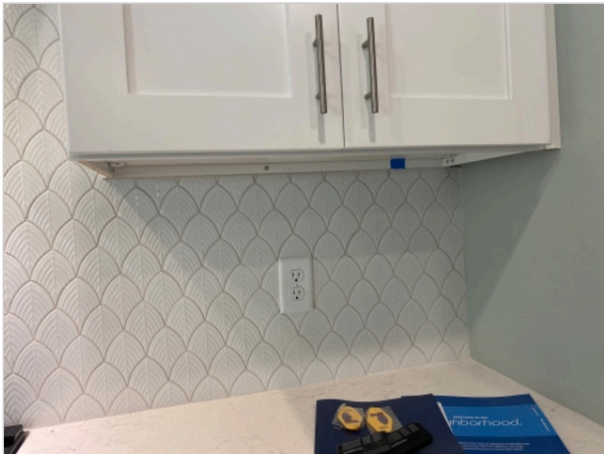
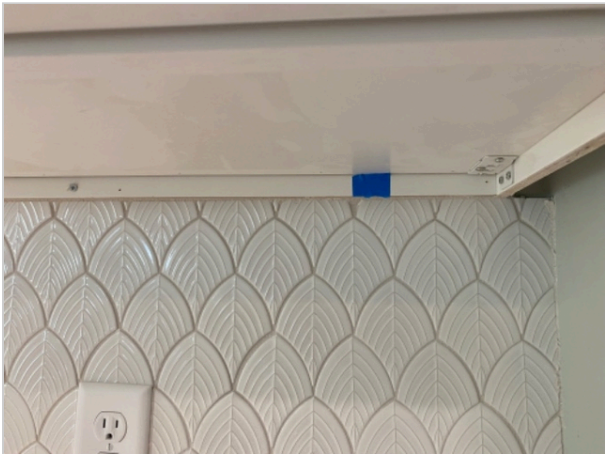
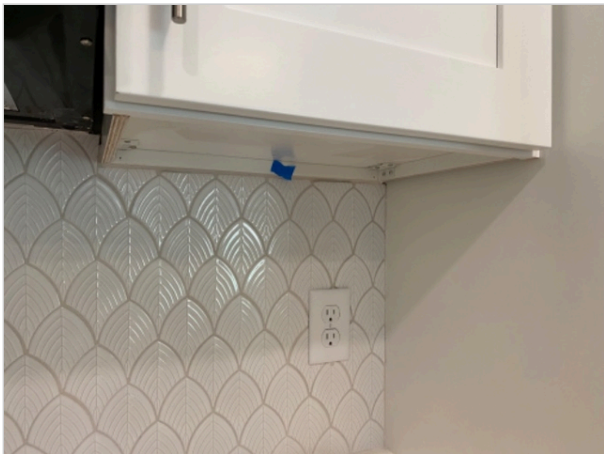
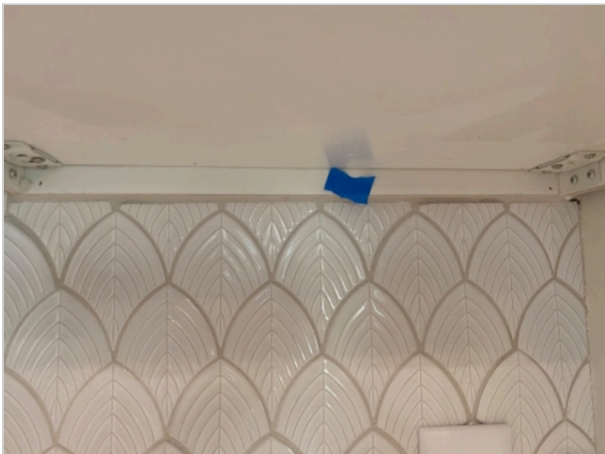
**Portions of the kitchens cabinets were not completely secure to the wall.** The cabinets should be secured to prevent them from falling.
