HOME INSPECTION REPORT

The inspected property consisted of a single story wood-framed structure with brick and wood siding that was vacant at the time of the inspection. There were material defects on the visible portions of the siding. The approximate temperature at the time of the inspection was 30 to 35 degrees Fahrenheit, and the weather was snowy. The utilities were on at the time of the inspection. The buyer and their agent were present during the inspection. The home was situated on a lightly sloped lot. The general grade around the home appeared to be adequate to direct rain water away from the foundation. The age of the home, as reported by the MLS sheet was said to be eighty to ninety years old. There was a concrete walkway leading to a concrete porch in the front of the home. There were material defects observed in the walkway or the porch.

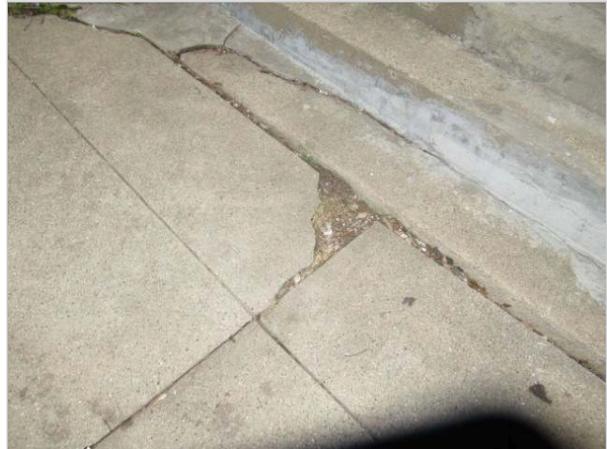
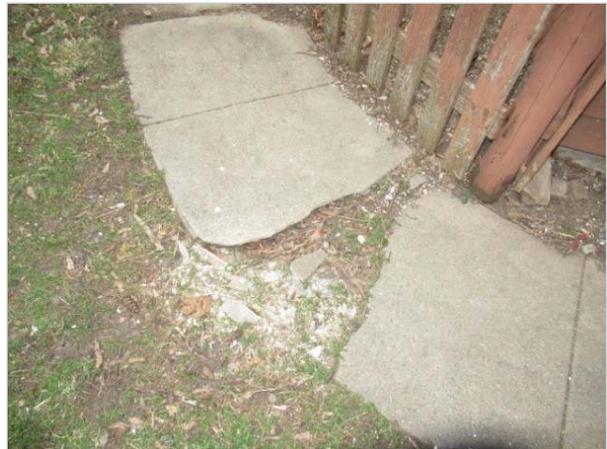
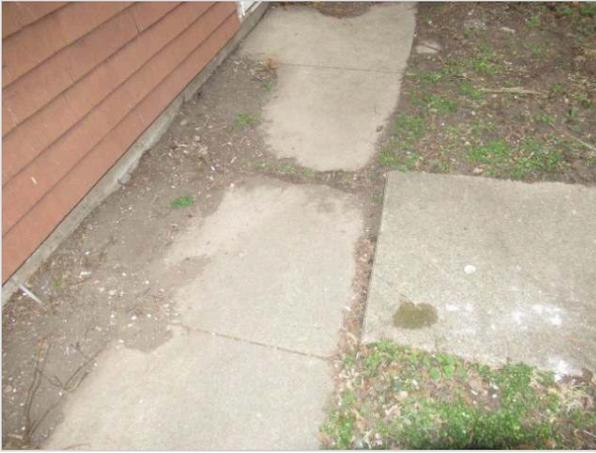
- ***The front and right walkways were cracked and damaged and should be corrected as this is a trip hazard.***

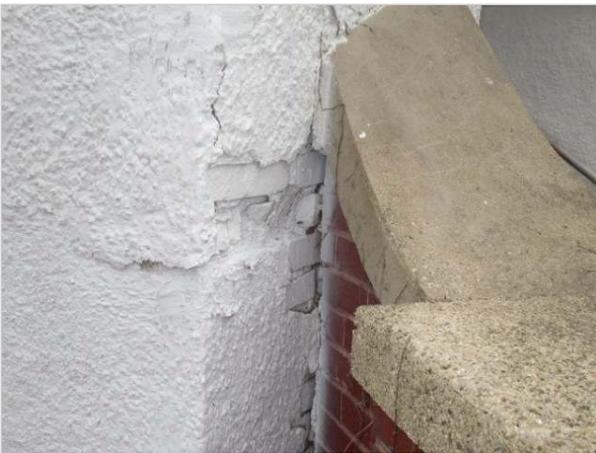
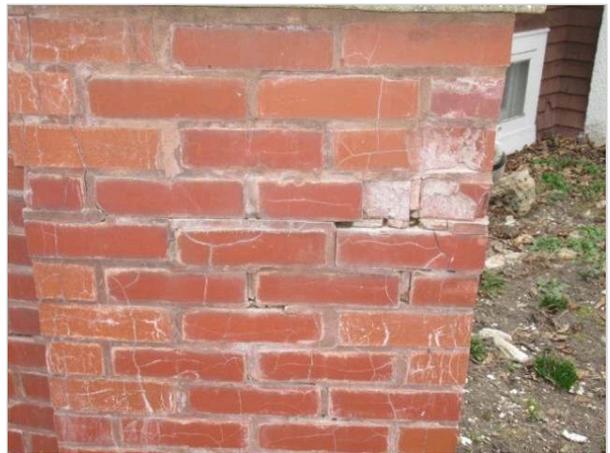
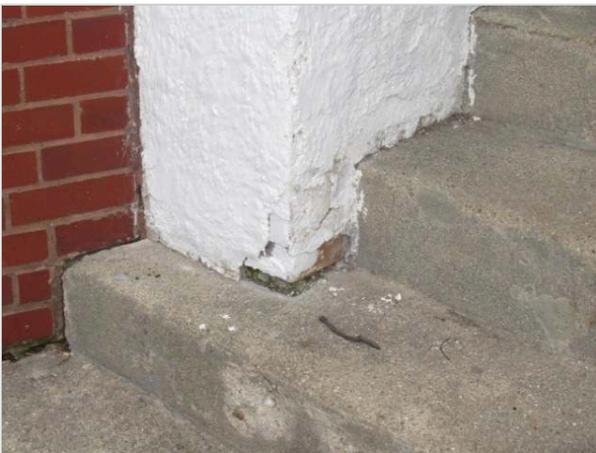
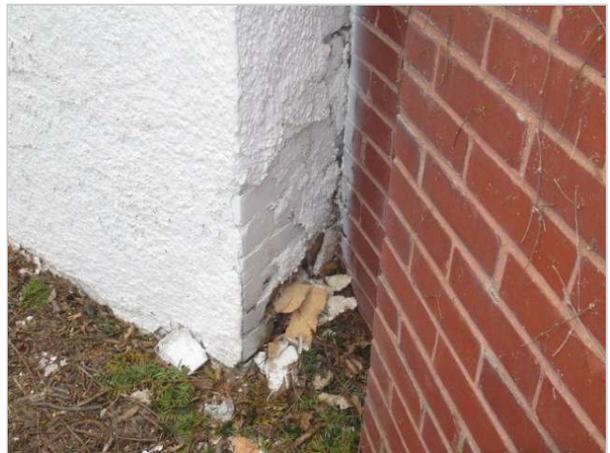
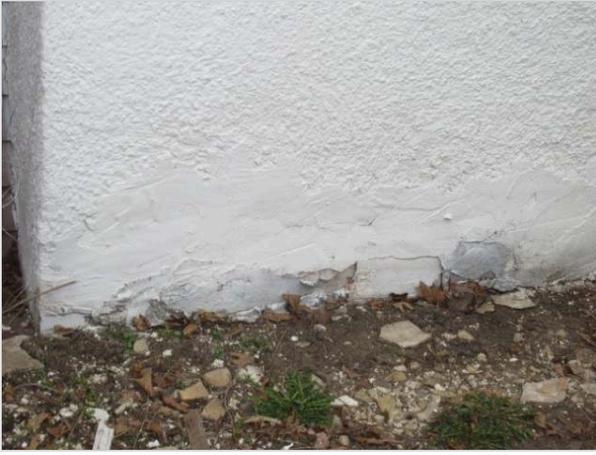
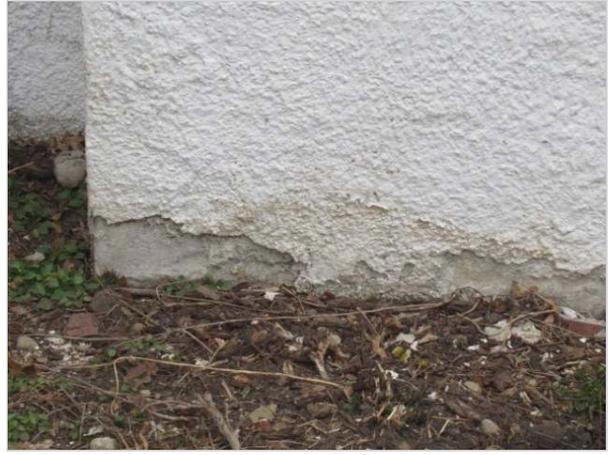
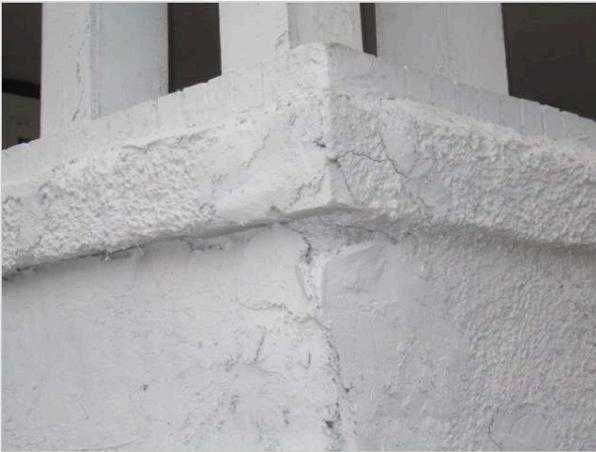
- ***There were sections of the brickwork skim-coat and brickwork throughout the home that were damaged and should be repaired.***

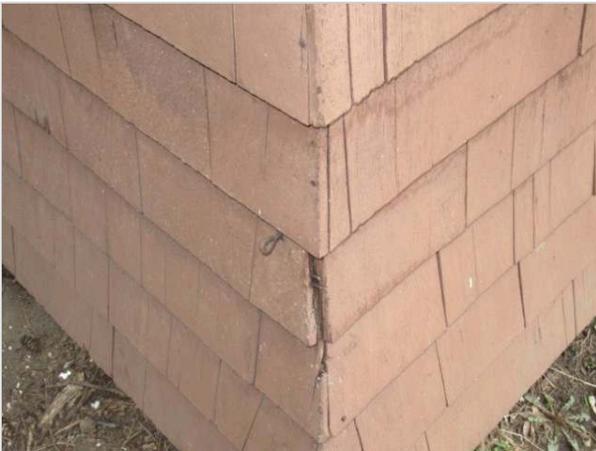
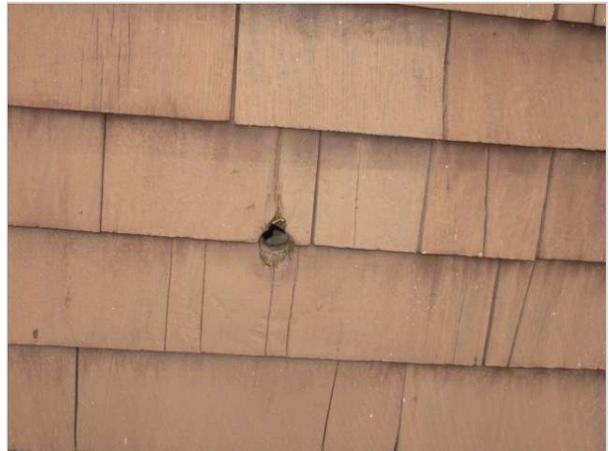
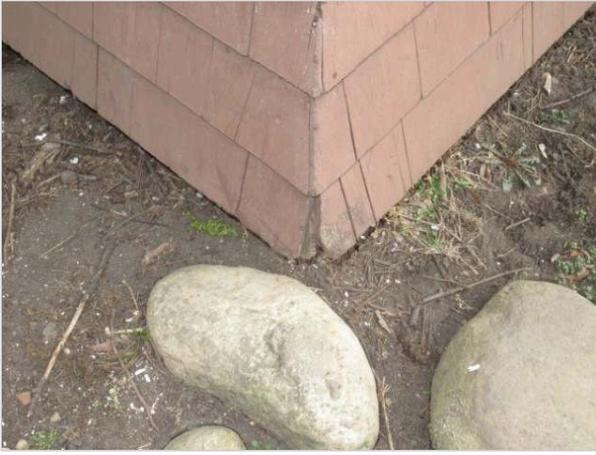
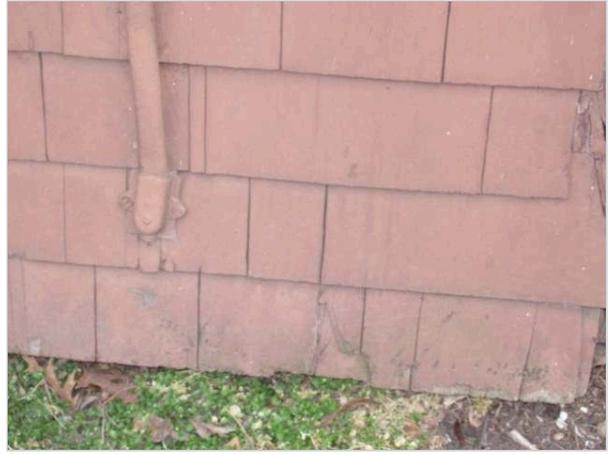
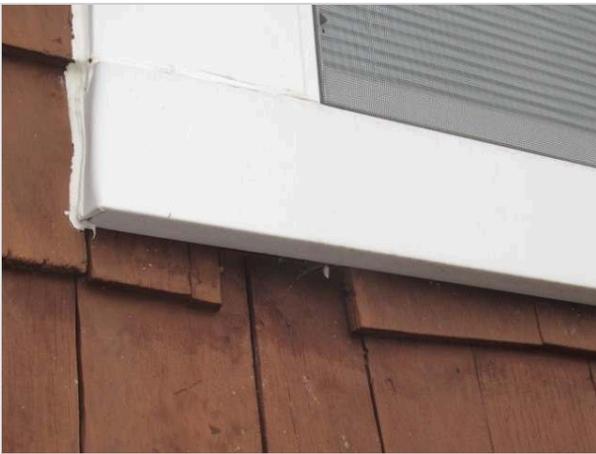
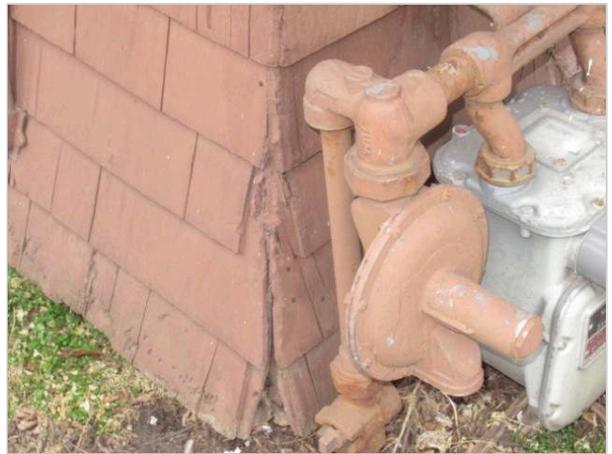
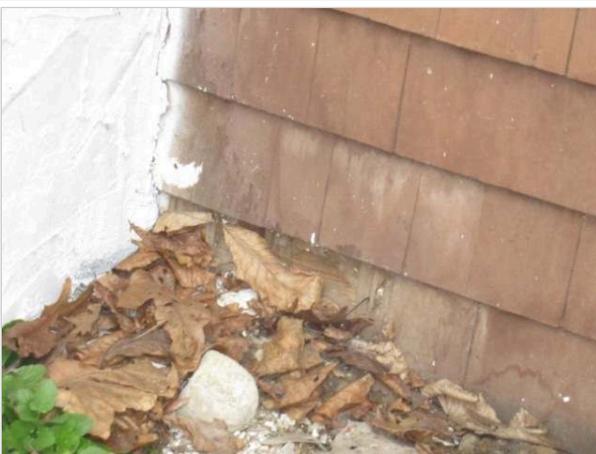
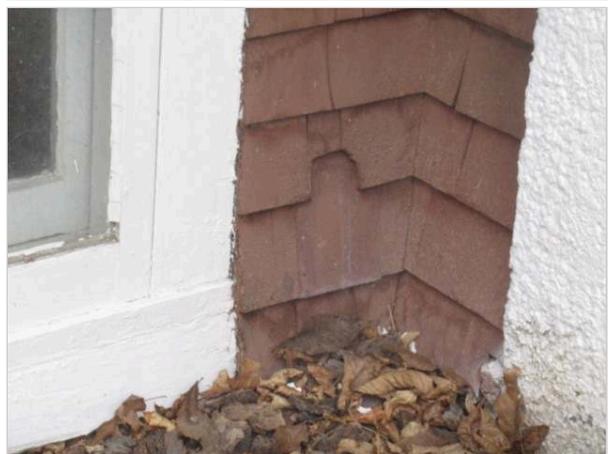
- *There were sections of the wood siding throughout the home that were damaged and should be repaired or replaced.*

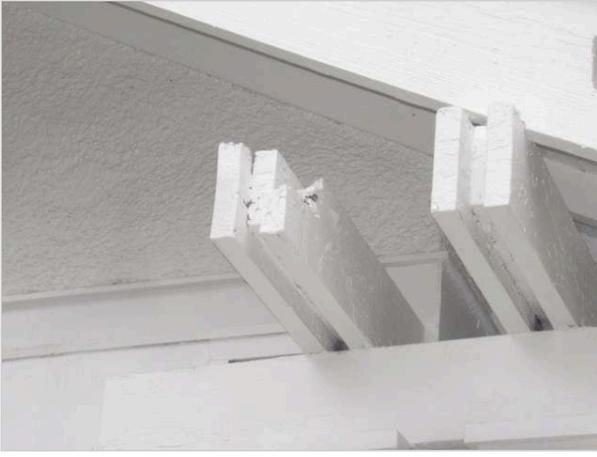
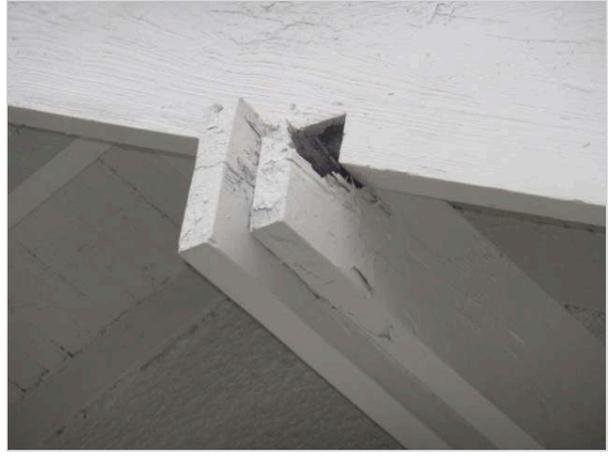
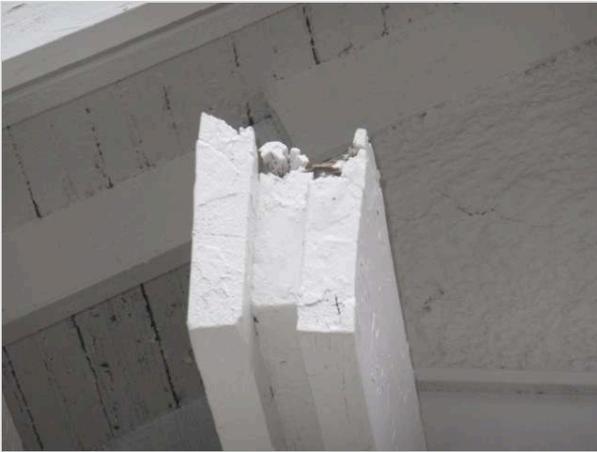
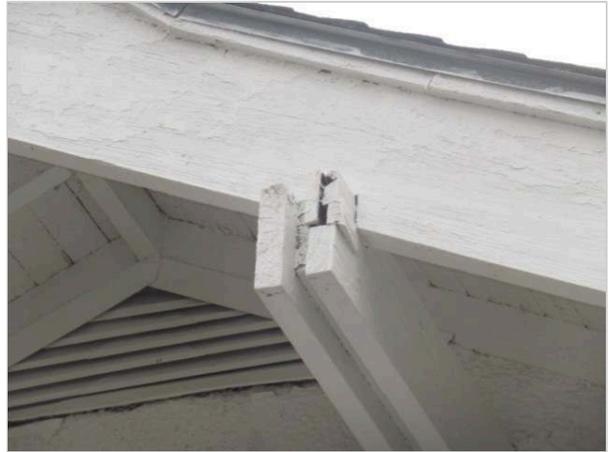
- *There were some exterior support joists at the front and right side of the home that were rotted and should be replaced.*

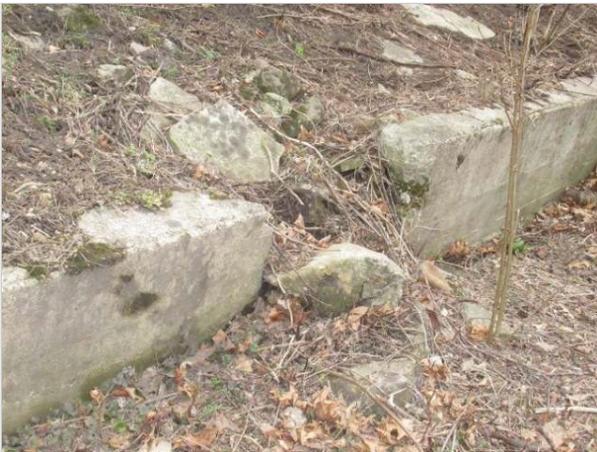
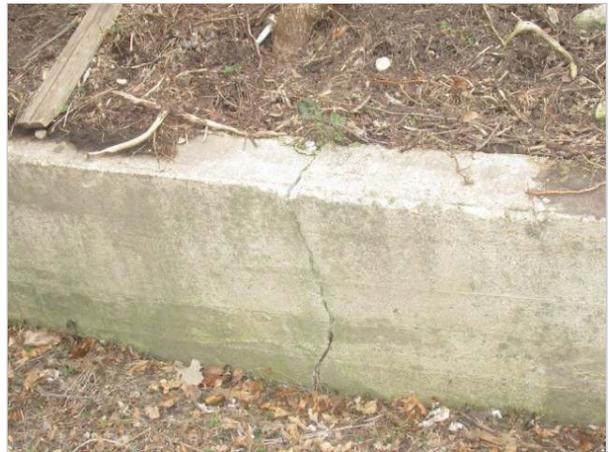
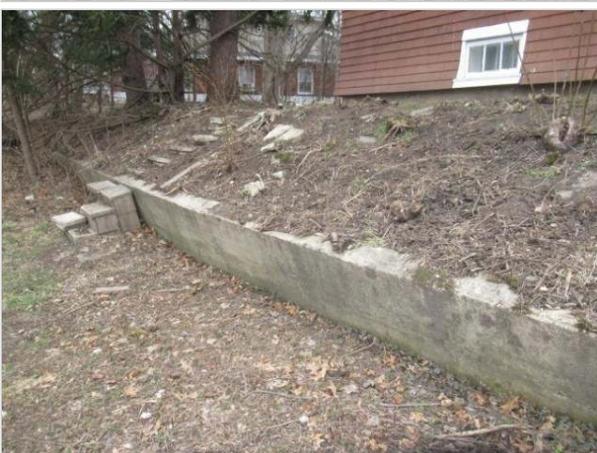
- *The left side retaining wall was damaged and leaning and should be repaired.*

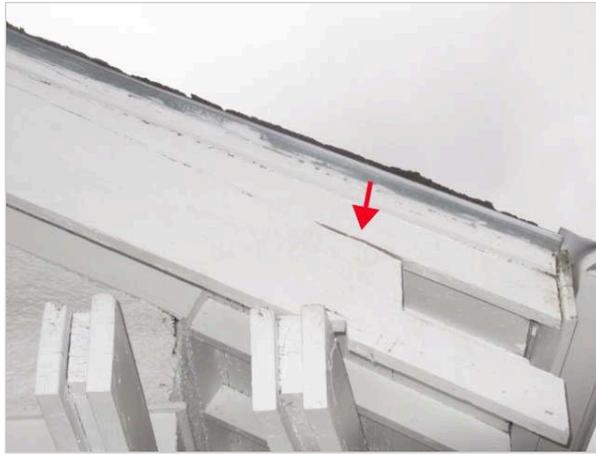
- ***The front fascia board was cracked and should be repaired or replaced.***

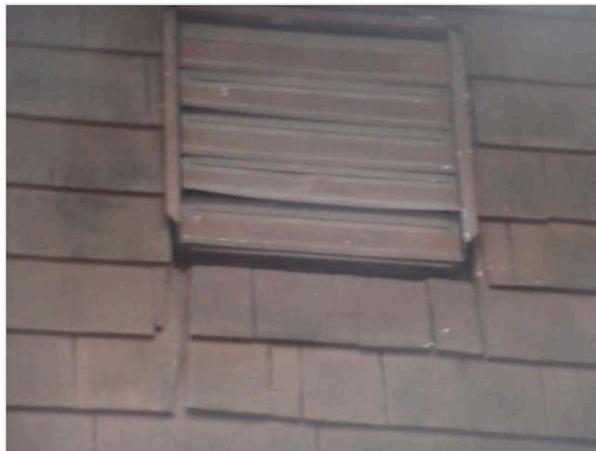
- ***The rear gable vent cover was damaged and should be repaired or replaced.***

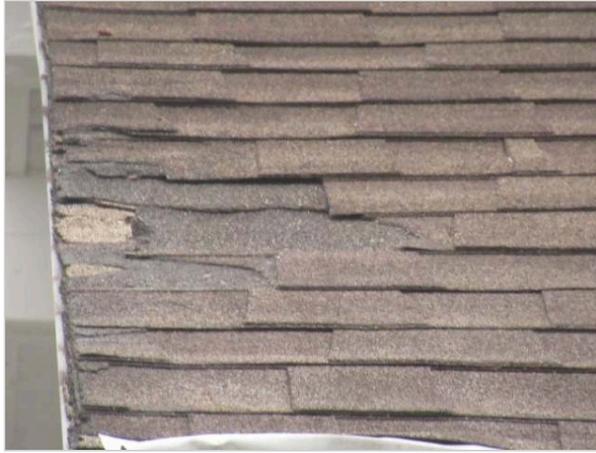
- ***There were some damaged roof shingles that should be further evaluated by a roofer and repaired.***

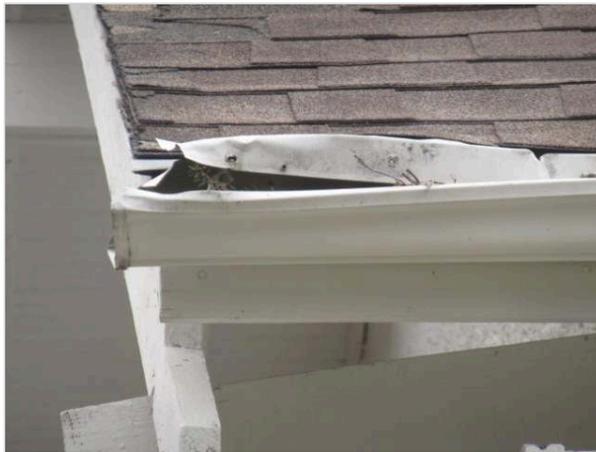
- ***The right side roof flashing was damaged and should be repaired or replaced.***

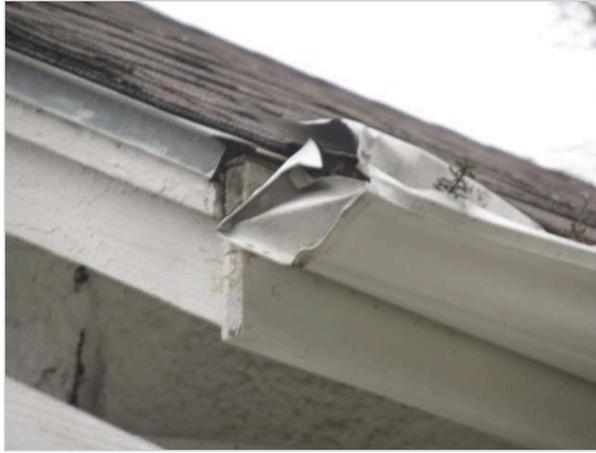
- ***One or more gutters were damaged and should be repaired or replaced.***

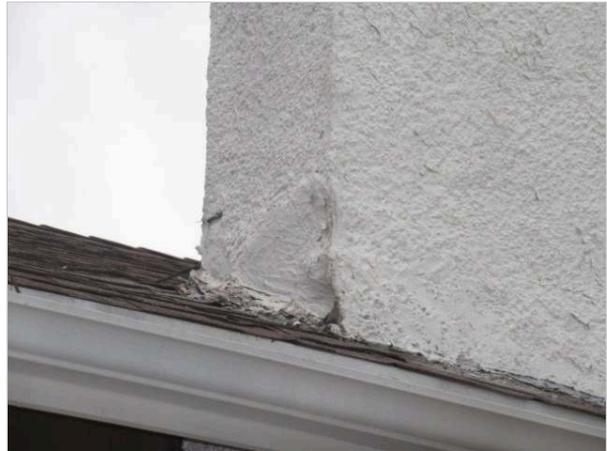
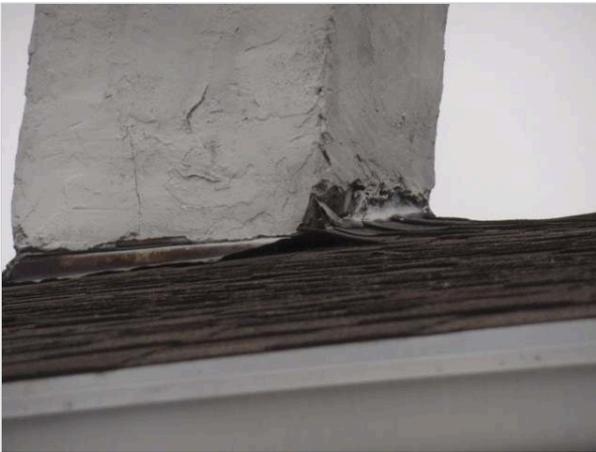
- ***There was damaged brickwork skim-coat at both chimneys that should be repaired.***

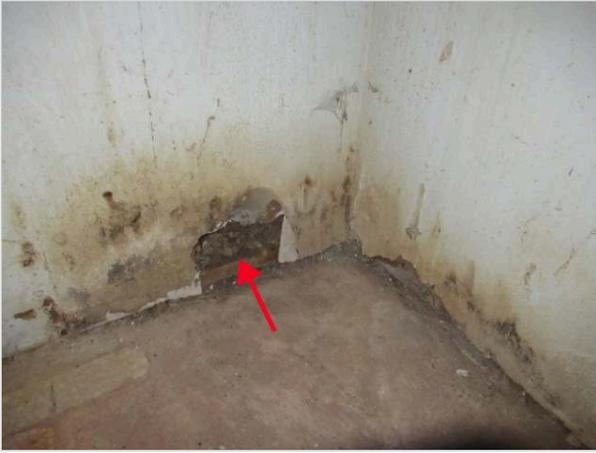
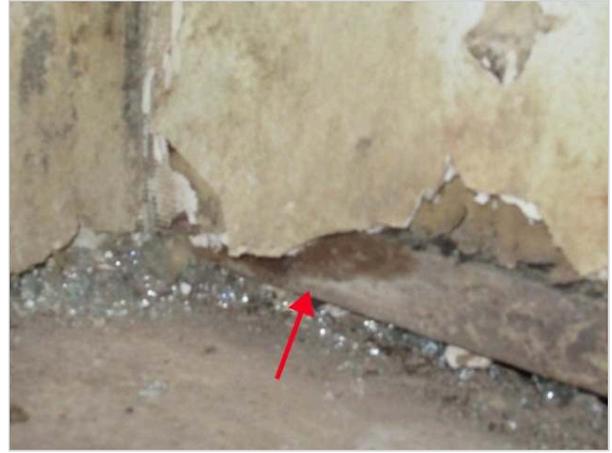
- ***There was active seepage at the left foundation that should be further evaluated by a water proofing company.***

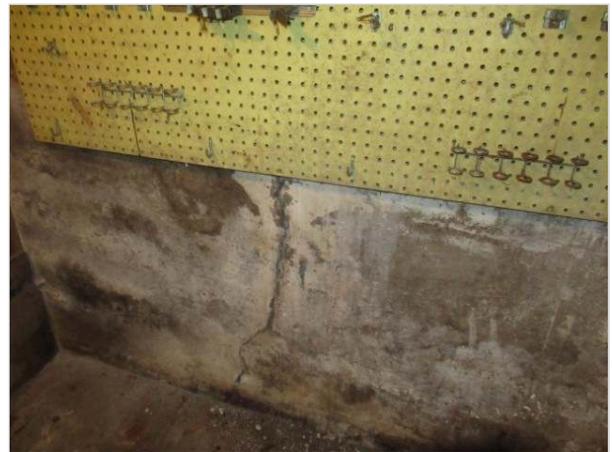
- ***There were a few substantial foundation cracks at the front and left walls that should be further evaluated by a foundation company.***

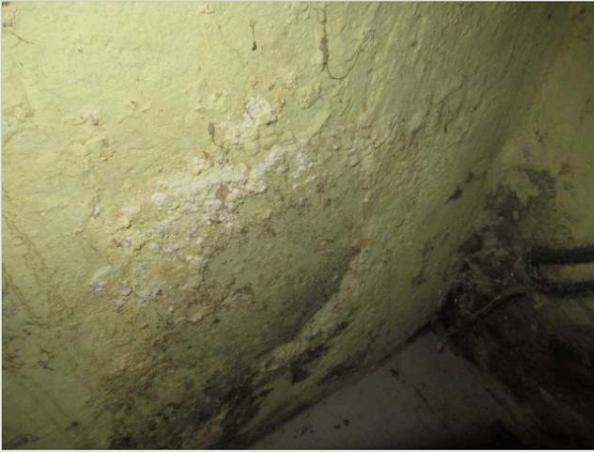
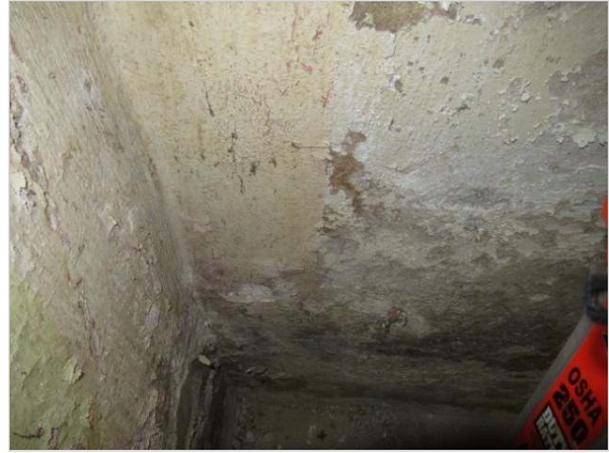
- ***There were signs of efflorescence throughout the basement that should be further evaluated by a waterproofing company.***

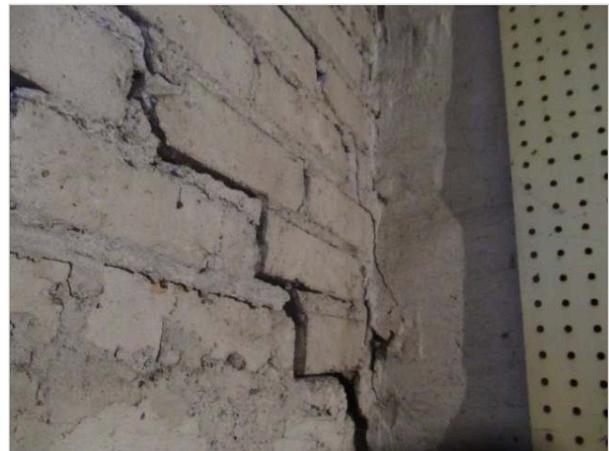
- *There was stair step cracking of the basement brickwork on the front and left sides of the home with shifted bricks that should be further evaluated and repaired by a foundation company.*

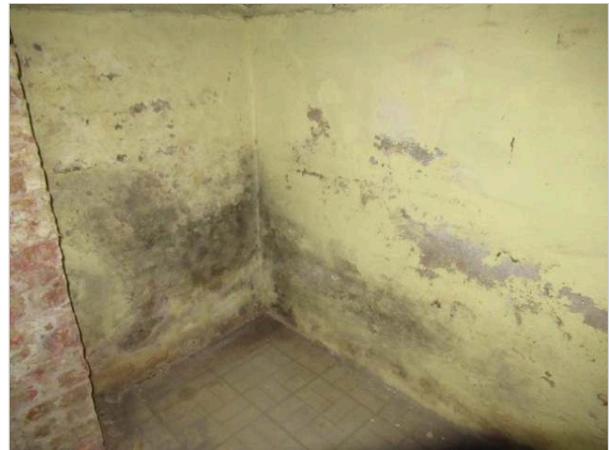
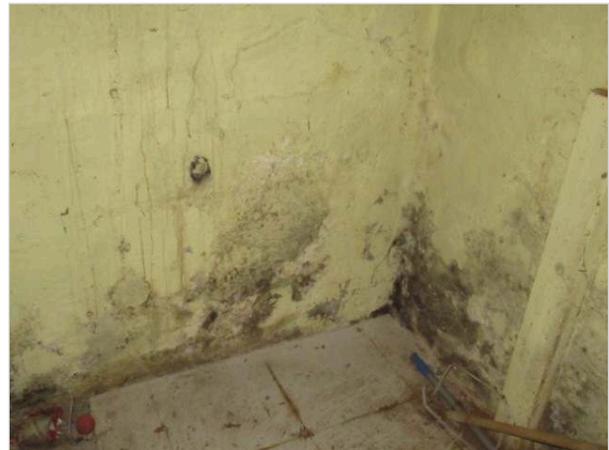
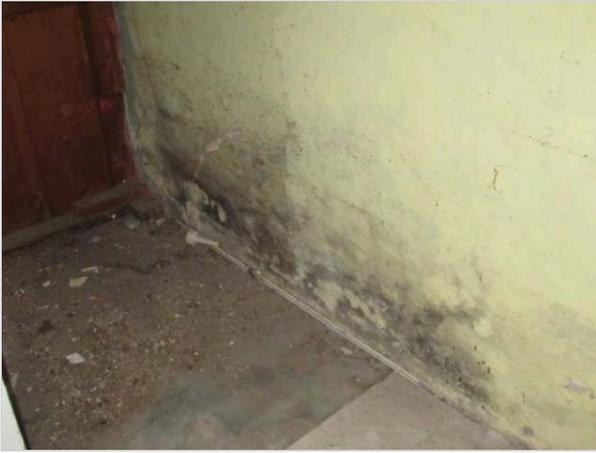
- **There was possible mold growth throughout the basement that should be further evaluated and treated as necessary.**

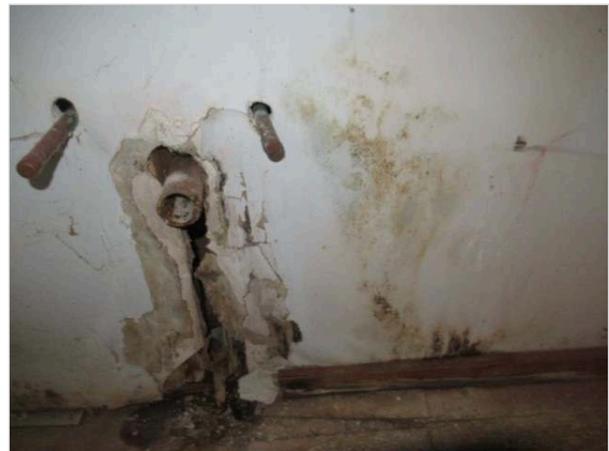
- ***There was water damage with a mold-like substance at the walls in the basement laundry room that should be repaired.***

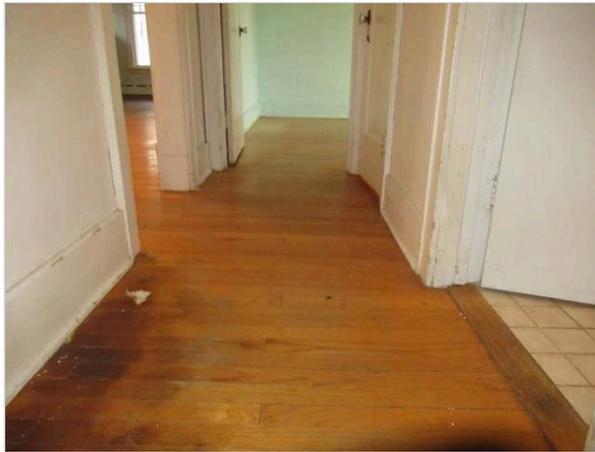
- ***Most of the basement ceiling was finished, which restricts a clear view of the floor joists. As a result, we were not able to see the entire floor structure during the inspection.***
- ***The floors were sloped and slanted throughout the first floor of the home and should be further***

evaluated by a floor or structural specialist.

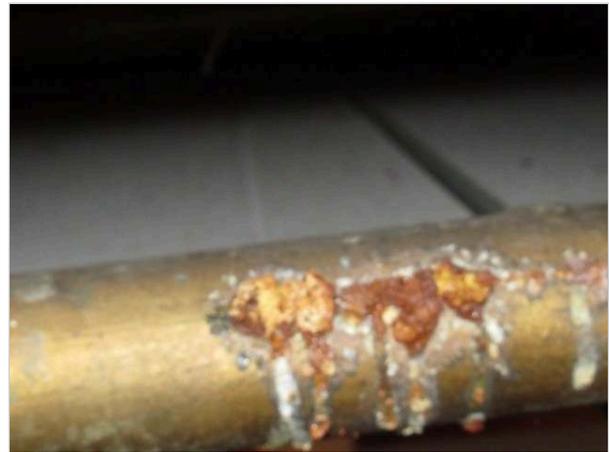
- ***It was too cold to test the outdoor spigots.***
- ***There were rusted and corroded plumbing pipes in the basement that should be further evaluated and corrected as necessary by a plumber.***

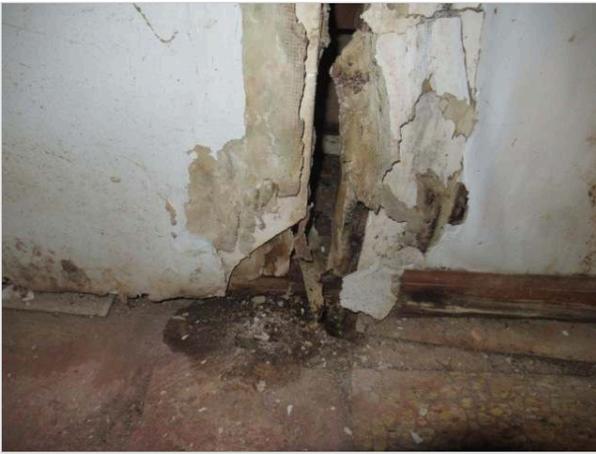
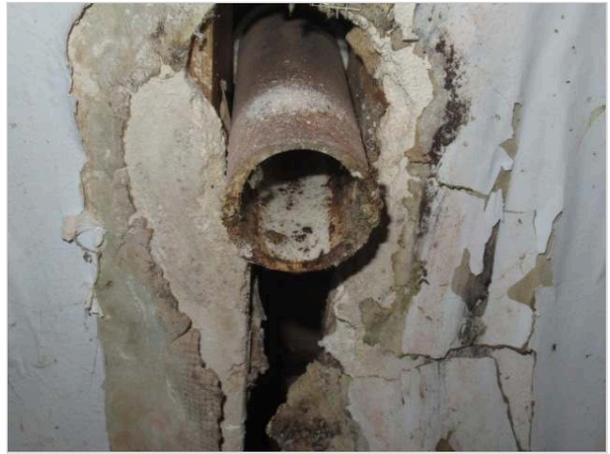
- ***There was active seepage with water damage at the basement utility sink plumbing that should be***

further evaluated by a plumber.

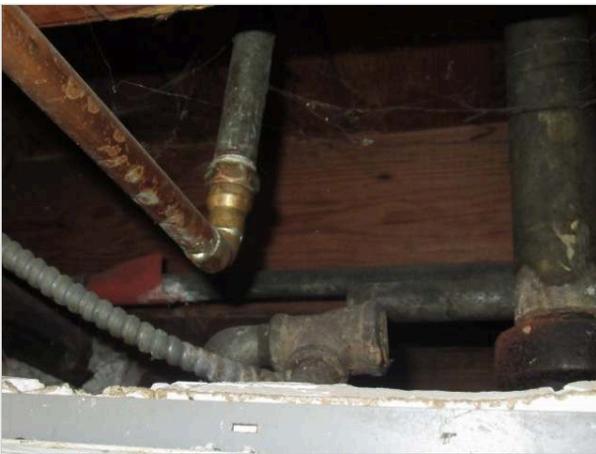
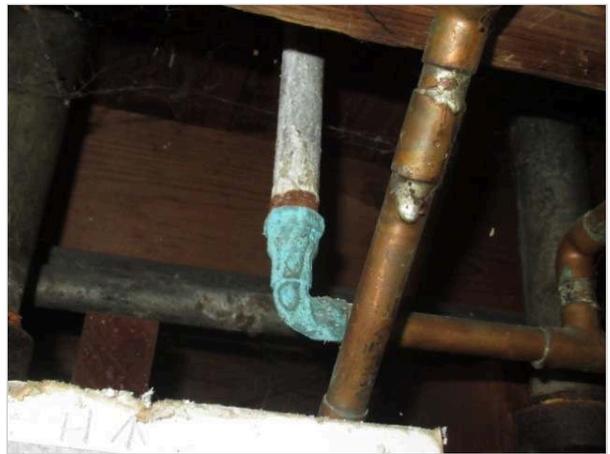
- *There were no dielectric unions where galvanized and copper pipes connected. A dielectric union is required to prevent corrosion and one should be installed.*

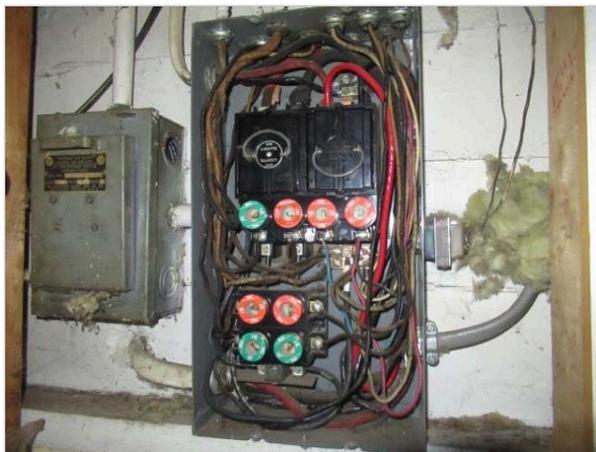
- ***The main electrical panel contained fuses and we recommend updating to a breaker panel.***

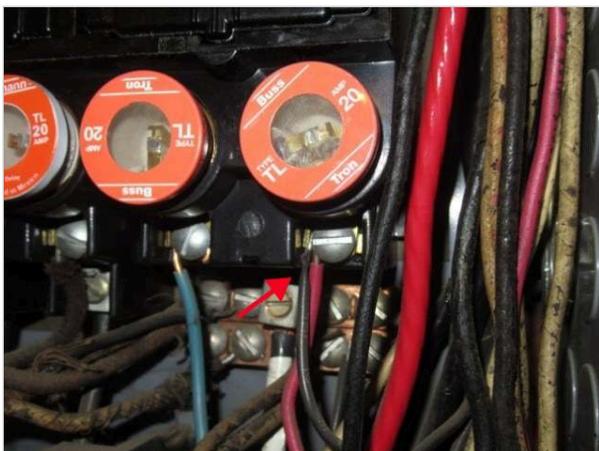
- *There were double taps observed in the main electrical panel that should be further evaluated and corrected by an electrician.*

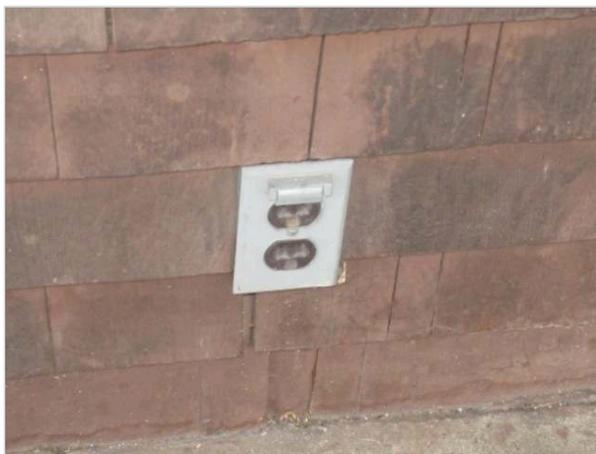
- ***The front exterior and kitchen outlet(s) were not GFCI protected and should be updated. All exterior outlets and outlets within six feet of a water source should be GFCI protected.***
- ***There were two prong outlets throughout the home that should be updated to grounded, three prong outlets.***
- ***An open ground was observed at the front exterior outlet and this should be corrected by an electrician.***
- ***One or more exterior outlets were not properly covered and this should be corrected.***

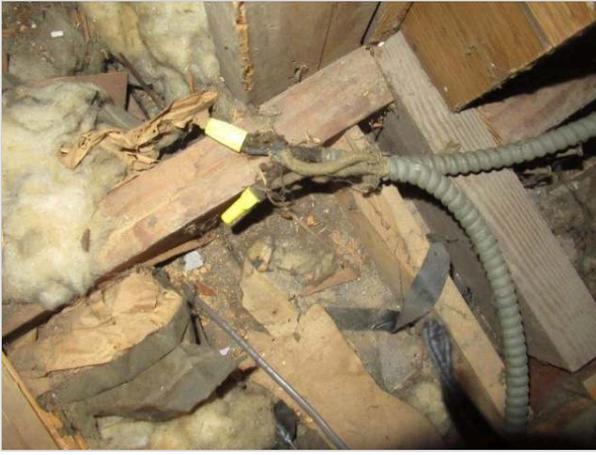
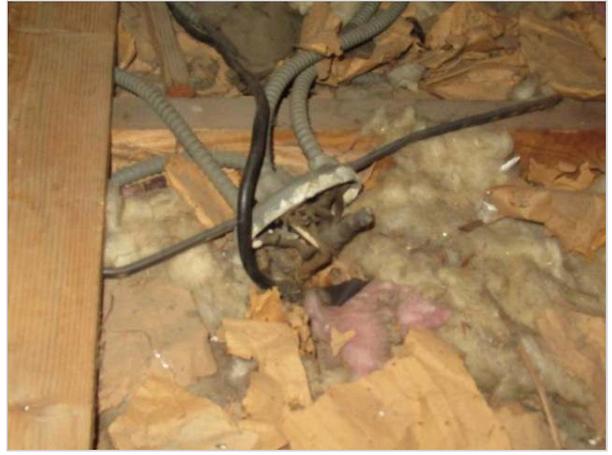
- ***Open electrical splices were noted in the attic. All electrical splices should be enclosed in an approved and covered electrical box.***

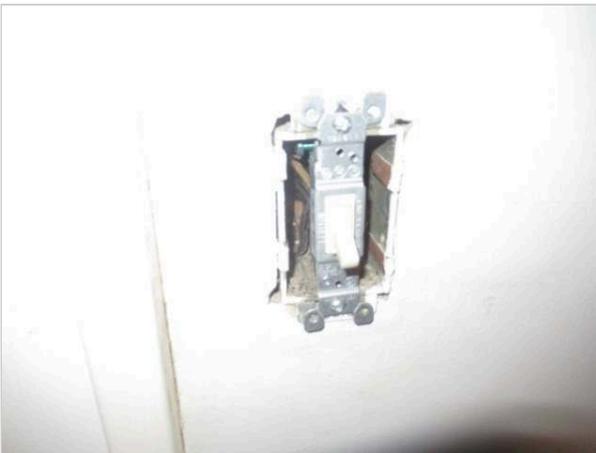
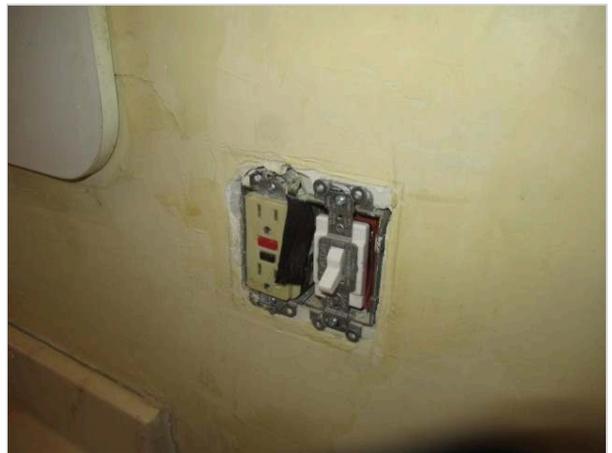
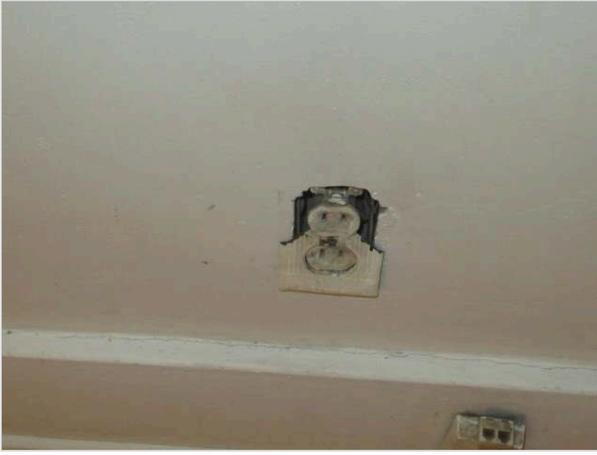
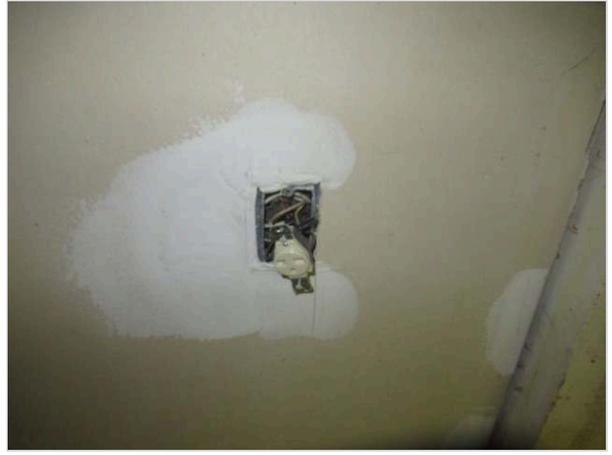
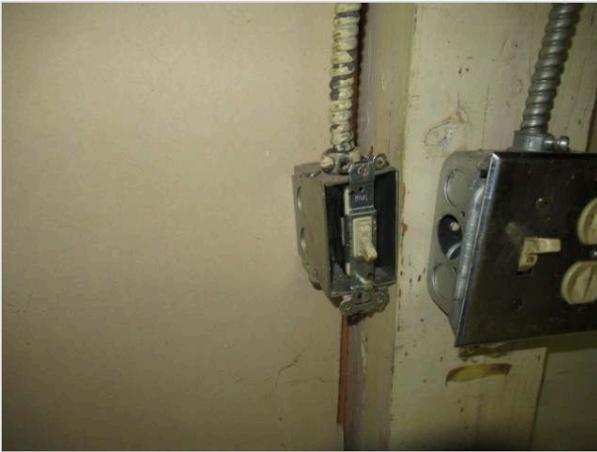
- *There were one or more switch plate or outlet covers missing throughout the home that should be replaced.*

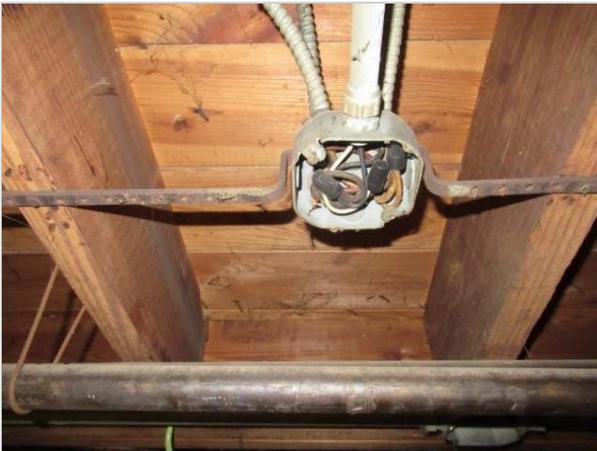
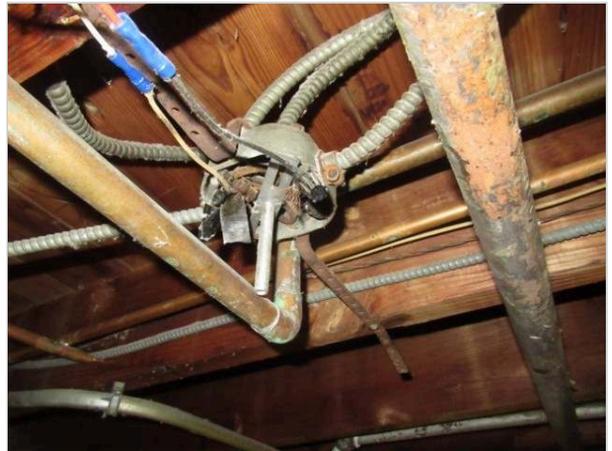
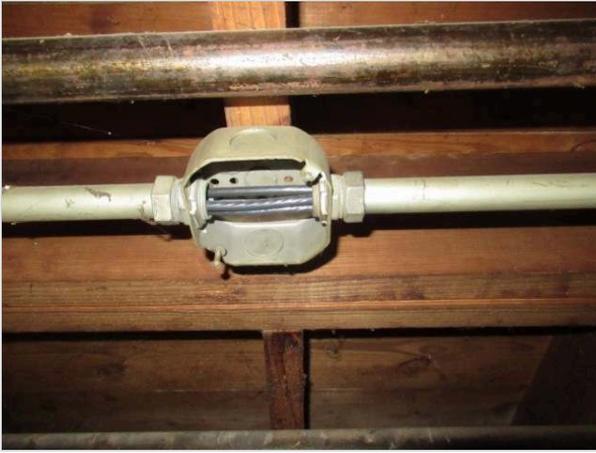
- *There were one or more junction box covers missing throughout the basement that should be replaced.*

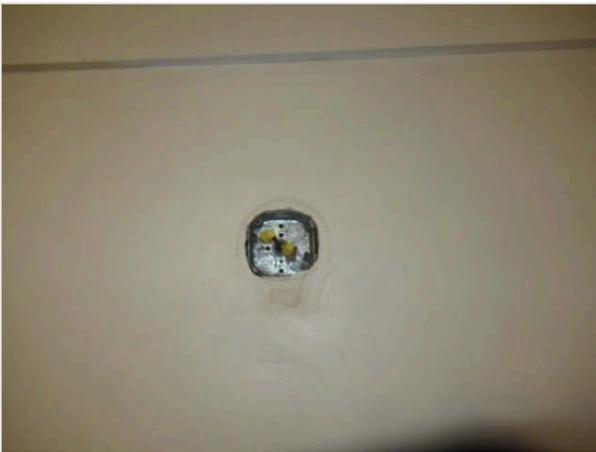
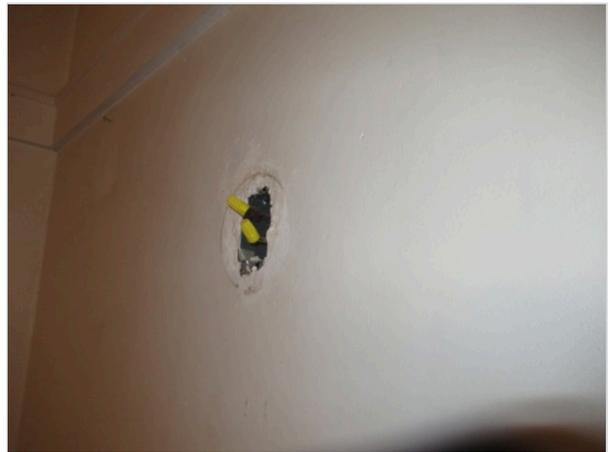
- *The dining room wall light fixtures were missing and should be replaced.*

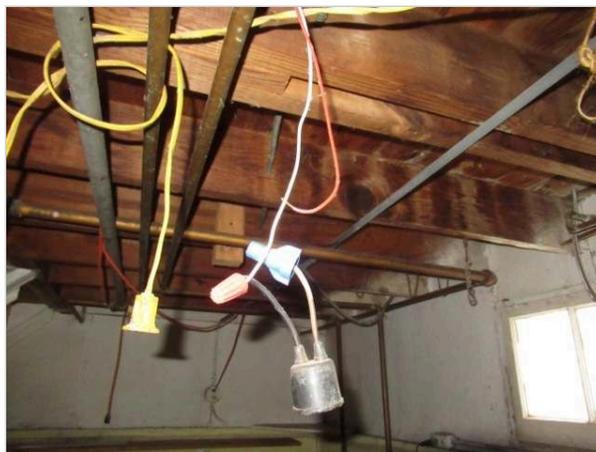
- *The hall bathroom exhaust fan was inoperable and should be serviced or replaced.*
- *Open electrical splices were noted in the basement. All electrical splices should be enclosed in an approved and covered electrical box.*

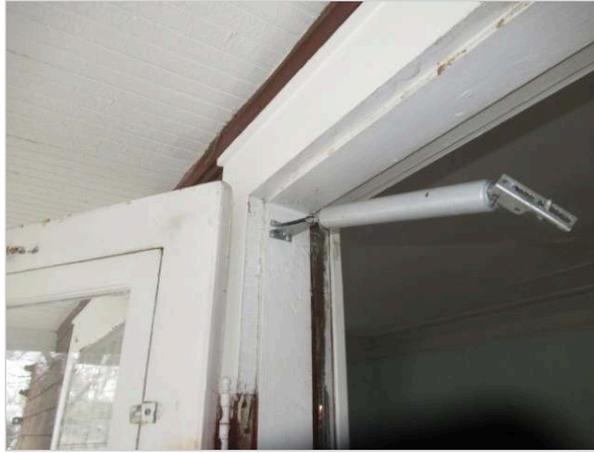
- ***There were some window screens that were torn and should be replaced.***
- ***The front storm door top closer was detached and should be repaired.***

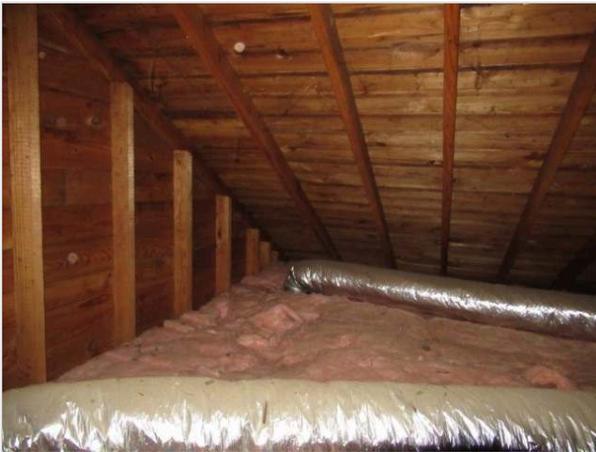
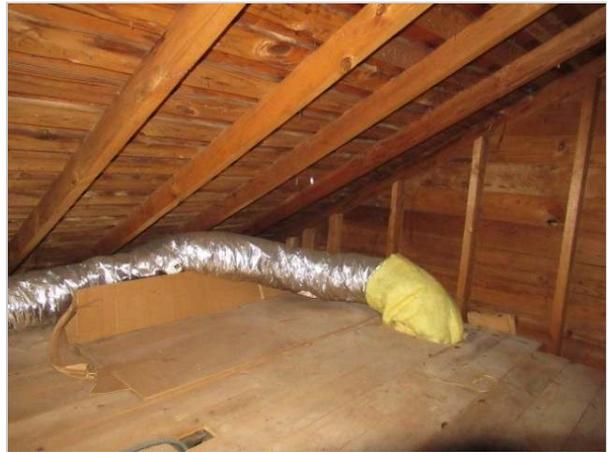
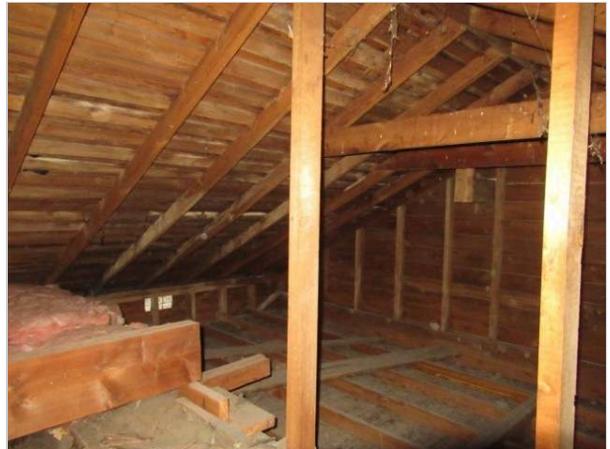
- ***There was some insulation in the attic which appeared to be of a material that may contain a small amount of asbestos. The EPA recommends that homeowners make every effort not to disturb the vermiculite insulation in their attics. If you plan to remodel or conduct renovations that would disturb the vermiculite, hire professionals trained and certified to handle asbestos and safely remove the material. More information on vermiculite can be found on the EPA web site; <http://www.epa.gov/asbestos/pubs/verm.html>***

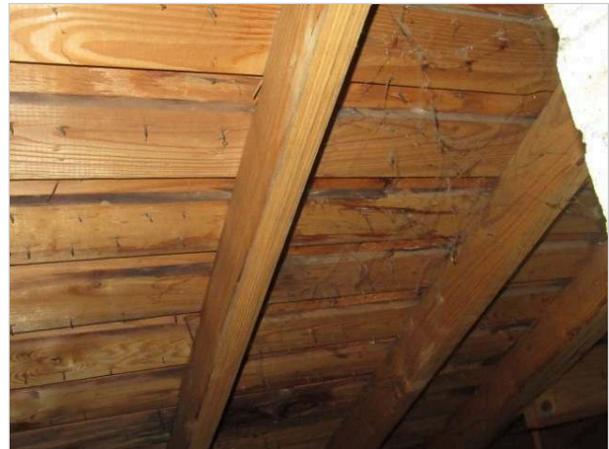
- ***There were signs of previous moisture at the right side of the attic that should be further evaluated and corrected.***
