**HomeTeam**<sup>®</sup>  
INSPECTION SERVICE

### HOME INSPECTION REPORT

*This summary provides a simplified overview of the results of the Friday, April 13, 2018 inspection at 123 Sample Drive, Woodbridge, VA 22191. Be sure to read the full body of the inspection report; it contains much more detail about the property. Any additional evaluations we've recommended must be performed prior to the conclusion of the inspection contingency period.*

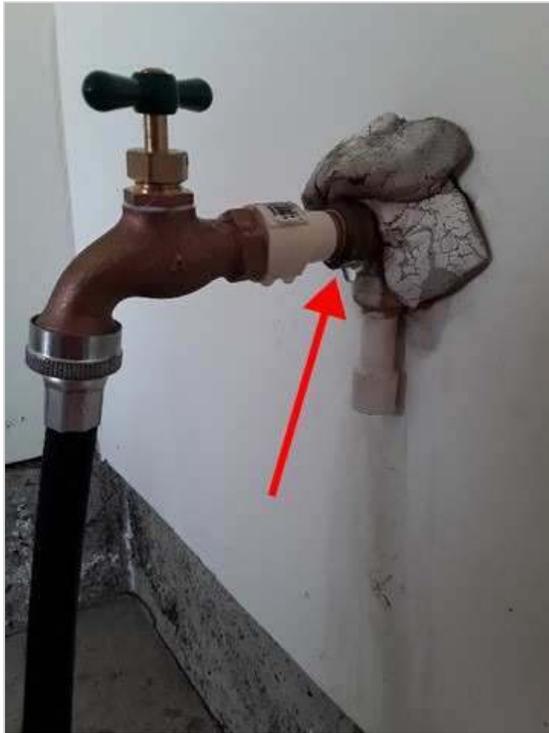
1. The left hose bib and the hose bib in the garage leaked when tested. Consult with a qualified contractor for repair.

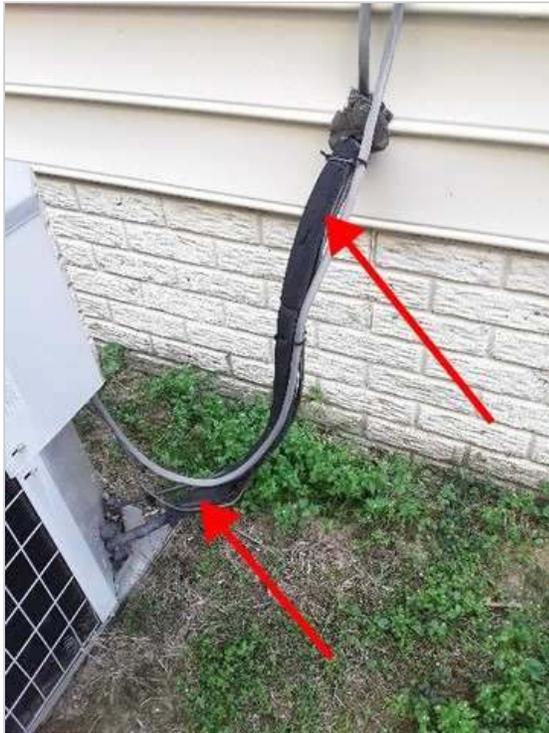
1. The insulation on the exterior air conditioning line set is dry-rotted. This could affect the efficiency of the system and should be replaced.

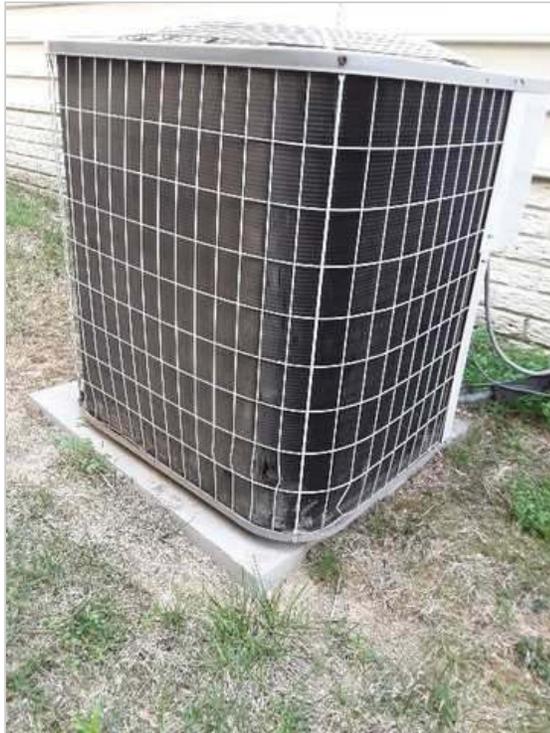
2. Outdoor air conditioner condensing units will typically last approximately 12-15 years before needing to be replaced. An outdoor condensing unit will last longer by doing regular maintenance. The subject condensing unit has been in service for approximately 13 years and was functioning at the time of inspection. The label on the unit was not legible due to wear and therefore the model and serial numbers were not available. The unit may potentially be at or nearing the end of its usable life.

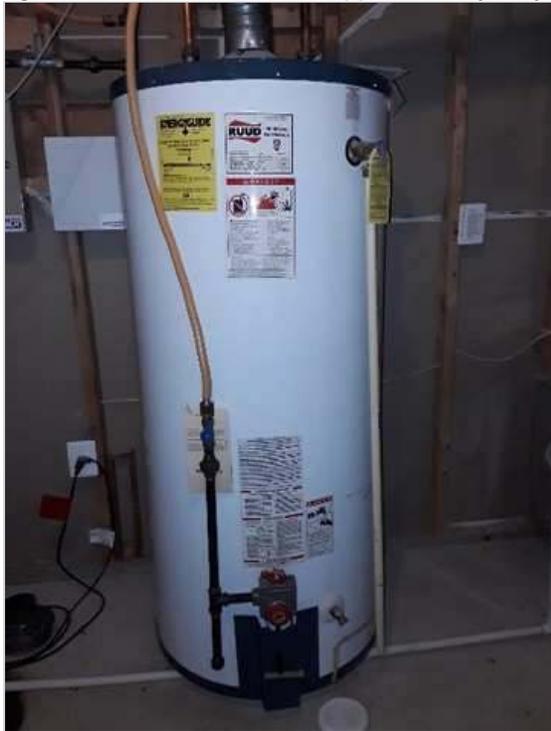
2. Most tank-type water heaters last 10 to 20 years, with the average age of replacement between 12 and 14 years. The age of the water heater was approximately 14 years old and was most likely at or nearing the end of its useful life.

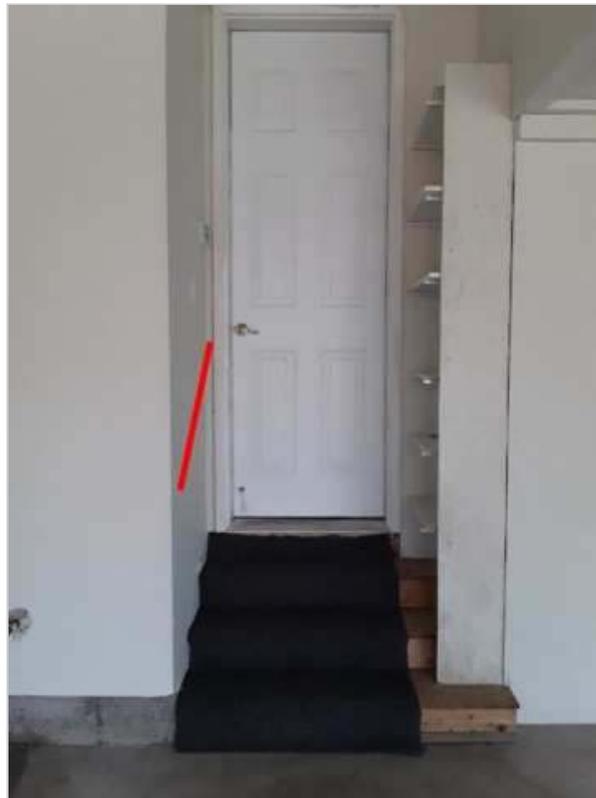
There was no handrail on the stairs leading to the garage. This can be a safety concern.

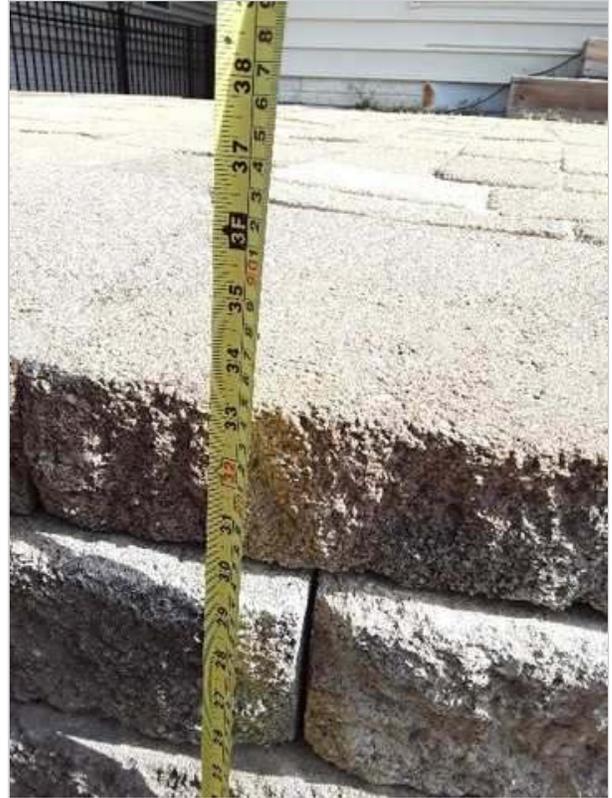
The earth beneath the cement paver patio in the rear of the home over time has started to erode away causing the pavers to shift creating several trip hazards found on the walkways around the house. In order to remedy the safety concern it will take extensive landscaping to relevel all of the pavers and the earth beneath them. Consult with a qualified contractor for estimates on repairs.

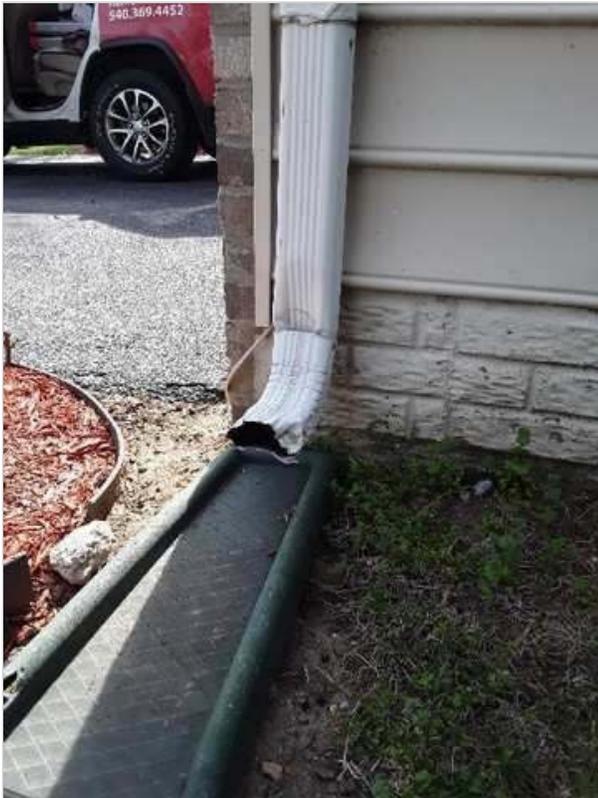
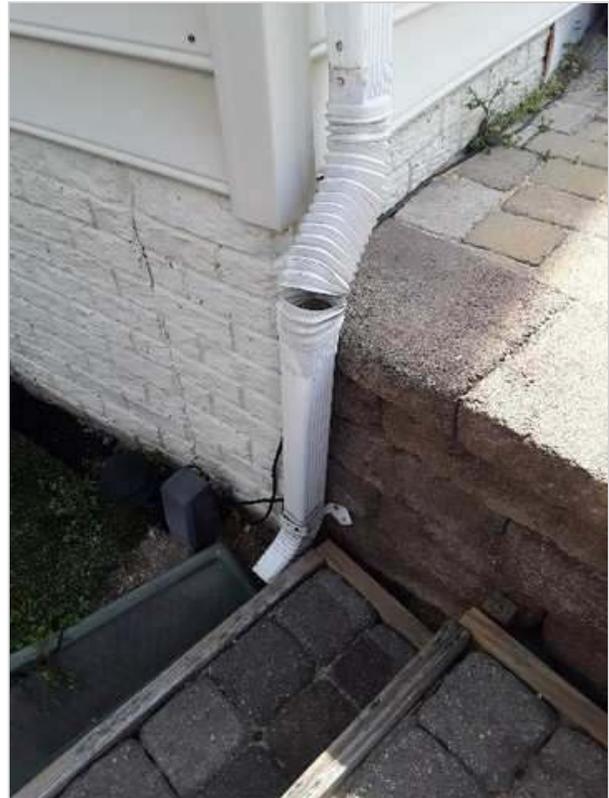
The right front and the right rear downspouts were damaged. This may restrict or improperly flow the water away from the foundation and should be corrected.

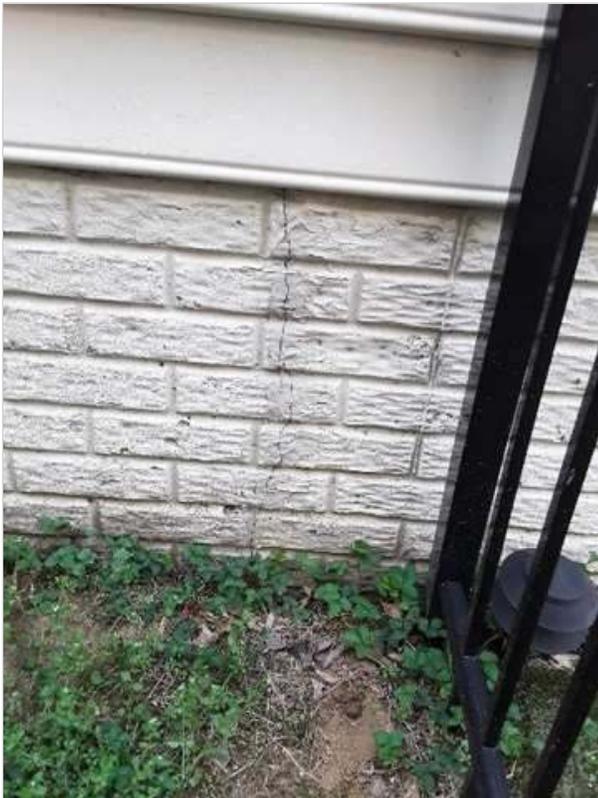
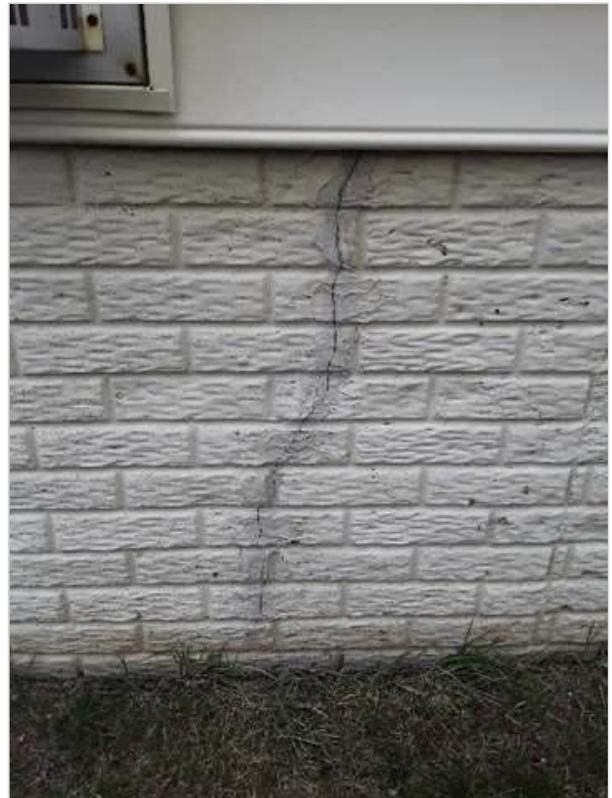
There were several minor, settlement cracks observed on the foundation. The cracks were 1/16-inch or less in width. These cracks are common and usually insignificant. All buildings experience some settlement. Settlement cracks most often occur within the first few years after construction as the soil under the structure accommodates itself to the load of the structure. However, the significance of cracks cannot always be judged by a single inspection. All cracks should be monitored for significant changes in characteristics. Consult with a company specializing in foundation repair if there is a marked change in the size or dimension of a crack.

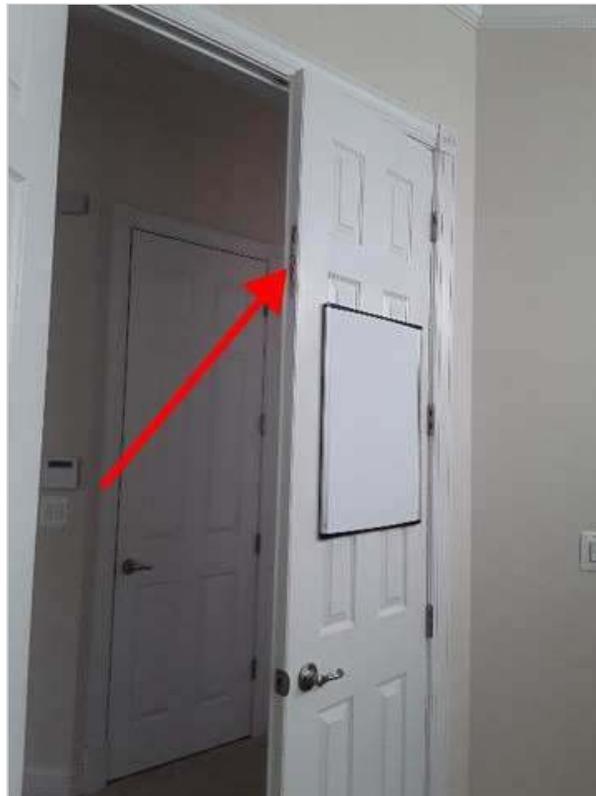
The latch was missing hardware on one of the door leading to the office on the main floor.

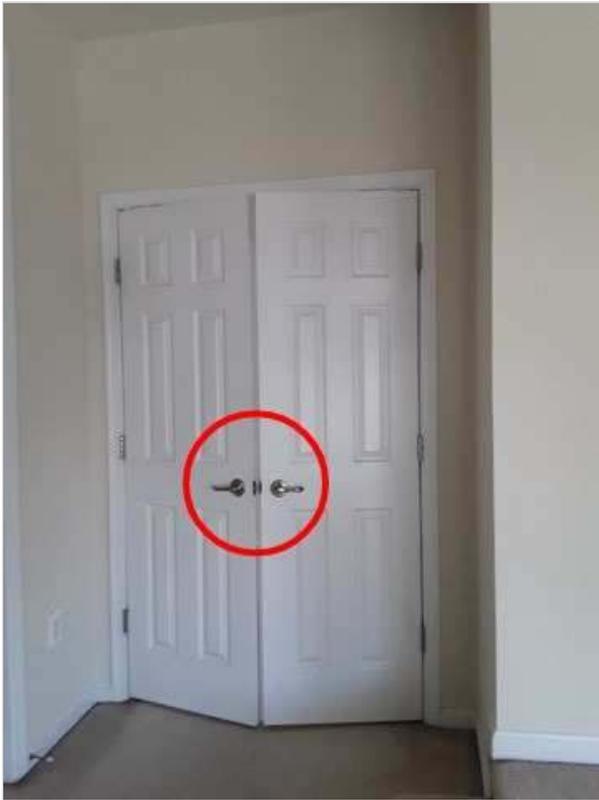
The french doors leading to the master bedroom did not latch properly,. This is normally easily corrected by a slight adjustment in the striker plate.

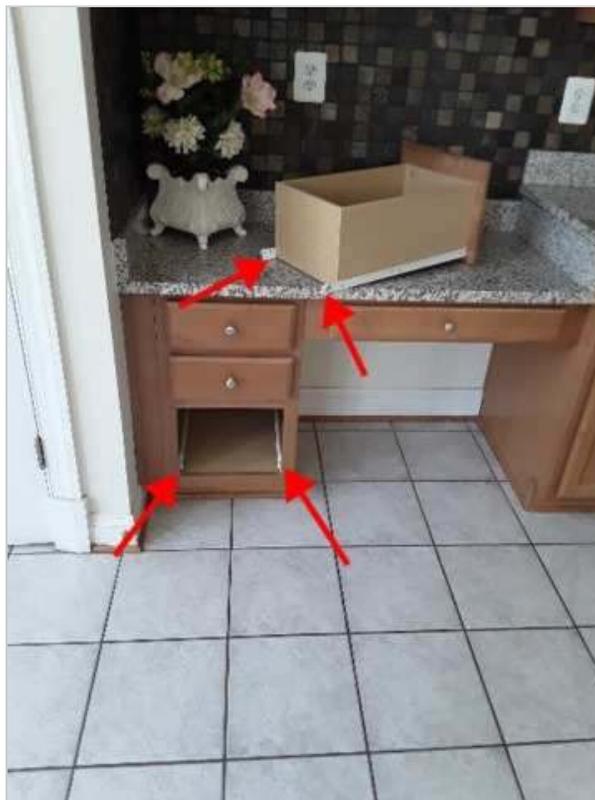
The drawer slides were bent on one of the kitchen drawers.

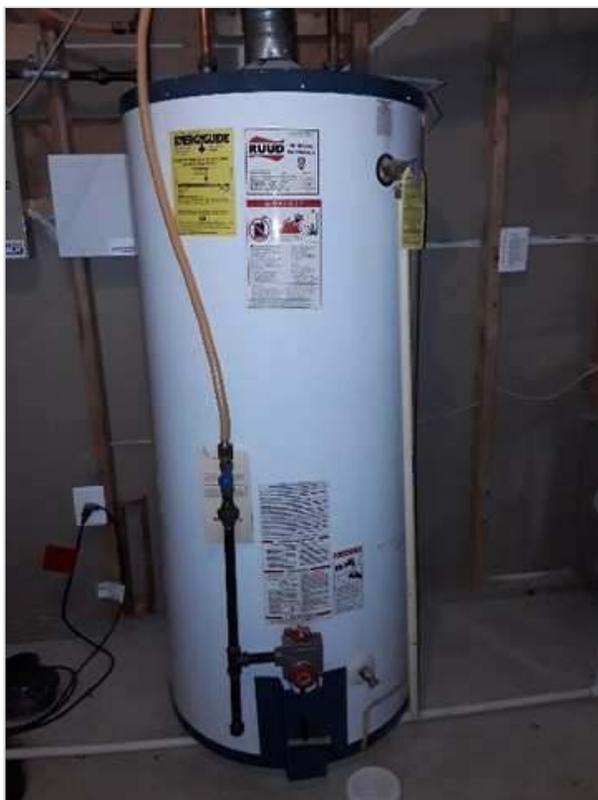
Most tank-type water heaters last 10 to 20 years, with the average age of replacement between 12 and 14 years. The age of the water heater was approximately 14 years old and was most likely at or nearing the end of its useful life.

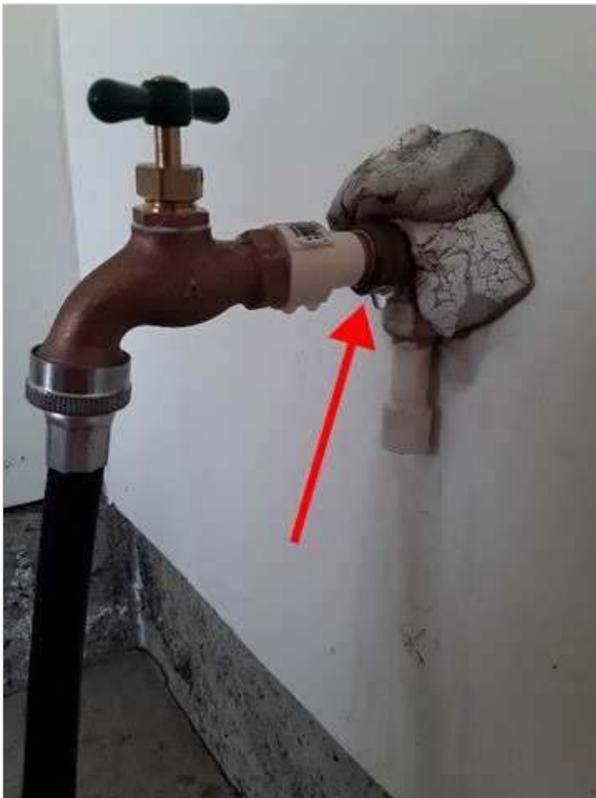
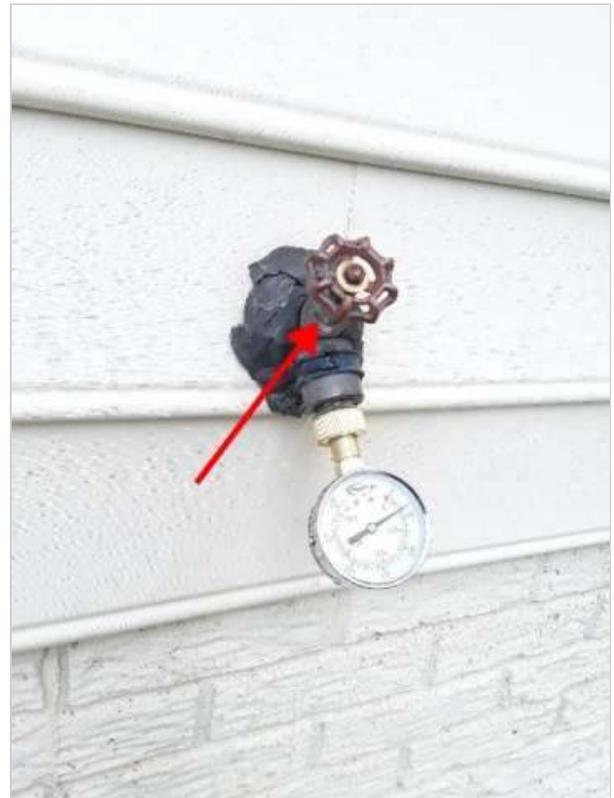
The left hose bib and the hose bib in the garage leaked when tested. Consult with a qualified contractor for repair.

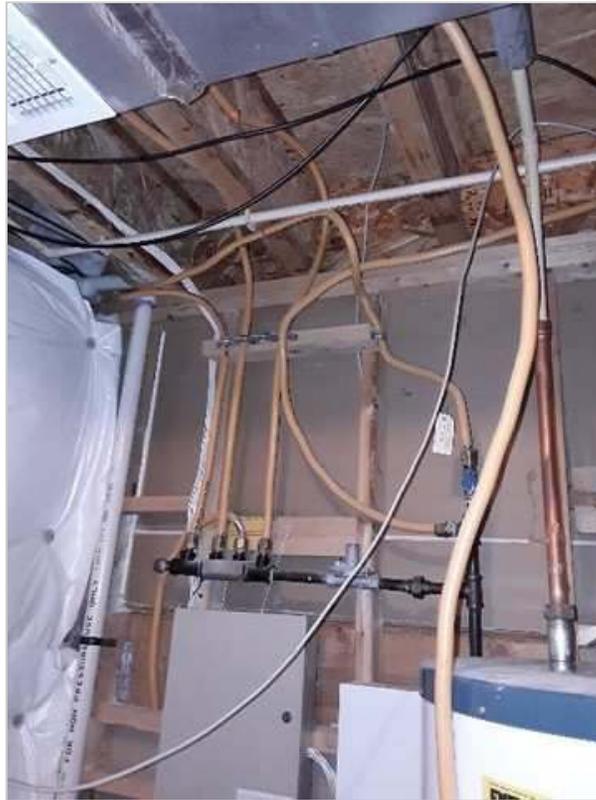
There was no bonding on the CSST gas plumbing found within the home. Manufacturers believe that this product is safer if properly bonded and grounded by the manufacturer's installation instructions. Proper bonding and grounding of the product should be determined by a contractor licensed to perform the work in the Commonwealth of Virginia.

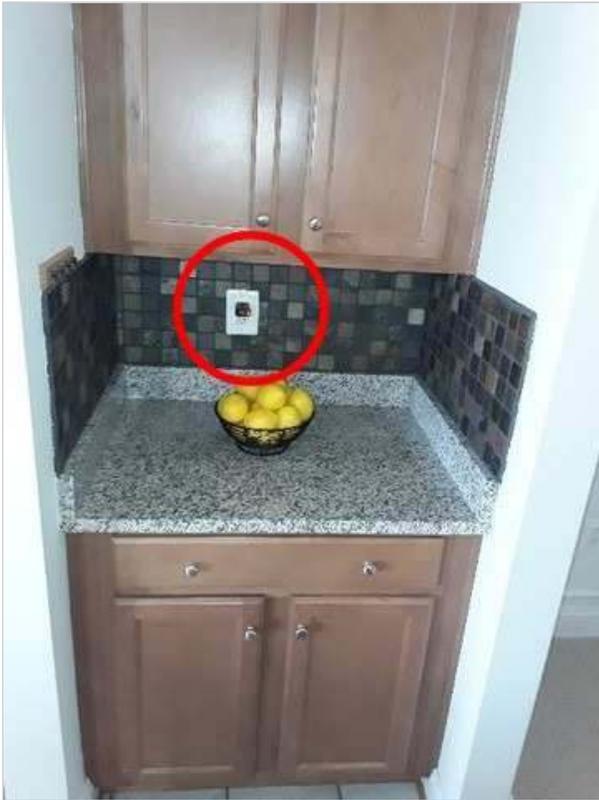
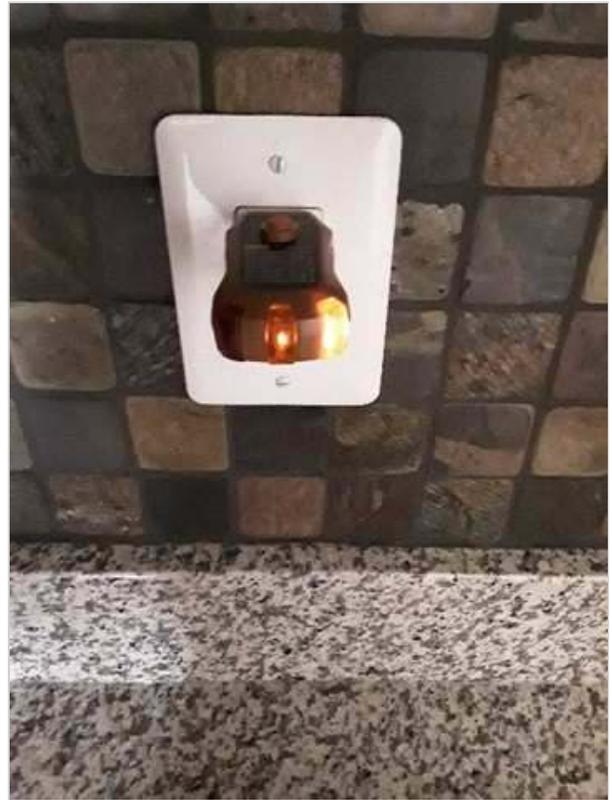
The GFCI outlet located in the kitchen is defective and should be replaced by a qualified electrician.

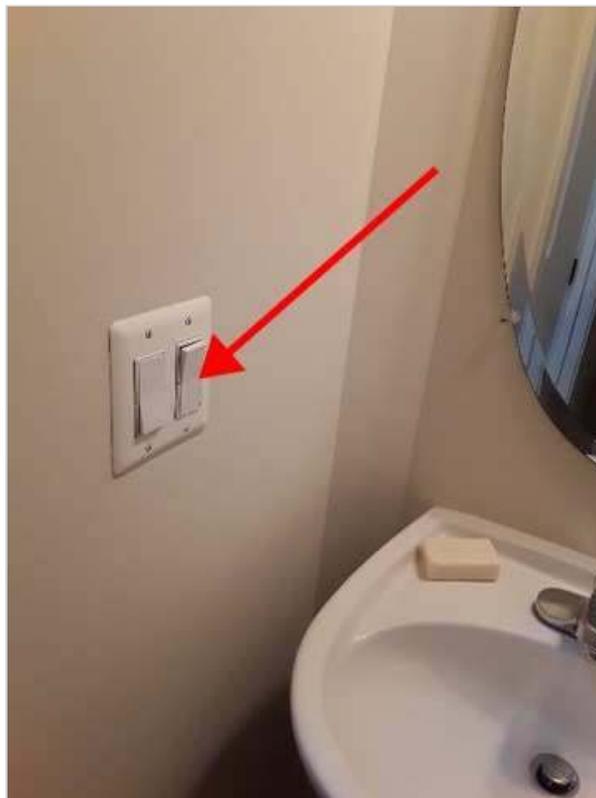
A broken switch was noted in the main level half bath. This could be a shock hazard due to exposed electrical contacts. The affected outlet(s) should be replaced by a qualified contractor.

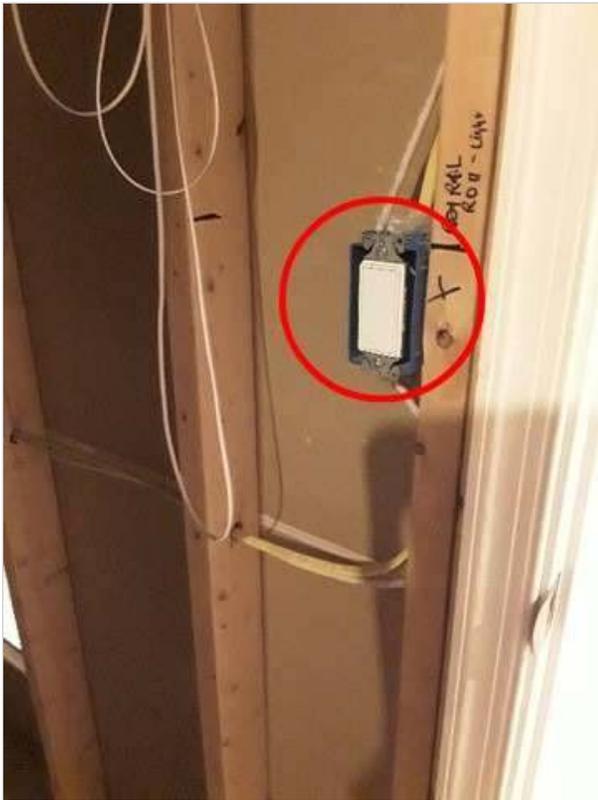
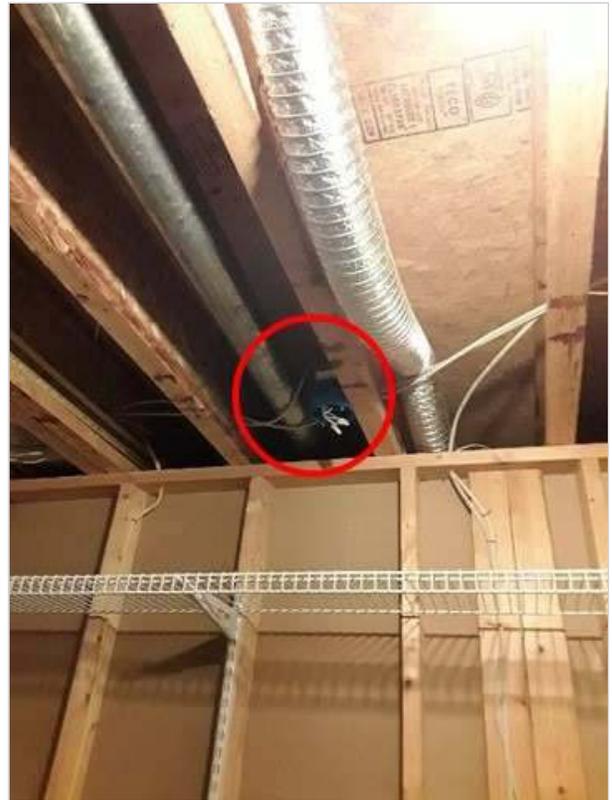
One or more devices were missing a switch/junction box/outlet cover in the mechanical/plumbing room. All switch/outlet boxes should be properly covered to avoid a shock hazard. Electrical related repairs should be performed by a qualified electrician.

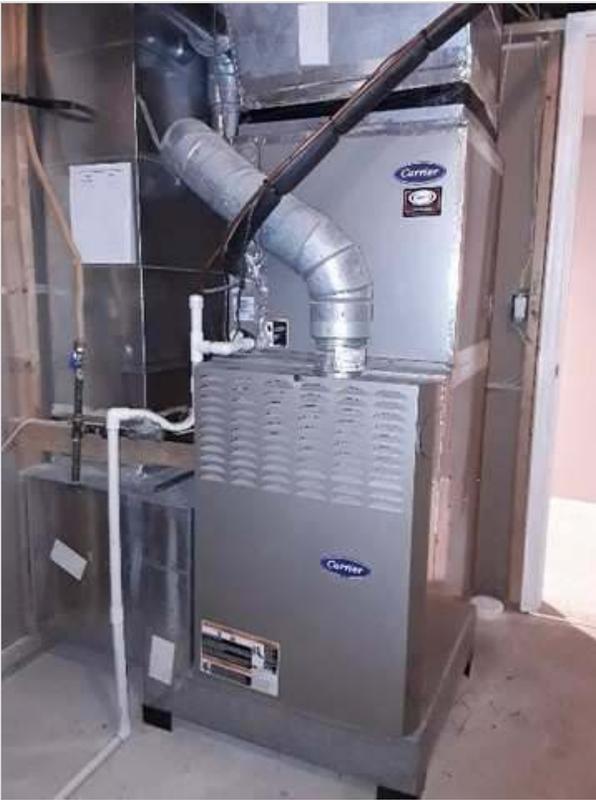
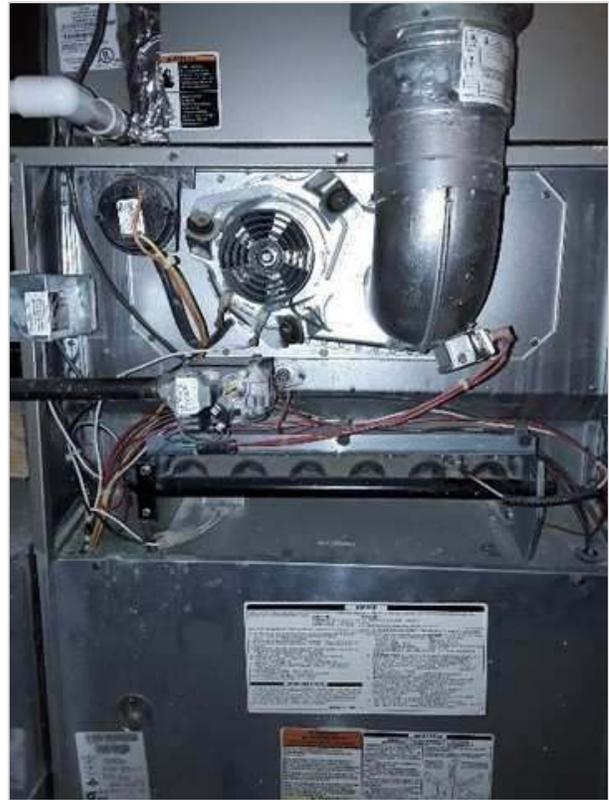
The average gas furnace will last about 15 years before needing to be replaced. A gas furnace will last longer by doing regular maintenance. The subject gas furnace has been in service for approximately 13 years and may be at or nearing the end of its usable life.

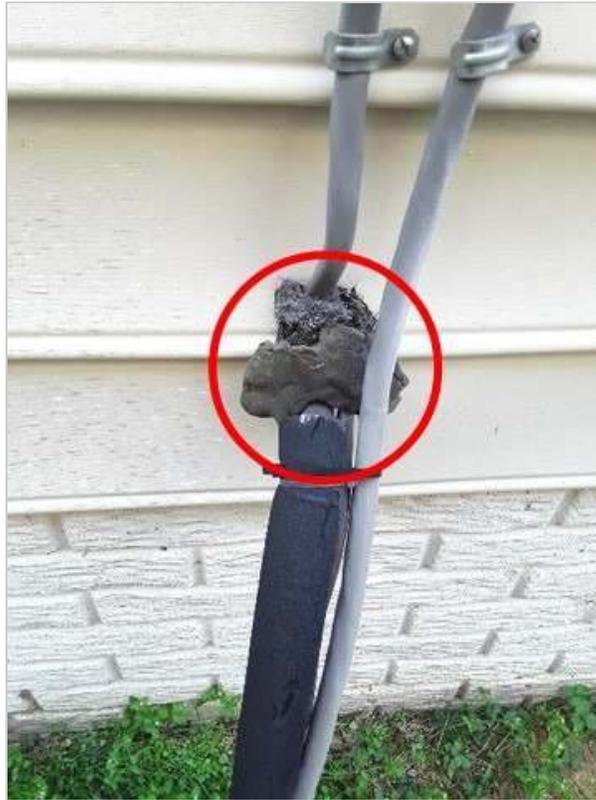
The lineset needs to be resealed where it passes through the exterior wall of the home to prevent water and/or insects from entering the home.

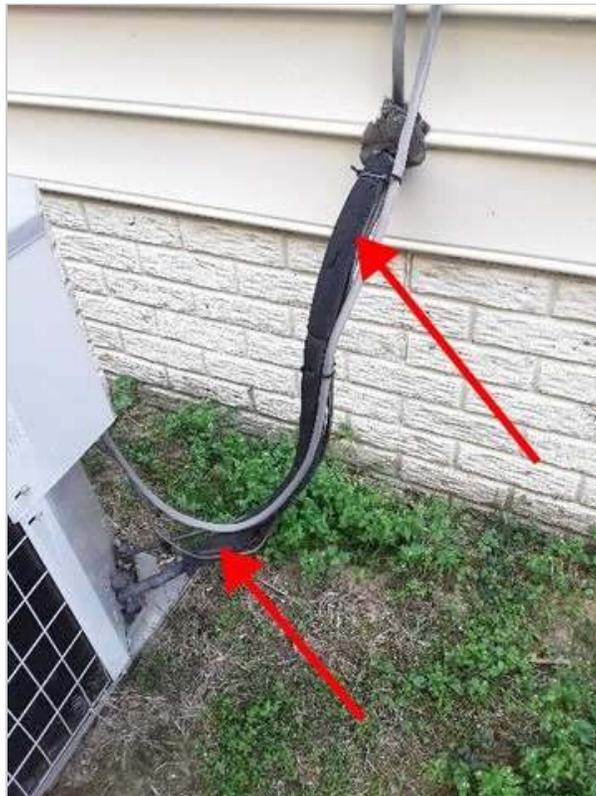
The insulation on the exterior air conditioning line set is dry-rotted. This could affect the efficiency of the system and should be replaced.
