Wednesday, August 26, 2020

On Wednesday, August 26, 2020 The HomeTeam Inspection Service made a visual inspection of 1234 Sample Dr. Any Town, USA 55555. Enclosed please find a written, narrative report of our findings in accordance with the terms of our Inspection Agreement.

HOME INSPECTION REPORT

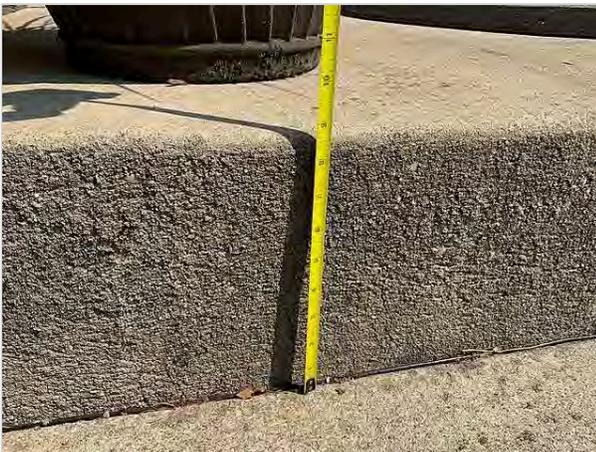
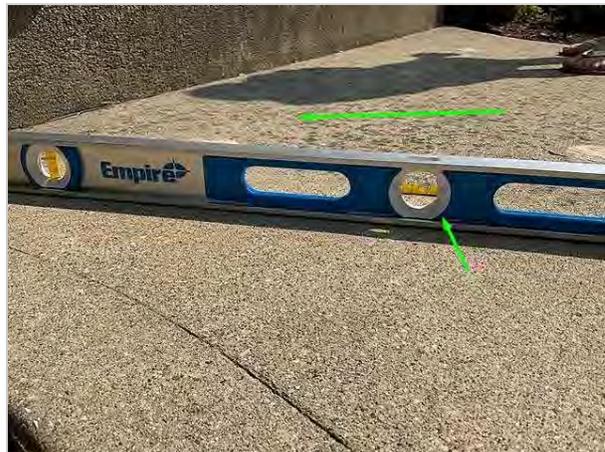
Due to some settlement of the walkway at the front of the home, the vertical distance between the walkway and stoop has become excessive, which may be a tripping hazard and the walking is now pitched toward the foundation of the home. This condition can cause rainfall and runoff to flow towards the foundation creating the potential for basement and foundation water problems. Additionally riser height should be 7 inches and not to exceed 7-3/4 inches to help prevent a tripping hazard. HomeTeam recommends consulting with a qualified contractor for estimates on raising or mud jacking the affected area to help reduce the potential for drainage toward the home and to reduce the risk of falling or tripping.

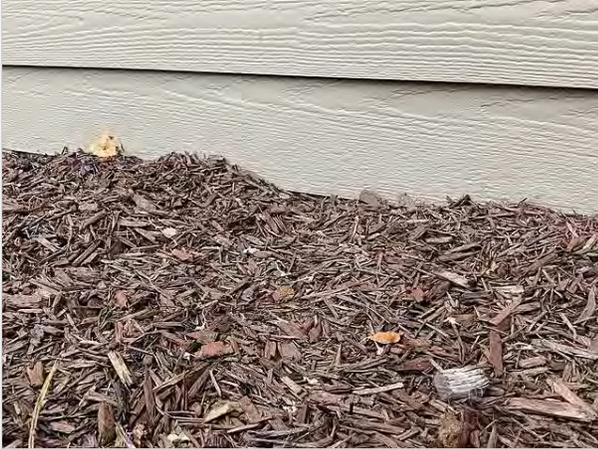
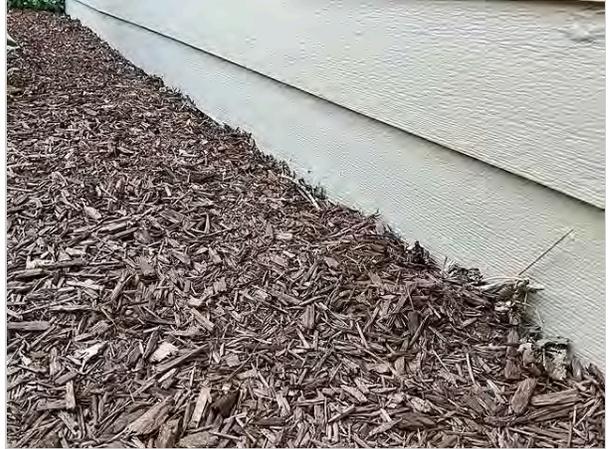
NOTE: Mulch and/or dirt around the home is in direct contact with the siding. This condition can cause water to penetrate behind the siding and into the wood and other absorbent materials in the home, causing wood rot and/or insect intrusion. The mulch and/or dirt should be pulled back or the grade adjusted so that there is no direct contact.

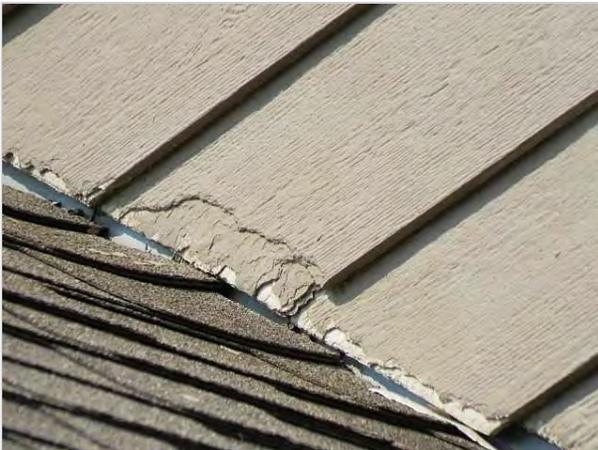
Photo 5

Areas of loose siding were noted on the home's exterior. Additionally other areas appear to have been previously repaired. Although these conditions do not have any effect on the structural integrity of the building, the loose areas should be secured or repaired and the previously repaired areas monitored to help prevent worsening conditions and/or water intrusion.

previously repaired areas

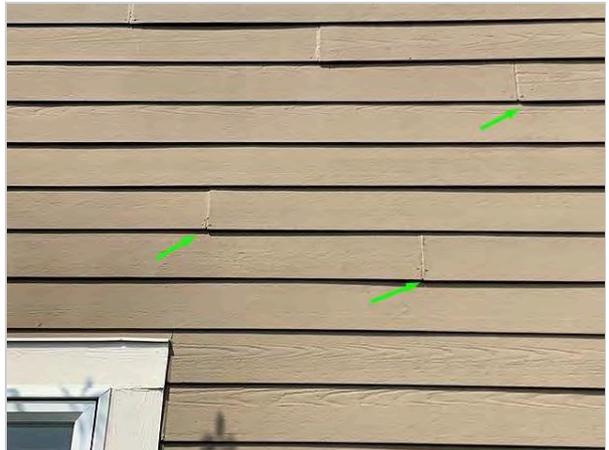
Photo 6

previously repaired areas

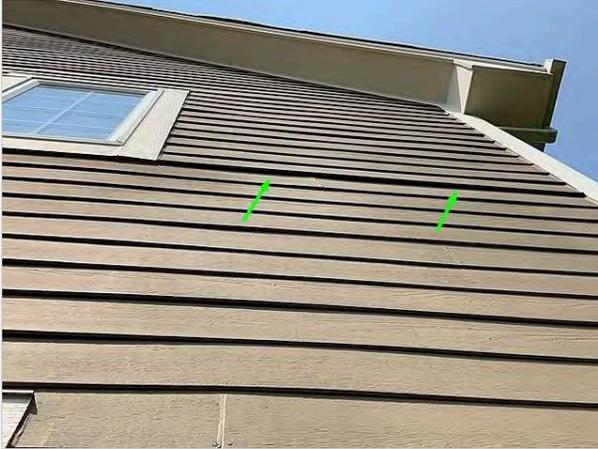
Photo 7

loose board upper right side

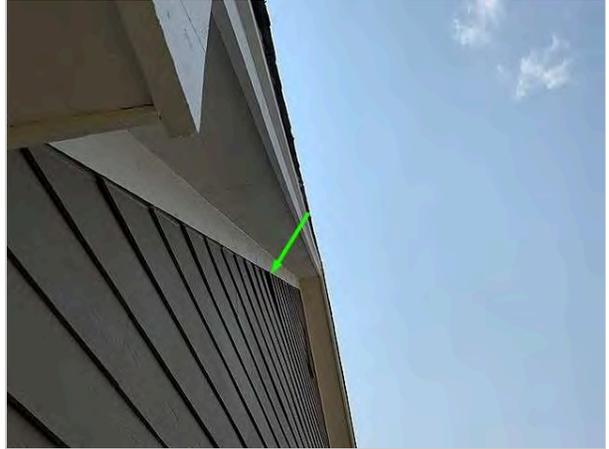
Photo 8

loose board upper left side

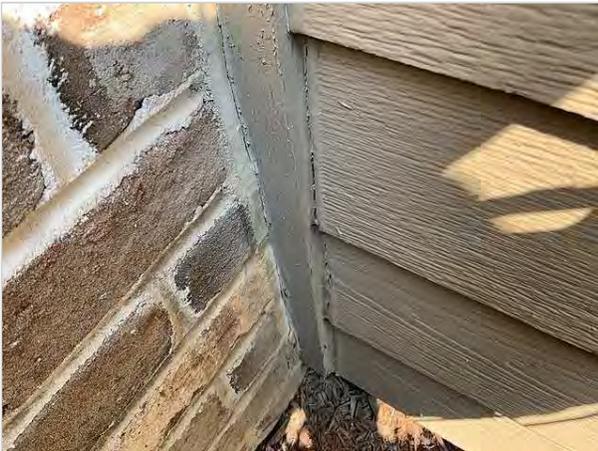
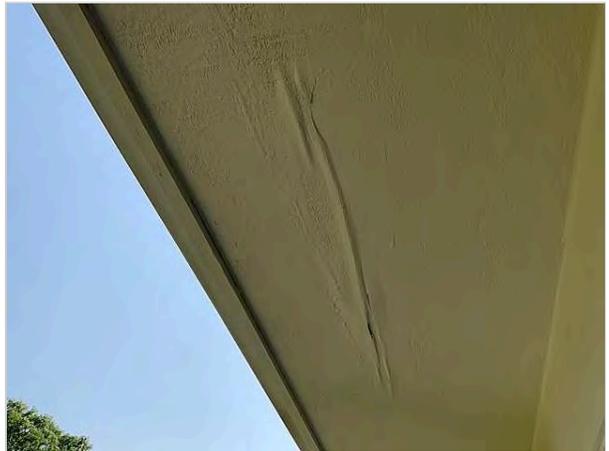
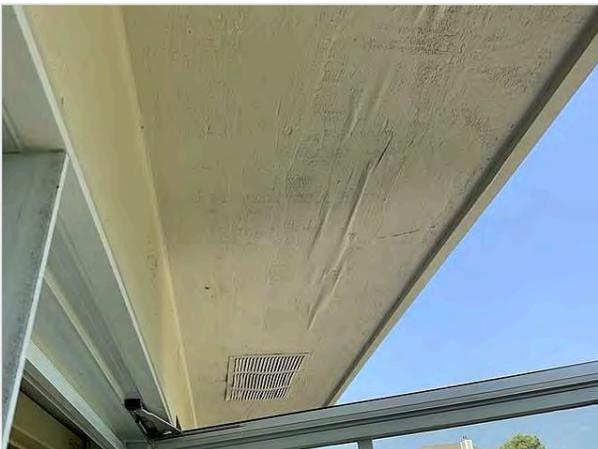
Minor areas of peeling paint and cracked or missing caulking were present on the exterior of the home. In order to preserve the life of the exterior surfaces and materials, all areas should be scraped, sealed, and painted after any damaged wood is repaired and any areas of cracked or missing caulking resealed to help prevent moisture intrusion. These are routine maintenance items.

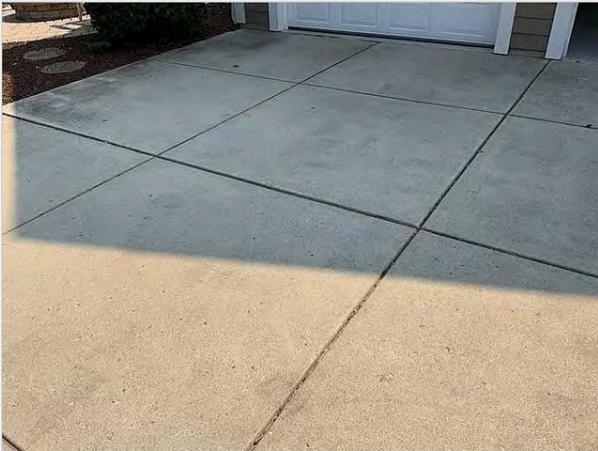
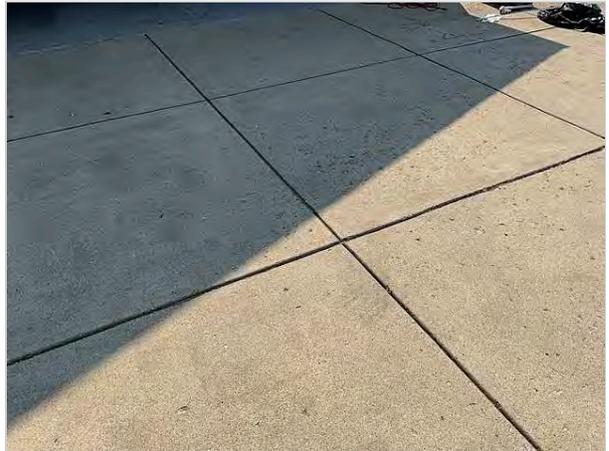
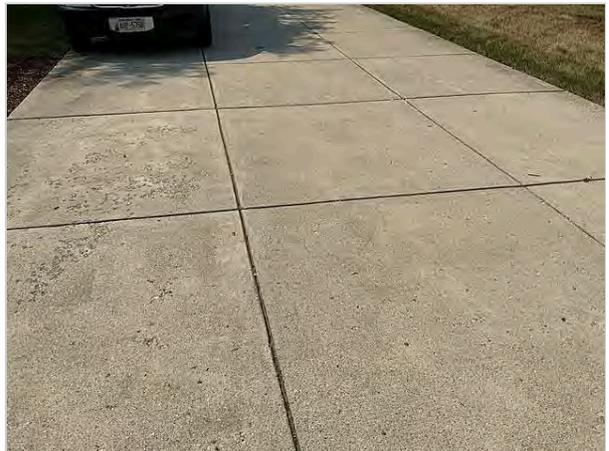
A concrete driveway is present on the left side of the structure. Cracks and spalling were observed on the driveway. Surface defects in driveways develop and progress with age and are considered normal as long as they do not create a safety hazard. Sealing defects may help slow the rate of deterioration.

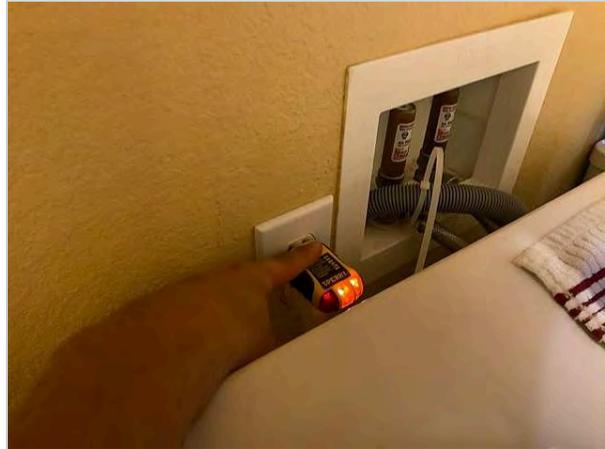
Photo 51

Laundry room lacks GFCI protection

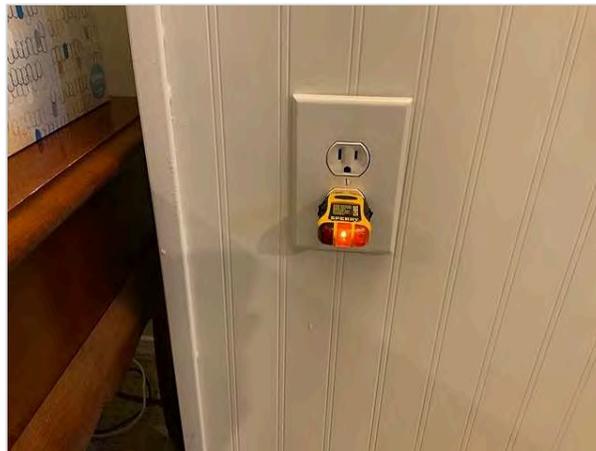
Photo 52

One of the three prong outlets in the finished basement had an open ground. The affected outlet should be grounded or connected to GFCI circuits to improve safety. This condition means that the third prong, also known as the ground prong is not doing its job. This is often caused by a missing or disconnected ground connection at an electrical device in the circuit. Consult with an electrician for the best course of action.

Open ground - furnace closet outlet

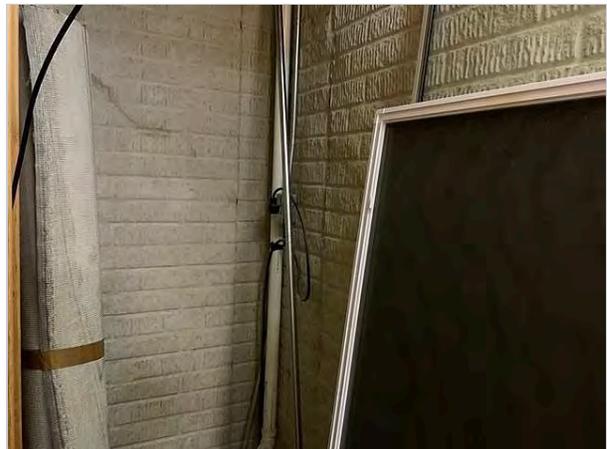
Photo 59

The sump pump appears to be missing a check valve. Check valves prevent the backflow of water back down into the sump crock which can overwork the sump pump and cause early failure. HomeTeam recommends consulting with a qualified plumber to instal a check valve in the discharge pipe.

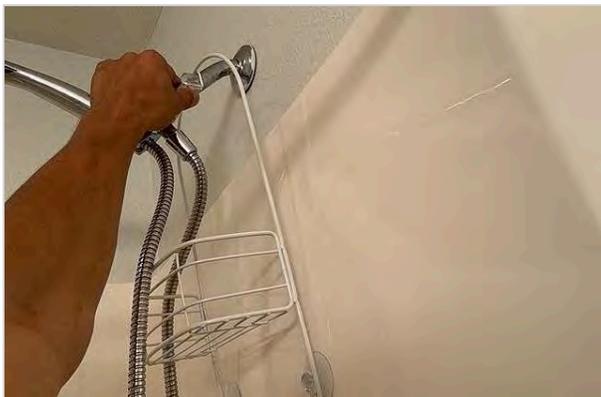
Photo 62

The shower head for the upstairs hallway bathroom is loose where it attaches to the wall. The pipe should be secured and the area sealed in order to prevent water intrusion.

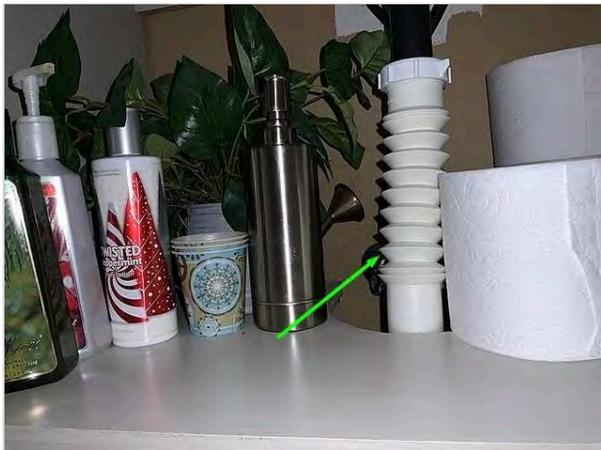
Photo 63

Flexible or accordion style drain lines are in use in the first floor half bathroom. While a home inspection is not a code inspection, plumbing codes require all waste pipe fittings to have smooth interior surfaces to allow for the free flow of water. The use of flexible drain lines in homes is an indication of non standard or amateur plumbing. HomeTeam recommends having the plumbing lines in the structure further assessed and corrected by a qualified plumber.

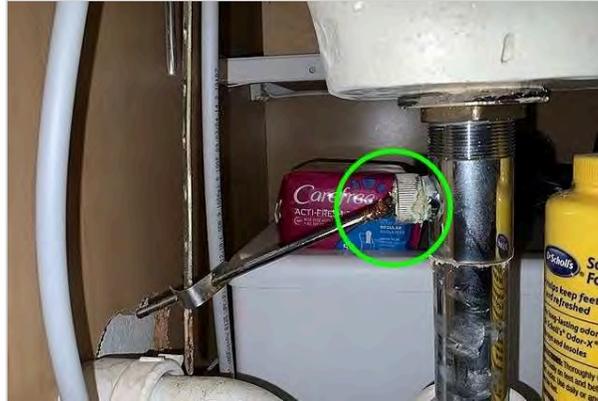
Photo 64

The rod for the sink stopper in the upstairs hallway bathroom is severely corroded. While no active leaks were noted, to help prevent a future leak from occurring, the assembly should be replaced.

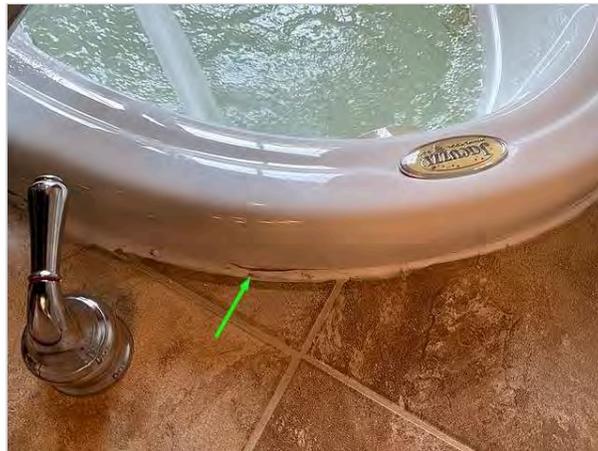
Photo 65

Some of the caulk was missing from around the base of the tub in the master bathroom. These areas should be sealed to prevent moisture penetration. Failure to keep walls sealed can cause deterioration and extensive moisture damage including mold growth to the interior walls, which is not always visible at the time of the inspection.

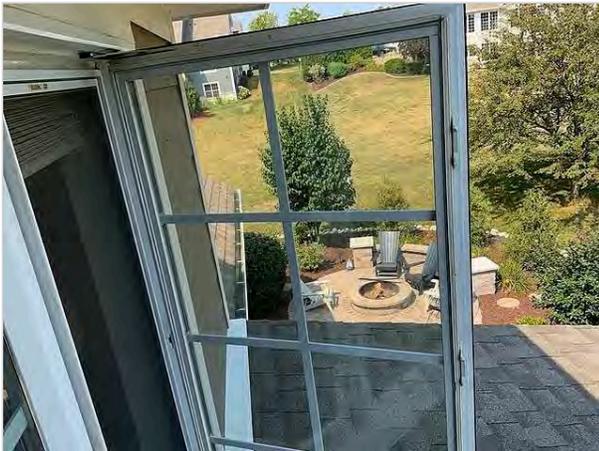
Photo 70

1. **Two of the windows in the structure had a broken thermal seal.** A window with a defective thermal seal will show a slow but gradual "fogging" effect, and the insulation value of the window is marginally reduced. HomeTeam recommends having the affected window(s) repaired or replaced and further assessed.
2. **Damaged hardware was noted on the front right upper bedroom window.** For proper functionality, the hardware should be repaired or replaced.

rear master bedroom window broken thermal seal

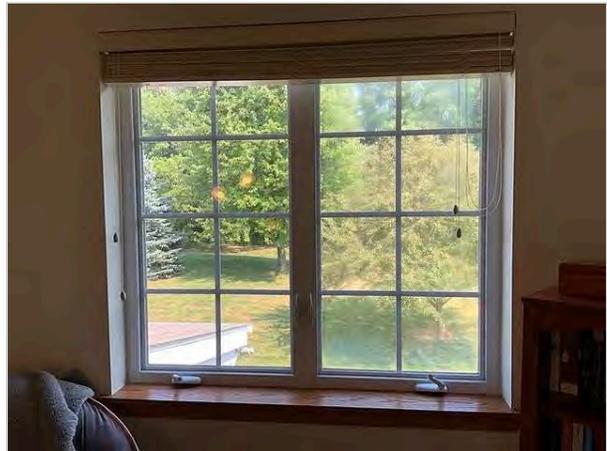
Photo 71

rear center bedroom broken thermal seal

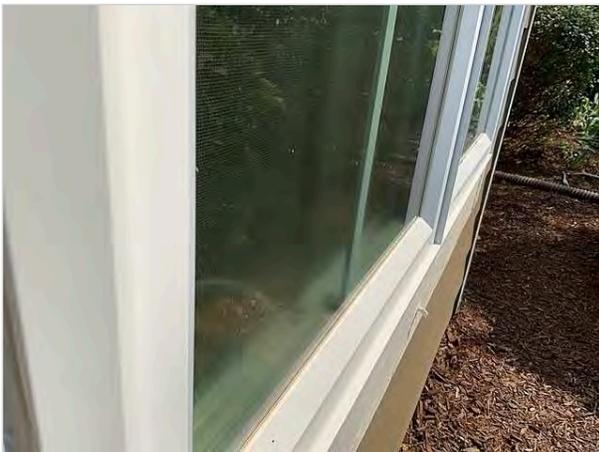
Photo 72

Garage left front broken thermal seal

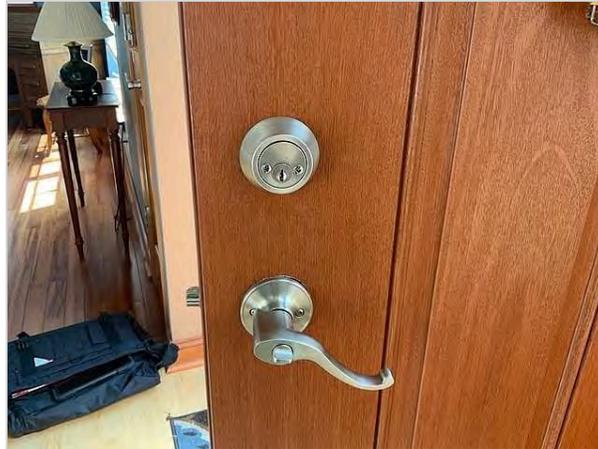
Photo 73

The exterior door on the front of the structure has a deadbolt that requires a key to unlock it from the interior of the home. For safety during emergency egress, all exterior doors should be operable without a key from the interior. The affected lock should be repaired or replaced to allow for manual, keyless operation from the interior.

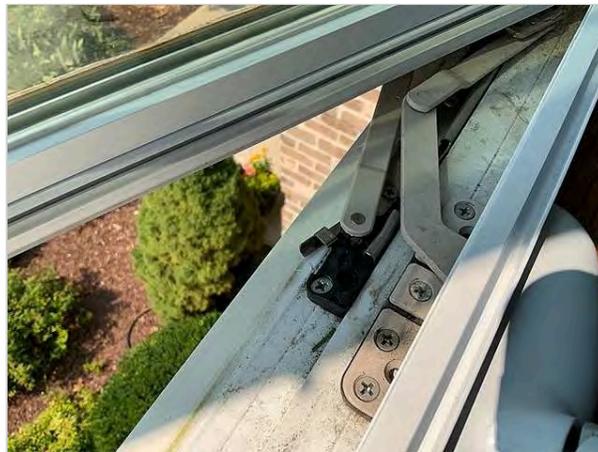
Photo 74

Damaged hardware was noted on the front right upper bedroom window. For proper functionality, the hardware should be repaired or replaced.
