On Thursday, June 15, 2023 The HomeTeam Inspection Service made a visual inspection of 123 Address Street, City, ST 12345. Enclosed please find a written, narrative report of our findings in accordance with the terms of our Inspection Agreement.

HOME INSPECTION REPORT

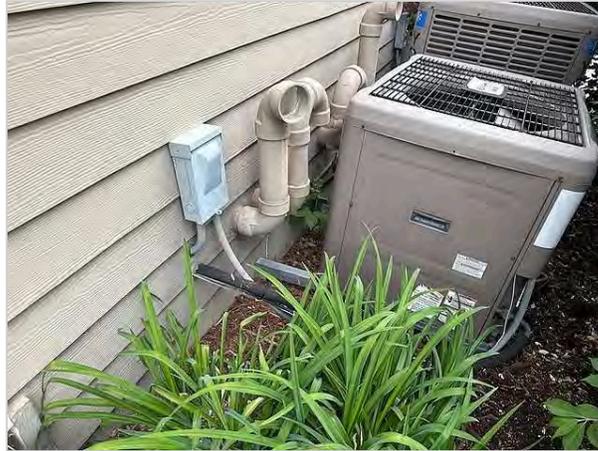
Photo 3

Due to washout or erosion, depressions or pockets were noted near the foundation around the air conditioning units. HomeTeam recommends adding fill soil to the areas to bring the area back up to grade and properly divert runoff away from the structure.

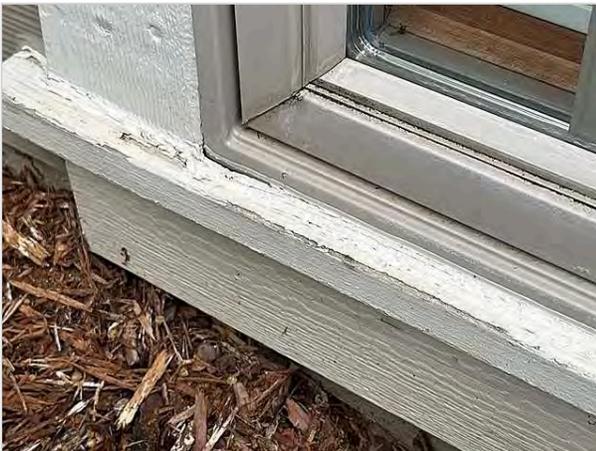
Photo 4

Peeling paint, weathered wood and cracked or missing mortar and caulking were present on the exterior of the structure. In order to preserve the life of the exterior surfaces and materials, and to help prevent moisture intrusion and damage to the interior building materials, all areas should be scraped, sealed, and painted after any damaged wood is repaired, and any areas of cracked or missing mortar or caulking should be repointed or resealed to help prevent moisture intrusion. These are routine maintenance items.

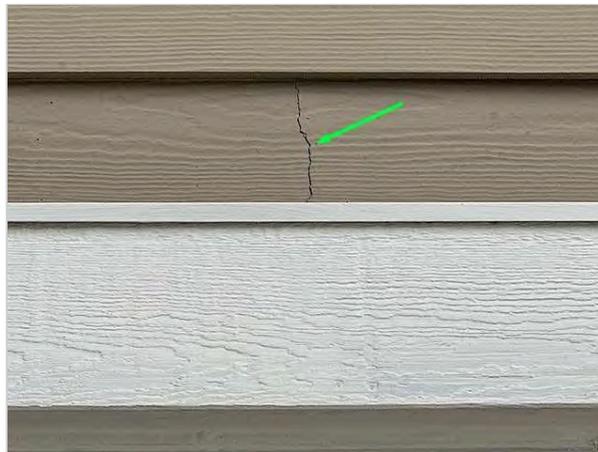
Photo 13

A piece of cracked siding was noted above the overhead garage doors. To help prevent worsening conditions and/or loosening of the board, HomeTeam recommends the crack be sealed or repaired.

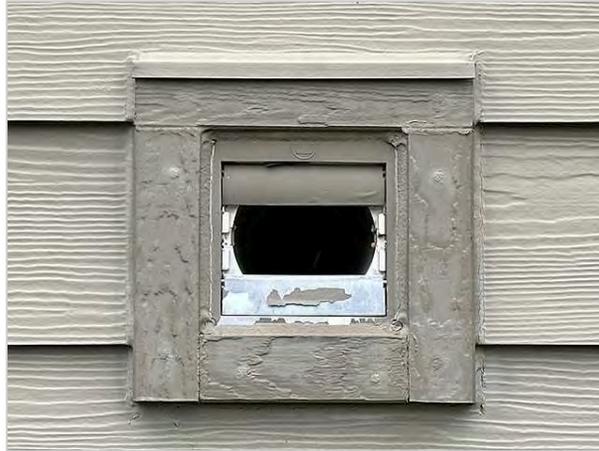
Photo 14

The vent cover at the right rear exterior of the home is damaged. The vent cover should be repaired or replaced to prevent birds or other small animals from entering the home.

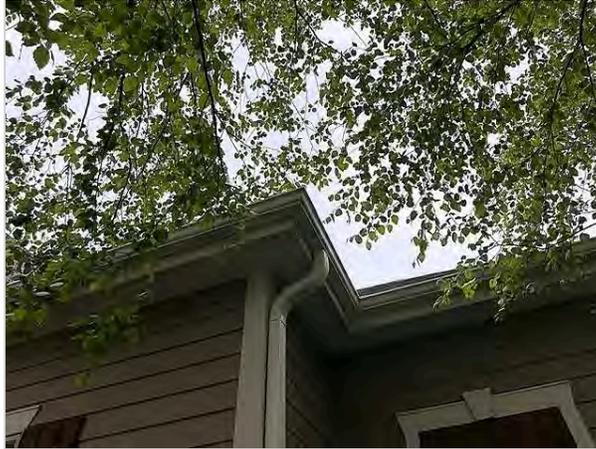
Photo 47

Tree branches were hanging over, or making contact with the roof and gutter on the front of the home. The trees should be trimmed or cut back away from the roof to avoid damage to the roofing material and unnecessary clogging of the gutters.

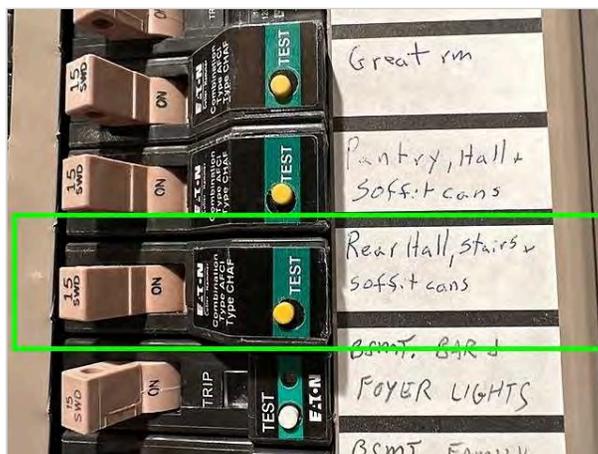
Photo 76

A breaker in the electrical panel in the basement has a tendency to trip. This condition is usually the result of too heavy a load on the circuit, or in some instances a cross connection on something running on the circuit. Although the condition happened on inspection, this appears to be an intermittent problem that was unable to be reproduced at the time of inspection. HomeTeam recommends consulting with a qualified electrical contractor to further assess and repair the circuit, load and fixtures as necessary.

Breaker trips for unknown reason

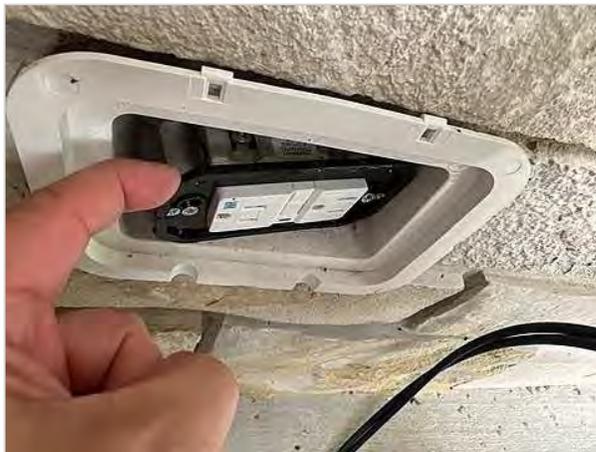
Photo 82

The front entry exterior outlet was not properly covered and was loose in the box. Uncovered exterior boxes can allow for rainwater to enter the circuit, and loose outlets could lead to a potential shocking hazard. HomeTeam recommends the outlet be secured and an outlet cover designed for use in wet locations be installed on the outlet.

Loose outlet front exterior

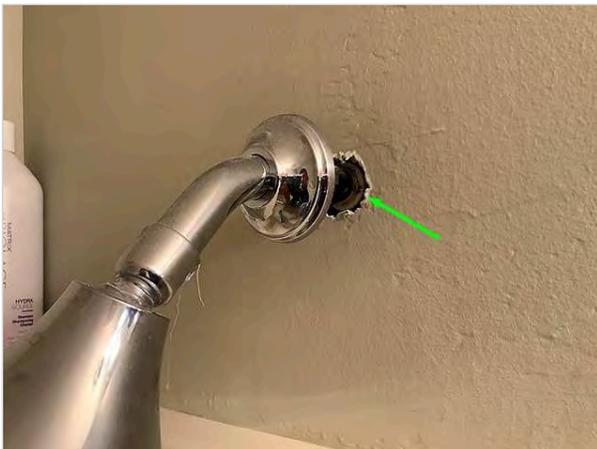
Photo 105

Missing caulking Jack and Jill bathroom

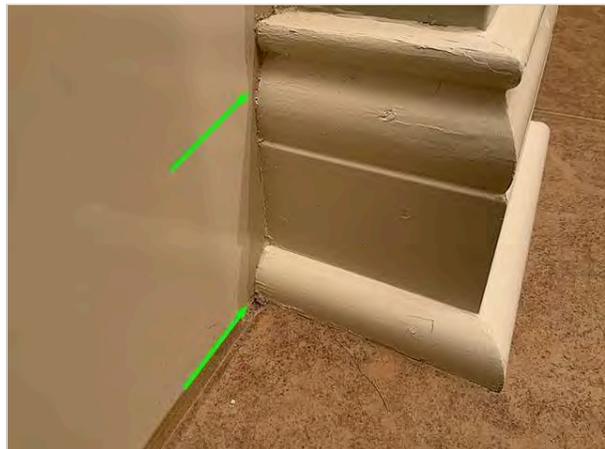
Photo 106

Deteriorated caulking Jack and Jill bathroom

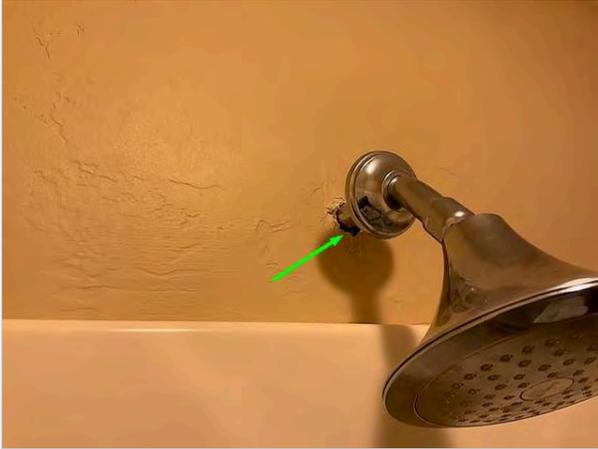
Photo 107

Missing caulking upstairs guest suite

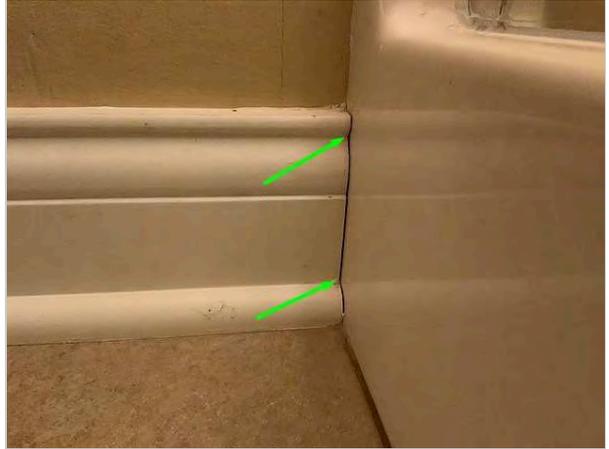
Photo 108

Missing caulking upstairs guest suite

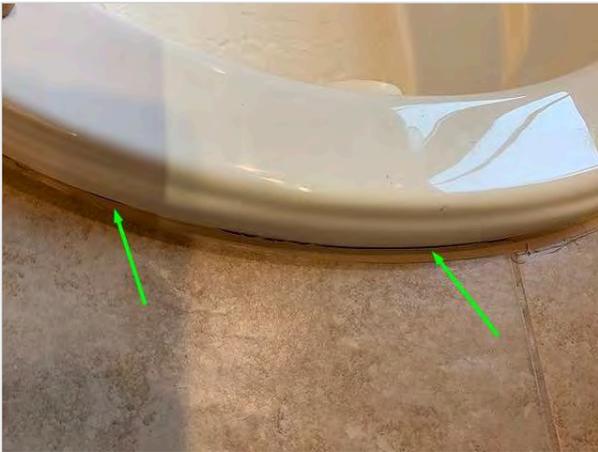
Photo 109

Missing caulking master bathroom

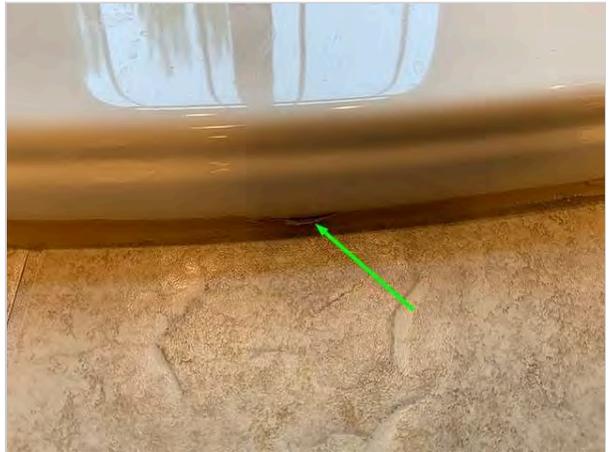
Photo 110

Missing caulking master bathroom

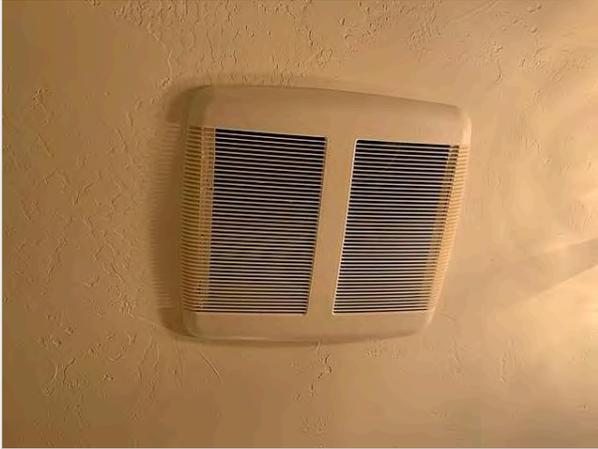
Photo 111

The hallway bathroom exhaust fan did not function properly at the time of inspection. The unit made a louder than normal noise during operation. To help prevent worsening conditions and for proper functionality, HomeTeam recommends consulting with a qualified contractor for options on repair or replacement of the fan.

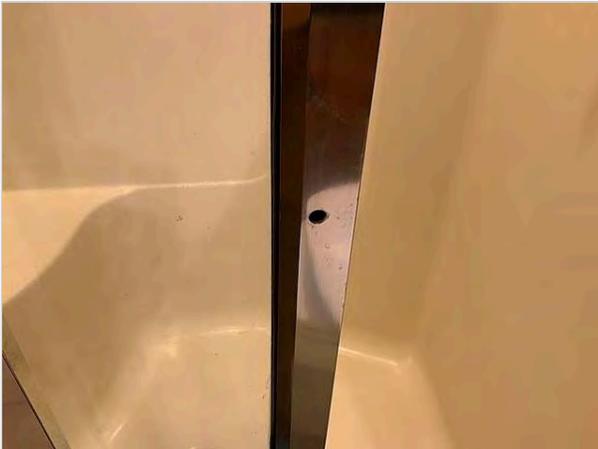
Photo 113

One of the shower door handles in the upstairs guest suite bathroom was missing. To restore functionality, HomeTeam recommends consulting with a qualified contractor for the replacement of the hardware.

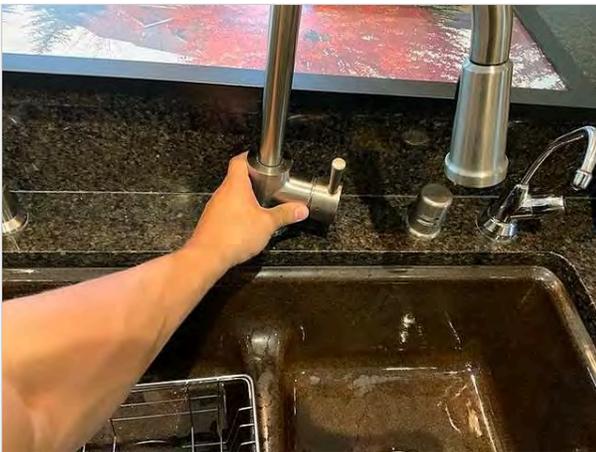
Photo 116

Kitchen faucet was not properly secured

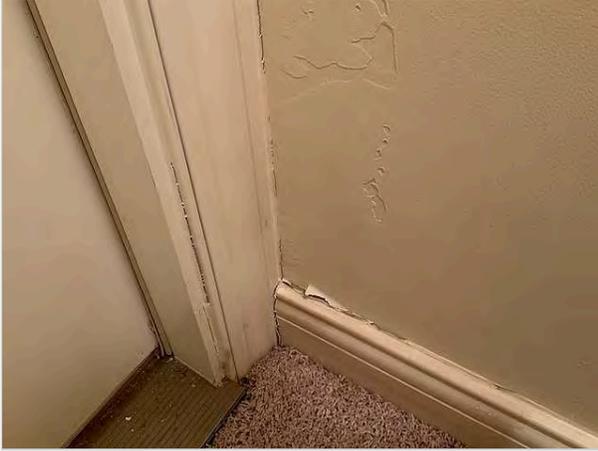
Photo 122

Cracked caulking peeling paint

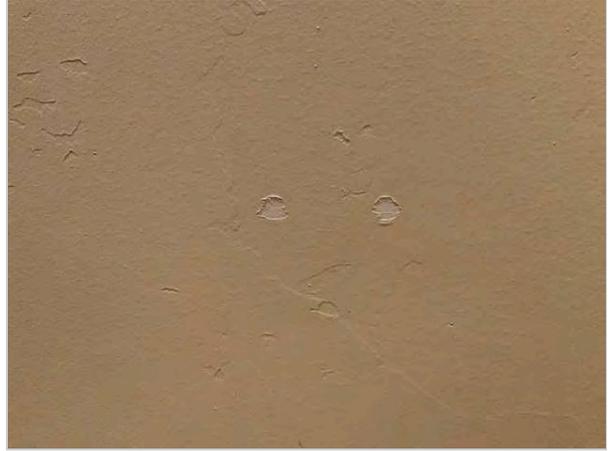
Photo 123

Scuffed paint/drywall

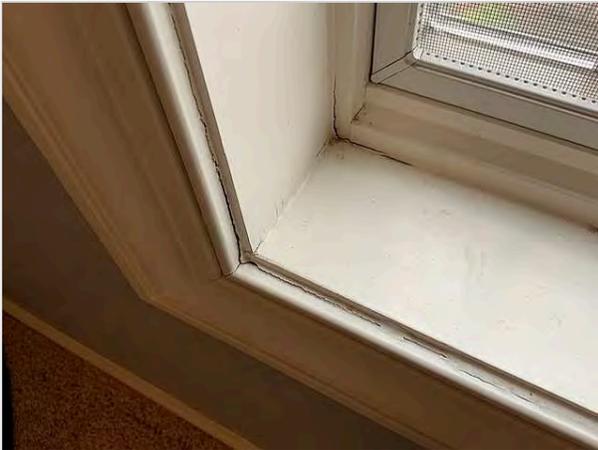
Photo 124

Cracked paint/caulking

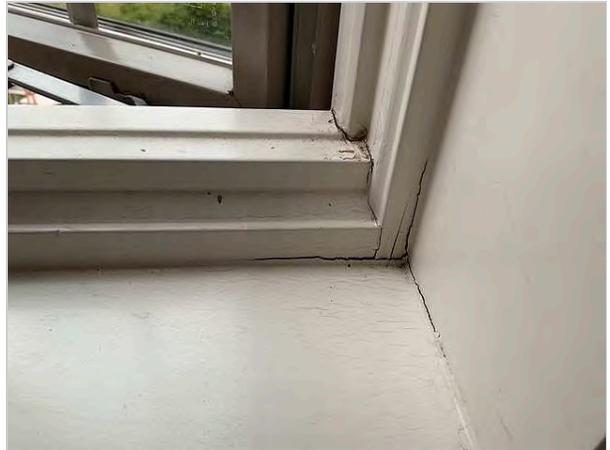
Photo 125

Cracked paint/caulking

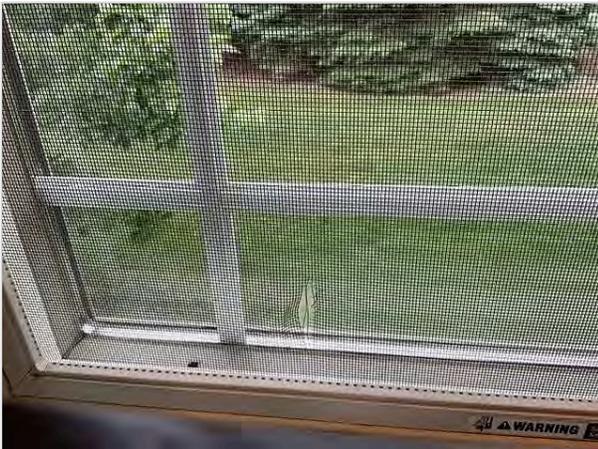
Photo 126

Several damaged or torn screens

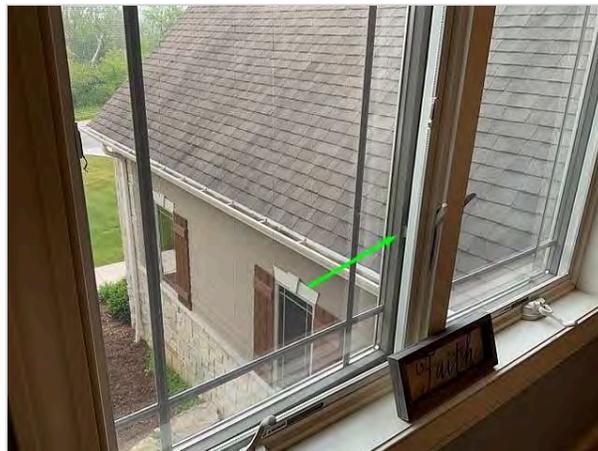
Photo 127

Upstairs front right bedroom window did not close by itself

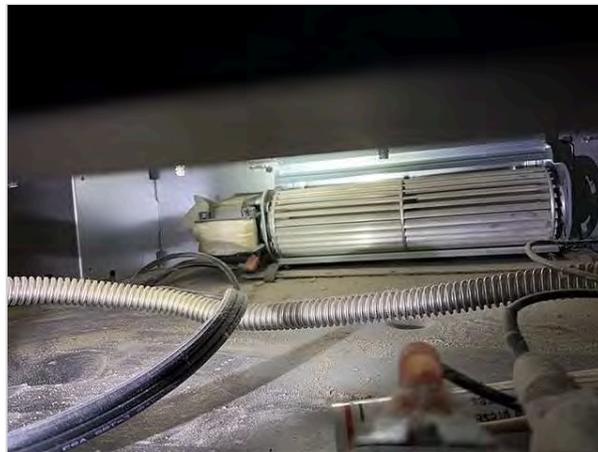
Photo 135

The blower motor on the living room fireplace did not function properly at the time of inspection. For proper functionality, HomeTeam recommends consulting with a qualified contractor for repair or replacement of the unit.

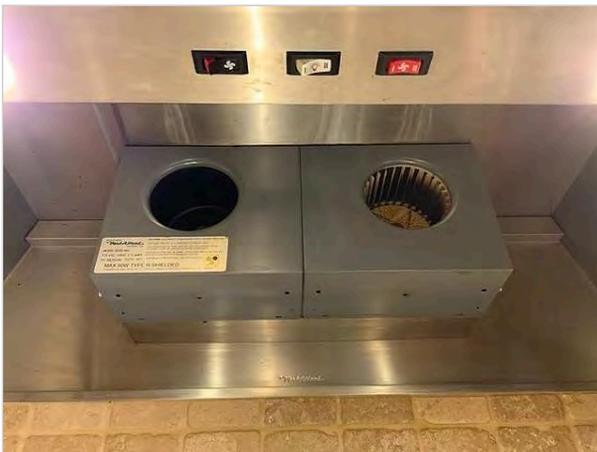
Photo 137

One of the fans for the range hood was nonfunctional at the time of inspection. For proper functionality, HomeTeam recommends consulting with a qualified contractor for further evaluation and repair.

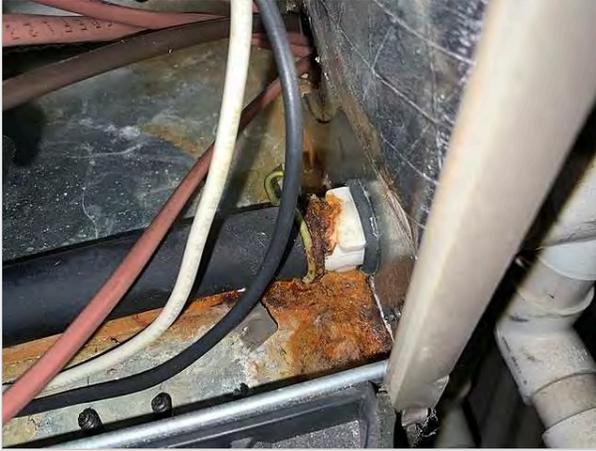
Photo 143

Evidence of prior water was present inside the furnace compartment. This condition may have been caused by a

prior leak in a condensate line or drain line which can damage the furnace cabinet or other operational components. HomeTeam recommends closely monitoring the area for any reoccurrence and consult with a qualified HVAC technician for repair as necessary.

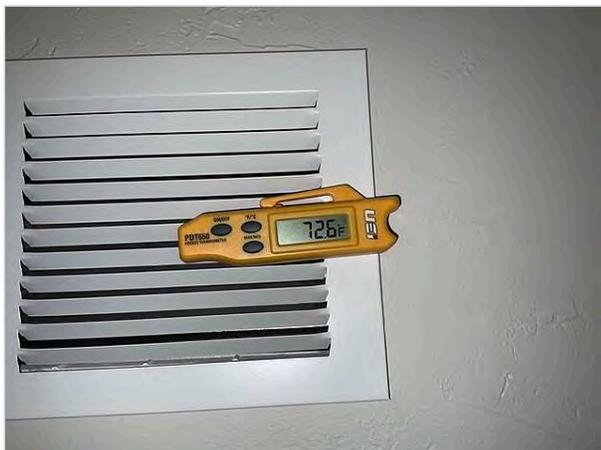
Photo 153

The temperature differential for the air conditioning units was approximately 9 to 14 degrees which is inadequate. Typically an air conditioning unit should have a temperature differential of approximately 16-22 degrees. To help improve the efficiency and performance, HomeTeam recommends consulting with a qualified HVAC technician for further evaluation and options on repair, recharge, or replacement.
