HOME INSPECTION REPORT

File Number: **6549**

Address of Inspection: **123 Sample Drive**

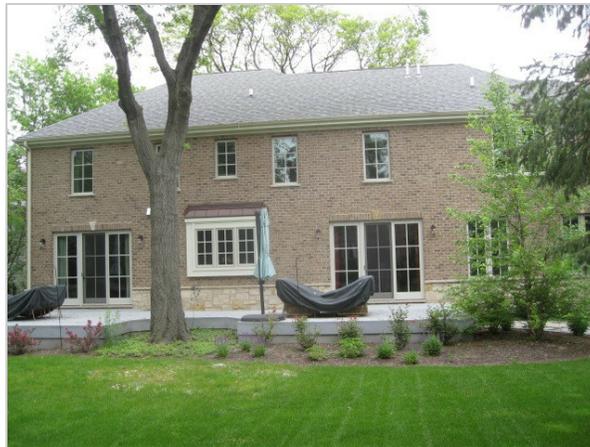
- ***We recommend monitoring the area in back by the house, between the sections of deck, to ensure water does not pool in this area.***

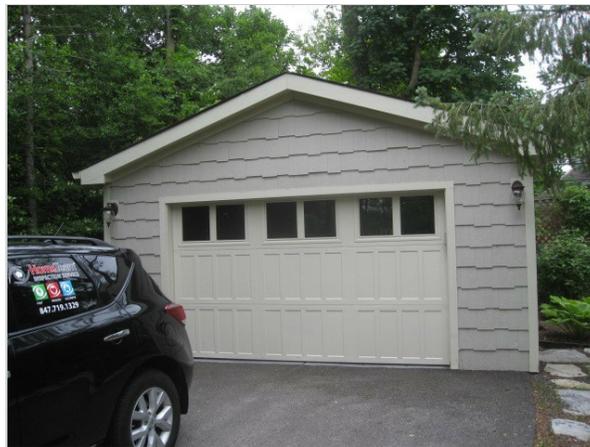
- *There was a car and storage in the detached garage that obscured some areas from visual inspection.*

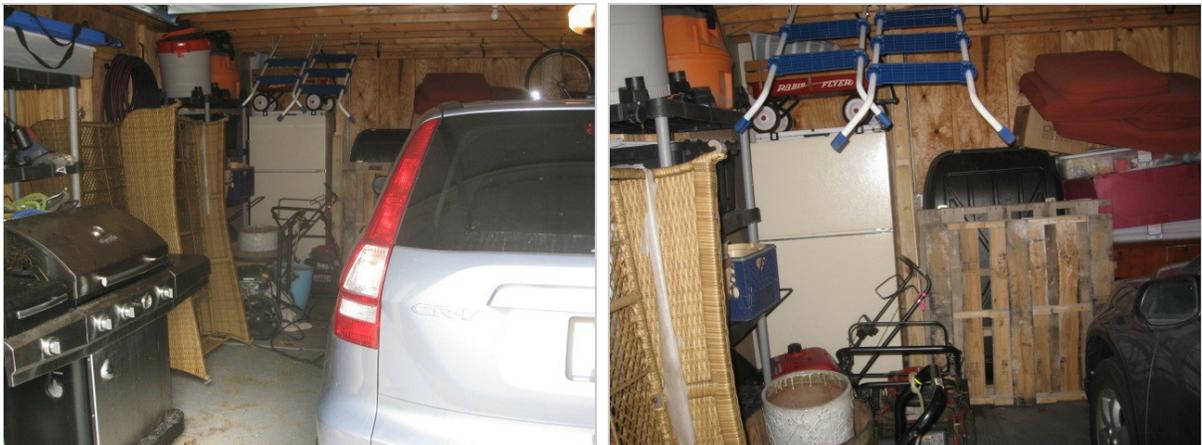
- *There was a car and storage in the attached garage that obscured some areas from visual inspection.*

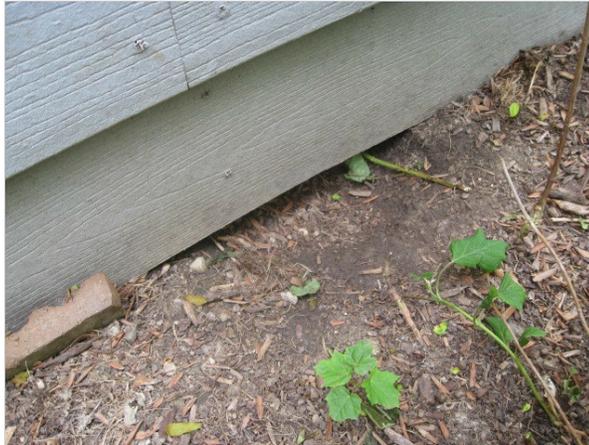
- ***There were signs of animal activity under the deck that should be corrected.***

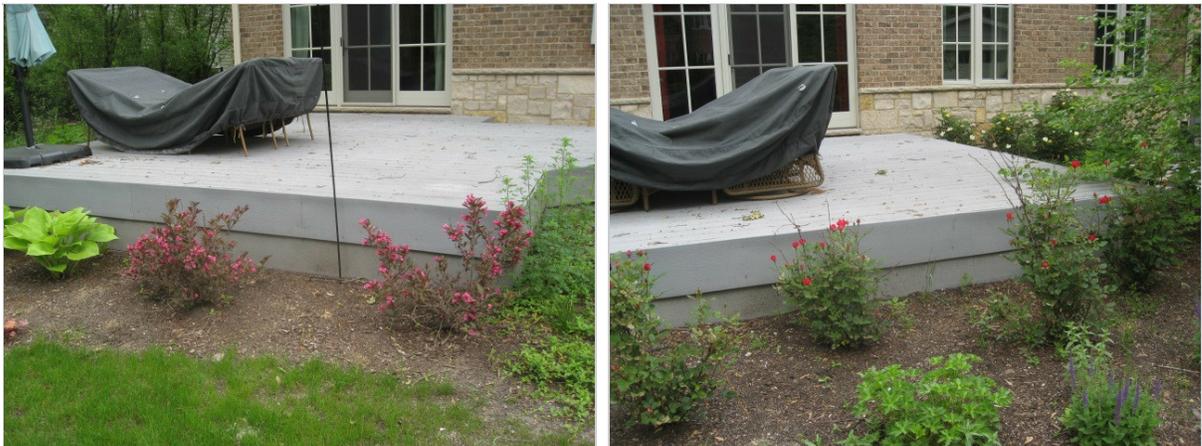
- ***There was no railing for the deck and we recommend that one be installed.***

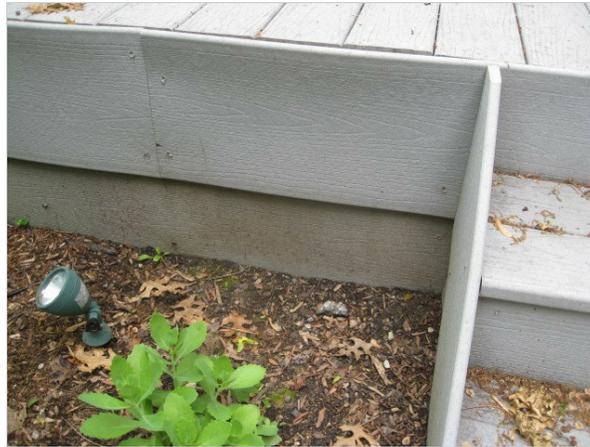
- ***We were unable to view the support structure under the deck due to the wood deck skirt around the outside perimeter of the deck.***

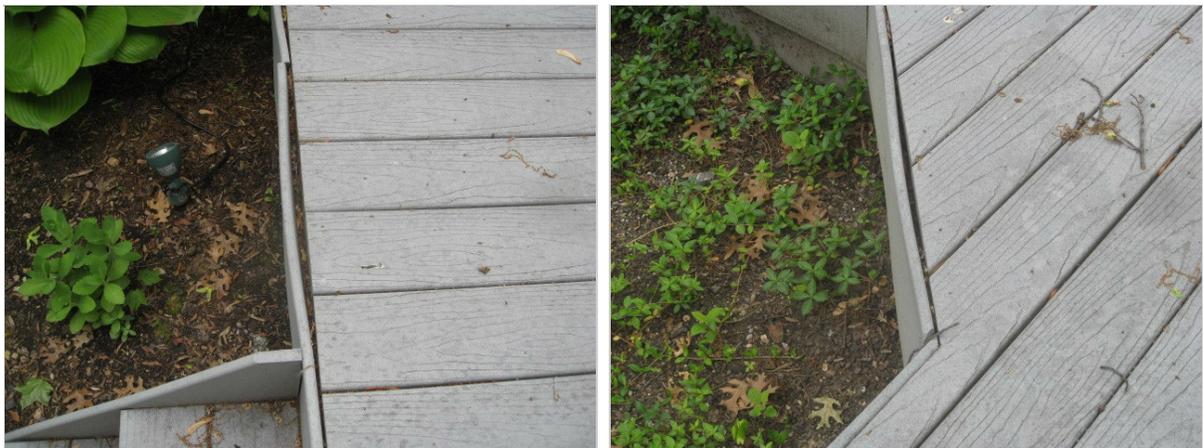
- ***There was movement and gaps along the outside trim boards for the deck that should be monitored for action.***

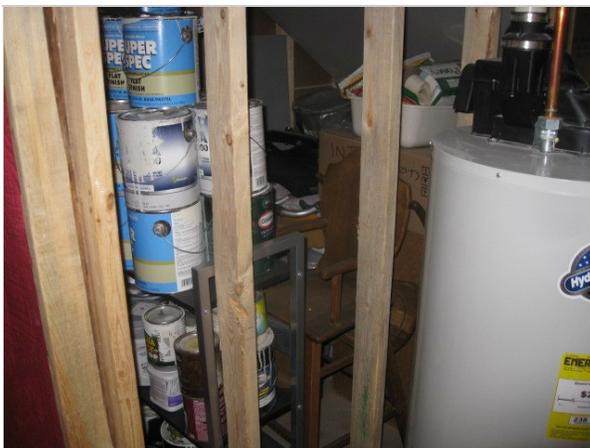
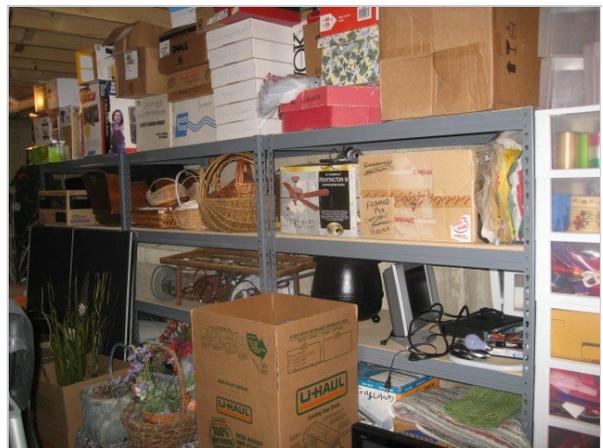
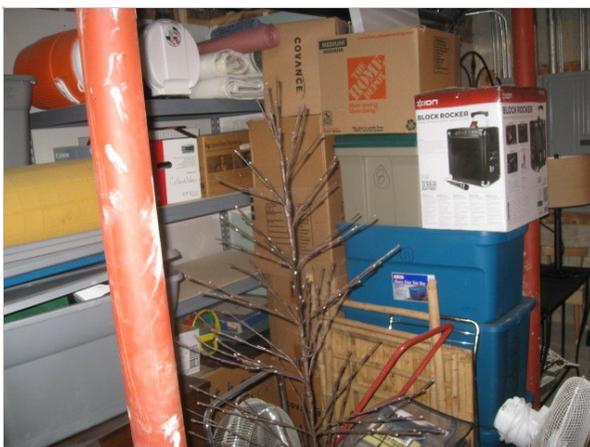
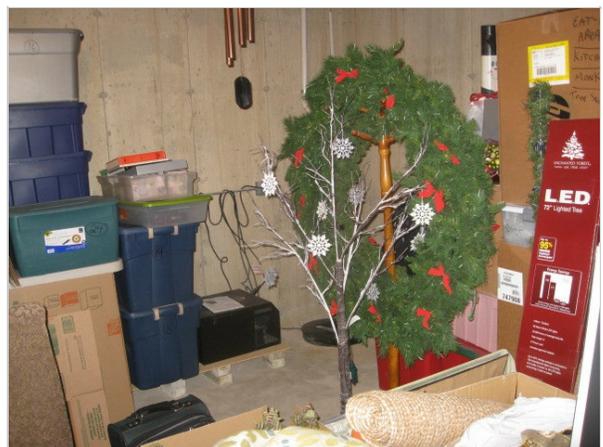
- ***There was storage throughout the utility room in the basement that obscured some areas from visual inspection.***

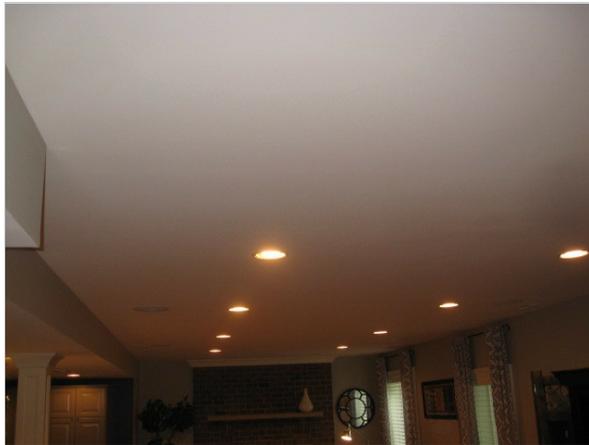
- ***Most of the basement ceiling was finished, which restricts a clear view of the floor joists. As a result, we were not able to see the entire floor structure during the inspection.***

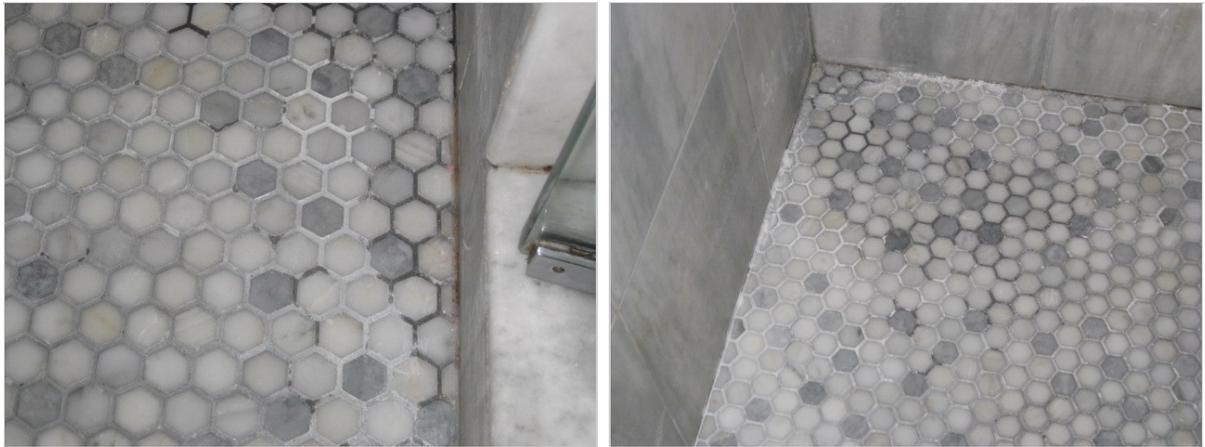
- ***There was quite a bit of mildew on the master bathroom shower floor that should be cleaned and corrected.***

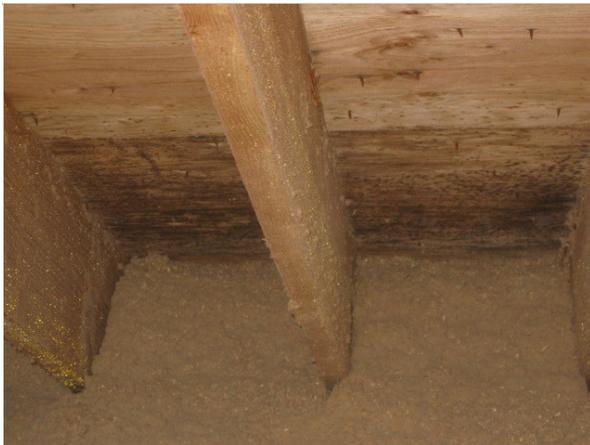
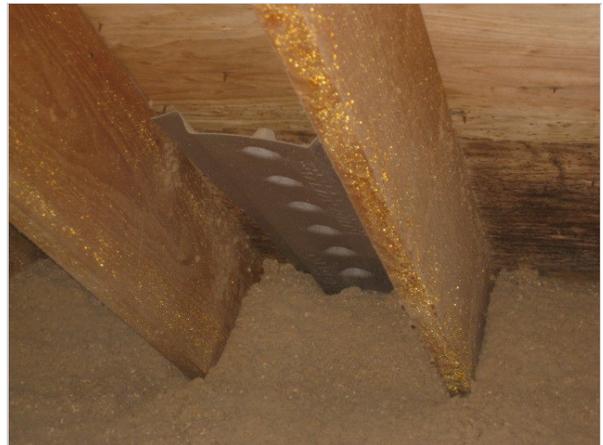
- ***There was darkened sheathing, with possible light mold growth, in the right front section of the attic that should be further evaluated and treated as necessary.***

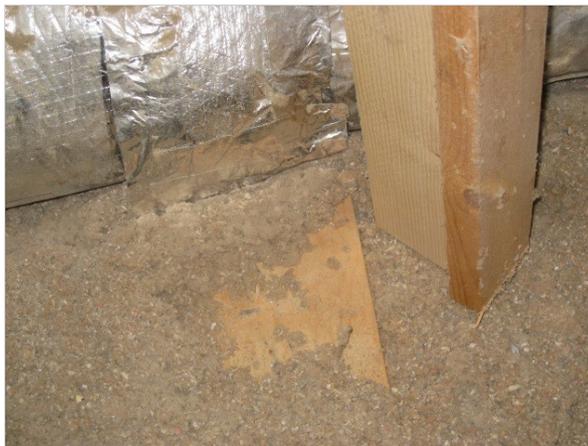
- ***One of the support columns on the far left side of the attic space was completely loose and needs to be secured.***
