### HOME INSPECTION REPORT

The HomeTeam Inspection Service made a visual inspection of 123 Main Street, Anytown, USA 55555. Enclosed please find a written, narrative report of our findings in accordance with the terms of our Inspection Agreement.

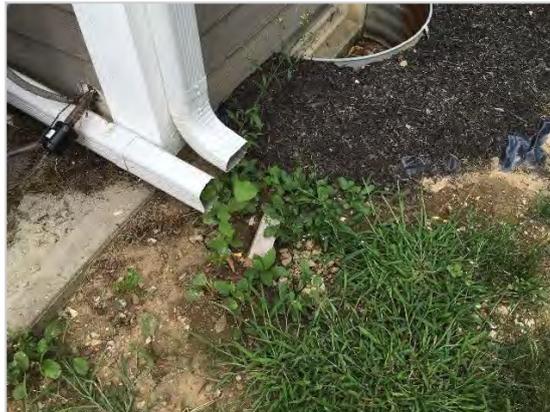
Photo 4

**A downspout was draining at or too close to the base of the foundation.** To reduce the likelihood of water problems at the base of the structure, all roof drainage should be directed at least six feet from the base of the foundation.

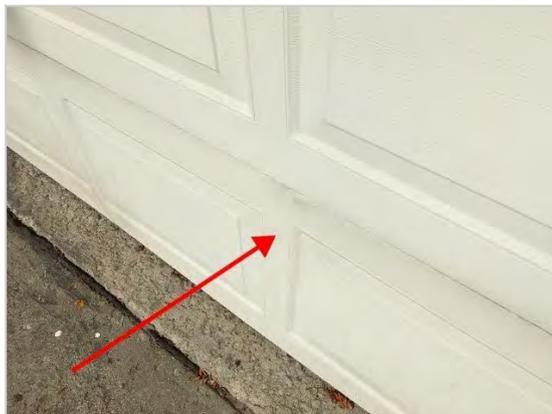
Photo 6

**The widest of the three garage door is dented from what appears to be impact.** The door was operating correctly at the time of the inspection. Care should be exercised to ensure that the door is not subjected to further impact, as the door may crack or fail.

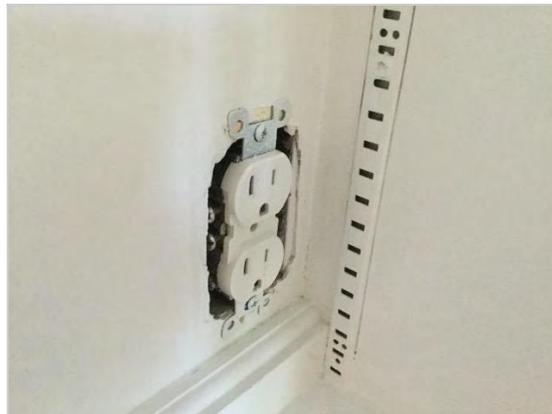
Photo 10

**Missing switch or outlet covers were observed in the living area.** All switch and outlet boxes should be properly covered to avoid a shock hazard. Electrical repairs should be performed by a qualified electrician.

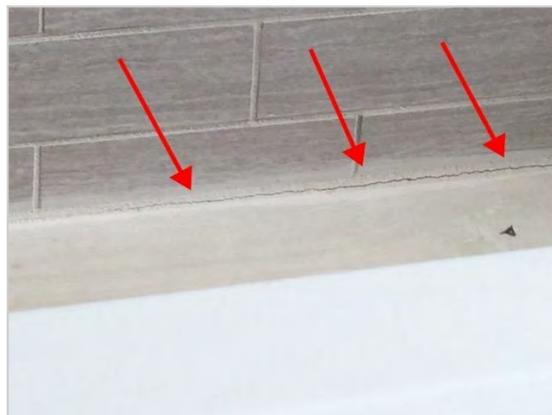
Photo 11

**Some of the caulk was missing from around the tub in the master bathroom.** These areas should be sealed to prevent moisture penetration. Failure to keep walls sealed can cause deterioration and extensive moisture damage including mold growth to the interior walls, which is not always visible at the time of the inspection.

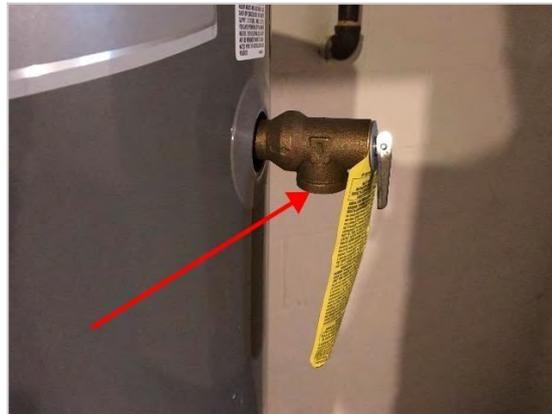
Photo 12

There was no drip leg installed on the T&P valve of the water heater. The drip leg directs water from the T&P valve toward the floor. A drip leg terminating within six-inches of the floor should be installed.

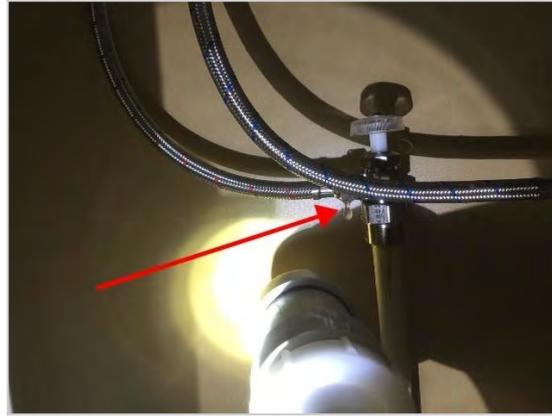
Photo 13

**Active water leaks were present at supply lines the time of the inspection.** The affected areas should be repaired, and nearby or associated plumbing lines should be further assessed at the time of the repair.

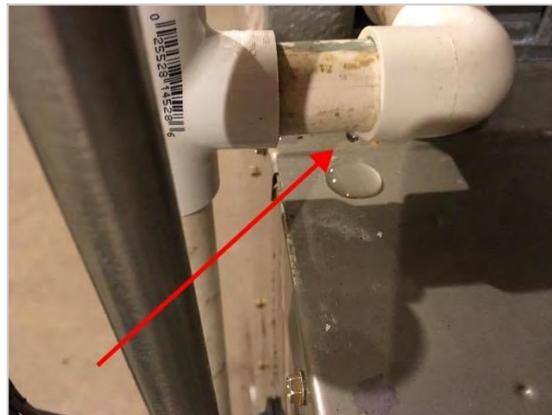
Photo 16

**A condensate leak was noted on the air handler drain line.** Repairs should be made by a qualified contractor.

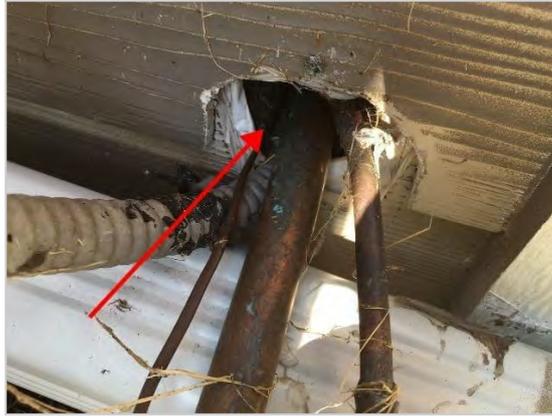
Photo 23

**The insulation on the exterior air conditioning line set is missing.** This could affect the efficiency of the system and should be replaced.
