HOME INSPECTION REPORT

On January 1, 2020 The HomeTeam Inspection Service made a visual inspection of 1234 Sample Drive, Anytown, FL 55555. Enclosed please find a written, narrative report of our findings in accordance with the terms of our Inspection Agreement.

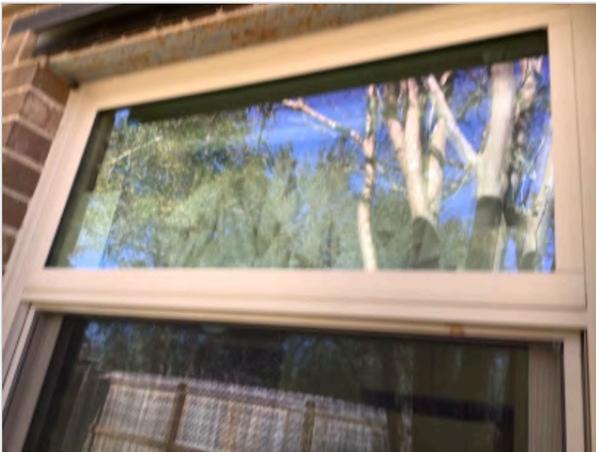
Photo 3

One or more of the steel lintels above the windows on the exterior of the structure is rusting and appears to have expanded. Lintels support masonry materials above doors and windows. Keeping the lintels sealed will help prevent rusting and expansion. Expanded lintels can lead to cracks in the masonry on the outside of the structure. The affected lintels should be properly sealed to prevent further expansion.

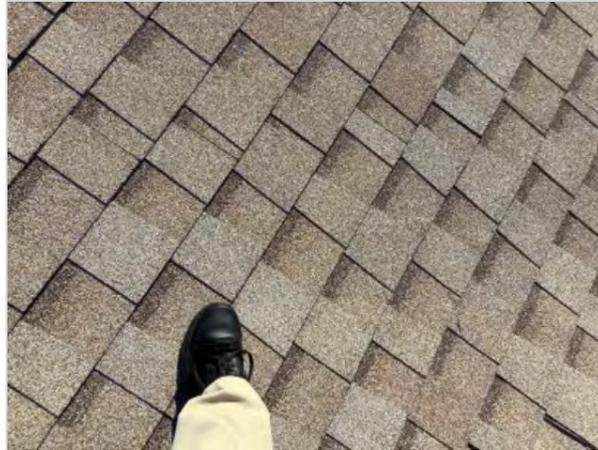
Photo 13

Numerous flashing techniques used on the newly installed roof are not the preferred methods of installing roof flashing. It appears that all of the areas in question have been caulked sufficiently however these areas should be monitored in the future to ensure they are not cracking allowing water to enter the attic structure.

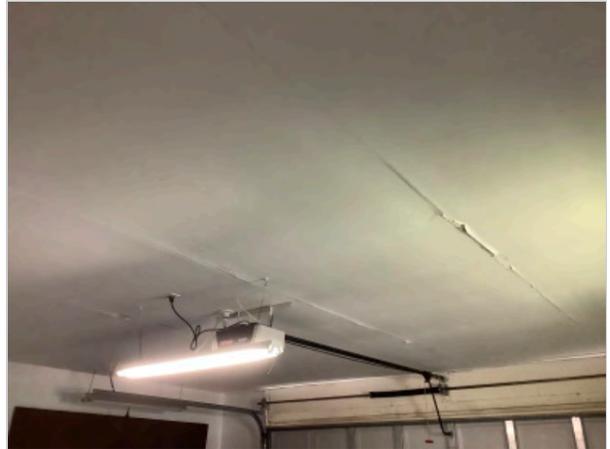
Photo 26

The garage door safety pressure reverse system appears to not be adjusted properly. This means that the door does not stop and reverse when resistance is placed at the base of the door. The opener should be adjusted or repaired.

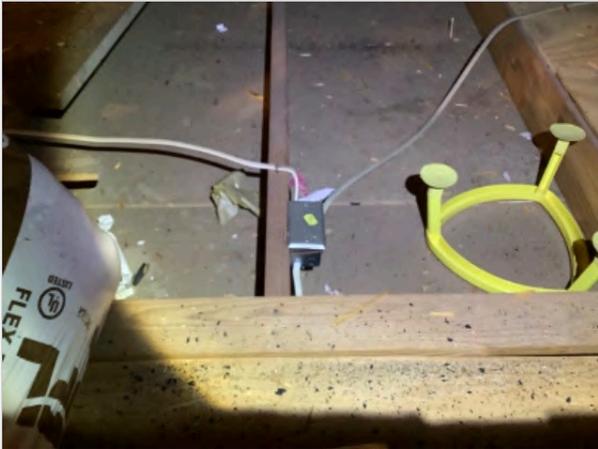
Photo 29

The bathroom exhaust fan is discharging into the attic. Excessive moisture can build up in the insulation, creating a condition for mold growth. Rainwater could also enter the attic at the vent location. The duct should be repaired from the fan exhaust to the exterior vent.

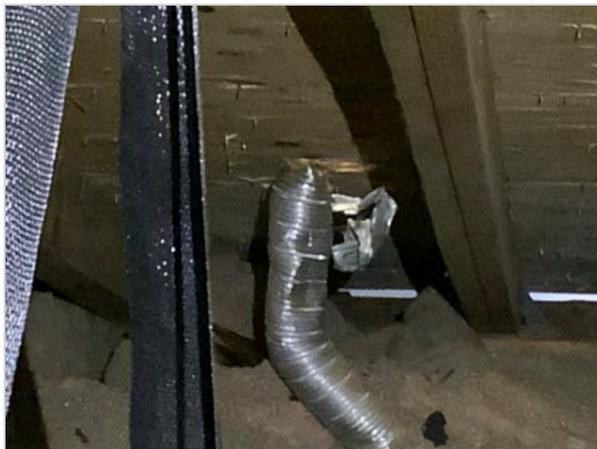
Photo 30

The range hood vent terminates in the attic and may be venting gases and grease into the attic space. Rainwater could also enter the attic at the vent location. The plumbing should be repaired so as to vent to the exterior of the structure. Consult with a licensed contractor to further assess the vent and make any necessary repairs.

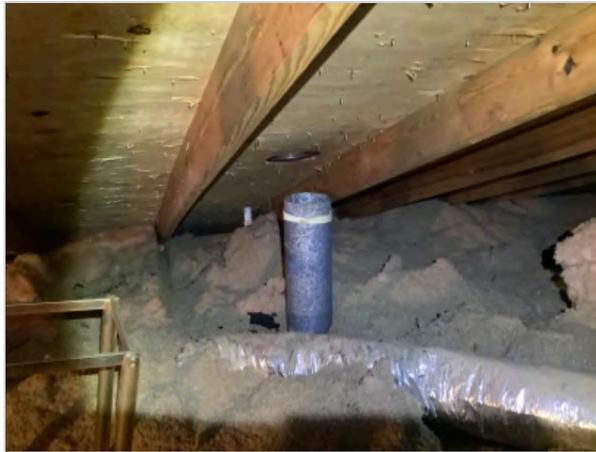
Photo 31

One of the rafters in the roof structure is loose. This condition could weaken the roof structure in the affected area. The area should be repaired and further assessed for additional repairs.

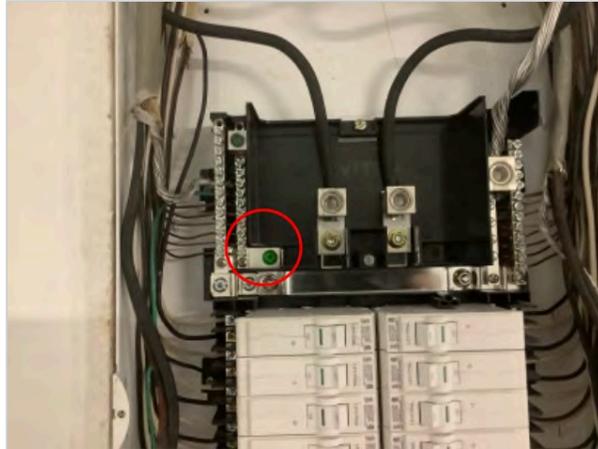
Photo 36

Ground and neutral appear to be bonded in the main panel. Electrical bonding should occur in the service panel. Recommend a licensed electrician review and correct.

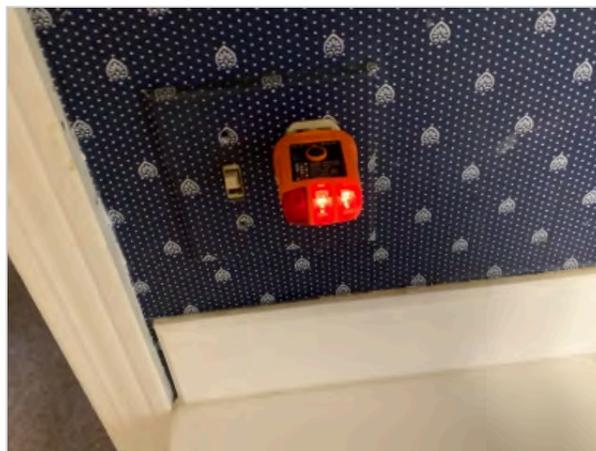
Photo 41

The home lacks GFCI protection.

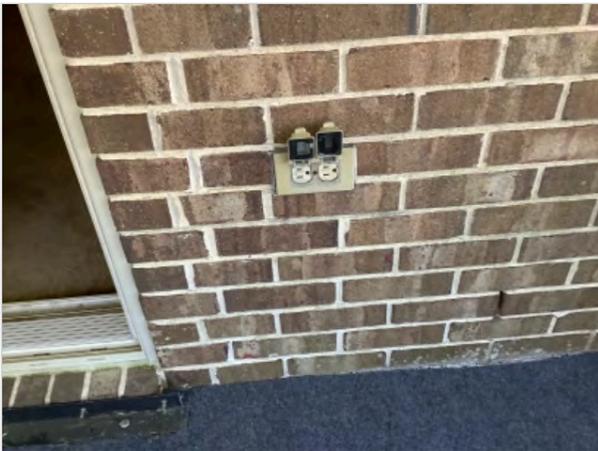
Photo 46

Multiple outlets were not functional. Consult with a qualified electrician for repair and further assessment of outlets.

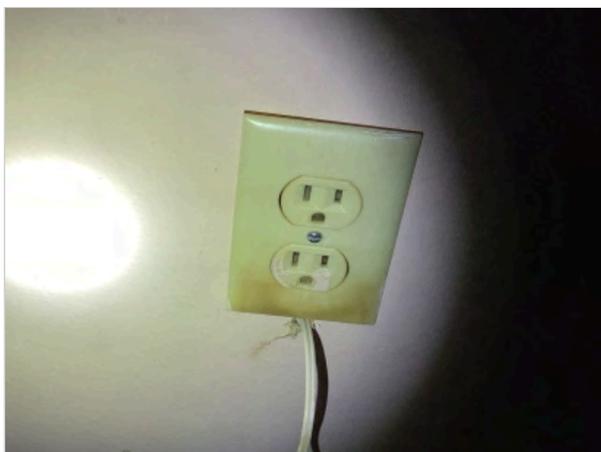
Photo 52

The receptacle is pulled loose from the wall.

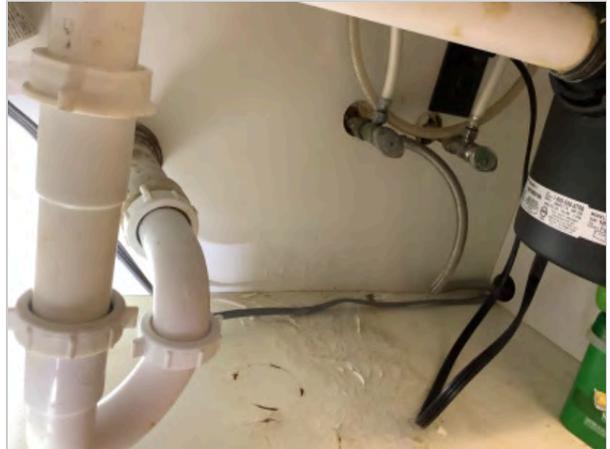
Photo 56

A leak was observed at the faucet to the kitchen sink. The faucet should be repaired or replaced to prevent water intrusion.

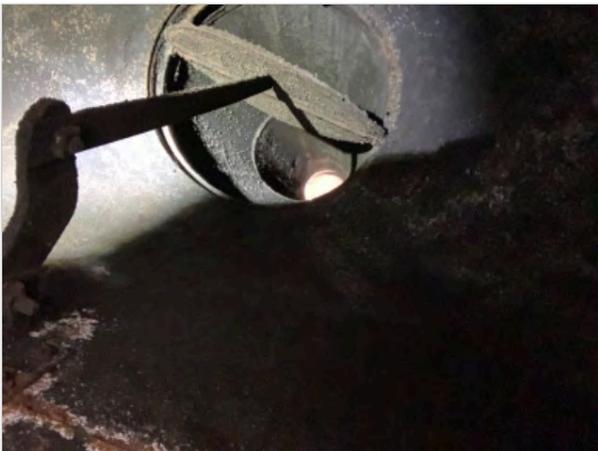
Photo 80

Cracks were present in the firebox of the fireplace located in the living room. Generally, firebox cracks are acceptable unless they are wide enough to fit a quarter into. The bricks and mortar inside the firebox are designed to act as a heat and spark shield and should be free of any voids. The firebox should be repaired and further assessed by a qualified chimney and fireplace service.
