### *HOME INSPECTION REPORT*

**123 Sample Drive  
Anytown, TX 55555**

# PROPERTY INSPECTION REPORT

| Concerning: | 123 Sample Drive, Anytown, TX, 55555 | | |

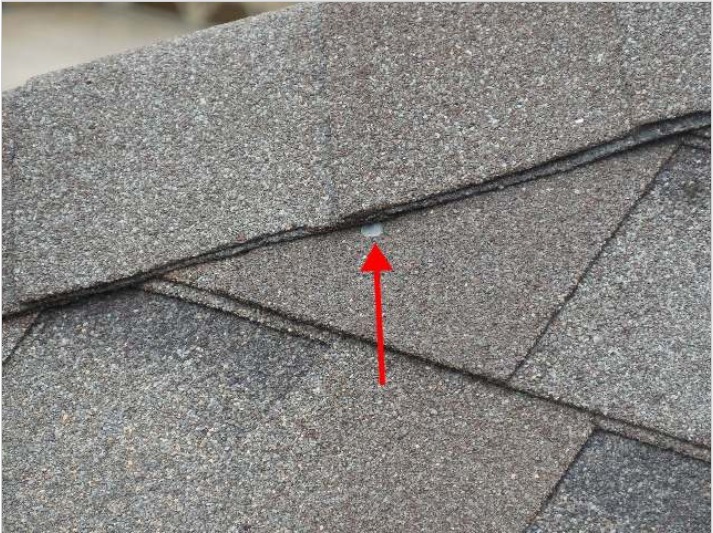
The following minor deficiencies were observed on the roof: exposed and/or rusted fasteners (nails). Recommend seal/caulking and repair to help prevent future damage.

Exposed nail head on roof.

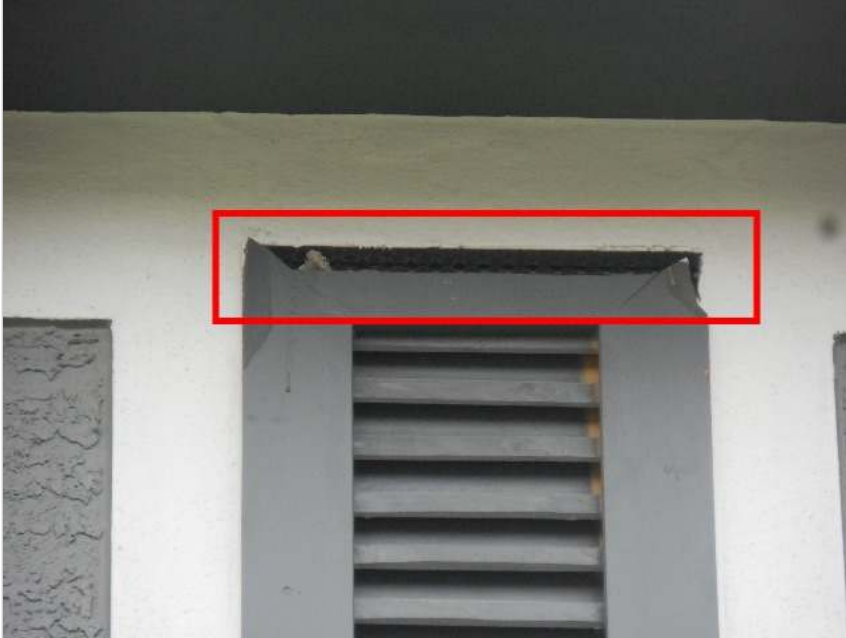
Trim was damaged at the top of the front facing gable vent. Recommend repairing and sealing.

Part of trim damaged/missing at front gable vent.

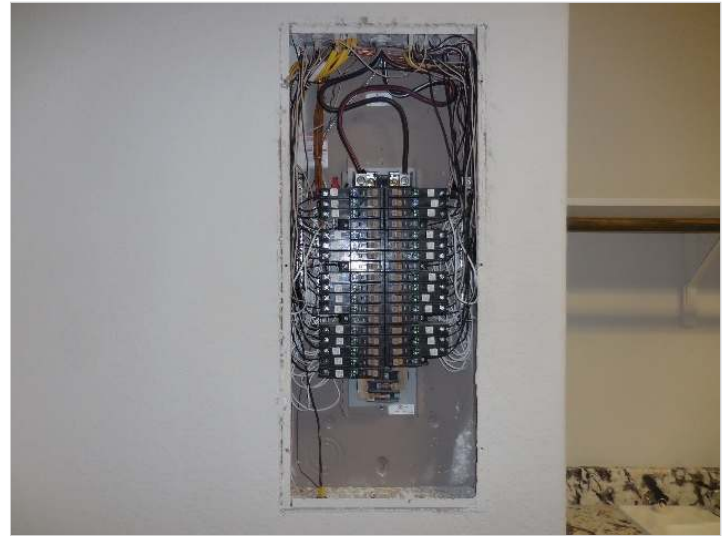
The sub-panel cover in the utility room was causing some of the breakers to trip when the panel door was closed (door hitting breaker handles). Recommend adjustment.

View of sub panel in utility room.

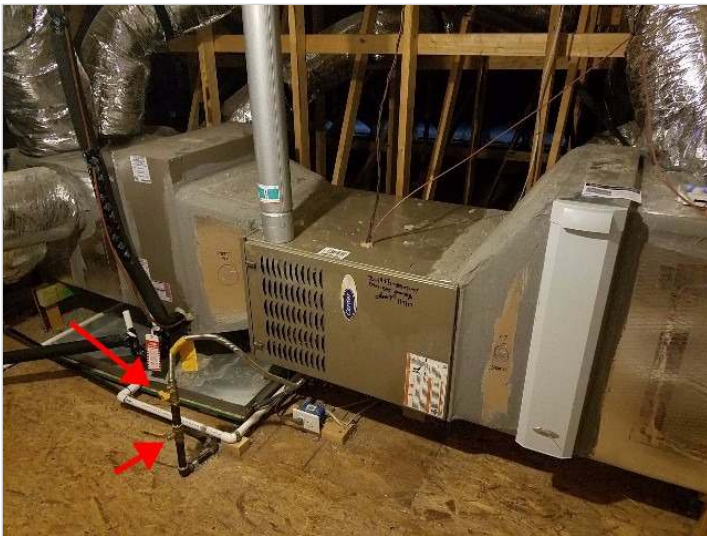
The heating units would not come on. Both unit gas valves and systems were OFF at the time of the inspection (at the units) and did not appear to be activated by the builder. After attempting to temporarily turn on the gas and units for testing they still did not respond. Recommend the builder activated the units (bleed gas lines) and demonstrate operation during final walk-through.

view of lower HVAC unit: gas and heater system off.

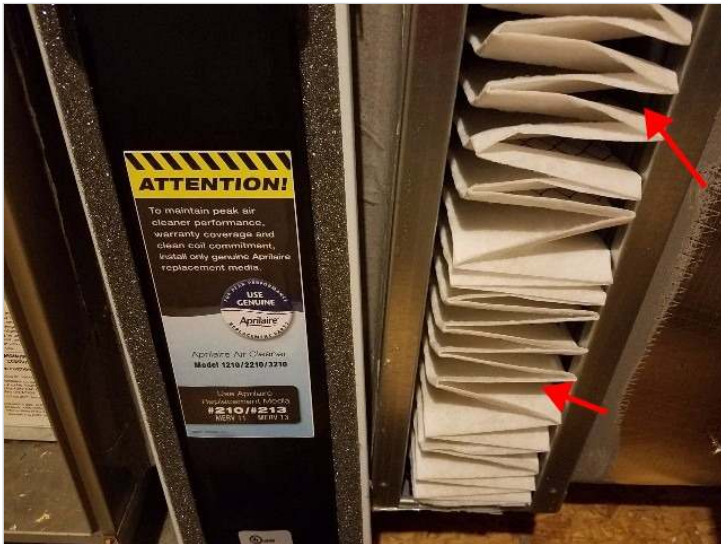
The media filter for the upper HVAC unit was installed backwards (not directed with the airflow in the system).

media filter installed backwards -- metal screen not facing suction side (upper HVAC unit).

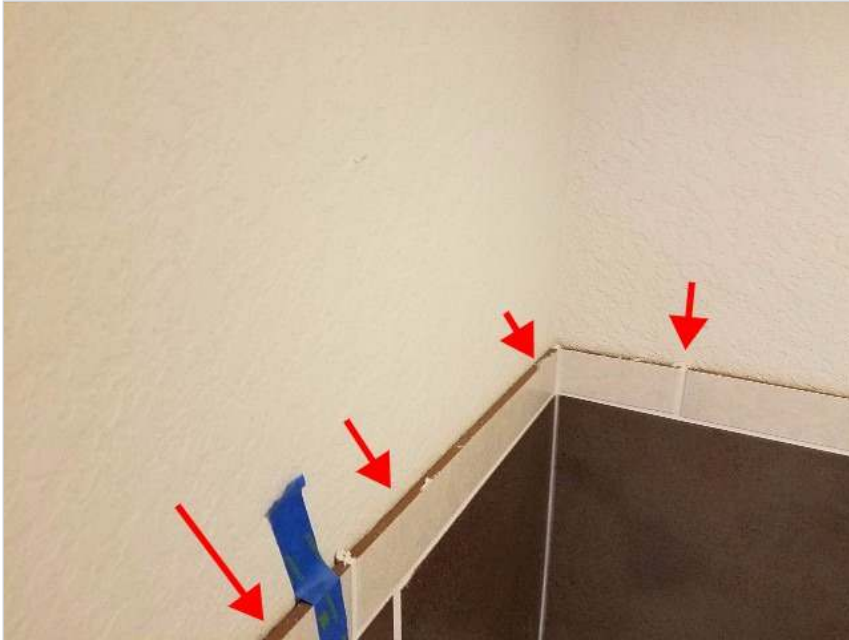
The top of the ALL bath shower enclosures were gapped at the intersection with the wall. Recommend proper caulking/sealing to help prevent damage and water penetration.

example of unsealed/caulked gaps at top of shower enclosures.

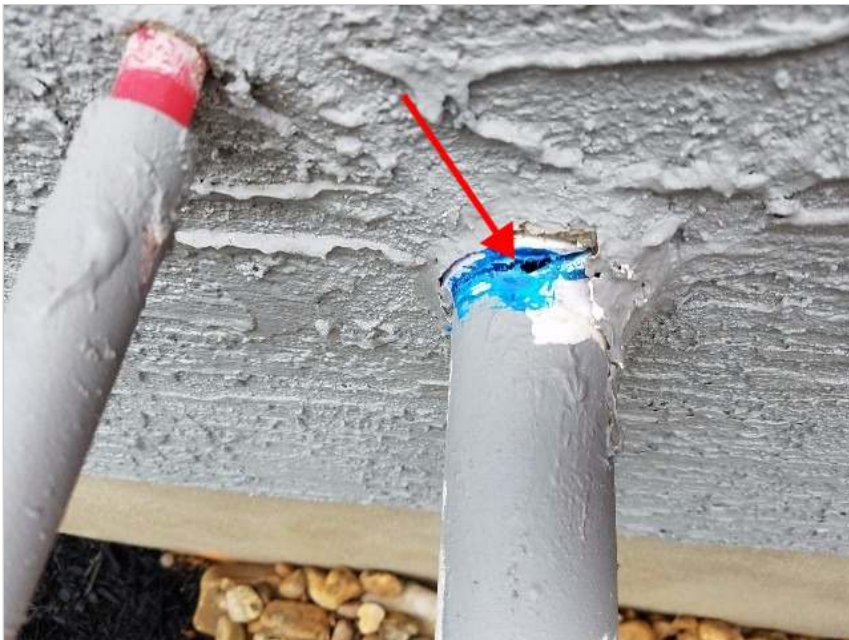
The drain line installed for an exterior back sink was broken at the wall and ineffectively glued back into place. Recommend properly repairing drain line.

Back exterior drain line broken.

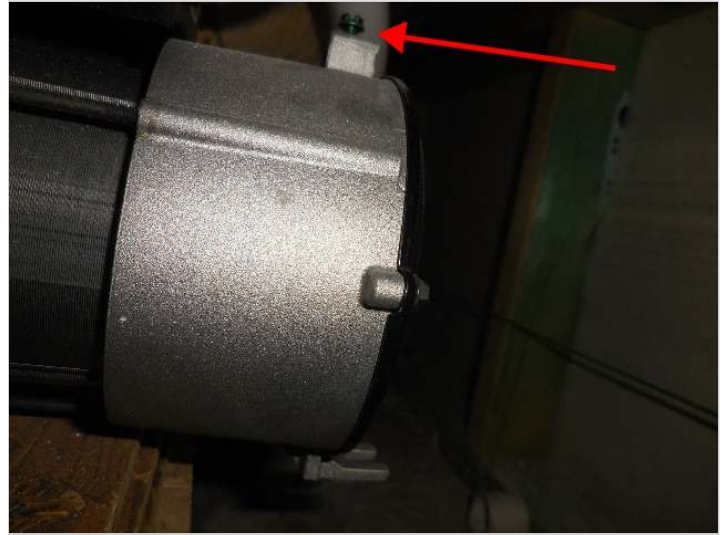
The spa tub pump was not properly bonded/grounded (or unable to determine).

Spa tub motor not bonded.

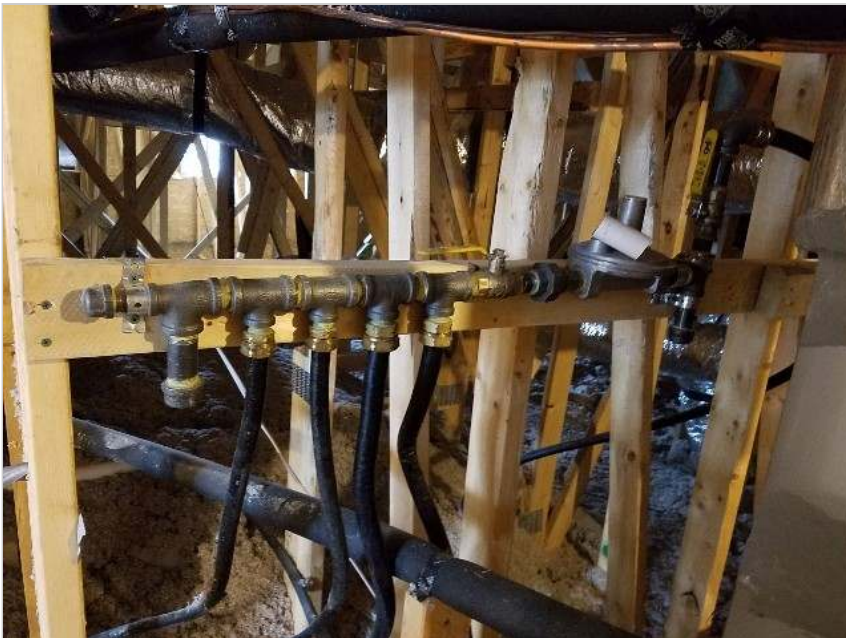
Corrugated Stainless Steel Tubing (CSST) was used in the gas supply system and we were unable to verify proper adherence to the manufacturer's bonding instructions. Bonding to the gas supply system was observed at the gas supply line next to the gas meter.

CSST manifold in attic space.

(New Homes with CSST) It is recommended that you consult with your builder and have them certify proper CSST bonding according to the specific manufacturers instructions.

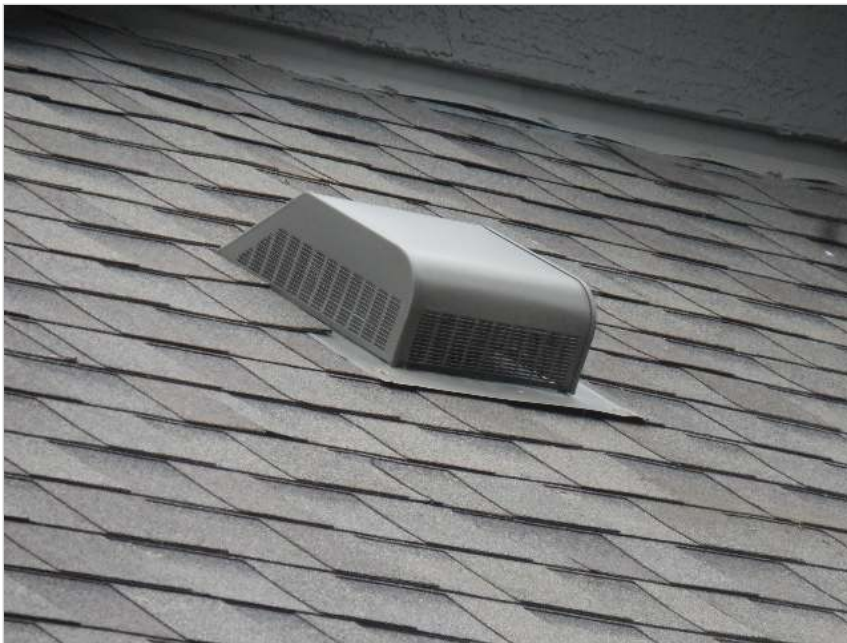
The dryer vent has a screened or grated termination cover which collects lint and is a potential fire hazard. Recommend removing and replacing with an appropriate dryer cover with back-draft damper

Screened dryer vent cover.
