HomeTeam[®]

HOME INSPECTION REPORT

The following items or discoveries indicate that these systems or components at 1111 Sample Dr, South/North Charlotte, NC 11111 do not function as intended or adversely affect the habitability of the dwelling; or appear to warrant further investigation by a specialist, or requires subsequent observation. This summary is not the entire report. The full report may include additional information of interest or concern to the client. It is strongly recommended that the client promptly read the complete report. For information regarding the negotiability of any item in this report under a real estate purchase contract, contact your NC/SC real estate agent or an attorney.

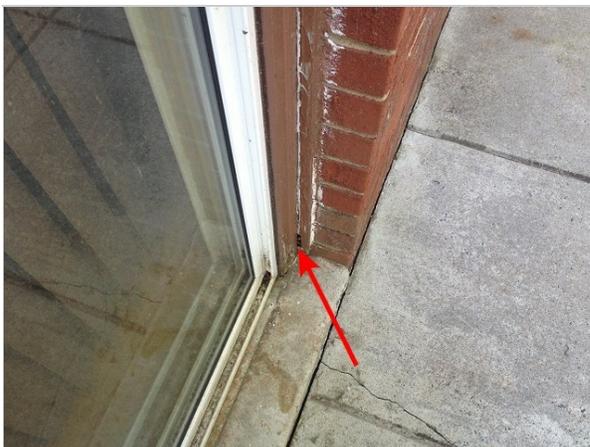
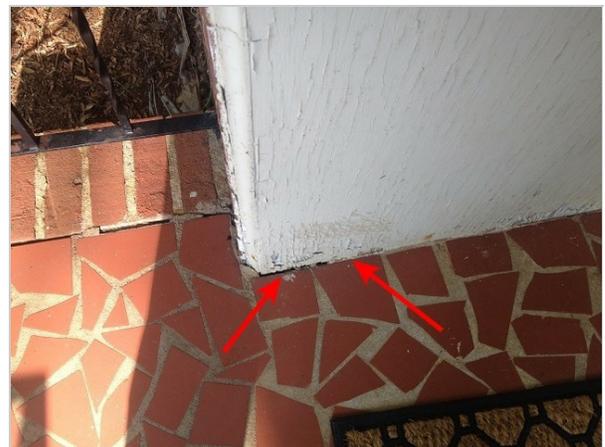
Figure 1

- Wood rot and/or decay damage found on the paneling, casing and/ or sill around the doors/windows in the following location/s of the property: (A) casing around the rear patio door; (B) left panel on the front porch. Conducive to allowing water infiltration to the wall sheathing, floor structure and wall framing. Needs further evaluation and repair by a licensed general contractor.

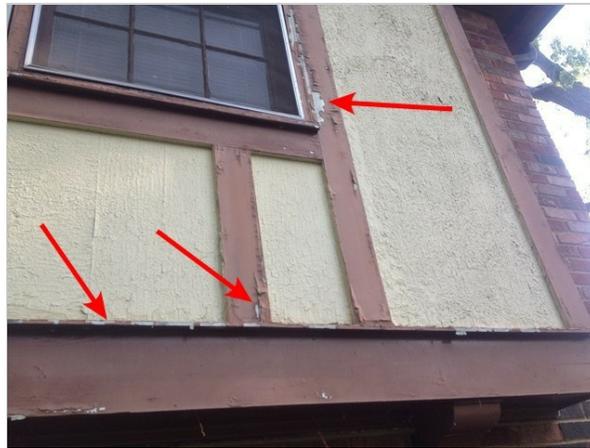
Figure 3

- The paint was peeling of exterior surface at the multiple locations-conducive for wood deterioration. Needs proper repair by a painting contractor.

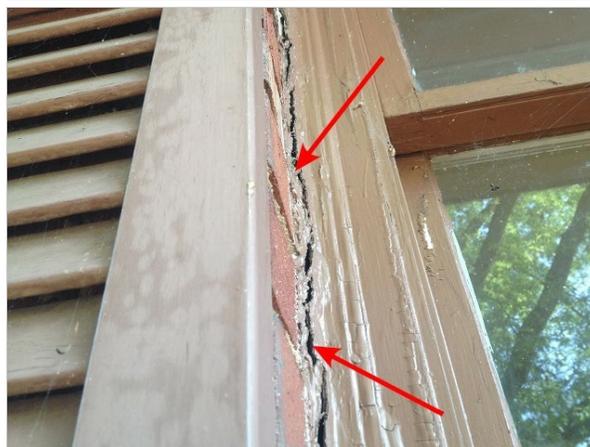
Figure 4

- Caulk is missing and/or deteriorated between the window jambs and brick walls - seen around front left window. Recommend caulking around windows to prevent ingress of water and increase the heating and cooling coast of the home.

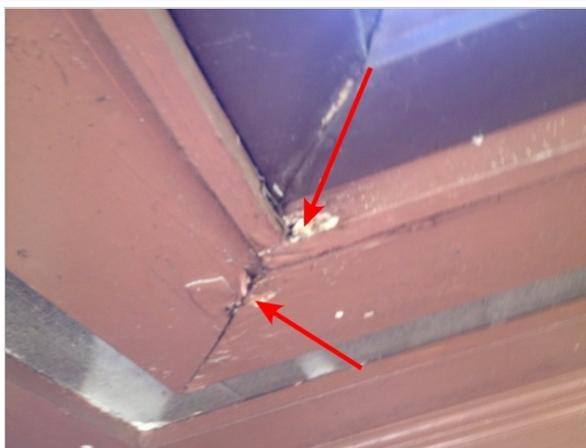
Figure 5

- Wood rot and/or decay damage found on the roof fascia/soffit boards in the following locations of the property:
(A) over the rear porch-conducive to allowing moisture damage the roof structure. Recommend a Licensed General Contractor evaluate further and repair/replace where necessary.

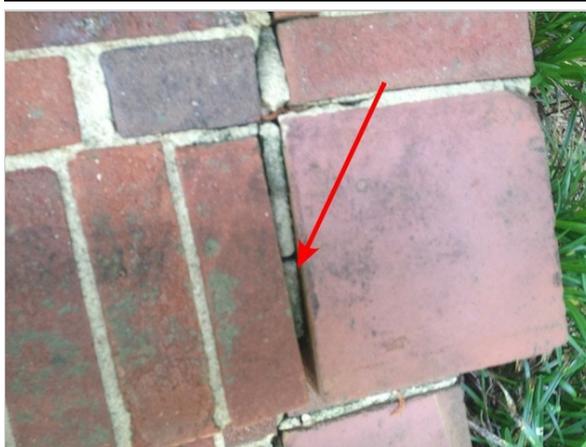
Figure 6

- Deteriorated/loose mortar between the brick/s at the rear porch entrance steps. This can become a potential tripping hazard. Recommend repair/replace deteriorated/loose mortar between brick/s where necessary.

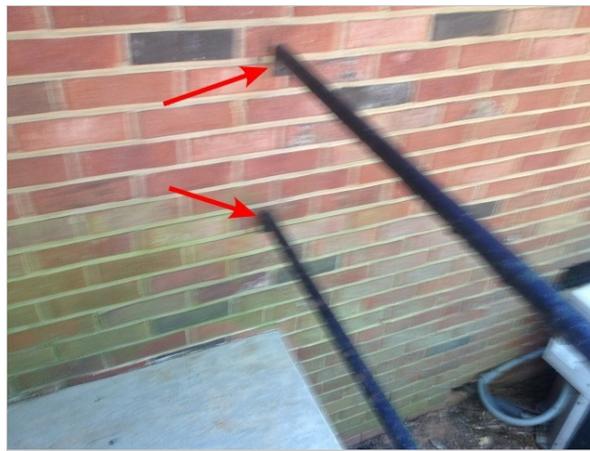
Figure 7

- The handrail on the rear porch / steps is not secure at the wall. This can become a potential tripping hazard. Recommend repair/resecure handrail where necessary.

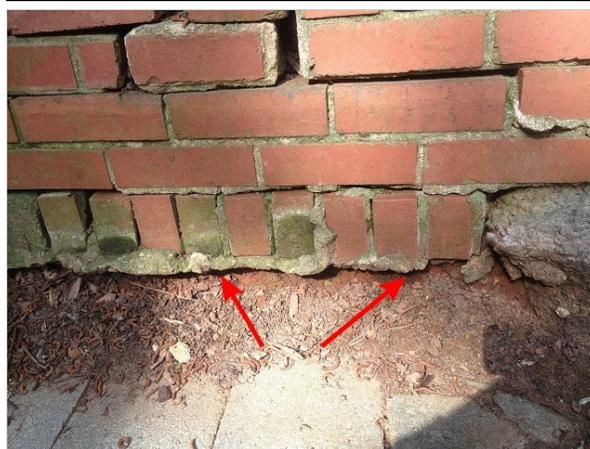
Figure 8

- The ground was washed out under the retaining wall on the left side of the rear patio. Considered as a safety hazard due to potential wall movement. Needs repair by a general contractor.

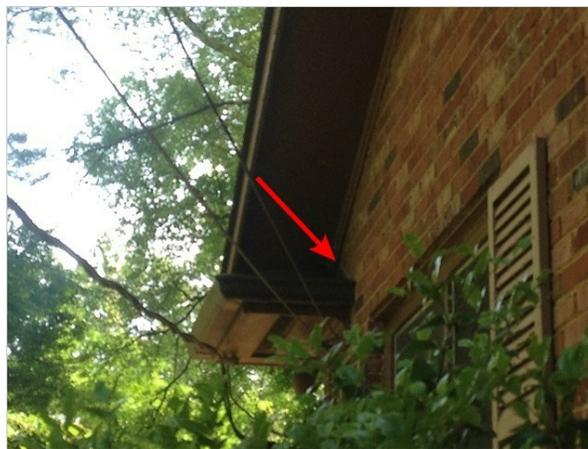
Figure 9

- There is no flashing where a portion of the roof abutts the house, observed in the following location: (A) around cornice roof on the left side of the house. Moisture intrusion into the property in this location would be possible, if left as is. Recommend a licensed Roofing Contractor evaluate and install flashing where missing or

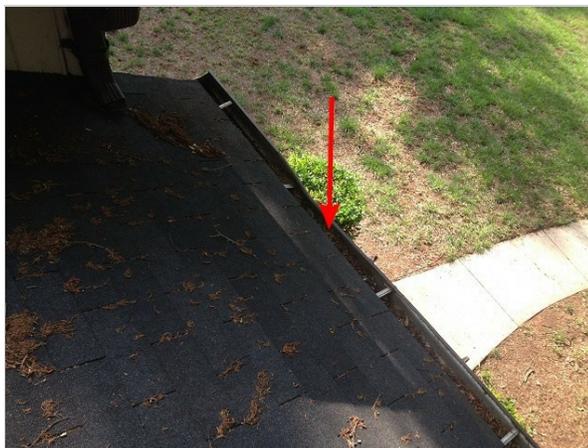
Figure 10

- The gutters on the house need to be serviced, such as cleaning, re-securing them, sealing seams, etc. Improperly functioning gutters can cause foundation problems.

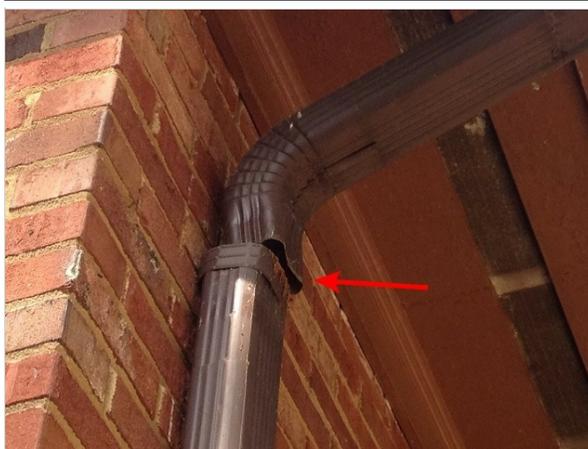
Figure 11

- One or more downspouts are loose or detached. This can result in water accumulating around the structure's foundation, or in basements and crawl spaces if they exist. Accumulated water is a conducive condition to wood destroying insects and organisms, and may also cause the foundation to settle and possibly fail over time. Recommend making repairs as necessary so downspouts are securely anchored and functional.

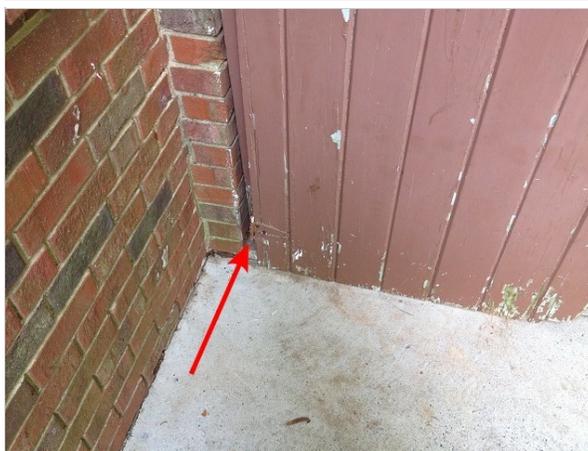
Figure 12

- Crawlspace access door was found to be loose and unsecured. Recommend resecure access door to prevent ingress of vermin and birds.

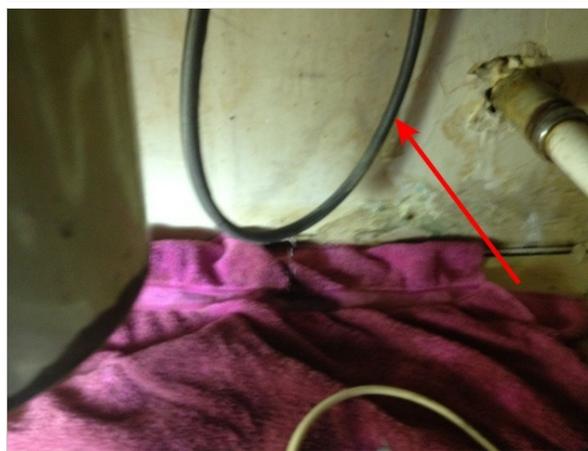
Figure 13

- The kitchen faucet was leaking under the sink. Needs repair by a licensed plumbing contractor.

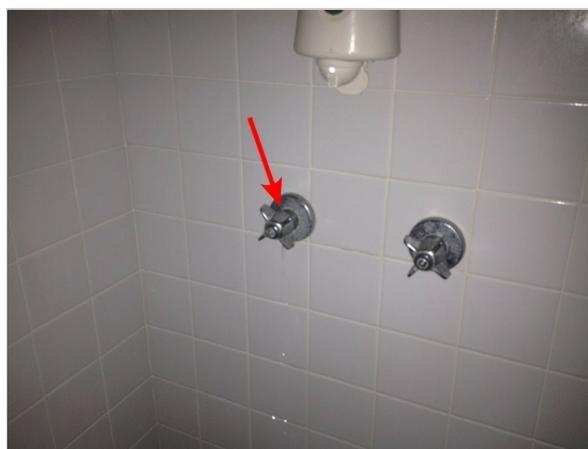
Figure 14

- The shower faucet in the master bathroom leaks around the stem while in use. Needs repair by a licensed plumbing contractor.

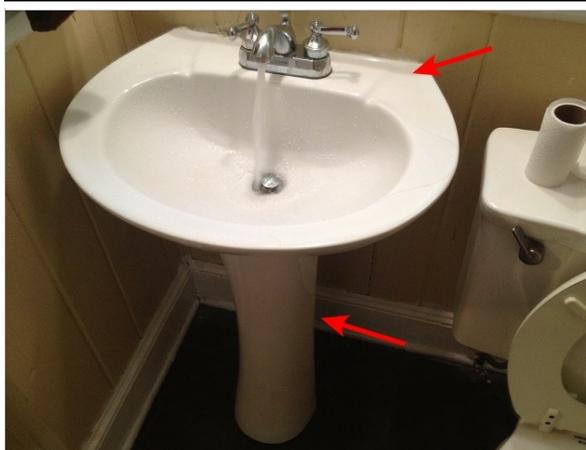
Figure 15

- The sink and pedestal were loose at the wall in the bathroom on the lower level. Needs repair by a licensed

plumbing contractor.

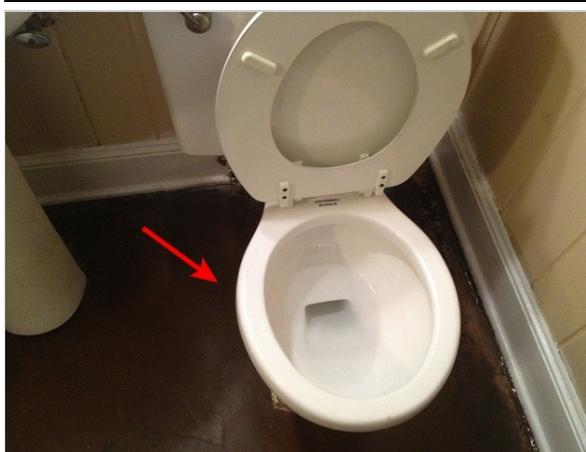
Figure 16

- Toilet found loose at the base and needs reanchoring - found in the following location:(A) in the lower bathroom. Any toilet that shows evidence of leaks or is loose and easy to move, should be remounted with a new wax ring seal to prevent potential leaks and water damage to the floor system and structure below. Visible evidence of floor stain marks and/or rot damage below the toilet may only become noticeable when the wax ring seal is replaced. Recommend repair/replace as required so toilet is securely fastened to the floor.

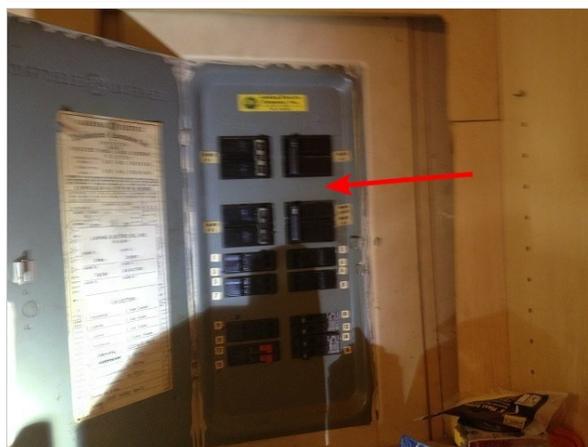
Figure 17

- The main panel was built in inside the cabinet and was not accessible for inspection. Recommended to have panel accessible and have the licensed electrical contractor to evaluate the panel.

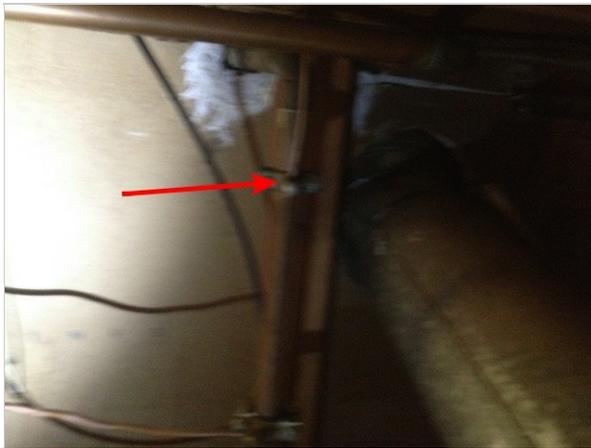
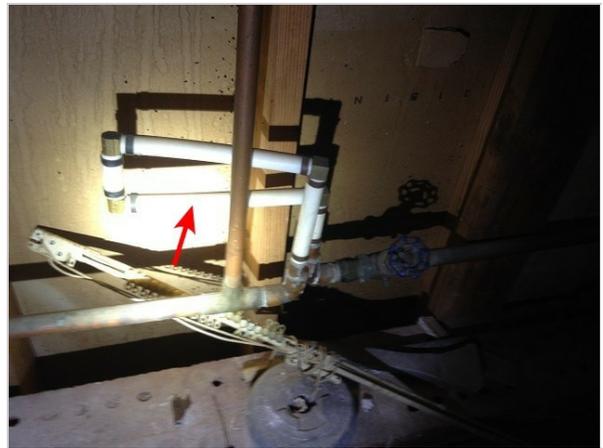
Figure 18

- The panel ground to a water pipe has been nullified by a plastic water main. Either an auxiliary ground should be established, or the panel should be regrounded. Needs repair by a licensed electrical contractor.

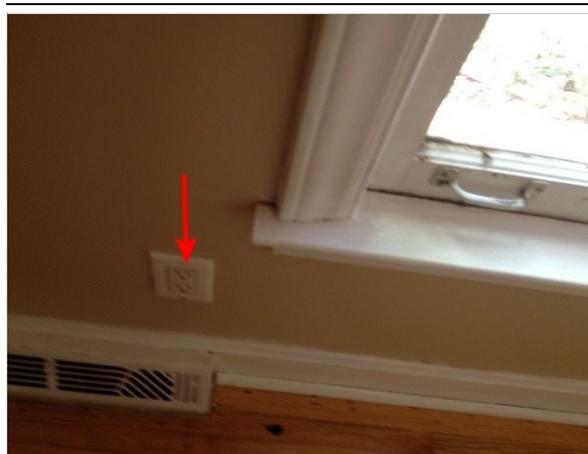
Figure 20

- Representative number of the wall receptacles in the house were were not grounded (open-ground), and do not meet the safety standards of modern wiring. Needs further evaluation and repair by a licensed electrical contractor.

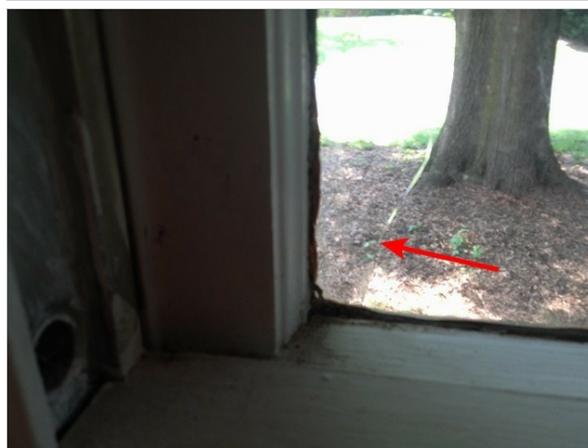
Figure 21

- One glass pane in the front family room had a broken or cracked glass pane that should be repaired or replaced.

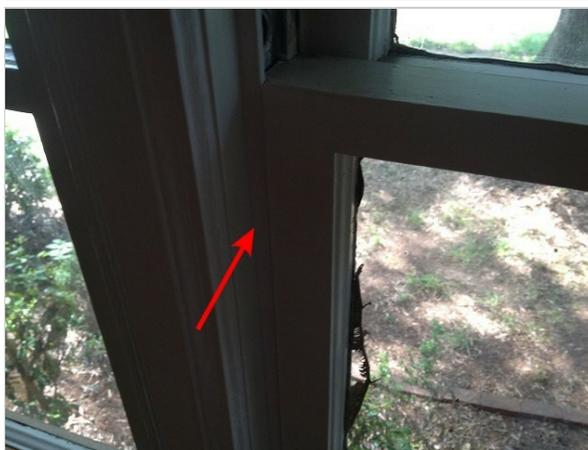
Figure 22

- A representative number of the windows were painted shut and could not be operated to verify operation or check for defects. The window(s) need maintenance to free them for opening and further inspection.

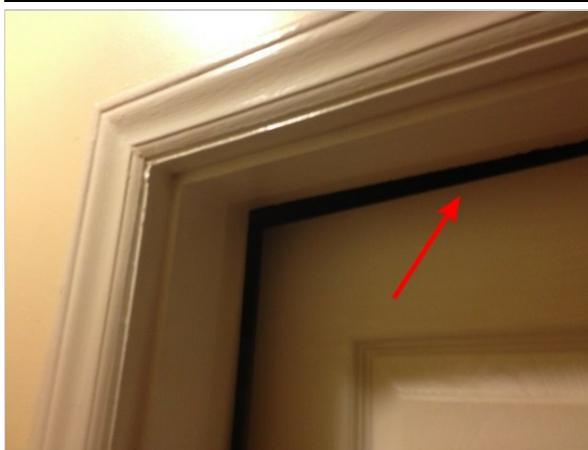
Figure 23

- The bedroom doors on the lower level and rear left bedroom bind in the jamb casing and is difficult to operate, and needs to be serviced to work smoothly.

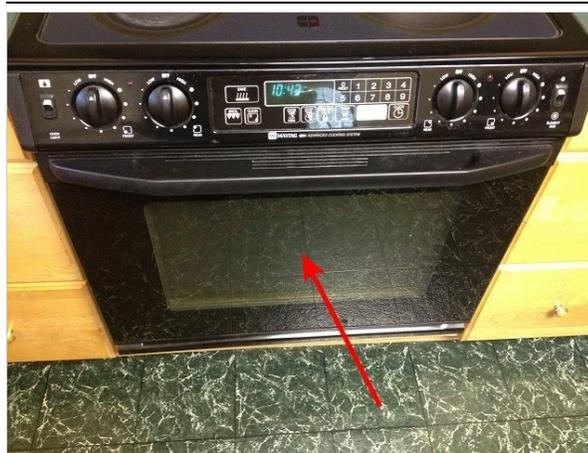
Figure 24

- The bottom heating element in the oven was not functioning. Needs repair by an appliances specialist.

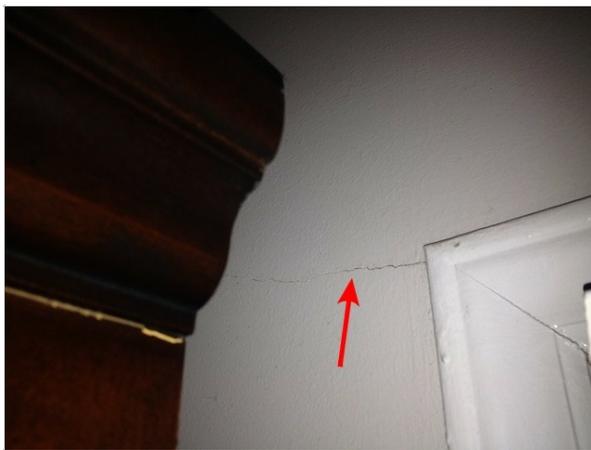
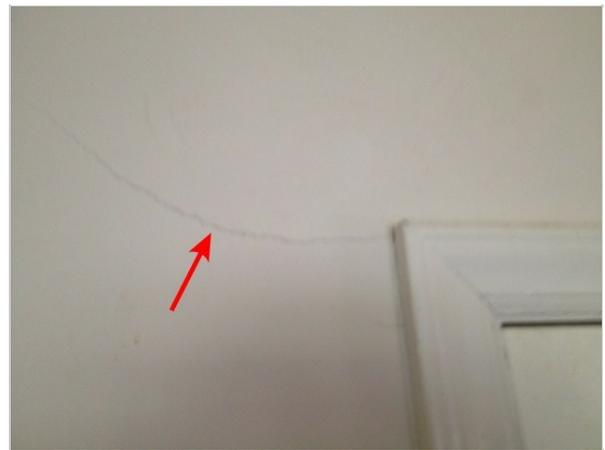
Figure 25

- Diagonal crack was noted on the wall located in master bedroom and rear left bedroom. This evidence suggests movement of the floor system. Additional movement will cause the crack to enlarge. A Licensed General Contractor should be consulted to determine the cause of the movement and if corrective measures are

needed.

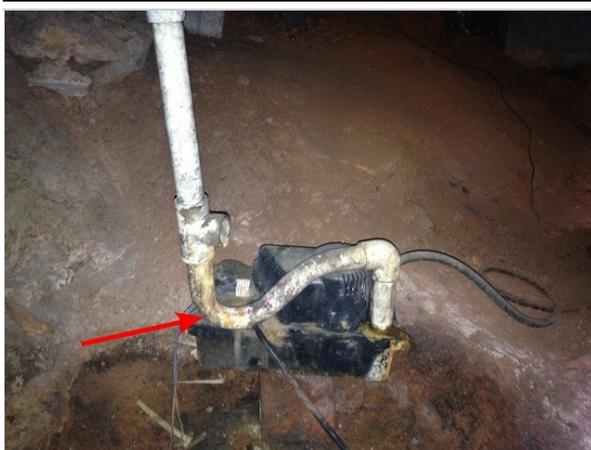
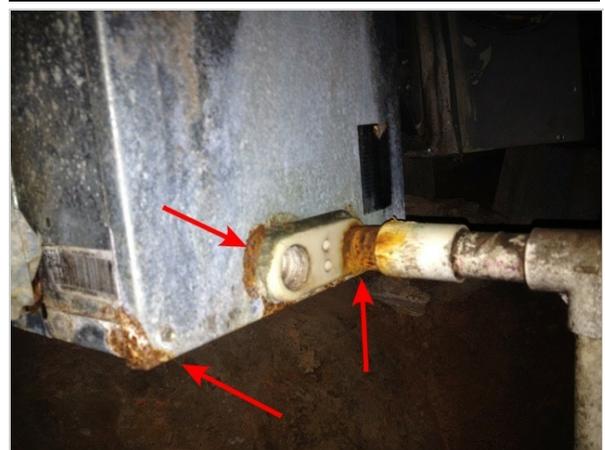
Figure 27

- The condensation water drain system was not functioning. The water was leaking around evaporator coil compartment-conductive for coil deterioration. Needs further evaluation and repair or service by a licensed HVAC contractor.

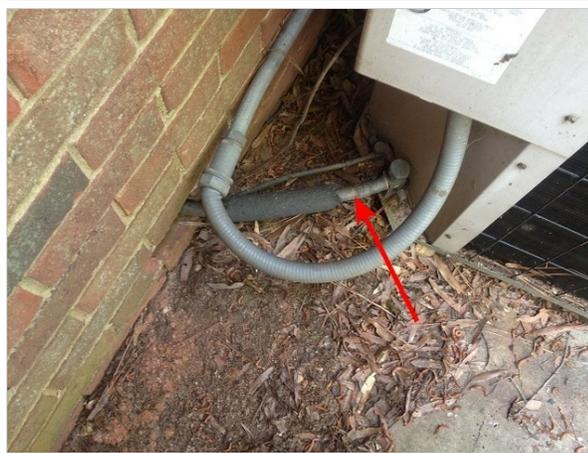
Figure 29

- Insulation for the outside condensing unit's refrigerant lines is damaged, deteriorated and/or missing in one or more areas. This may result in reduced efficiency and increased energy costs. Recommend replace insulation as necessary.

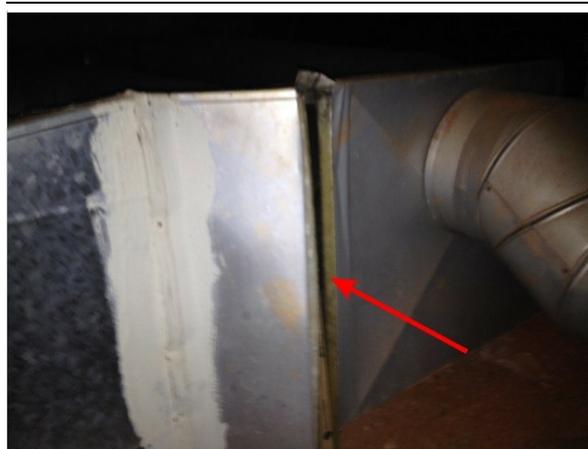
Figure 30

- The cover was missing on the filter compartment-conductive for dust penetration inside of the air handler. Needs repair by a licensed HVAC contractor.
