HOME INSPECTION REPORT

On Thursday, August 6, 2020 The HomeTeam Inspection Service made a visual inspection of 123 Sample Dr. Any Town, USA 55555. Enclosed please find a written, narrative report of our findings in accordance with the terms of our Inspection Agreement.

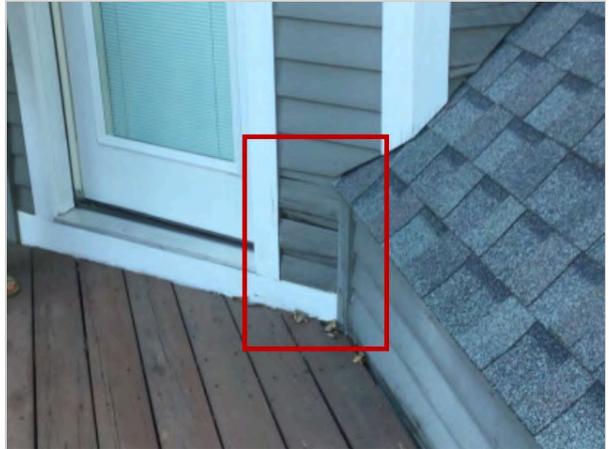
Photo 6

Second floor deck

Peeling paint was noted on all areas. In order to preserve the life of the exterior surfaces and materials, all areas should be scraped and painted.

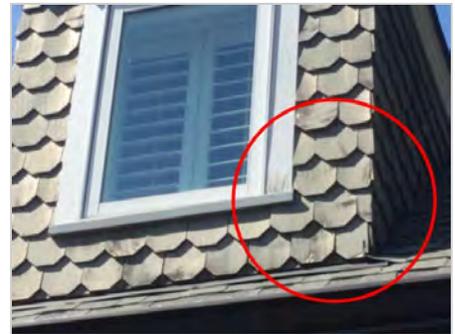
Photo 9

Numerous shingles all over house

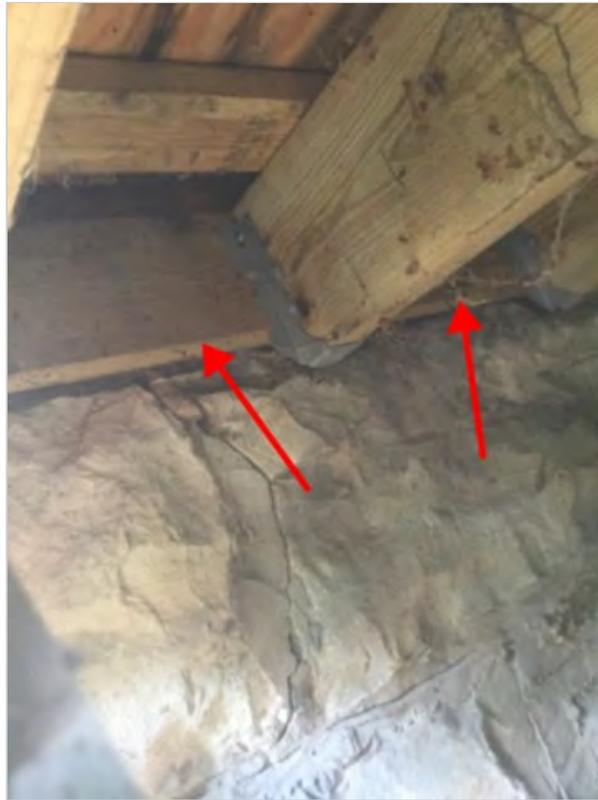
Photo 35

There is an insufficient amount and/or type of bolts attaching the ledger board to the structure. There should be two, 1/2" diameter lag screws or through bolts, with one-inch washers, at both ends, within five inches from the ends. Additionally, there should be an alternating pattern of same sized fasteners and washers, every 12-16 inches. (If utilizing bolts, they should have nuts and one-inch washers additionally on interior side.) Specific modifications to the

The ledger board did not show signs of pulling away from the house at the time of the inspection.

Under porch at foundation

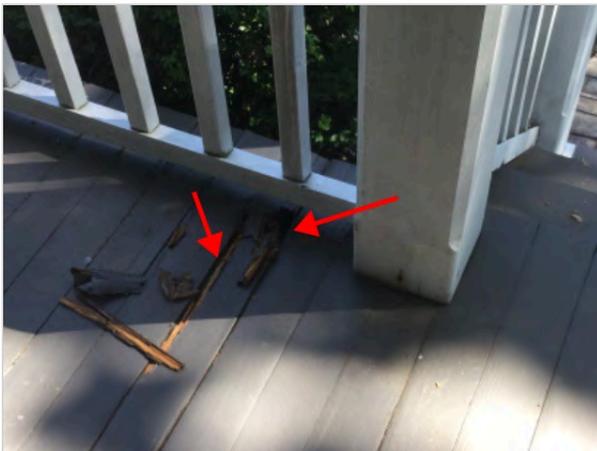
Photo 36

Rotted wood was noted on the front porch floor . The areas should be repaired and sealed.

Front center

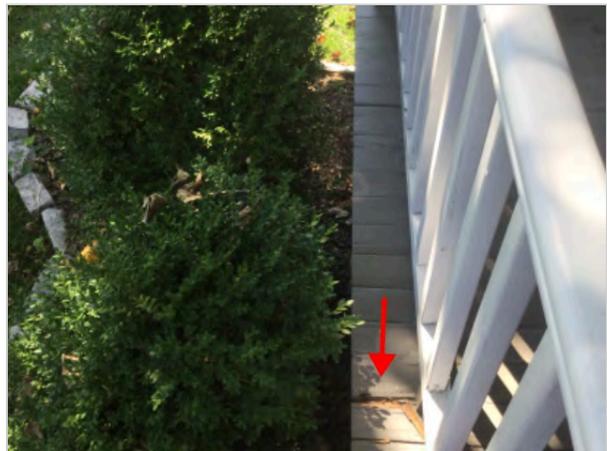
Photo 37

Front left

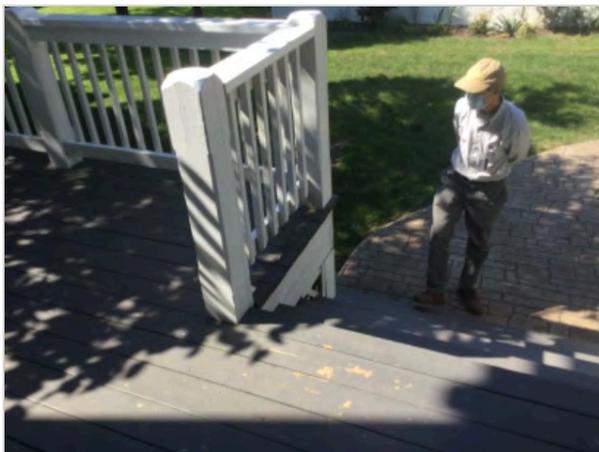
Photo 41

A graspable handrail is not present on the deck.

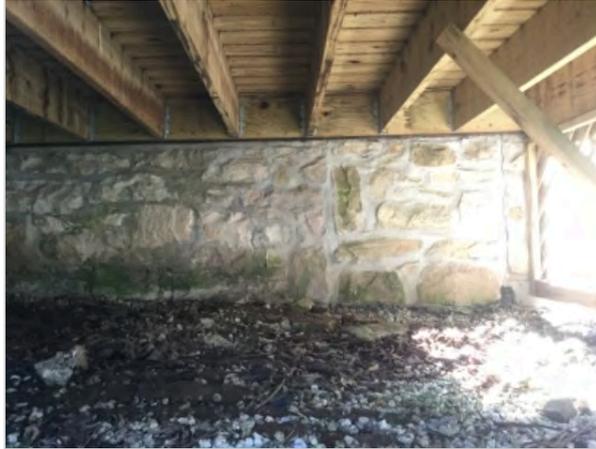
Photo 42

There is an insufficient amount and/or type of bolts attaching the ledger board to the structure. There should be two, 1/2" diameter lag screws or through bolts , with one-inch washers, at both ends, within five inches from the ends. Additionally, there should be an alternating pattern of same sized fasteners and washers, every 12-16 inches. (If utilizing bolts, they should have nuts and one-inch washers additionally on interior side.) Specific modifications to the existing condition that are similar to the recommended standard cannot be specified by HomeTeam Inspection Service.

The ledger board did not show signs of pulling away from the house at the time of the inspection.

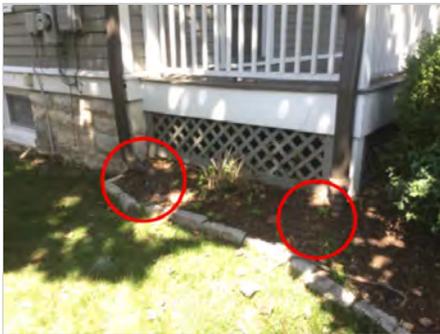
Photo 54

Some of the downspouts around the structure are draining into the ground with no conclusive termination point. HomeTeam recommends ensuring termination points for all downspouts is far enough from the structure and configured in such a way as to ensure water flows away from the foundation during periods of rain.

Left front

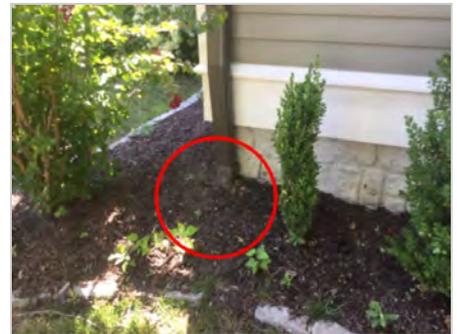
Photo 56

Right

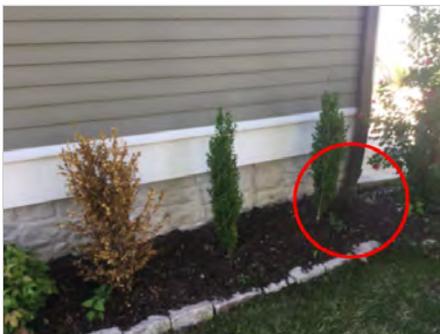
Photo 57

Right rear

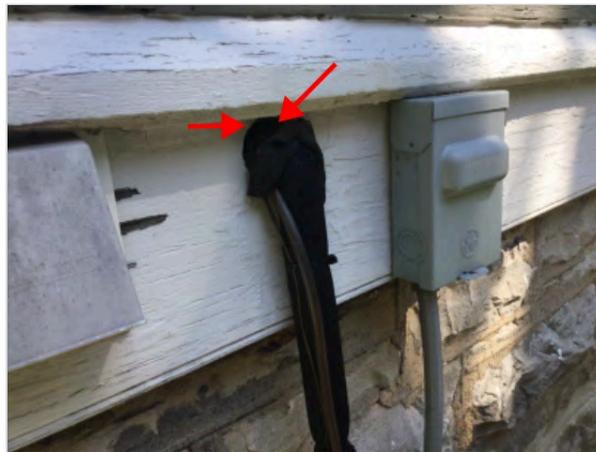
Photo 61

Caulk is missing from areas where cabling or tubing enters the house. Caulk helps prevent moisture from entering the home and helps keep out pests. It is recommended that the gapped areas around the areas noted below be sealed.

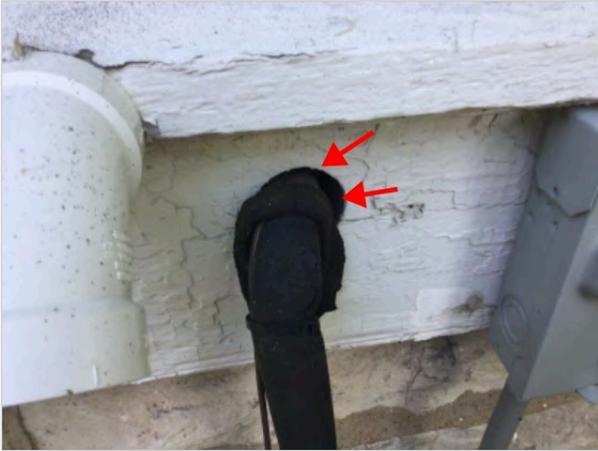
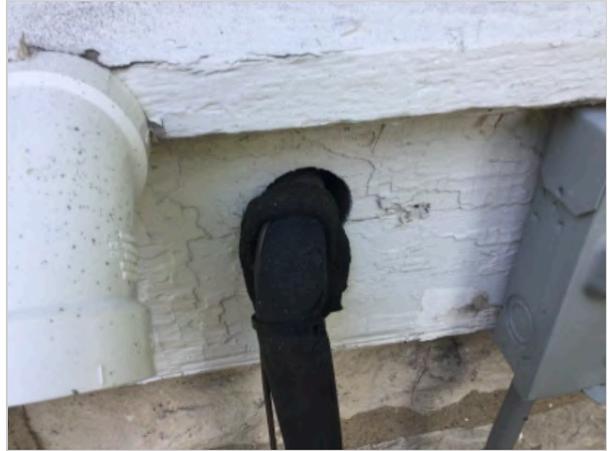
Caulk is missing from areas where cabling or tubing enters the house. Caulk helps prevent moisture from entering the

home and helps keep out pests. It is recommended that the gapped areas around the areas noted below be sealed.

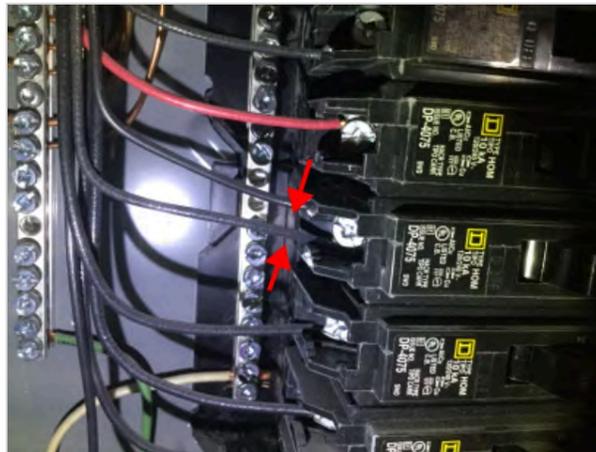
Photo 71

A circuit breaker in the electric panel had two attached circuits (wires). Each circuit should have its own dedicated breaker to prevent nuisance tripping and ensure good terminal contact, which may help prevent overheating. This situation is commonly referred to as a "double-tap". An electrician should repair this condition and further assess the panel for any additional required repairs.

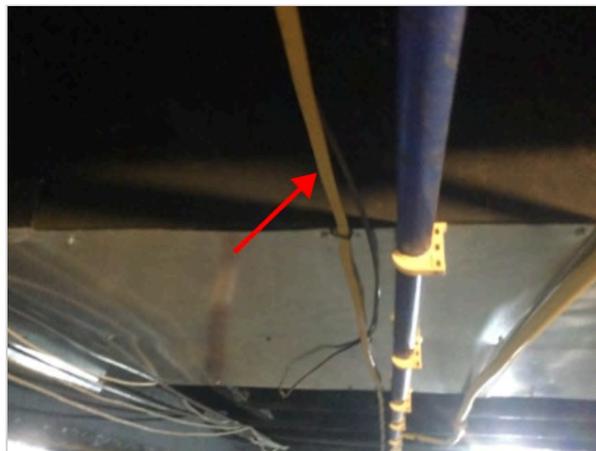
Photo 74

Evidence of amateur wiring was observed in one or more areas of the home, with specific locations listed below. Amateur wiring may not conform to standards methods and could be a safety concern. Consult with a qualified electrician for repairs and further evaluation.

Center of basement, cabling run under joists

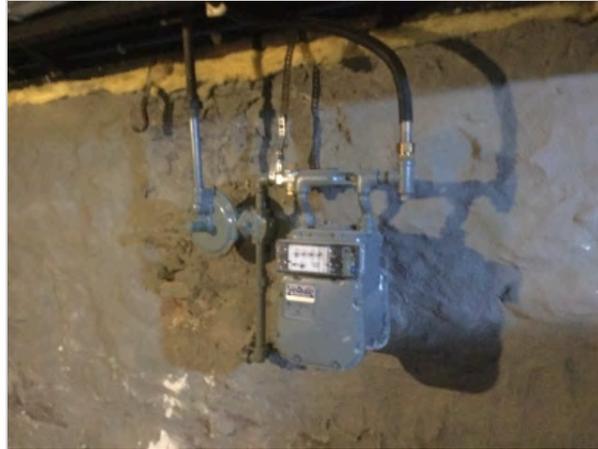
Photo 75

Corrugated stainless steel tubing (CSST) is in use in the structure. There have been questions as to whether CSST poses an unreasonable risk from damage caused by lightning. Manufacturers believe the product is safer if properly bonded and grounded as required by manufacturer's installation instructions. Proper bonding and grounding of the product can only be determined by a licensed electrical contractor. Consult with an electrician to ensure the CSST is properly configured. Local utilities may shut off gas supply if CSST lines are not properly grounded or bonded.

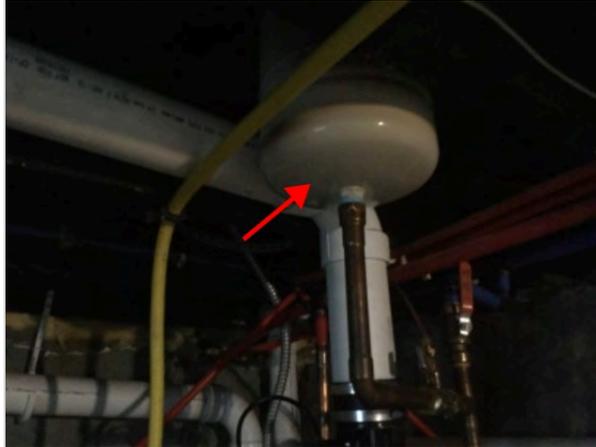
Photo 83

The expansion tank lacks a support strap, placing torque on the plumbing connection, which could lead to a leak. It is recommended that a support strap be added to add support from the joist above.

Need support strap under expansion tank

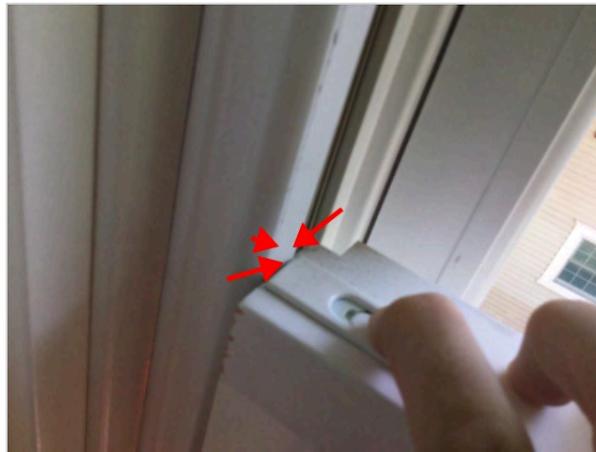
Photo 97

One or more windows could not be opened using reasonable force at the time of the inspection. This condition could be caused by paint, obstructions or lack of use. Repairs or adjustments may be required. For safety reasons, it is important that at least one window opens in each room of the home.

Front left bedroom 2nd floor

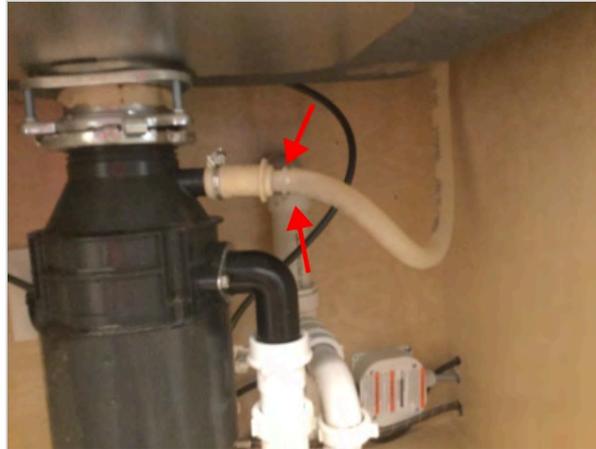
Photo 106

The dishwasher's drain hose is not equipped with an anti-siphon valve (air gap) and may not be configured in a way to prevent a back-flow of grey water into the dishwasher. Consult with the manufacturer to determine if this particular model requires an air gap or external high loop (some are integrated and are not visible). If so, HomeTeam recommends having an anti-siphon valve (air gap) installed or the drain hose looped higher than the attachment point of the drain hose (high loop) to the disposal/plumbing drain to prevent grey water returning back into the dishwasher.
