HOME INSPECTION REPORT

On Wednesday, April 6, 2022 The HomeTeam Inspection Service made a visual inspection of 123 Anywhere Drive Town, USA 55555. Enclosed please find a written, narrative report of our findings in accordance with the terms of our Inspection Agreement.

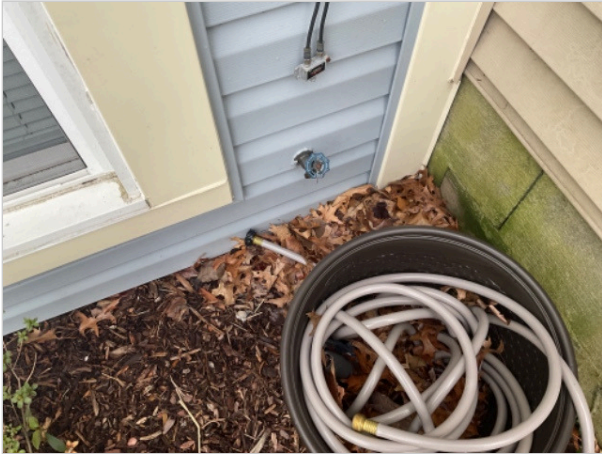
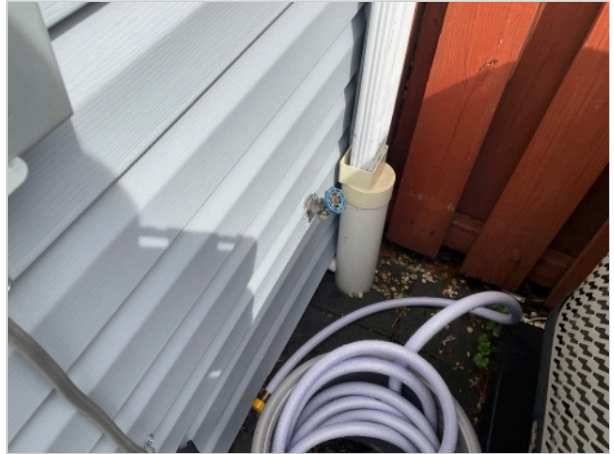
Exterior hose bibs did not function when tested. During winter months and times of colder temperatures, homeowners often turn off hose bibs from the interior to prevent pipes from freezing and bursting. Due to the possibility of uncontrollable leaks at the faucet handle if activated, HomeTeam does not activate shutoff valves. Once temperatures remain safely above freezing the client should check the hose bibs for proper operation.

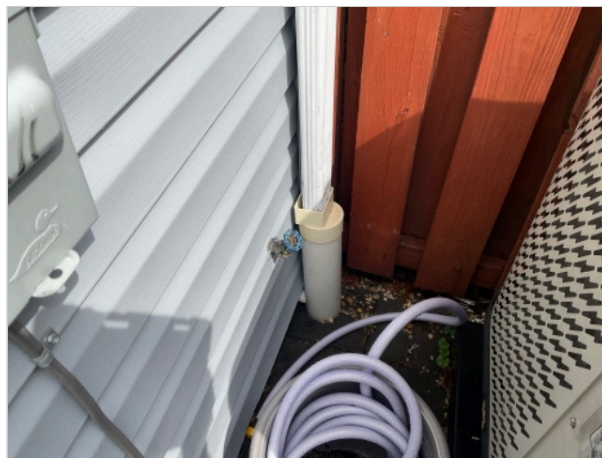
Photo 7

Some of the downspouts around the structure are draining into the ground with no conclusive termination point. HomeTeam recommends ensuring termination points for all downspouts is far enough from the structure and configured in such a way as to ensure water flows away from the foundation during periods of rain.

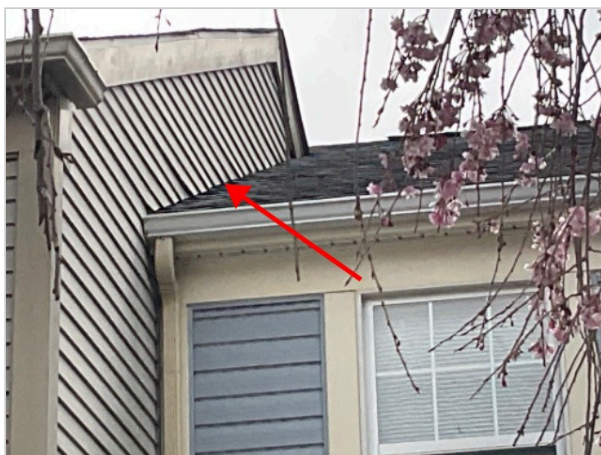
Photo 12

1. Flashing is not installed at the wall of adjacent townhouse, which may lead to water intrusion and damage.
2. One or more popped nails were noted on the roof at the time of the inspection.

Flashing is not installed at the wall of adjacent townhouse , which may lead to water intrusion and damage. Consult with a qualified roofer for installation or repair.

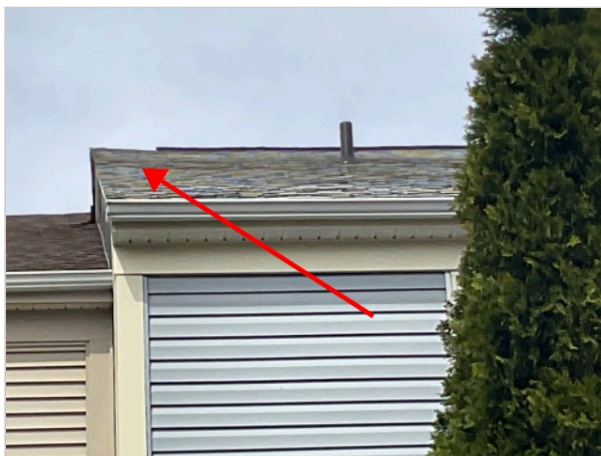
Photo 13

One or more popped nails were noted on the roof at the time of the inspection. A popped nail can be identified by a lifted corner on a shingle. The heating and cooling of the roof will often cause roofing nails to lift under the shingles, causing the corner to lift. While it is not likely that the condition is causing a leak, the nails should be reset and sealed to prevent wind from getting under the shingle and possibly lifting the shingle off the roof. Consult with a qualified roofer for repair.

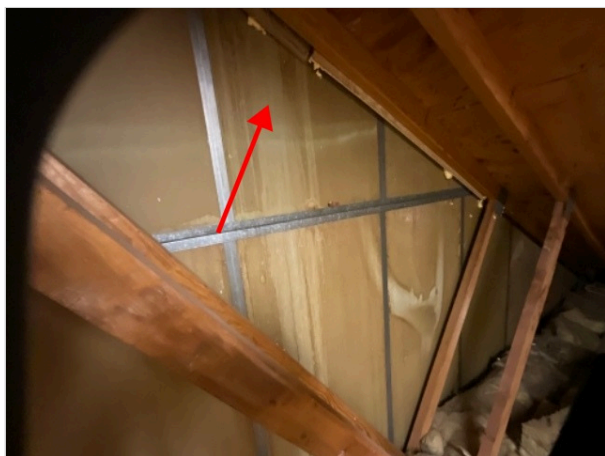
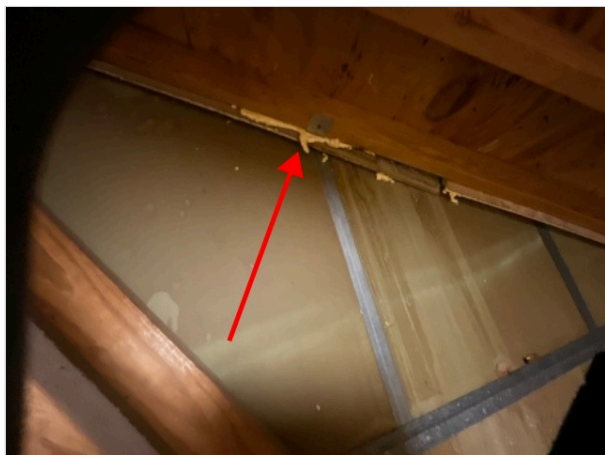
Parts of the attic show signs of previous water intrusion. These areas also show signs of a possible previous repair with spray foam. The areas were dry at the time of the inspection. The buyer should maintain vigilance in monitoring the areas for any recurrence of the previous issue and should rectify any issues immediately upon observing them.

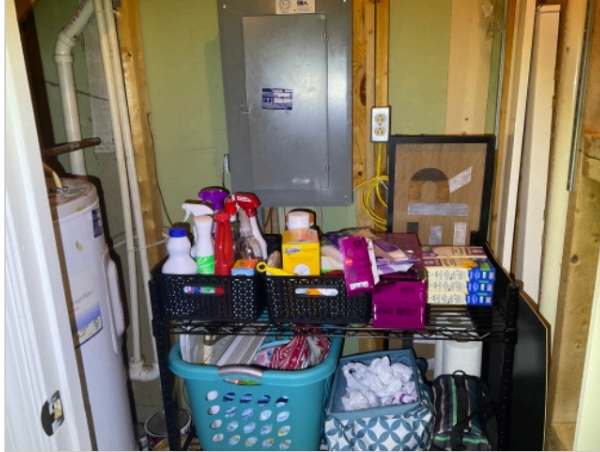
Photo 31

Items should not be stored immediately in front of the main electrical panel. There should be a clearance of at least 36 inches in front of the panel for access.

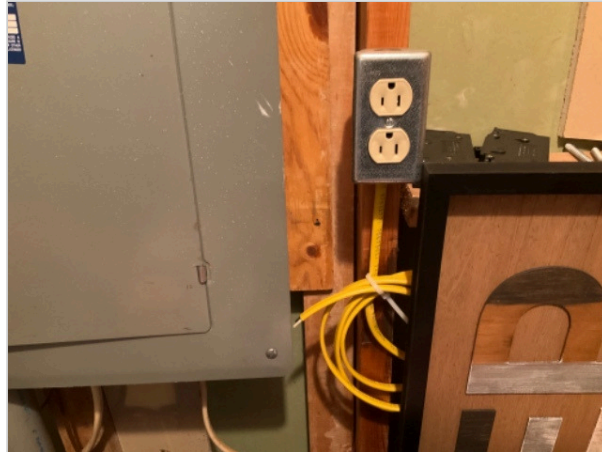
Photo 37

The outlet in the utility closet was not wired.

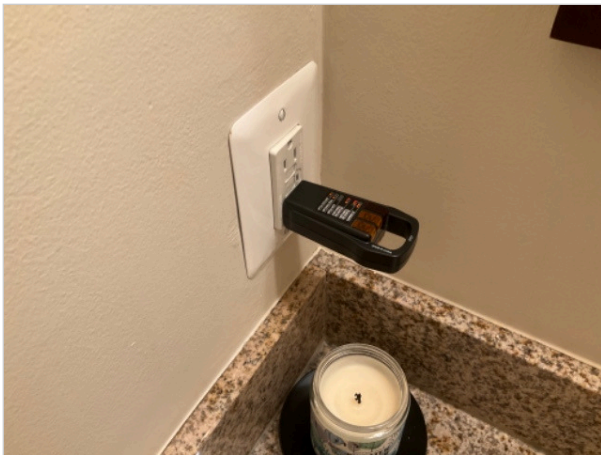
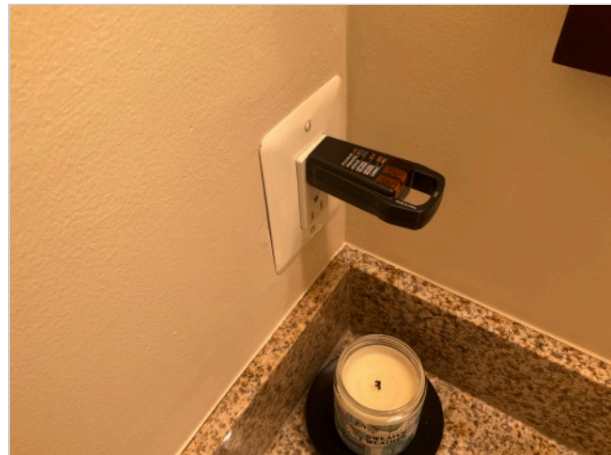
One outlet was not functional. GFCI protection was missing deeming it a safety concern. Consult with a qualified electrician for repair and further assessment of outlets.

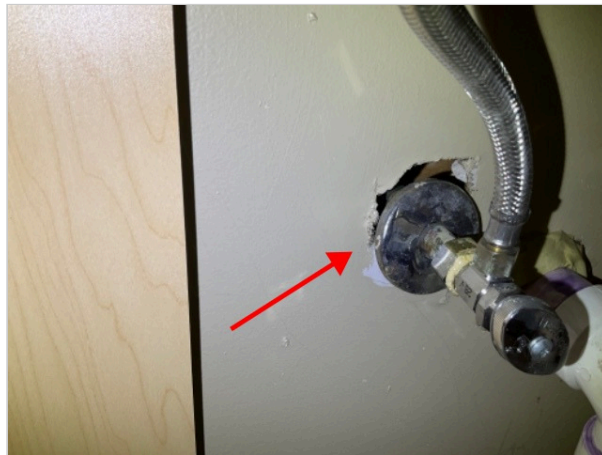
Photo 44

The hot water valve is not secured to the wall.

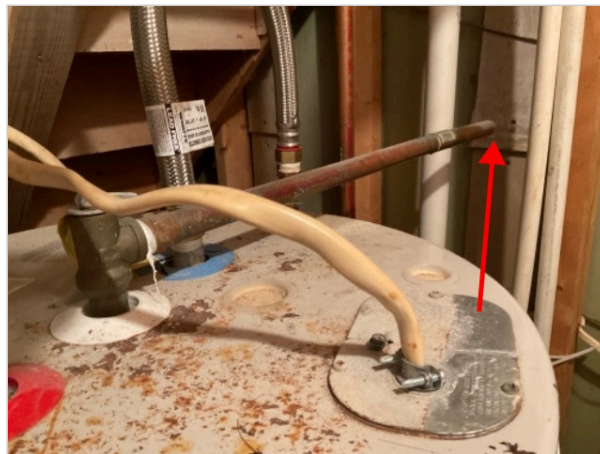
Photo 50

1. The water heater overflow leg does not terminate properly and should be repaired or rerouted.

The water heater overflow leg does not terminate properly. The overflow leg should be repaired/replaced with one that terminates properly.

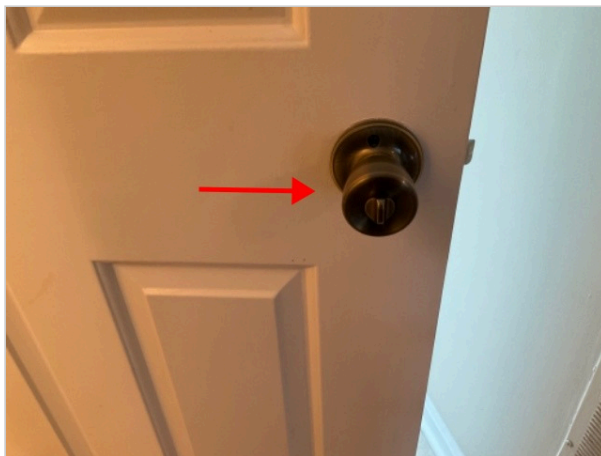
Photo 57

1. An interior door lock is inoperable or otherwise in need of repair.

The half bathroom door lock is inoperable or otherwise in need of repair. For personal security consult with a qualified locksmith for repair.

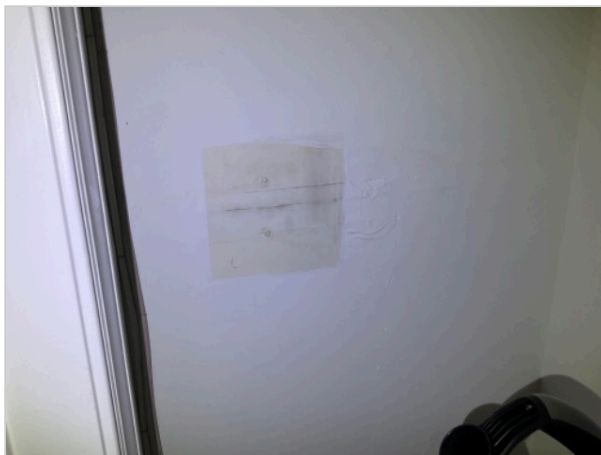
Photo 58

Previous repairs are evident in the structure. The presence of repairs does not indicate any current or ongoing issue. However, HomeTeam is not able to see behind areas of repair and is unable to determine if the cause of the previous damage has been corrected. Monitor and correct as needed.

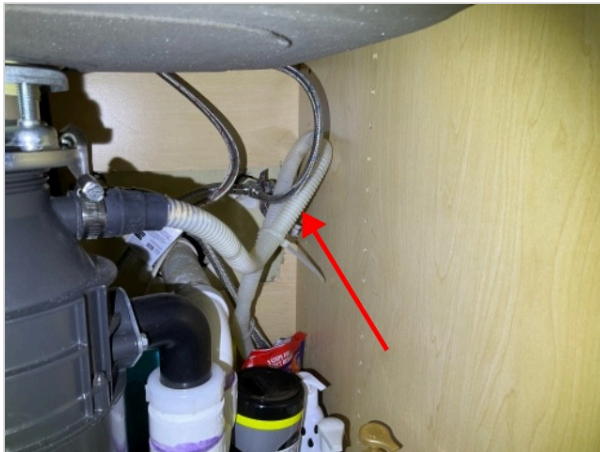
Photo 68

The dishwasher did not appear to have an anti-siphon device installed in the drain line. An anti-siphon device prevents cross contamination between potable water and wastewater. Consult with the manufacturer to determine if this particular model requires an air gap or external high loop (some are integrated and are not visible). If so, HomeTeam recommends having an anti-siphon valve (air gap) installed or the drain hose looped higher than the attachment point of the drain hose (high loop) to the disposal/plumbing drain by a qualified contractor.

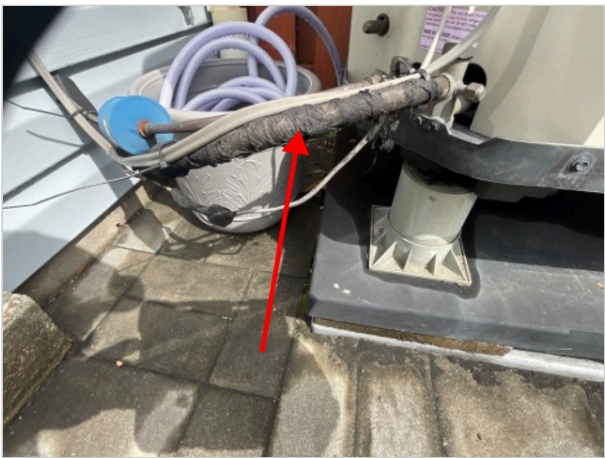
Photo 79

The unit has deteriorating condensate line insulation.
