HomeTeam[®]

HOME INSPECTION REPORT

On Saturday, August 4, 2018 The HomeTeam Inspection Service made a visual inspection of 123 Sample Dr, Anytown, AZ 55555. Enclosed please find a written, narrative report of our findings in accordance with the terms of our Inspection Agreement.

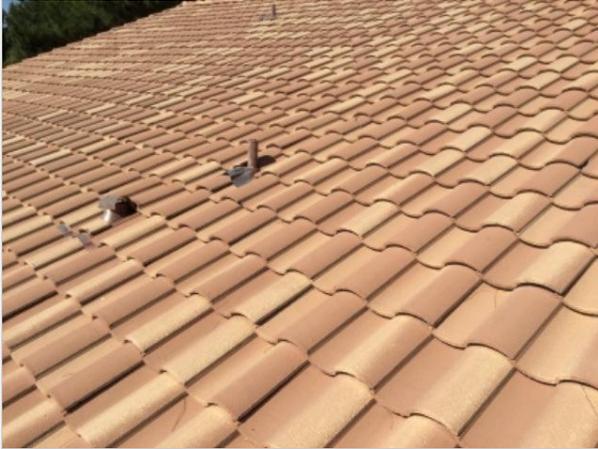
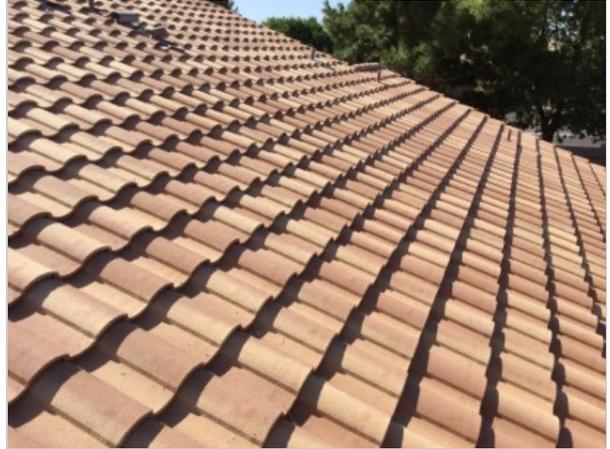
> **Concrete mortar packs missing or cracked were observed.** Suggest repair or replacement by a qualified roofing contractor.

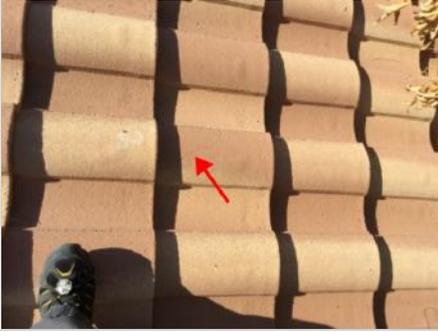
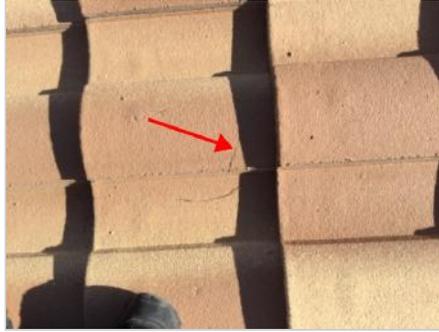
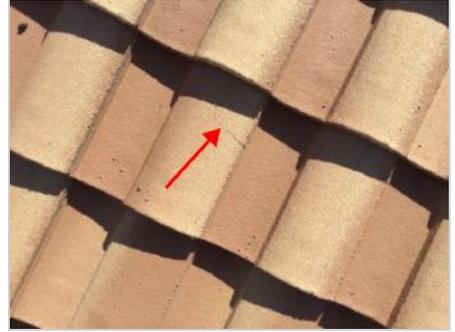
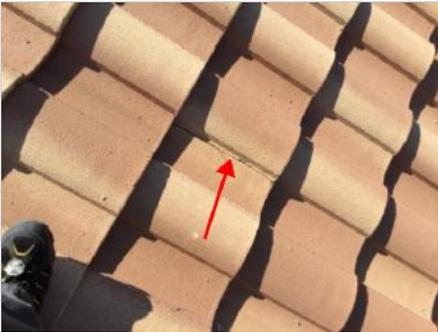
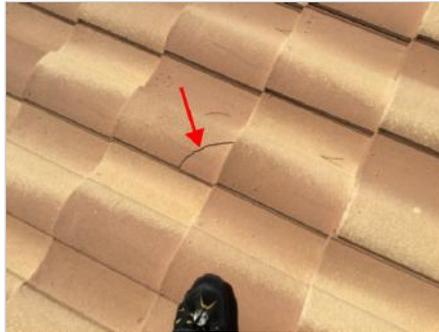
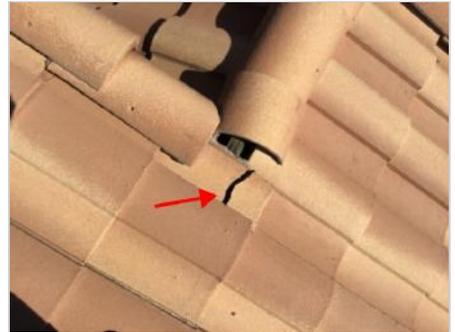
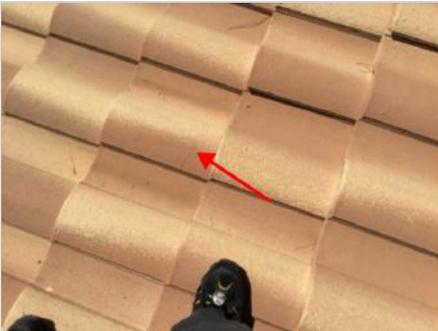
> **5 to 10 cracked, slipped, or missing concrete tiles were observed.** Suggest repair or replacement by a qualified roofing contractor.

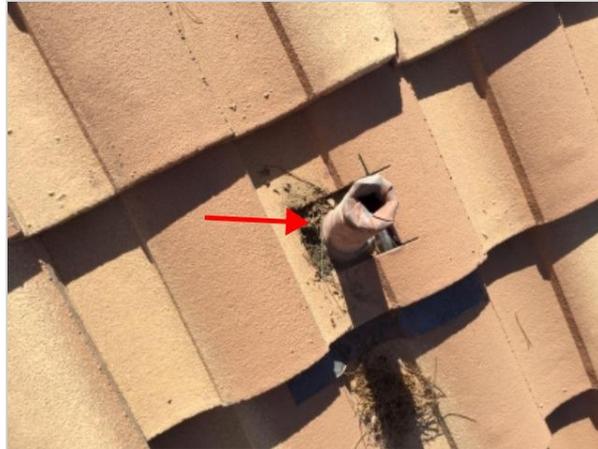
Photo 16

> **Excessive leaves and other debris were observed on roof.** This debris can trap moisture on roof and cause deterioration of the roofing material.

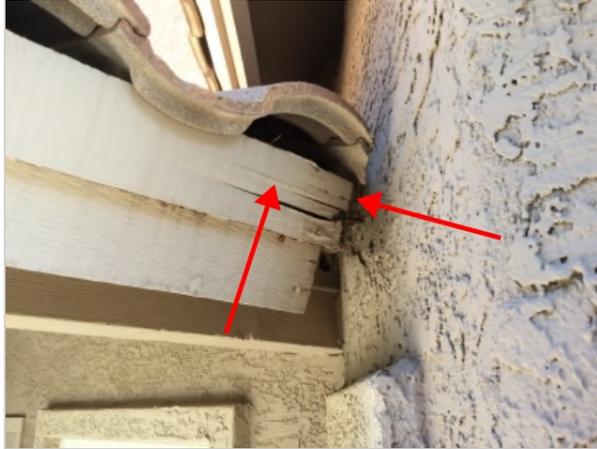
Photo 17

> **Fascia board showing signs of previous moisture intrusion through either splitting, staining, warping or surface degradation.** Suggest evaluation by a qualified party to determine where moisture is/was being introduced. Once the moisture intrusion has been eliminated, the fascia boards should be repaired or replaced as necessary.

Rear Patio Area

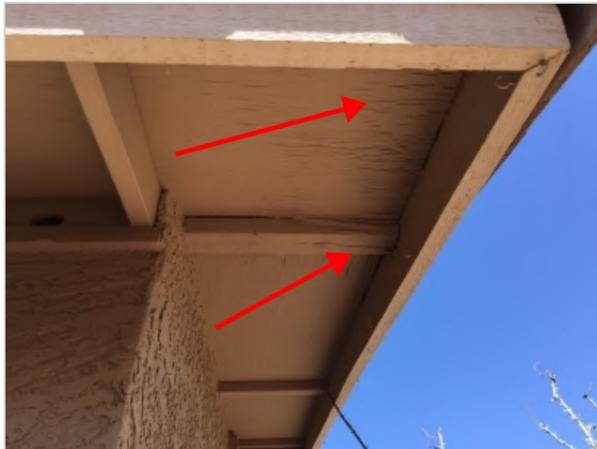
Photo 18

> **One under-eave areas found with evidence of prior moisture intrusion.** Suggest repair by a qualified roofing professional to fix moisture intrusion and assess damage to sheathing.

Front Left Corner

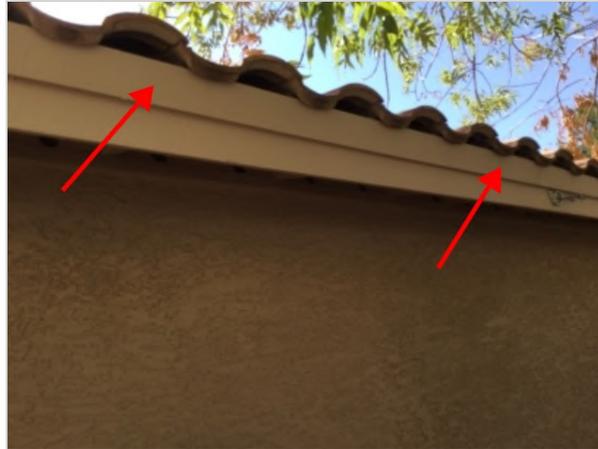
Photo 19

> **Flashing is not installed at the fascia board, which may lead to water intrusion and damage.** Consult with a qualified roofer for installation or repair.

Right Side

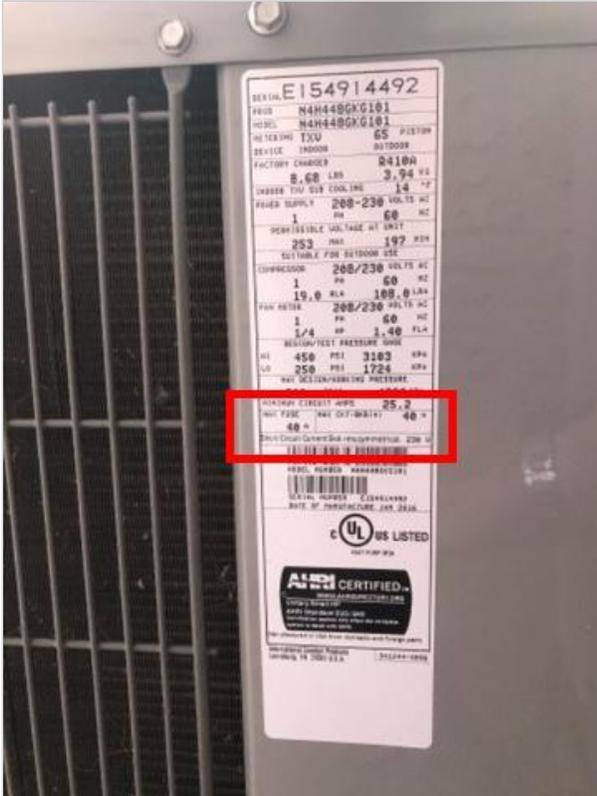
Photo 24

> HVAC unit does not have the correct fusing or breakers based on the information on the HVAC label. Suggest repair by a qualified HVAC technician or qualified electrician.

Outdoor Unit- Max Fuse 40 Amp

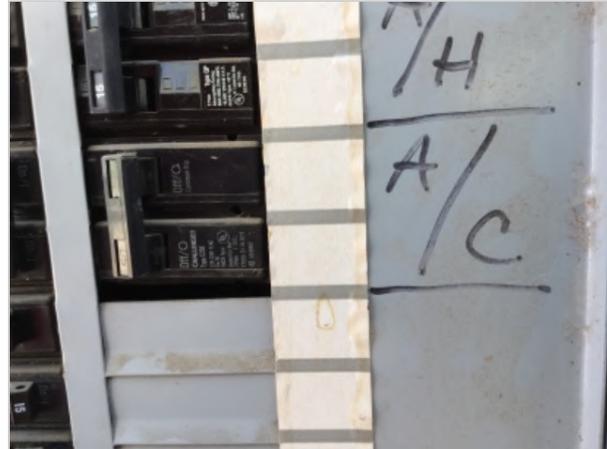
Photo 25

Circuit Breaker- 50 Amp

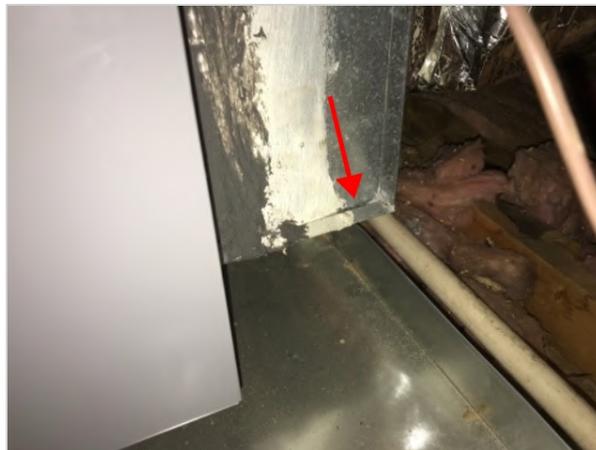
Photo 26

> **At least one location on and around air handler where conditioned air is escaping into attic.** Suggest review and repair by a qualified HVAC technician to maximize cooling efficiency of system.

Right Side of Air Handler

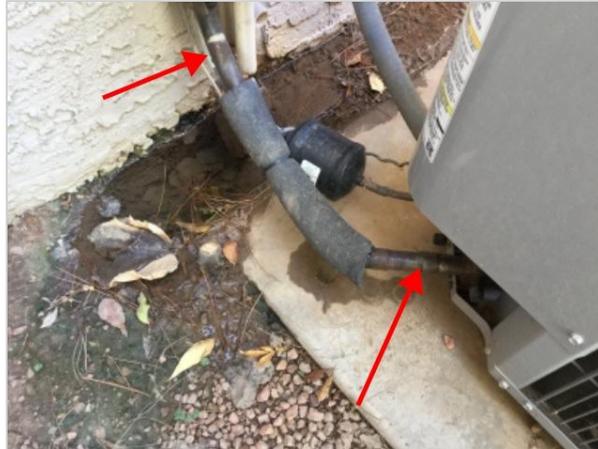
Photo 27

> **The insulation on the air conditioning line set is missing.** This could affect the efficiency of the system and should be replaced.

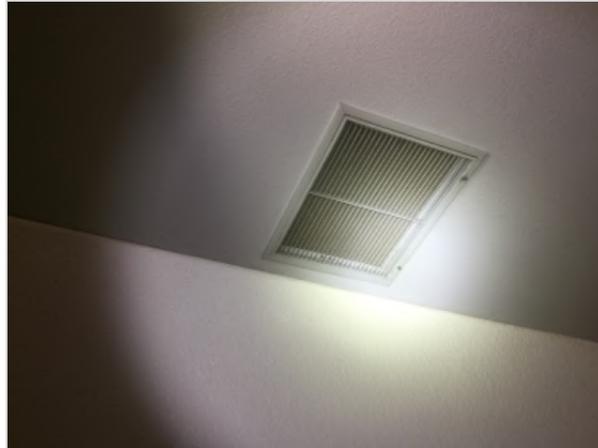
Photo 29

> **The air filter is very dirty and should be replaced.** Clogged and dirty filters affect the performance and efficiency of the HVAC system. A clogged filter can also cause damage to the system. The filter should be replaced immediately upon taking ownership of the structure.

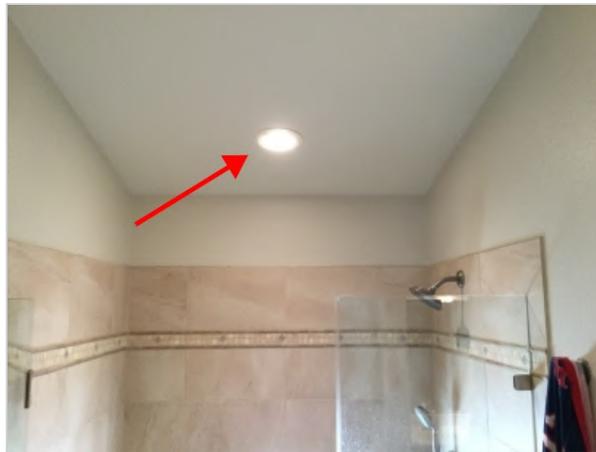
Photo 33

> **The shower light installed in the master bath is not suitable for use in wet locations and may present a safety hazard. The fixture should be replaced or repaired.**

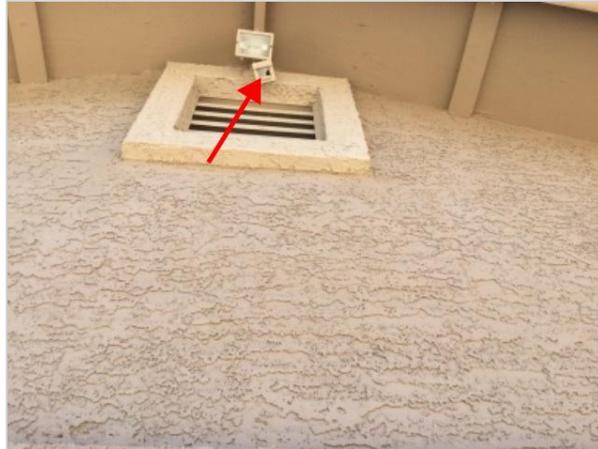
Photo 34

> **At least one light fixture appeared to be broken. Suggest repair or replacement by a qualified party.**

Above Garage Door

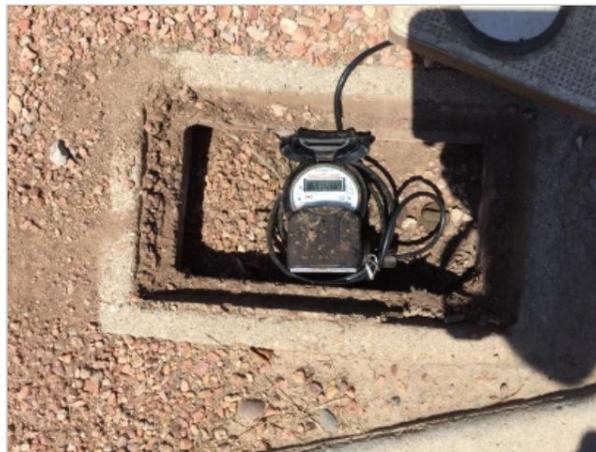
Photo 39

> **Water meter enclosure partially filled with rocks and dirt.** Suggest that this enclosure be cleaned out to allow access to water meter as well as meter shutoff actuation.

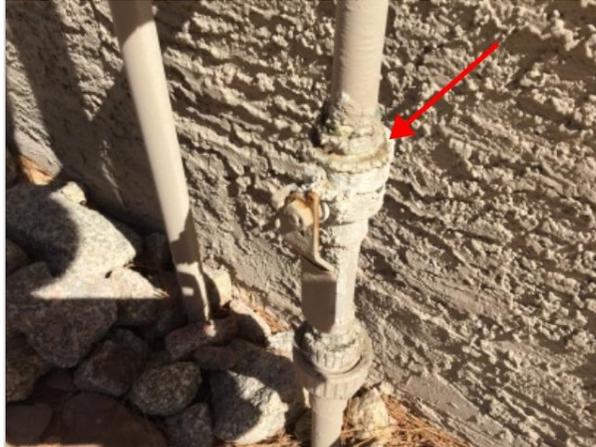
Photo 42

> **Active water leaks were present at supply lines the time of the inspection.** The affected areas should be repaired, and nearby or associated plumbing lines should be further assessed at the time of the repair.

Rear Right Side

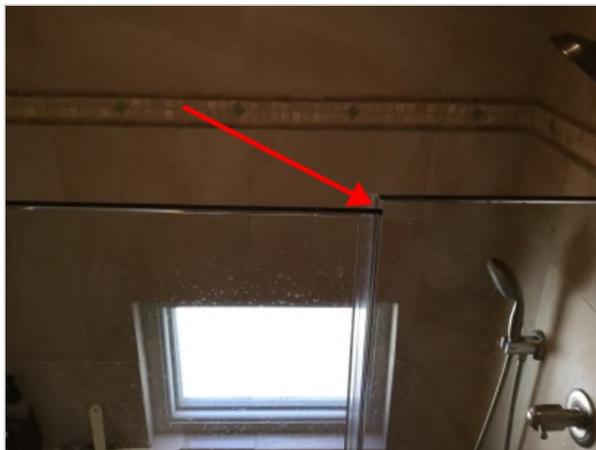
Photo 43

> **Shower door requires adjustment to ensure that the door closes properly.** Without adjustment, either the shower door or the stationary glass panel will eventually get chipped. Suggest repair by a qualified party such as the company that installed the shower door.

Master Bath

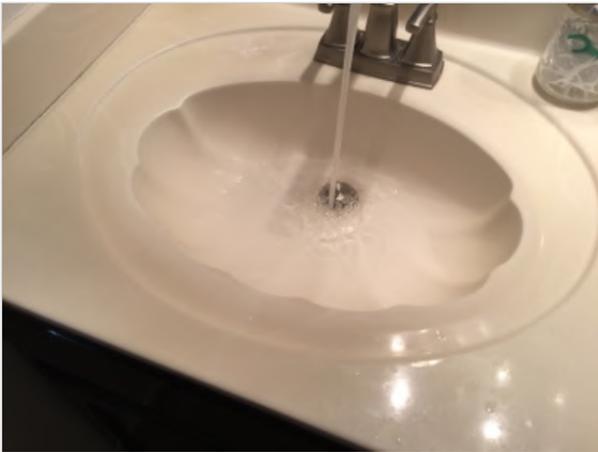
Photo 44

> **The sinks in both bathrooms drain very slowly,** indicating a possible obstruction in the drain line or vent.

Master Bath- Left Sink

HomeTeam recommends having the affected line cleared and other lines further assessed at the time of clearing.

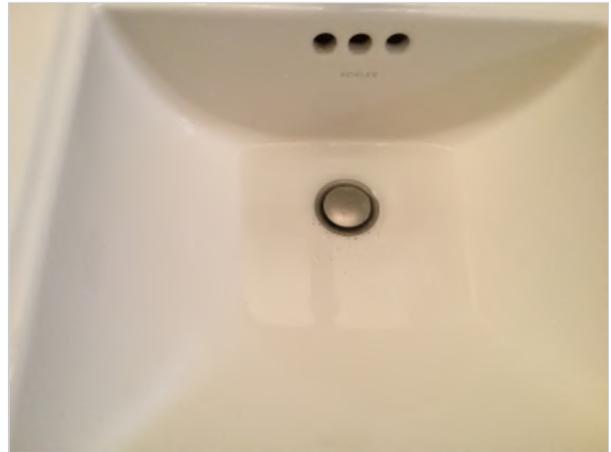
Photo 45

Hall Bath

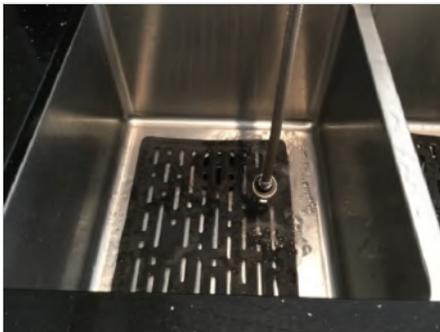
Photo 46

> **Cross connections observed and noted.** Cross connections are a possibility wherever supply plumbing and solid or liquid waste could come together and contaminate potable water with waste to create a serious health issue. Home inspection standards require the inspector to look for and call out any cross connections observed.

Kitchen Sink

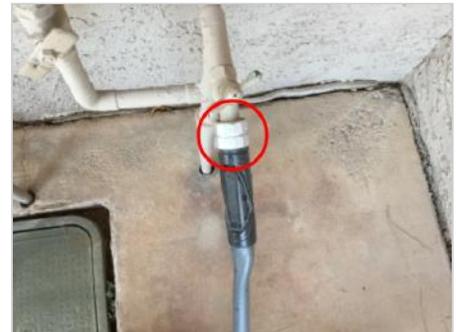
Photo 48

No Vacuum Breaker

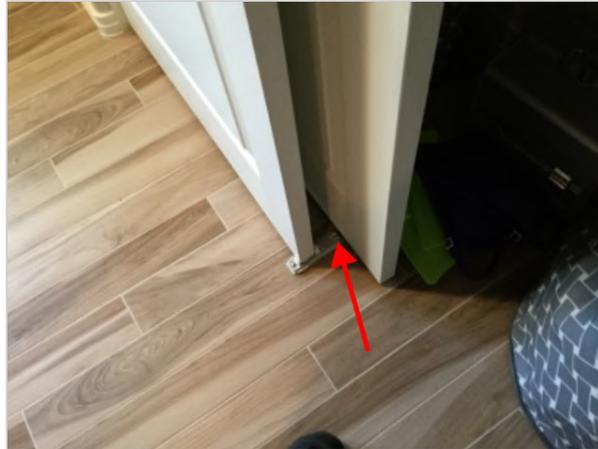
Photo 51

> **Closet door hardware missing or in need of repair.** Suggest repair or installation by a qualified party.

Left Front Bedroom Closet

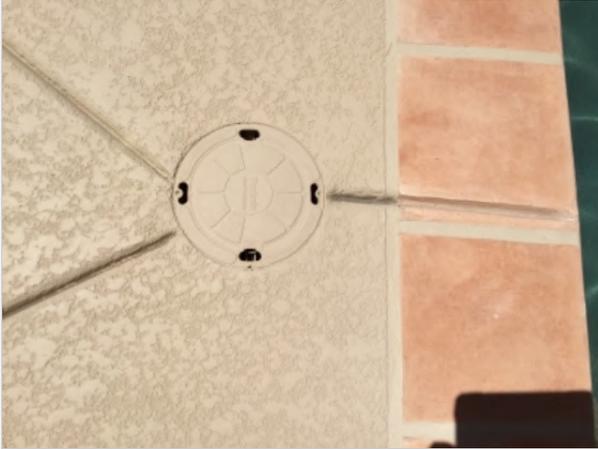
Photo 60

> The self-fill system appeared to be damaged and/or inoperable at the time of the inspection. This could preclude proper water levels and functioning of the pool circulatory and filter systems. Recommend they be evaluated by a pool specialist for repair or replacement as necessary.

Cover Painted in Place

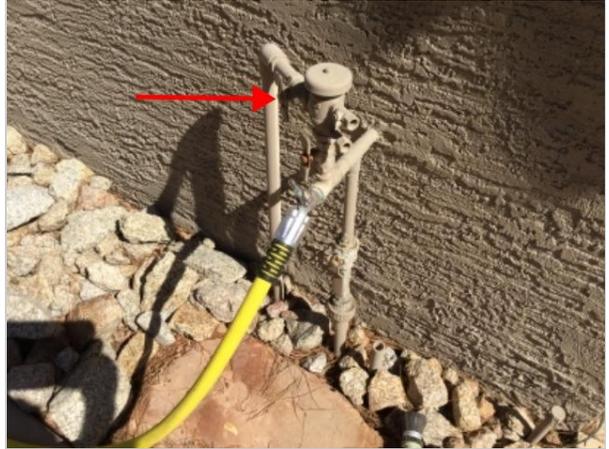
Photo 61

Valve Off

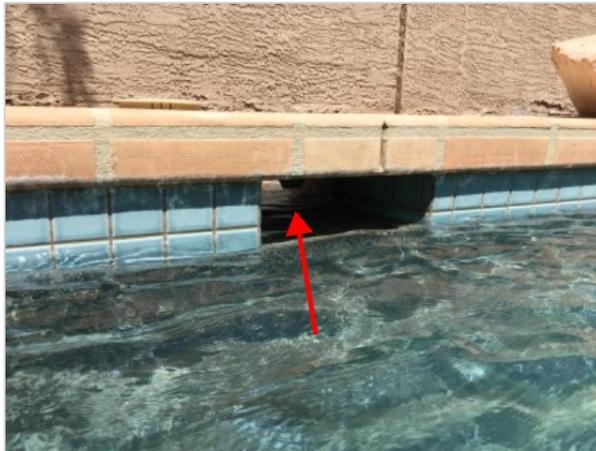
Photo 62

> **Weir valve on skimmer is missing or damaged.** The weir valve functions to keep debris pulled into skimmer from floating back into pool/ spa. Suggest repair or replacement by an authorized party.

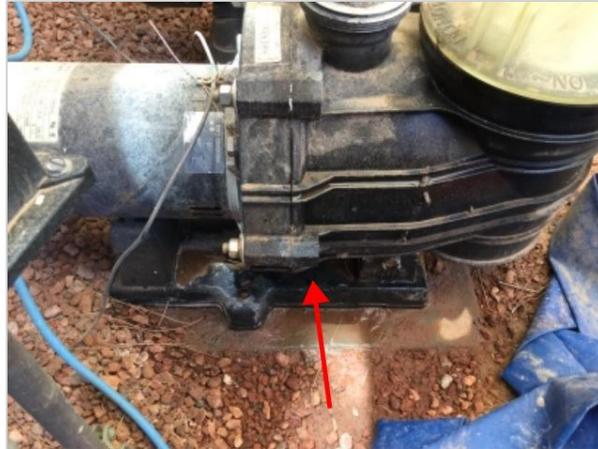
Photo 63

> **Leaks were observed in the pool circulatory system.** In addition to water loss and issues this could introduce air into the system and cause damage to the pump and filter. Recommend that the cause of the leak be determined and corrected by a qualified party to ensure proper function of the circulation and help prevent damage to components.

Water Feature Pump Leaking

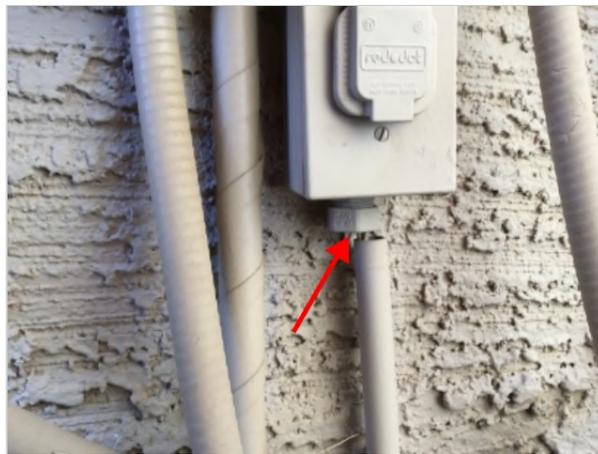
Photo 67

> **Conduit has separated in at least one area.** Suggest repair by a qualified electrician to insure that wiring is properly protected.

Pool Light Power

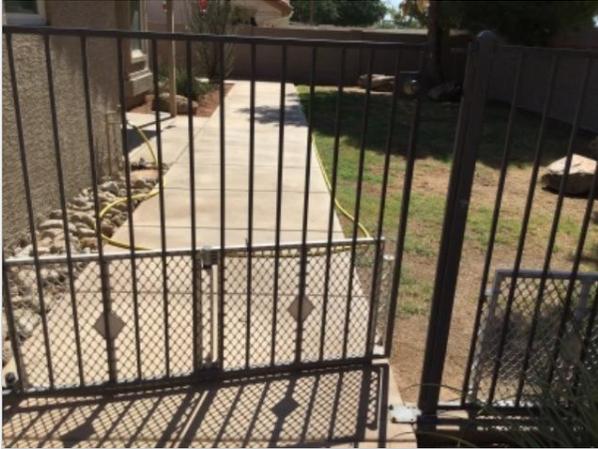
Photo 68

Spring Requires Adjustment

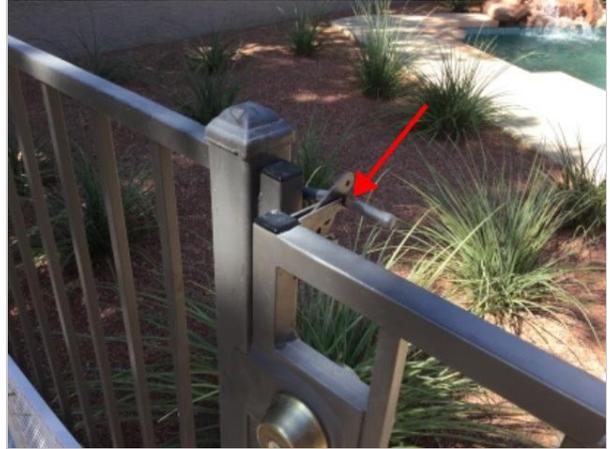
Photo 69

Gate Requires Adjustment
