# HomeTeam<sup>®</sup>

### HOME INSPECTION REPORT

On Sunday, October 18, 2020 The HomeTeam Inspection Service made a visual inspection of 1234 Smith Road on Main Street in Libertyville. Enclosed please find a written, narrative report of our findings in accordance with the terms of our Inspection Agreement.

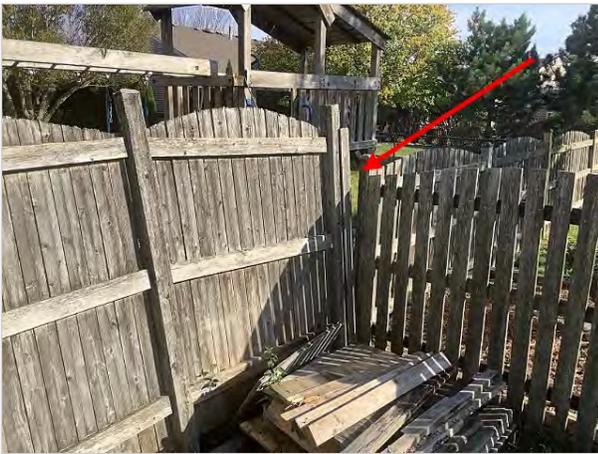
Photo 1

Gap in right corner from fence falling away at left

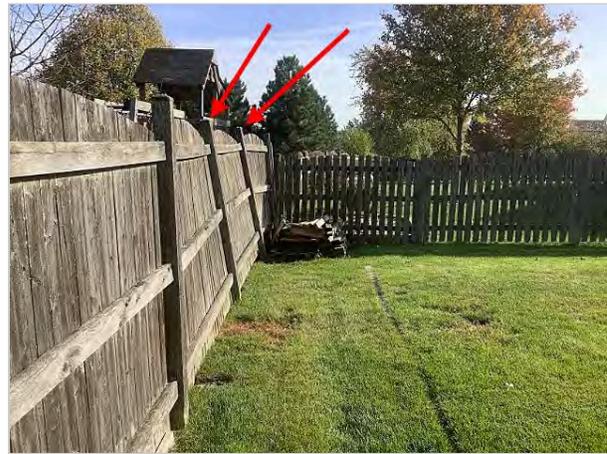
Photo 2

Main fence vertical supports weak and failing - fence loose and swaying away

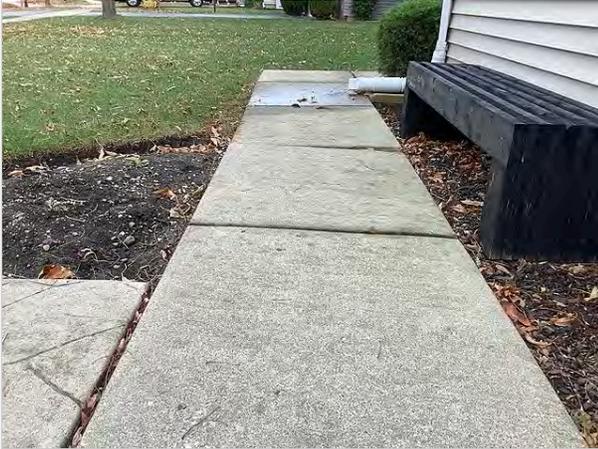
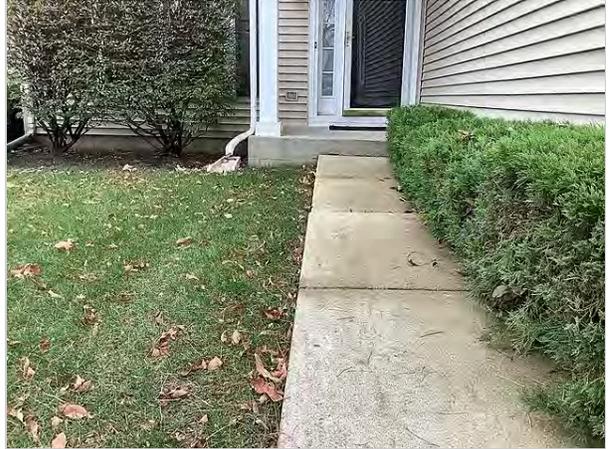
**Trip hazard present on the walkway to the front entrance.** The hazards can be repaired using a suitable or similar surfacing material to "feather" the out-of-level condition to make a smooth transition.

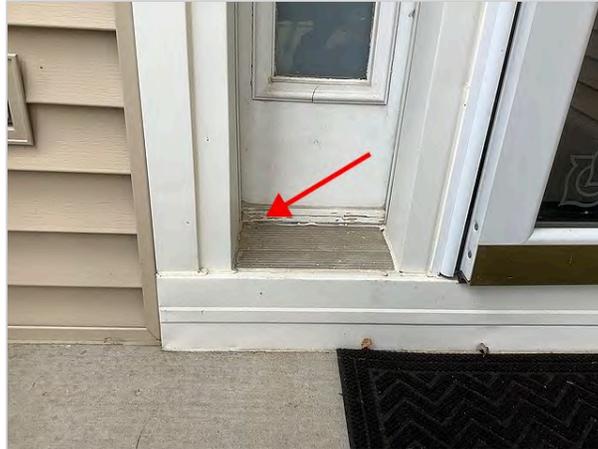
**Photo 7**

**Exterior caulking penetrations is cracked or missing.** The caulking should be repaired or replaced to help prevent water intrusion.

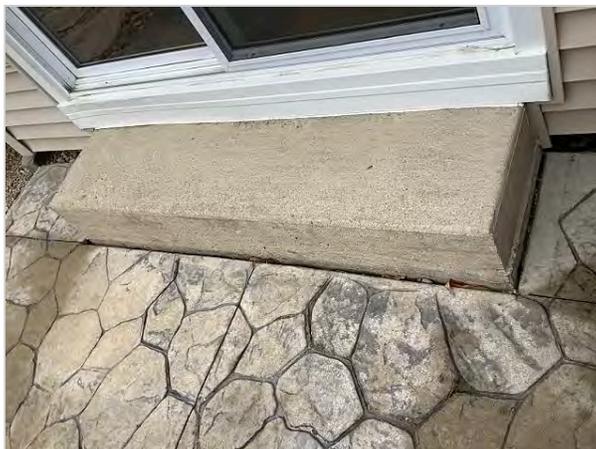
**Photo 11**

A gap was observed at the patio around the rear stoop. These areas can allow water to penetrate and cause further unseen damage. Penetrating water could create unseen problems with the structure. It is recommended that these areas be repaired as needed to help prevent water penetration.

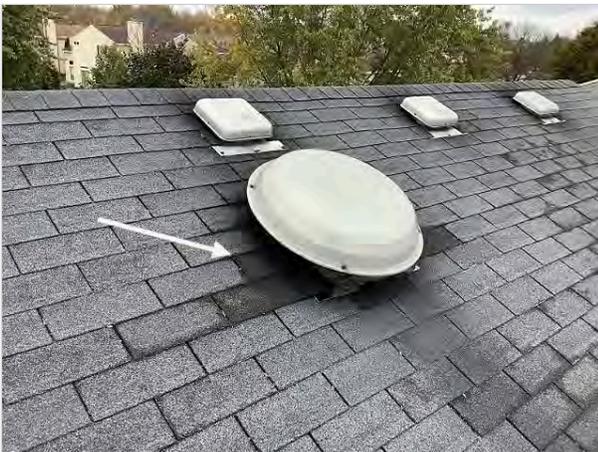
Photo 19

Previous repairs were evident on the roof. These signs may indicate exterior damage, problems with installation, age, previous water intrusion, or other factors, all of which should be considered when evaluating the health of the roof.

Newer shingles around attic fan

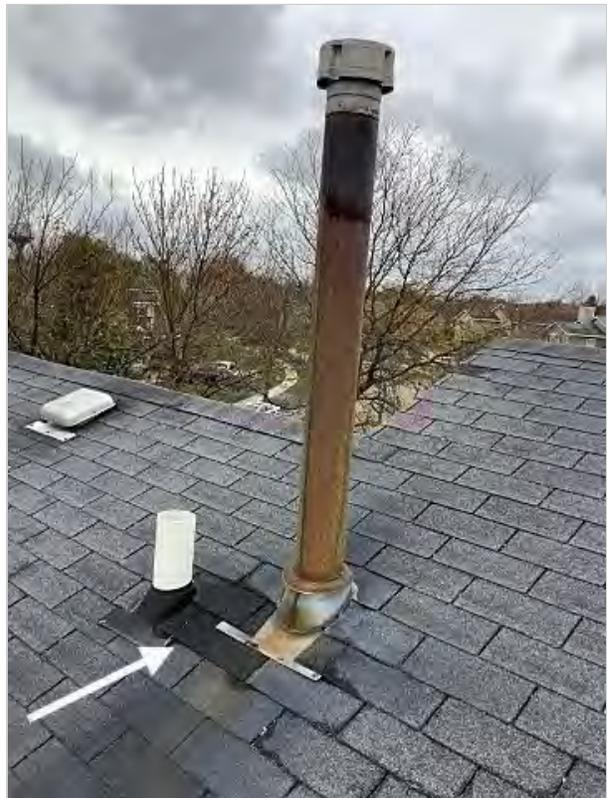
Photo 20

Newer shingles around plumbing and gas exhaust vents

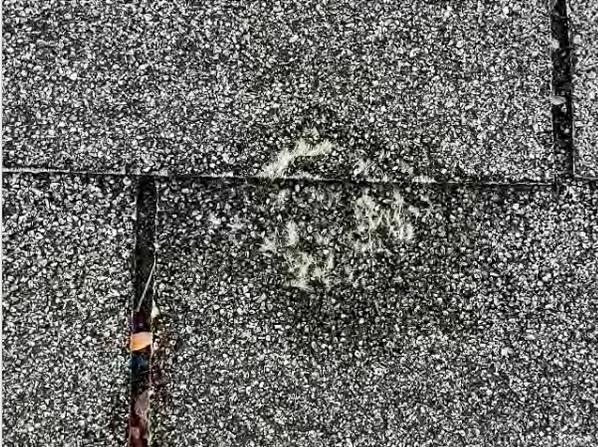
Photo 21

**The roof appears to be at or near the end of its life** and requires evaluation by a professional roofer for remaining viability.

Aggregate worn through - fiberglass reinforcing fibers visible

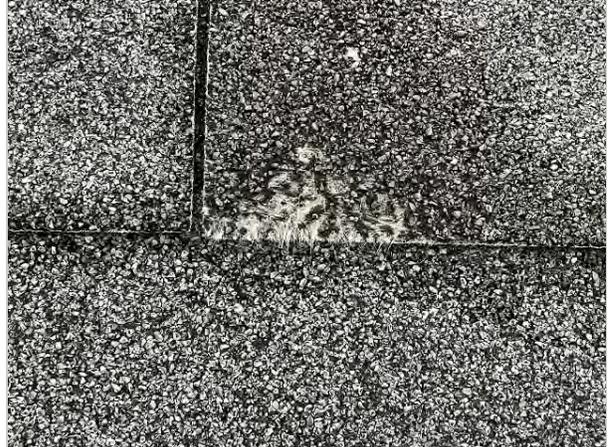
Photo 22

Aggregate worn through - fiberglass reinforcing fibers visible

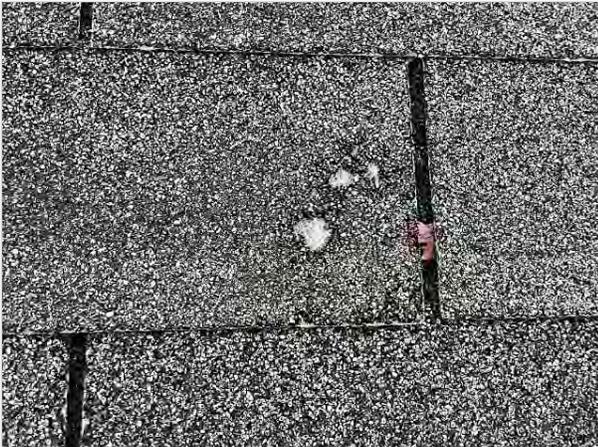
Photo 23

Aggregate worn through - fiberglass reinforcing fibers visible

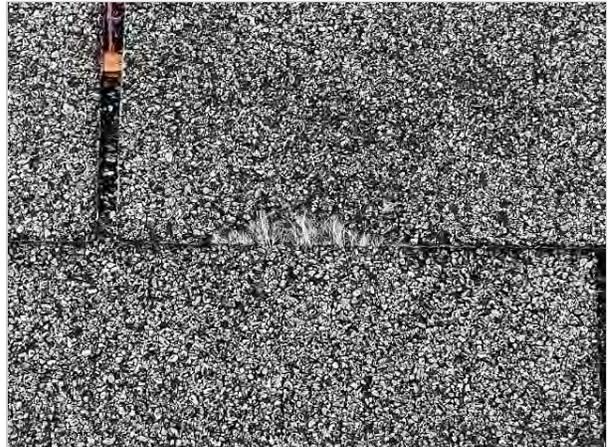
Photo 24

Aggregate worn through - fiberglass reinforcing fibers visible

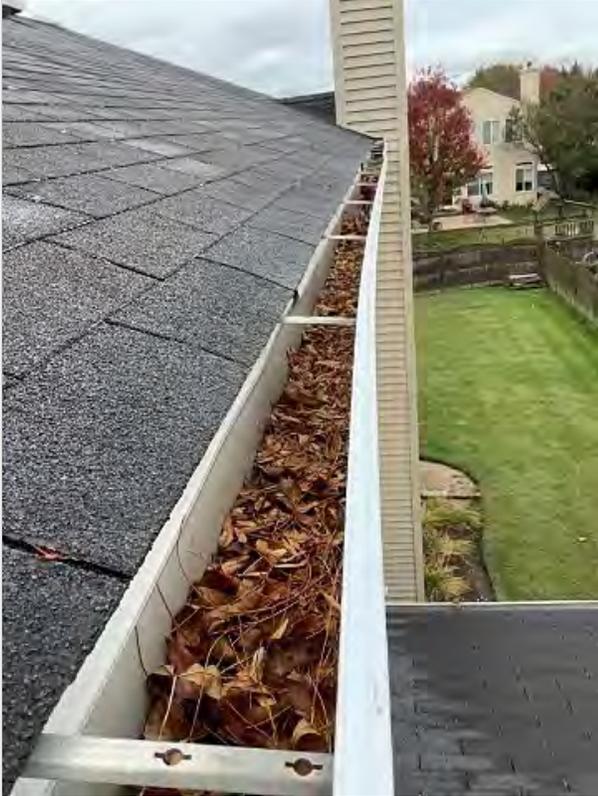
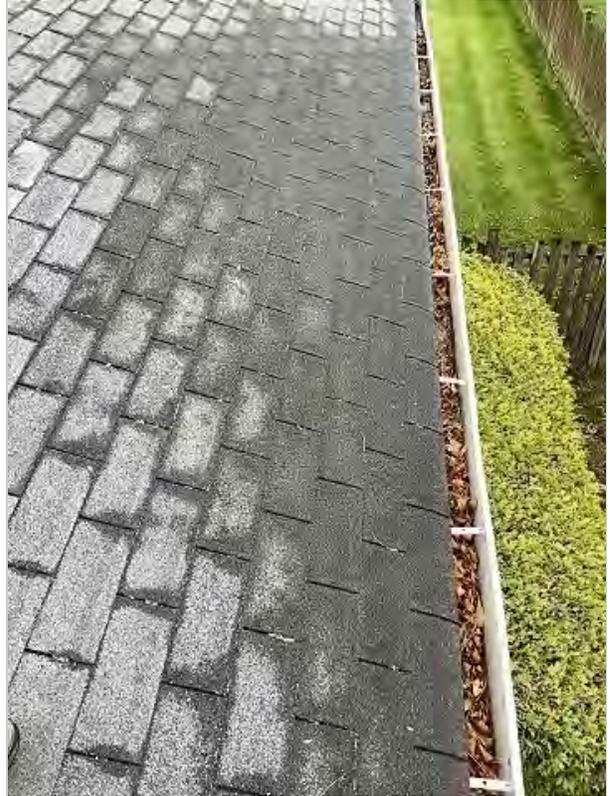
**Gutters were in need of cleaning at the time of the inspection.** Clogged gutters can cause roof drainage water to drain at the base of the foundation, causing basement water problems. Overflow from gutters can cause damage to fascia that is not visible or apparent at the time of the inspection. The gutters should be cleaned.

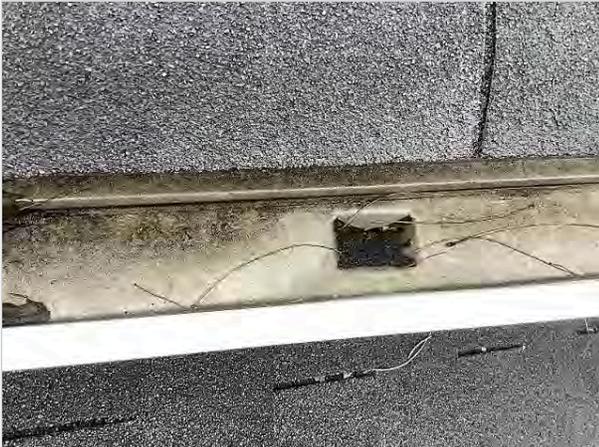
**Photo 31**

**Some of the downspouts are missing and draining improperly onto the roof.** HomeTeam recommends ensuring termination points for all downspouts are extended directly into the roof gutter system to prevent premature wearing of roofing materials and configured in such a manner to ensure all water flows away from the foundation during periods of rain.

Missing downspout - gutter draining directly onto roof below

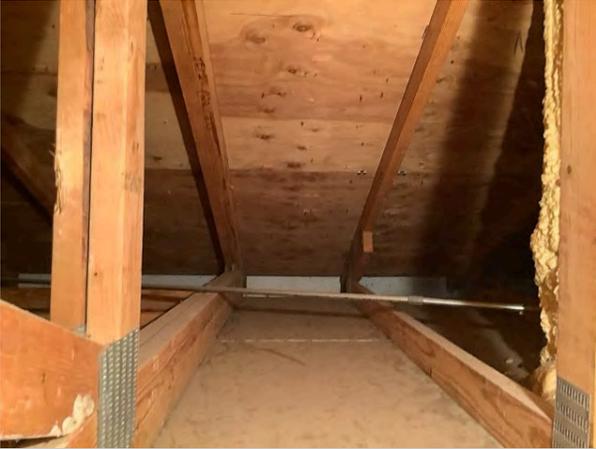
**Photo 47**

No insulation observed in garage ceiling or rafters

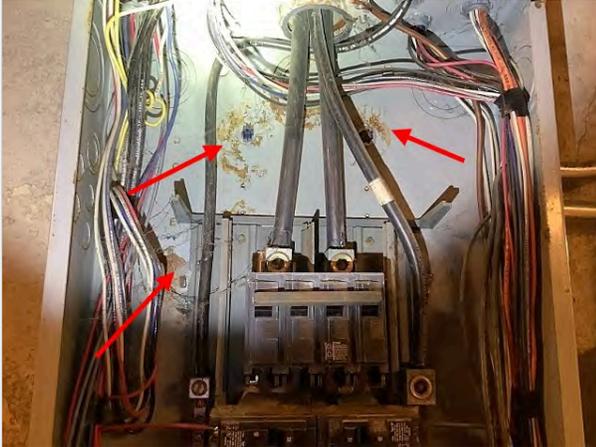
Photo 58

**Corrosion was observed on the metal electric panel due to direct contact with the concrete foundation wall.** The electrical connections inside the box have not been affected by corrosion; however, oxidation potential exists in its current state. HomeTeam recommends that a licensed electrician further evaluate the condition of the electrical panel for possible insulating/isolating solutions that separate it from direct contact with the wall.

Corrosion in main electrical panel due to condensation from metal box being attached directly onto concrete wall

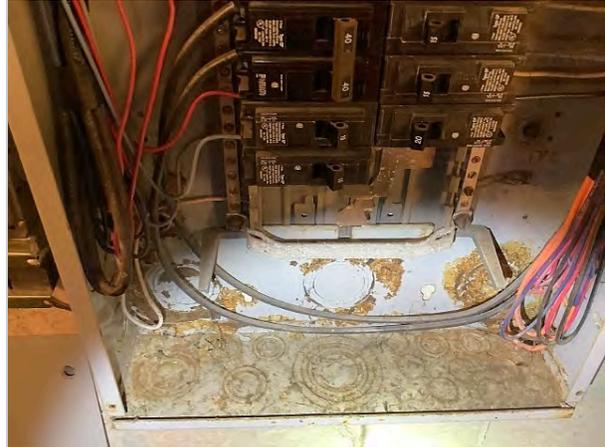
Photo 59

Corrosion at bottom of electrical panel

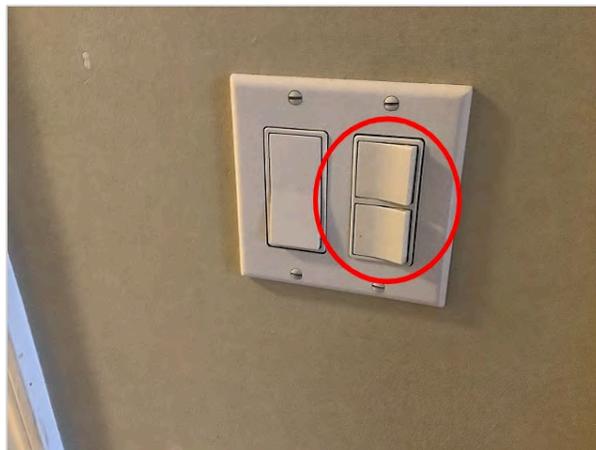
Photo 60

Could not identify function of these two switches in upper level hallway

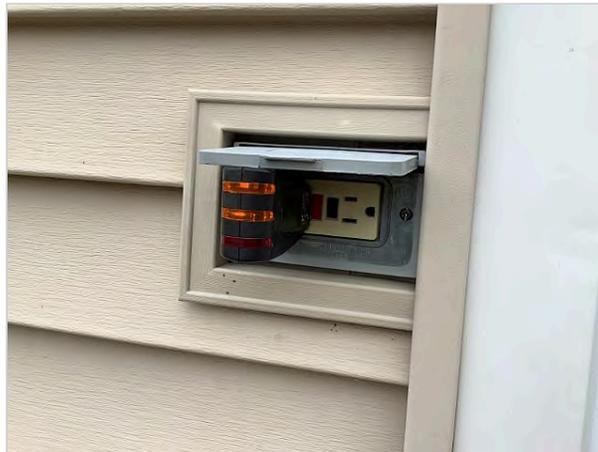
**Photo 61**

The GFCI receptacle on the rear patio was loose and needs to be resecured.

GFCI functions well however electrical outlet box is loose and needs to be resecured

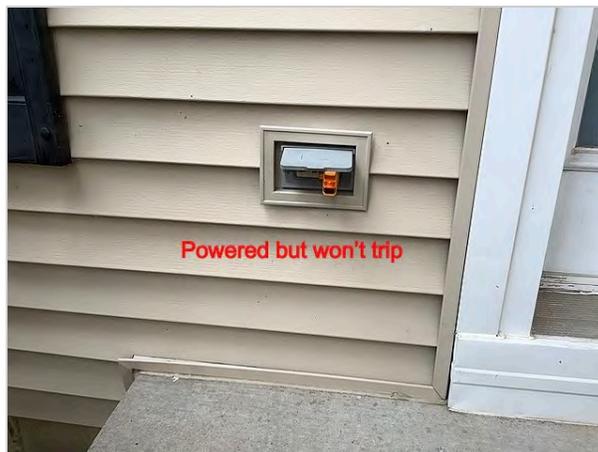
**Photo 62**

**The GFCI outlet located on the front porch is defective and should be replaced.**

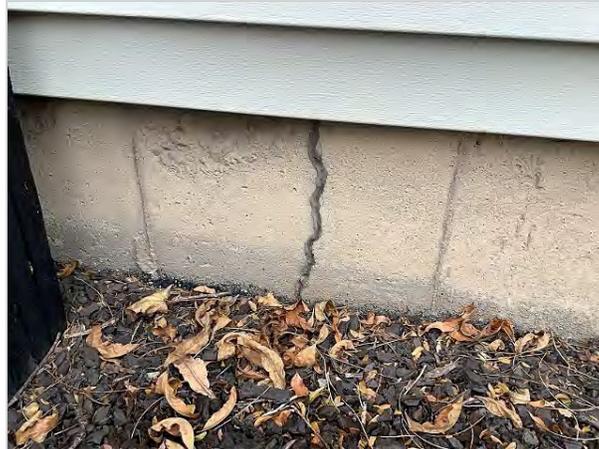
**Photo 63**

A crack was observed at the foundation wall. These areas can allow water to penetrate and cause further unseen damage. Penetrating water could create unseen problems with the structure. It is recommended that these areas be closely monitored for water intrusion and professionally sealed as needed to help prevent water penetration.

Sealed crack observed on front foundation wall - no water intrusion found on inside wall surface (crawl space)

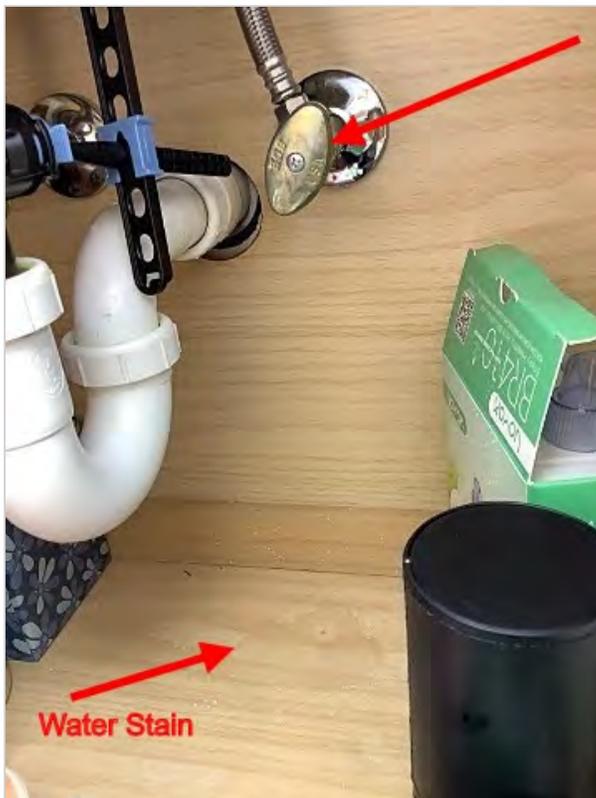
Photo 85

**Active water leaks were present at supply lines at time of inspection.** The affected areas should be repaired, and nearby or associated plumbing lines should be further assessed at the time of the repair.

Upper level hall bath - left sink - cold water supply line shutoff valve leaks when turned on - currently turned off to prevent leaking

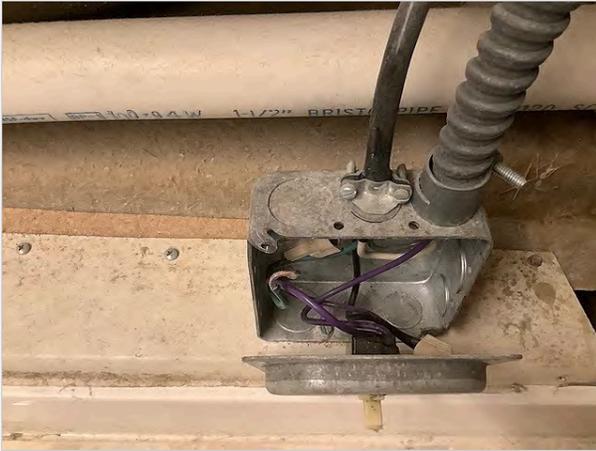
Photo 87

1. Corrosion was observed inside the main electric panel due to condensation from direct contact with the concrete foundation wall.
2. A GFCI circuit for the jetted tub was not present. Consult with a licensed electrician to improve safety of this device.

GFCI missing

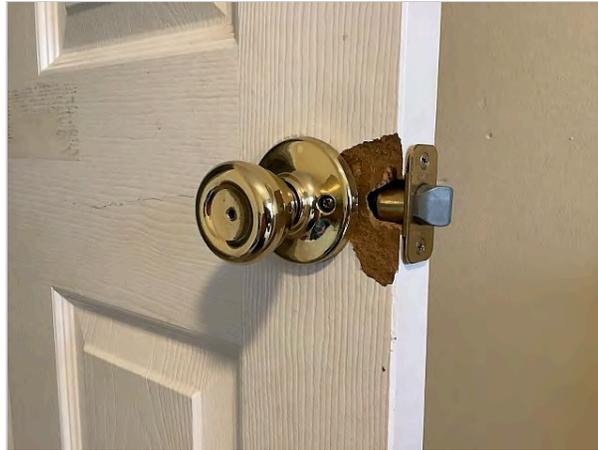
**Photo 97**

Front bedroom door damaged

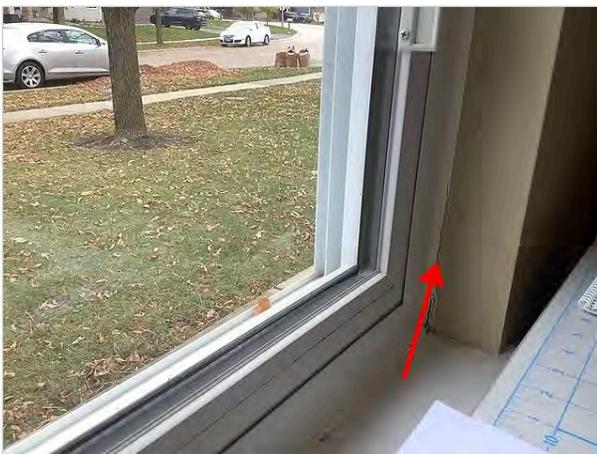
**Photo 98**

**The interior caulking between the window and frame is cracked and deteriorated.** The caulking should be re-sealed to help direct rain water away from the structure.

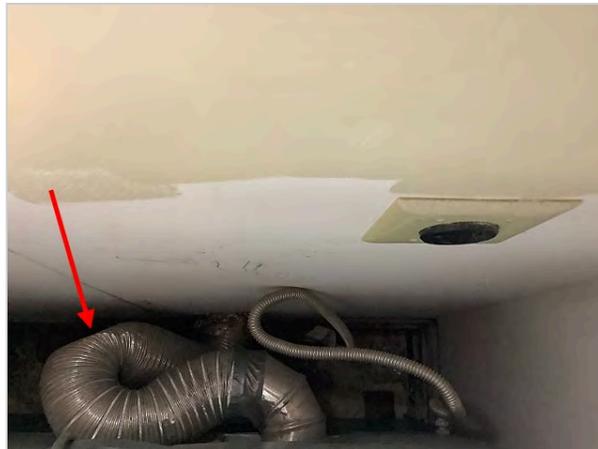
**Photo 115**

**The dryer vent has been reduced in size from the required 4-inch pipe.** To prevent clogs and lint buildup, the dryer vent pipe should consist of 4-inch pipe its entire length as it vents to the exterior of the structure. Consult with a qualified contractor for repair/replacement to ensure full size exhaust venting.

Slightly crushed and reduced in size

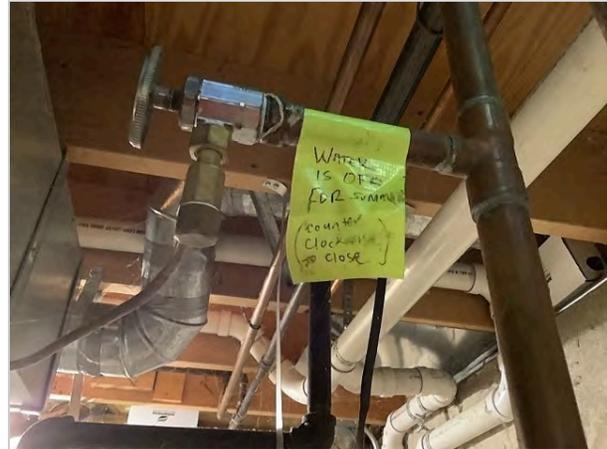
Photo 126

Humidifier valve was off and could not be turned on using reasonable force
