# HomeTeam<sup>®</sup>

### HOME INSPECTION REPORT

On Thursday, July 30, 2020 The HomeTeam Inspection Service made a visual inspection of 123 Sample Dr. Anytown, USA 55555. Enclosed please find a written, narrative report of our findings in accordance with the terms of our Inspection Agreement.

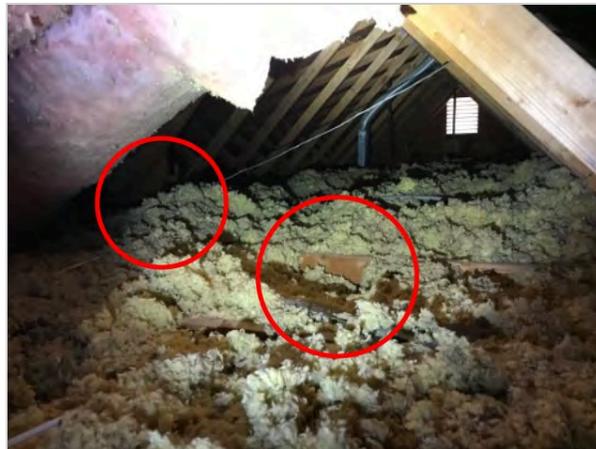
Photo 3

> **Insulation in attic has area(s) where insulation has been displaced.** This typically occurs when work is being done in attic and insulation is disturbed in the process. Insulation should be of consistent depth to provide a consistent thermal barrier. Suggest that this be addressed by a qualifying party.

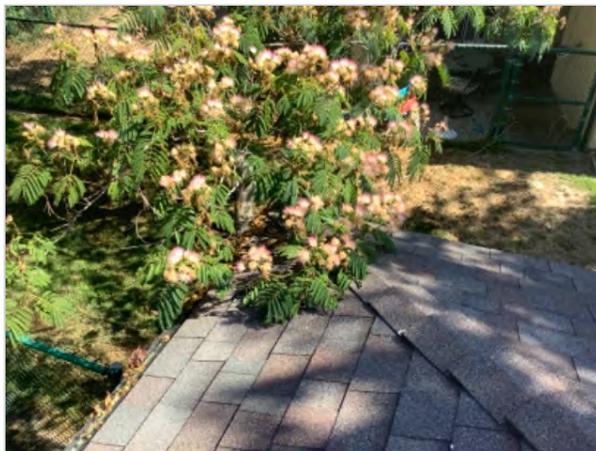
**Photo 4**

> **Vegetation observed in contact with the cladding, roof, or fascia that could have a detrimental effect on the surface.** Suggest that this vegetation be trimmed to allow at least 12 inches of space between plant and structure.

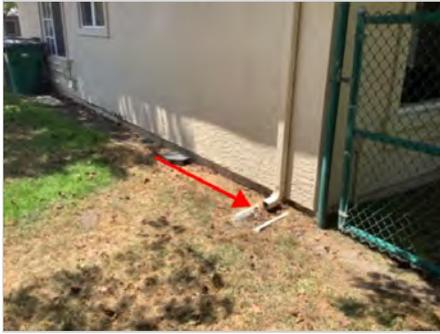
Photo 5

> **Several downspout(s) did not have proper termination to direct runoff away from foundation of home.** Suggest that downspouts with proper terminations be installed by a qualified party.

Back right

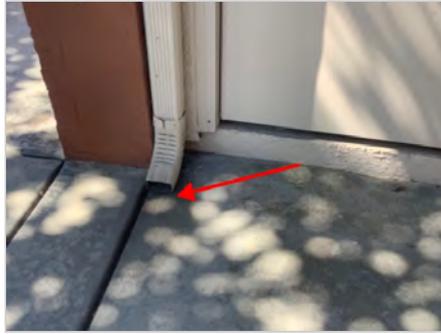
Photo 6

Front left

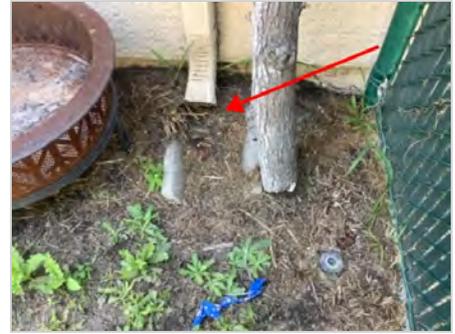
Photo 7

Back left

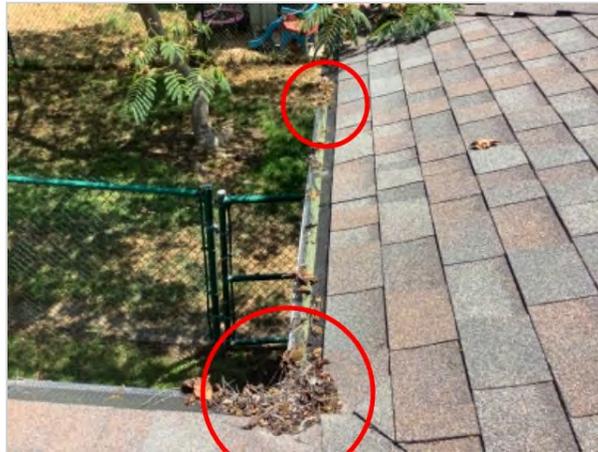
Photo 8

> **Roof gutter(s) observed with excessive debris.** Suggest periodic cleaning to insure that runoff is properly directed rather than held.

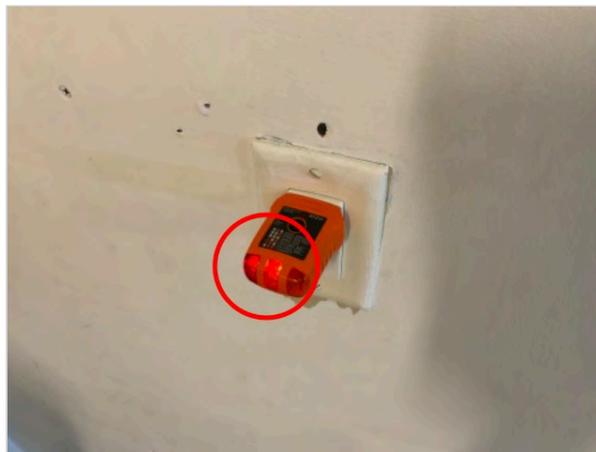
**Photo 13**

> **One outlet has hot and neutral wires reversed (aka reversed polarity).** This is a safety concern and should be repaired and further assessed by a licensed electrician. Please note that we only test outlets that are visible and readily accessible at the time of the inspection.

Right of garage entry door

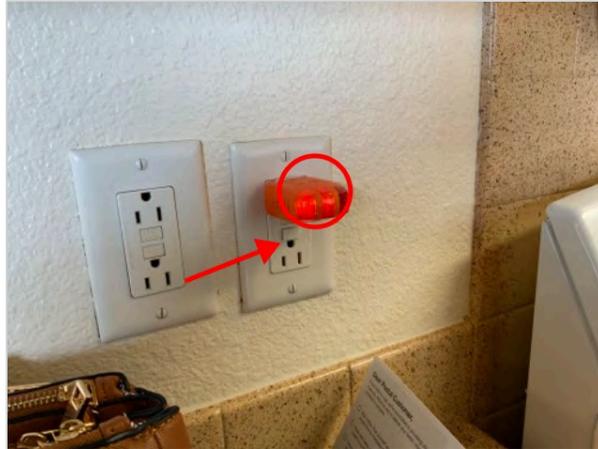
Photo 14

> **The GFCI outlet located in the kitchen is not functioning correctly ( will not trip)** and should be repaired or replaced by a qualified electrician. GFCI breakers protect from shock in areas where water may be present and AFCI breakers protect from spark in other locations in the structure.

First outlet to the left of stovetop

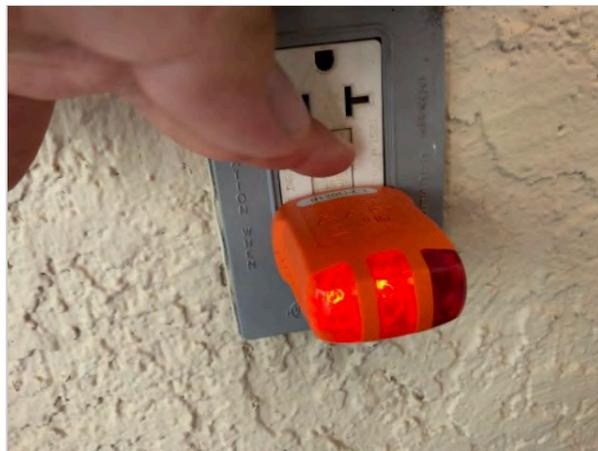
Photo 15

> **The GFCI outlet located on the exterior is not functioning correctly ( still hot when tripped)** and should be repaired or replaced by a qualified electrician. GFCI breakers protect from shock in areas where water may be present and AFCI breakers protect from spark in other locations in the structure.

Patio

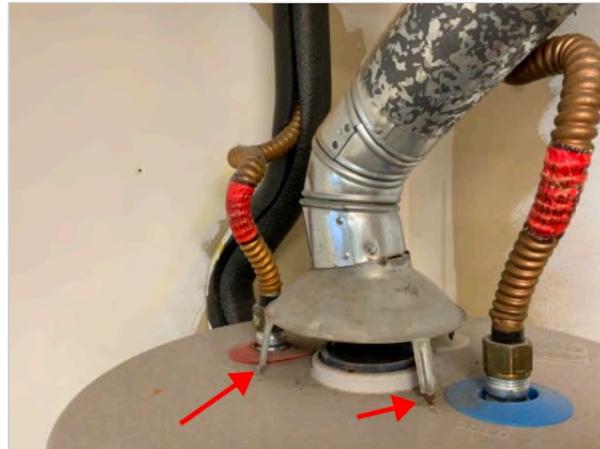
**Photo 18**

> **Flue pipe to water heater not properly secured.** The pipe should be secured with 3 screws at all joints to allow proper venting of gases.

Water heater exhaust

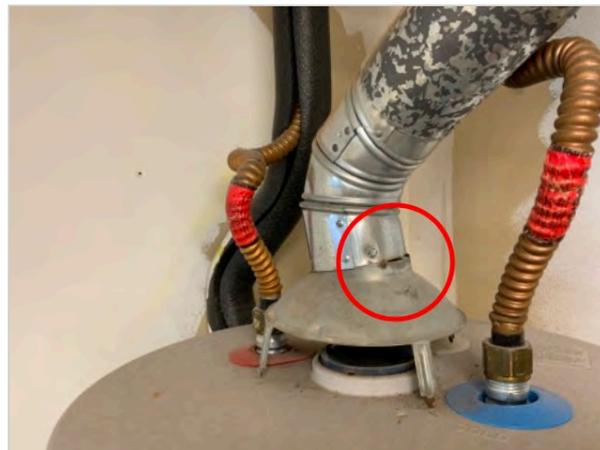
**Photo 19**

**The water heater flue pipe is not sealed properly to prevent noxious fumes from entering the structure, the flue connection should be properly sealed.** Consult with a qualified plumber for repair.

Flue vent

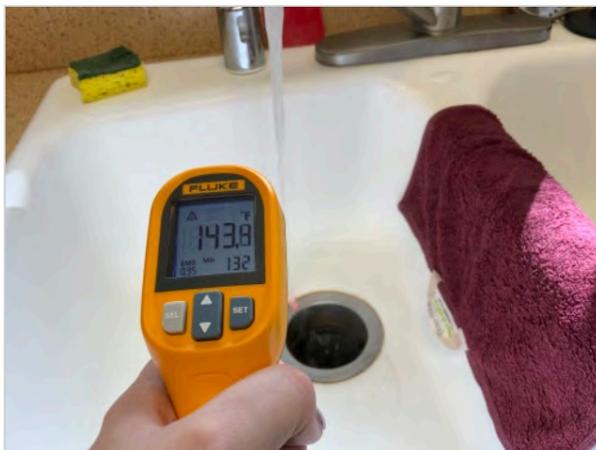
Photo 20

**Note- The hot water temperature is high and may pose a risk of burning.** HomeTeam recommends adjusting the hot water temperature by turning down the water heater thermostat.

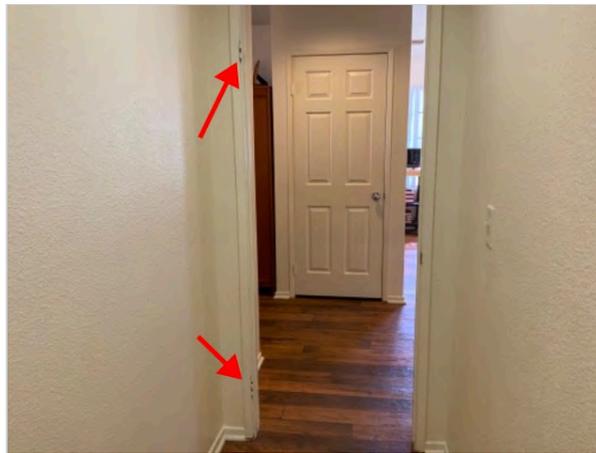
**Photo 22**

**Note- Interior door missing from it's jamb.** Suggest removal of hinges (if not already removed) or replacement of door by a qualified party.

Hallway door jamb

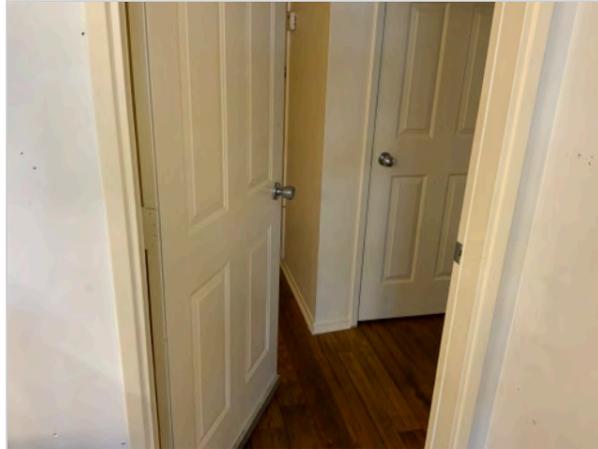
**Photo 23**

**> Door between garage and dwelling does not properly auto-close or auto-latch for proper fire separation. Suggest adjustment or hinge replacement by a qualified party to allow door to close and latch fully from an open position (45 degrees to close).**

Garage entry door

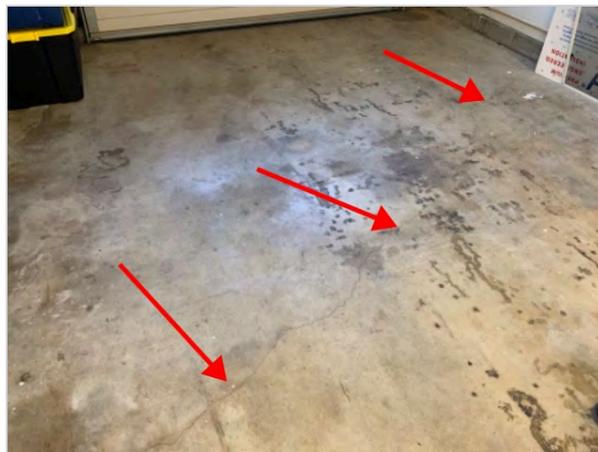
**Photo 24**

> **Crack(s) observed in concrete garage, driveway, or walkway.** Cracks that have separated and/ or have experienced upheaval at crack itself are of greater concern than those that have not. Suggest filling with epoxy or caulking to limit moisture intrusion and monitoring for further movement.

Garage

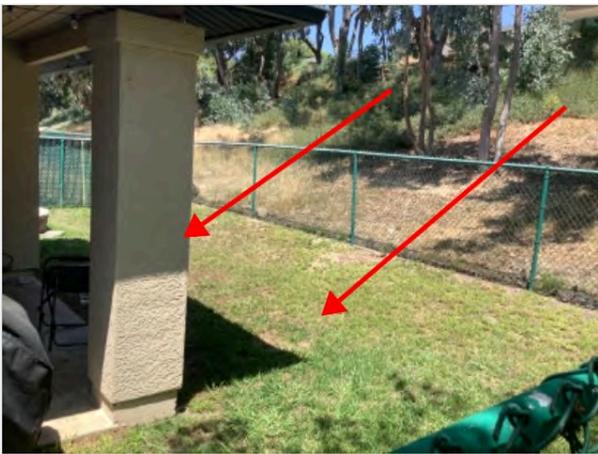
**Photo 25**

> **Grading surrounding the structure appears to be insufficient to carry water away from the foundation in at least one location.** HomeTeam recommends having the soil regraded or swales added at rear and right side of the structure and further assessed at the time of corrections.

Back

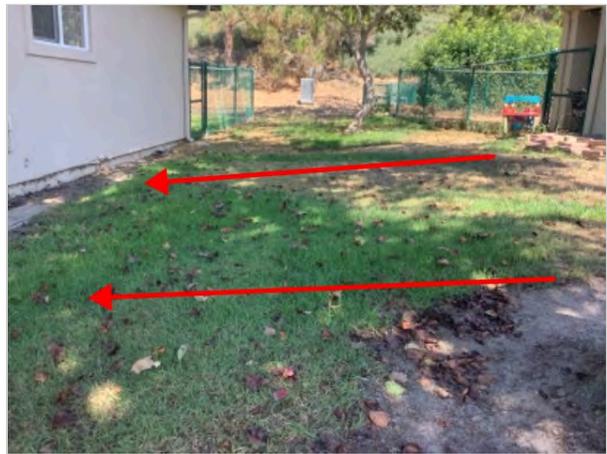
**Photo 26**

Right
