HOME INSPECTION REPORT

The HomeTeam Inspection Service made a visual inspection of 123 Main Street, Anytown, USA 55555. Enclosed please find a written, narrative report of our findings in accordance with the terms of our Inspection Agreement.

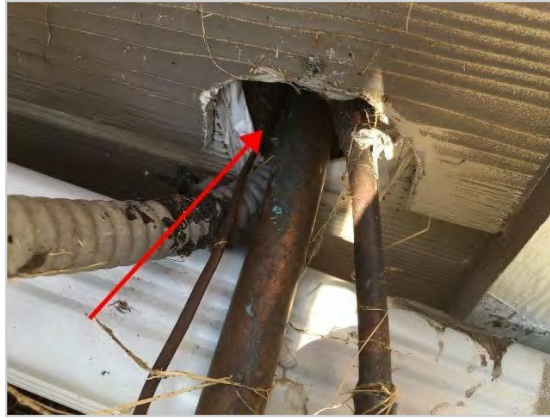
Photo 23

The insulation on the exterior air conditioning line set is missing. This could affect the efficiency of the system and should be replaced.
