### HOME INSPECTION REPORT

On Thursday, July 29, 2021 The HomeTeam Inspection Service made a visual inspection of 123 Anytown Rd SC, USA 55555. Enclosed please find a written, narrative report of our findings in accordance with the terms of our Inspection Agreement.

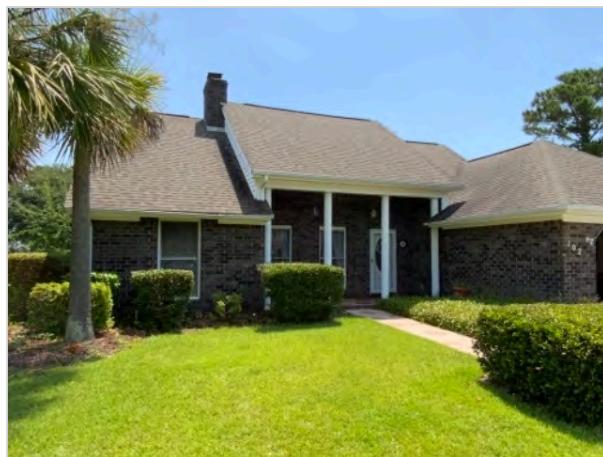
Photo 5

**Damaged siding was noted on the front of the structure's exterior.** This condition does not have any effect on the structural integrity of the building. The areas should be repaired to prevent water intrusion.

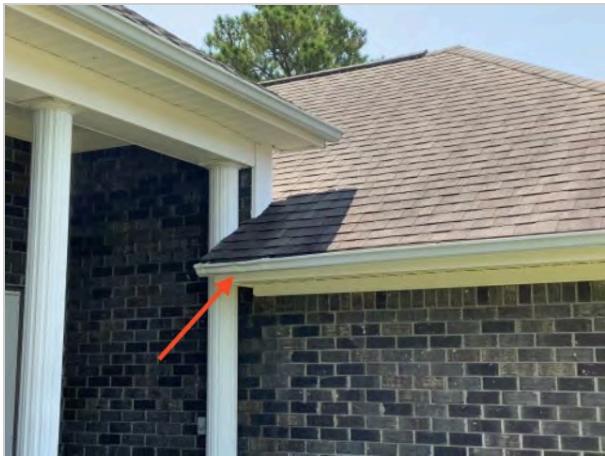
**Photo 13**

**Downspouts were draining at or too close to the base of the foundation.** To reduce the likelihood of water problems at the base of the structure, all roof drainage should be directed at least six feet from the base of the foundation.

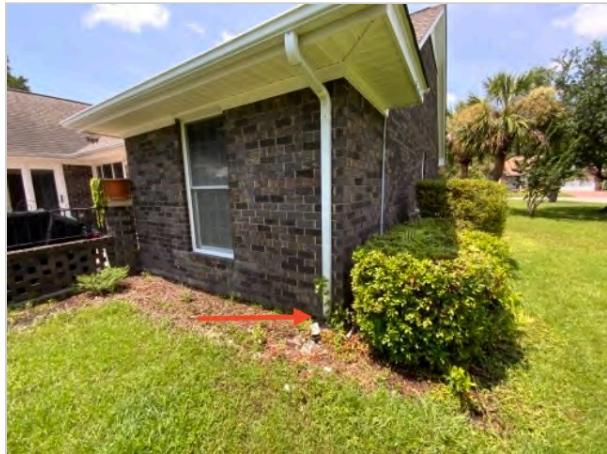
Photo 15

A downspout has separated from the gutter. Damaged gutters can cause roof drainage water to drain at the base of the foundation. The gutters should be repaired.

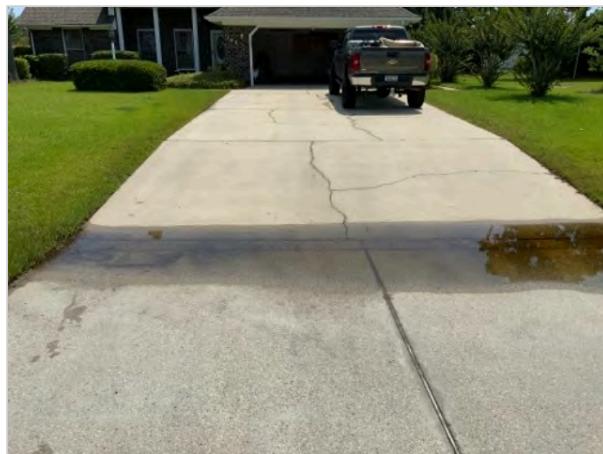
Photo 33

A concrete driveway is present in the front of the structure. Cracks and spalling were observed on the driveway. Surface defects in driveways develop and progress with age and are considered normal as long as they do not create a safety hazard. Sealing defects may help slow the rate of deterioration.

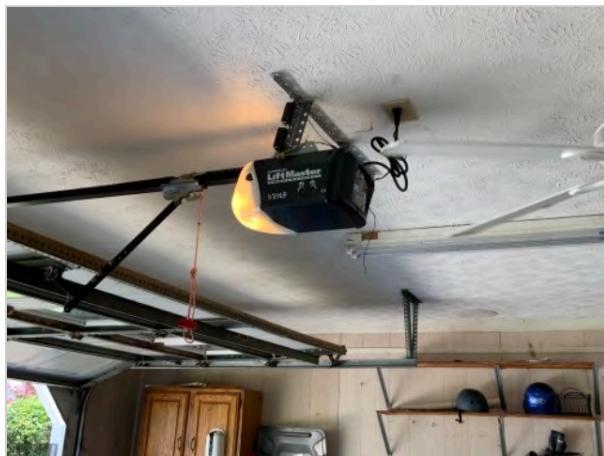
Photo 37

**The garage door safety pressure reverse system is not operable.** This means that the door does not stop and reverse when resistance is placed at the base of the door. There are no auto-reverse sensors in place. The opener should be adjusted or repaired.

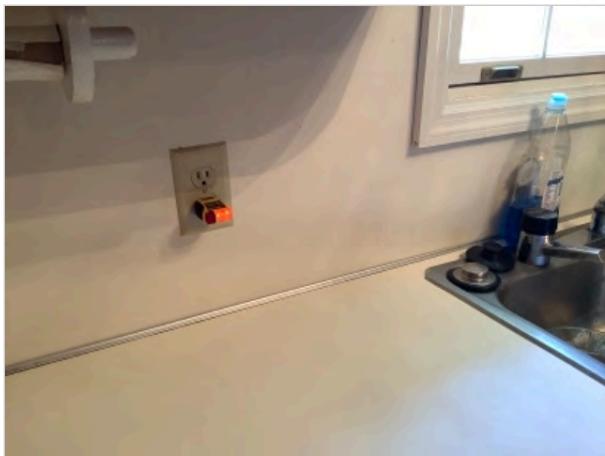
Photo 57

Multiple outlets lack GFCI protection.

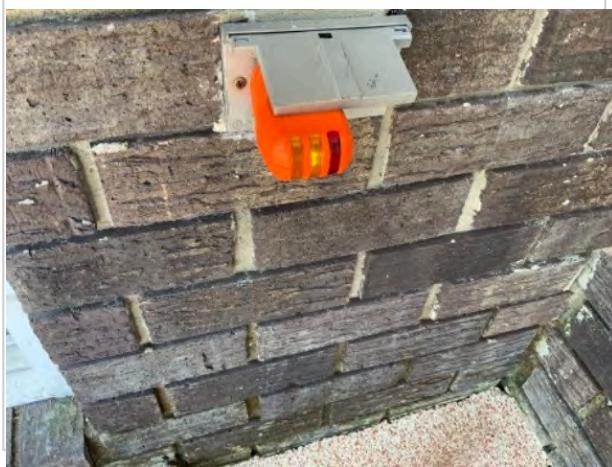
**Photo 63**

**One of the three prong type outlets in the structure had an open ground. The affected outlet should be grounded, replaced with two-prong outlets, or connected to GFCI circuits to improve safety.** This condition means that the third prong, also known as the ground prong, is not doing its job. This is often caused by a missing or disconnected ground connection at an electrical device in the circuit. Consult with an electrician for the best course of action.

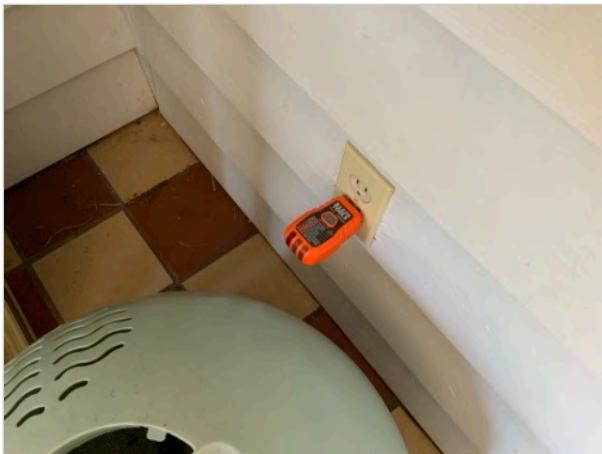
**Photo 64**

**Two outlets were not functional.** Consult with a qualified electrician for repair and further assessment of outlets.

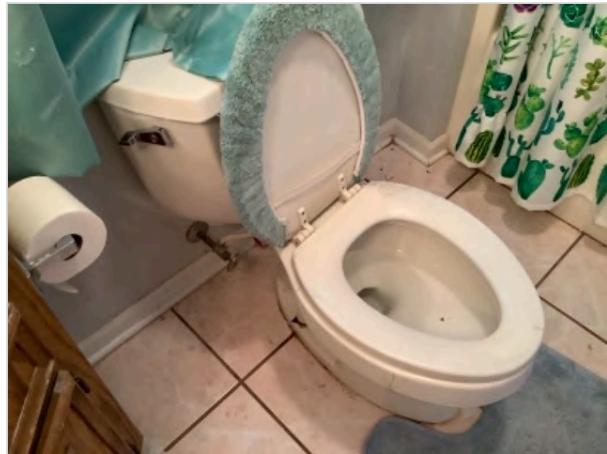
**Photo 67**

**The toilet in the hall bath is loose.** Failure to secure the toilet may lead to leakage around the wax ring. The toilet should be secured.

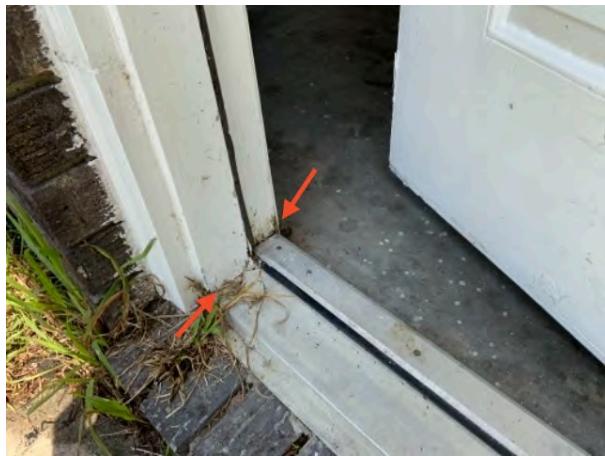
**Photo 83**

**The base of the door frame to the garage was damaged from apparent moisture exposure.** The door frame should be repaired and the surrounding area should be further assessed at the time of repair for any additional damage.

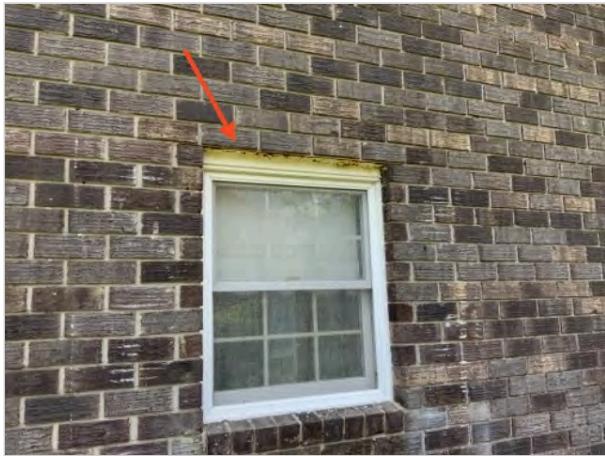
Photo 85

**One or more of the steel lintels above the windows on the exterior of the structure is rusting.** Lintels support masonry materials above doors and windows. Keeping the lintels sealed will help prevent rusting and expansion. Expanded lintels can lead to cracks in the masonry on the outside of the structure. The affected lintels should be properly sealed to prevent further expansion.

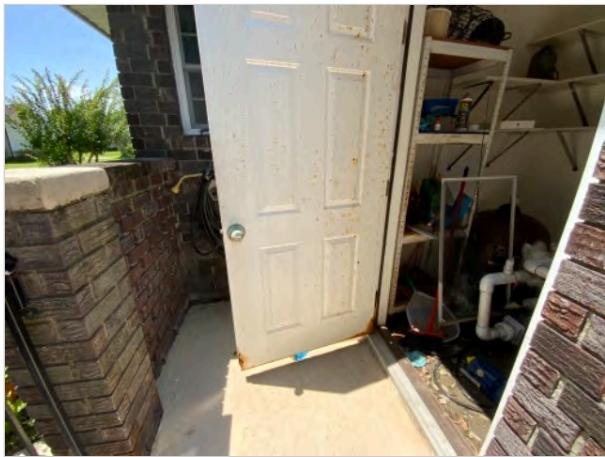
Photo 87

**The door to the pool filter room was damaged from apparent moisture exposure.** The door and frame should be repaired and the surrounding area should be further assessed at the time of repair for any additional damage.

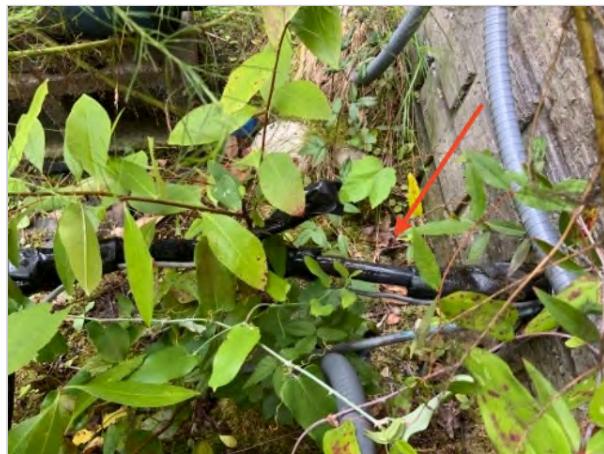
Photo 109

**The insulation on the exterior air conditioning line set is damaged.** This could affect the efficiency of the system and should be replaced.

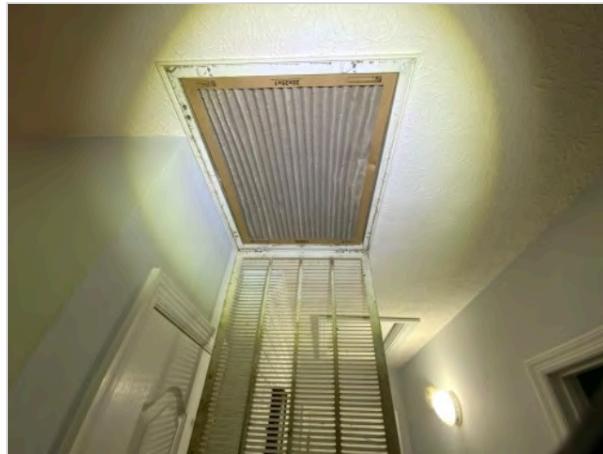
**Photo 112**

**The air filter is dirty** and should be replaced. Prolonged operation of an HVAC system with a dirty filter can cause internal damage to the compressor valves that may not be observable during the inspection; operating with a dirty filter may also damage the air handler.
