### HOME INSPECTION REPORT

# PROPERTY INSPECTION REPORT

**Concerning:** \_\_\_\_\_ 123 Main St Anywhere, TX 55555

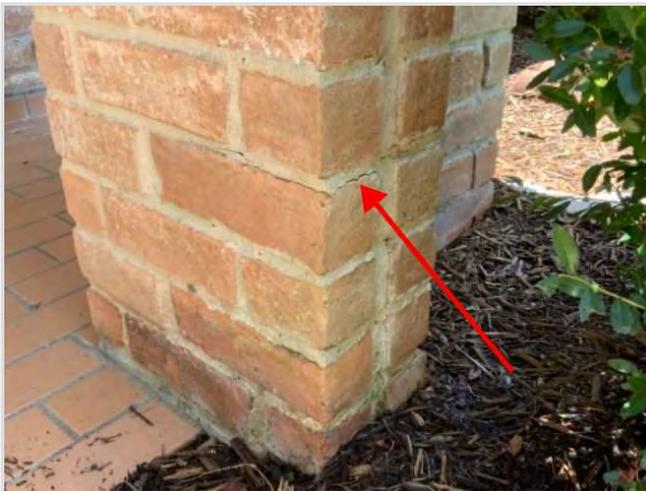
Signs of previous differential movement/settlement was observed; indicated by one or more of the following conditions; Cracks in brick veneer, and doors that are not square in jamb, etc.

Brick cracks (front porch column)

In our opinion, the distress patterns observed were not severe, repairs seem to be adequate and the foundation appeared to provide acceptable performance at the time of inspection. Due to signs of previous repairs, it is highly recommended that the buyer obtain any documentation related to the foundation repairs, to include any transferable warranty, prior to closing on the purchase of the home.

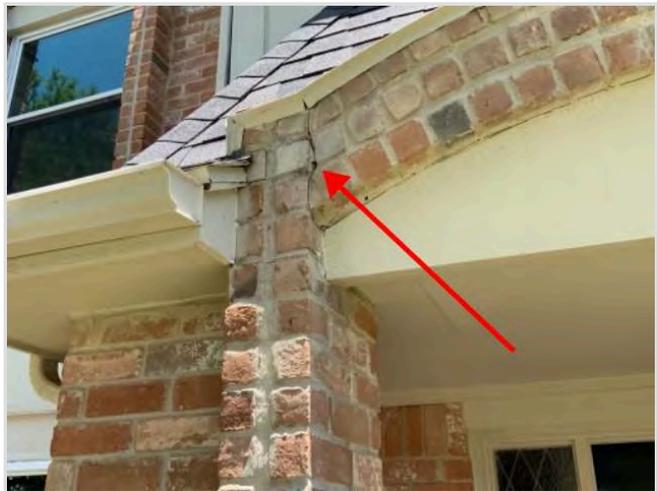
Brick cracks above front porch

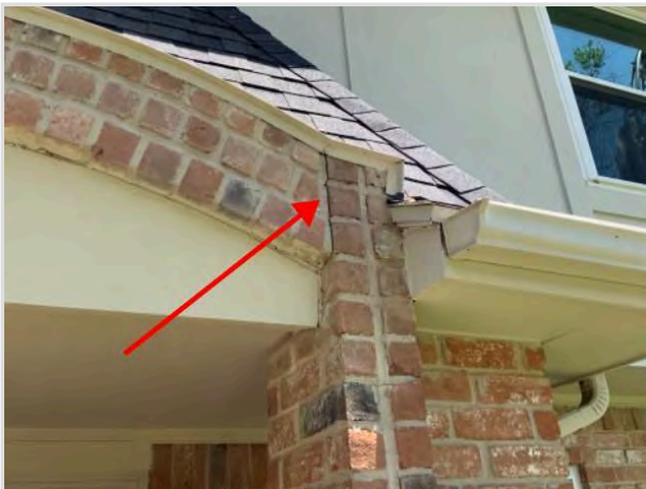
Brick cracks above front porch

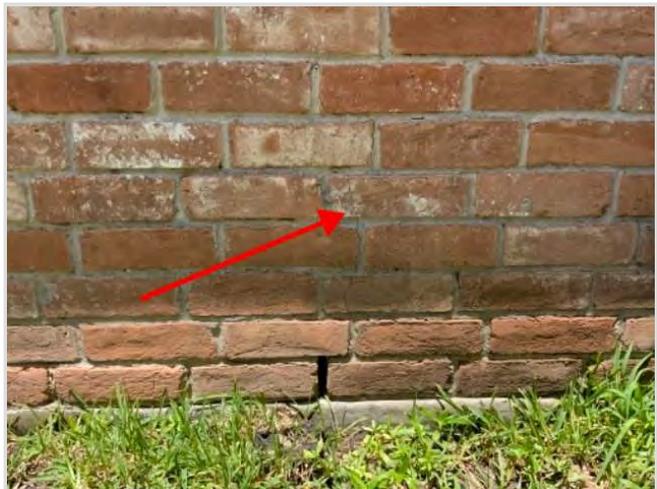
Brick crack (right side)

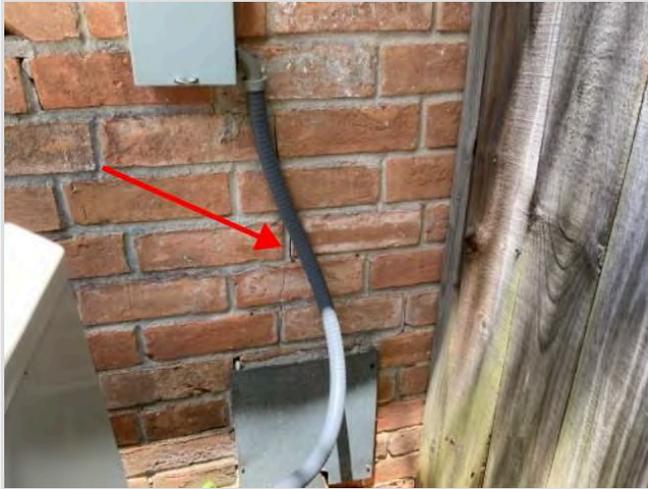
Brick crack (right side)

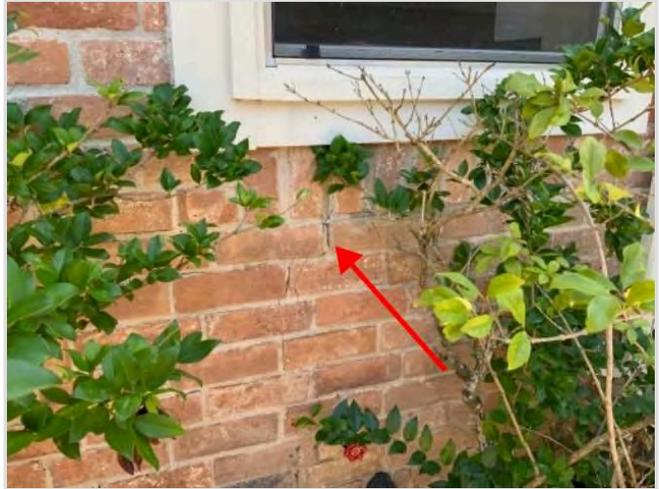
Brick crack (left side)

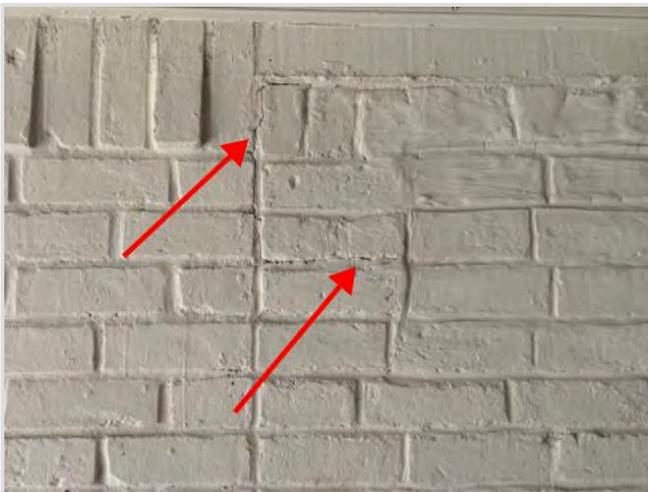
Brick crack (back porch)

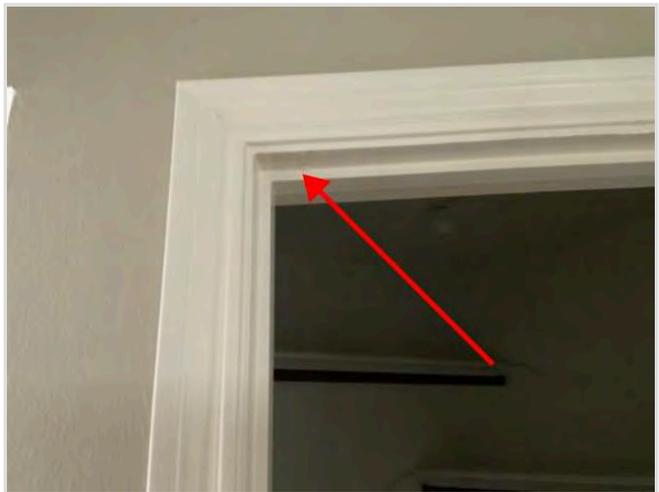
Door sticks / not square in jamb (master closet)

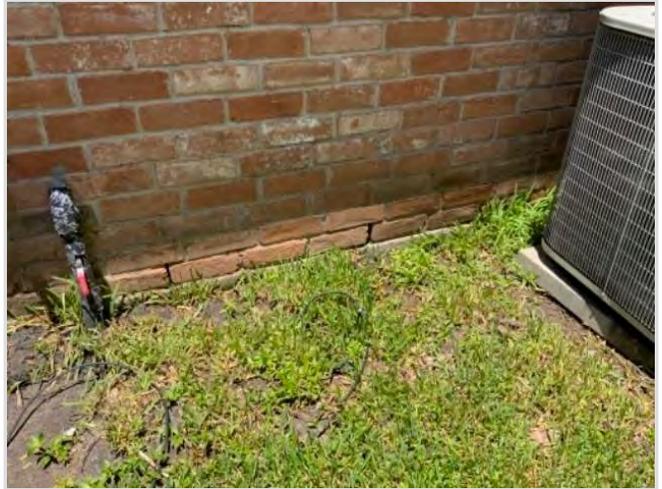
Portions of the slab edges were not viewed due to soil and vegetation build up. High soil level is considered a conducive condition to termite activity, water penetration and limits visual observation of the foundation slab. Common industry practice recommends a clearance of at least 4-6 inches from bottom of exterior wall covering to soil.

High soil (right side)

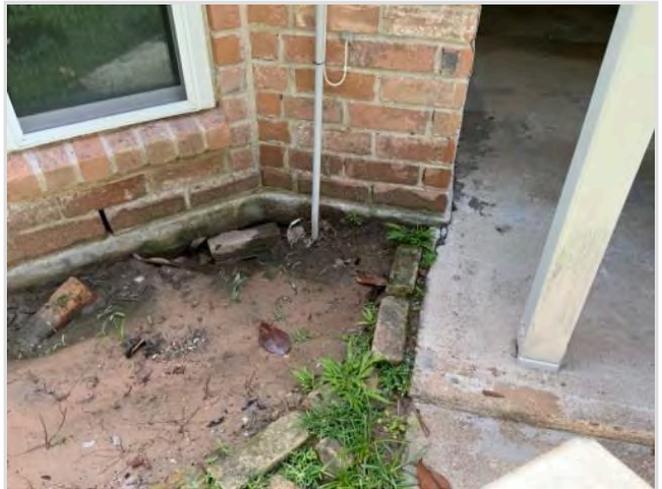
High soil (rear)

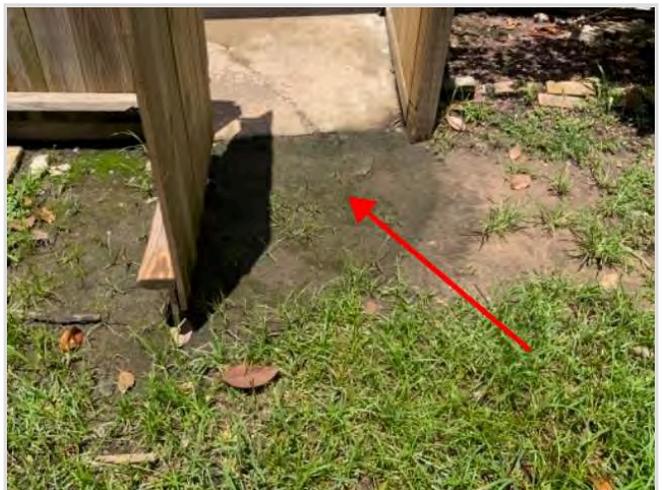
Soil grade and drainage patterns around areas of house would not properly direct water away from the house and foundation system (low areas), which would allow water to saturate the soil near the slab, which can affect foundation performance.

Low area (back gate)

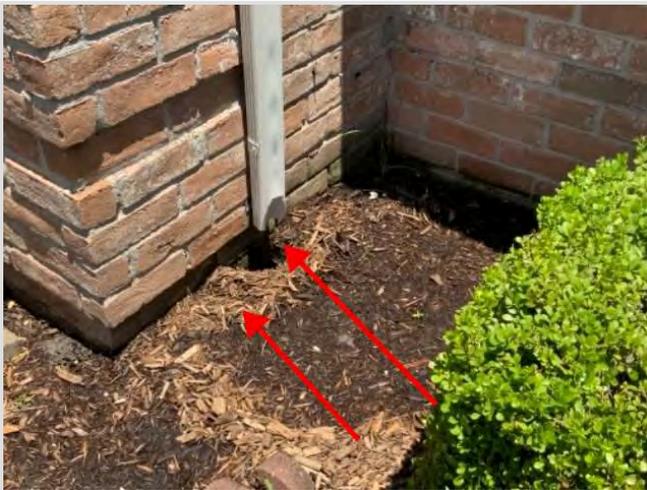
One or more gutter downspouts were missing the bottom elbow piece.

Missing the bottom elbow piece and splash pad (front)

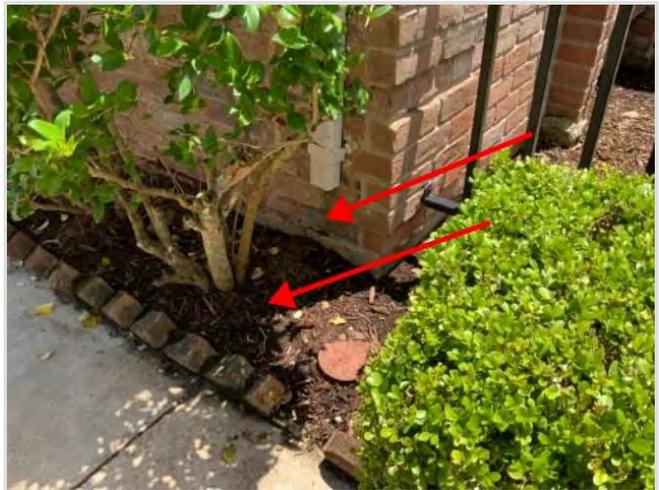
Missing the bottom elbow piece and splash pad (left side)

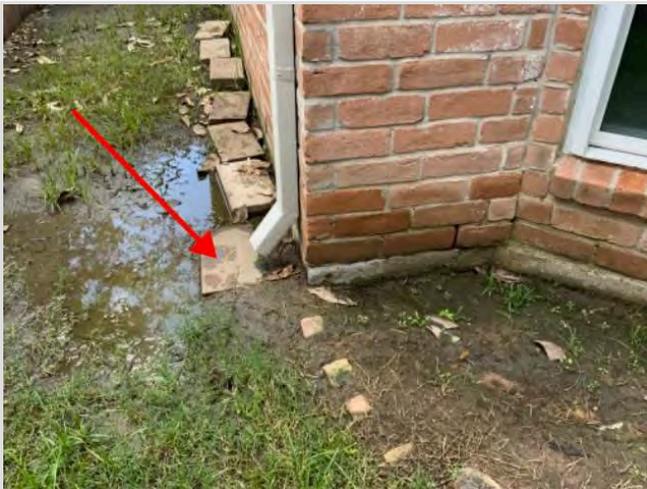
Splash pads were not installed at gutter downspout terminations in several locations. Splash pads help prevent soil erosion and water saturation near the slab, which can negatively affect foundation performance.

Missing splash pad (right side)

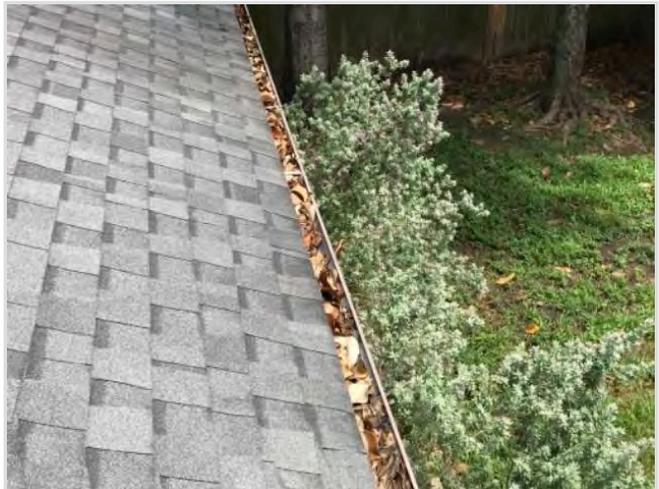
Debris in gutters (garage)

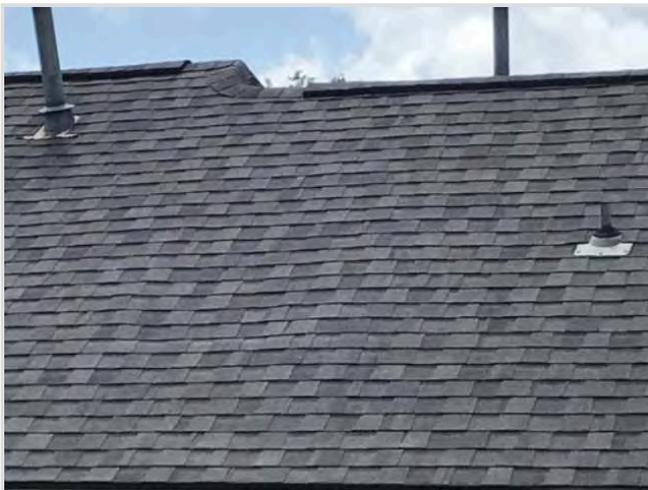
The asphalt-fiberglass shingle roof was moderately worn with areas of significant wear (ridge shingles). The metal roof / flashing above the front porch brick was starting to show signs of rust corrosion. This area could be painted to help prevent further rusting. Portions of the flashings/vent covers were starting to show signs of rust corrosion. These items could be painted to help prevent further rusting. Previous repairs had been made in one or more locations. The Texas Real Estate Commission requires inspectors to report if previous repairs have been made to roof systems.

Moderately worn shingles

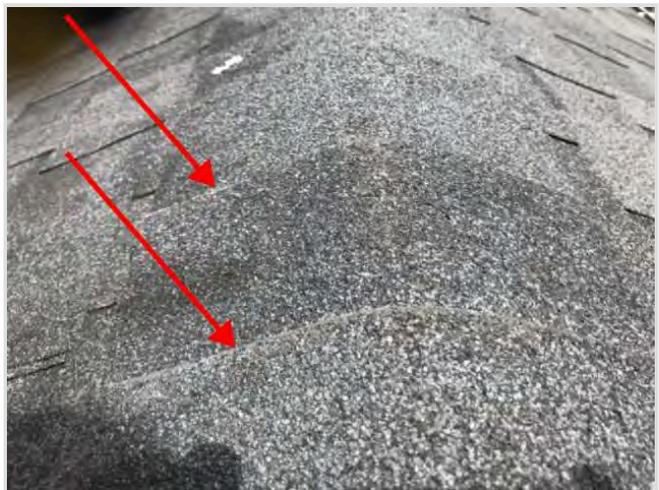
Exposed fiberglass at ridge shingles indicates significant wear

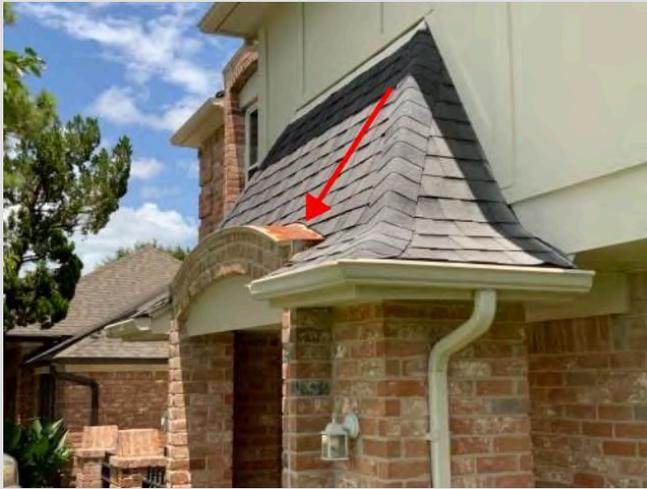
Rusted metal roof (above front porch)

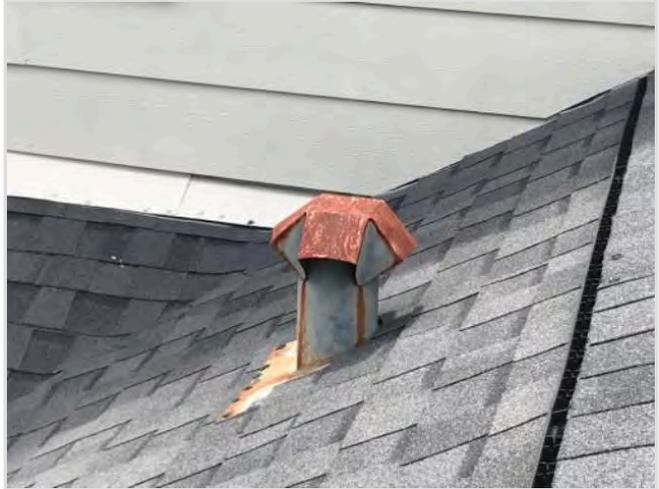
Rusted vent cover

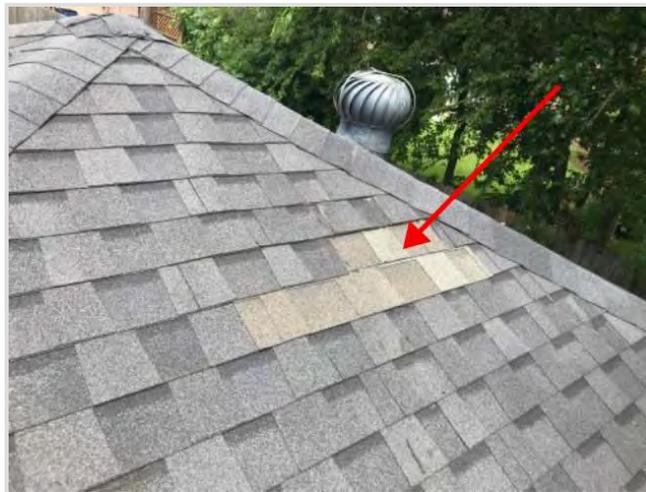
Previous roof repair (garage)

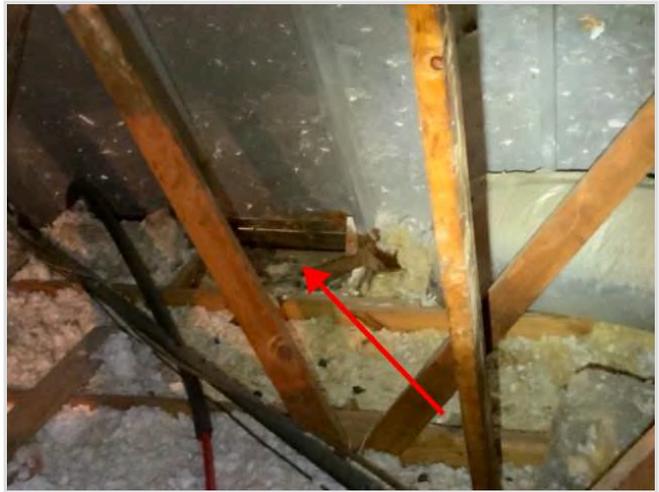
Not all areas of the attic space were properly insulated (insulation missing/inadequate).

Missing insulation

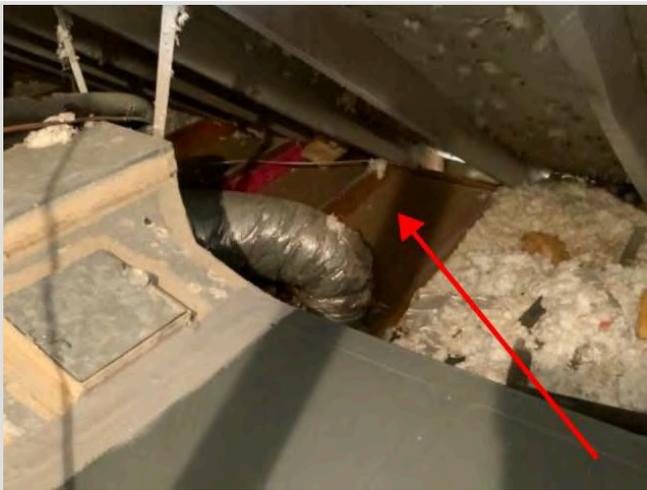
Missing insulation

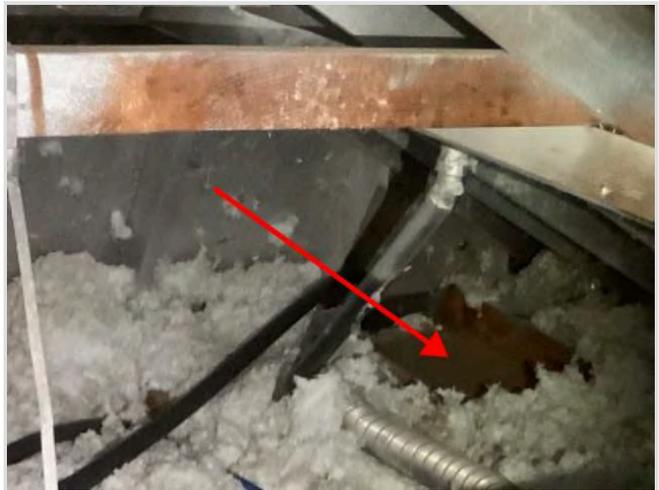
Missing insulation

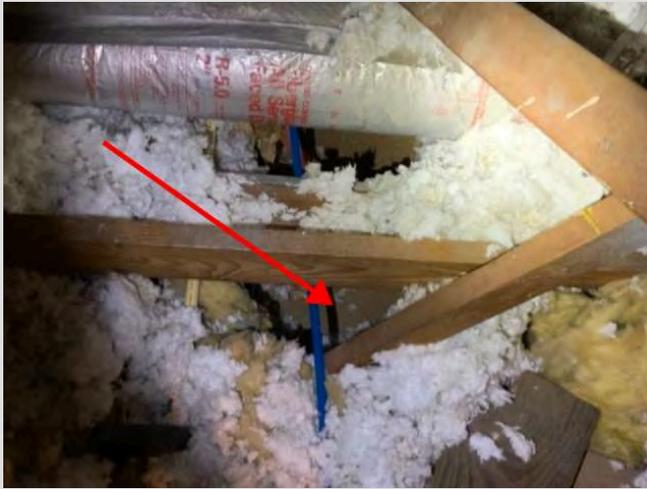
Missing insulation at dropped ceiling (behind water heater)

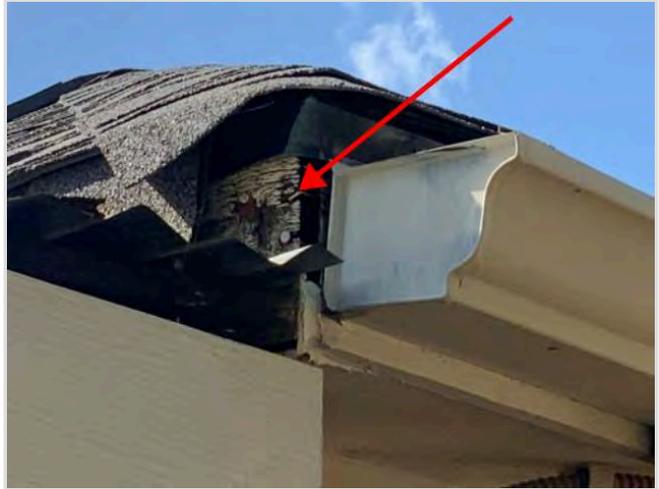
There was wood rot/water damage to portions of the soffit and/or fascia boards.

Wood rot at fascia above metal back patio roof

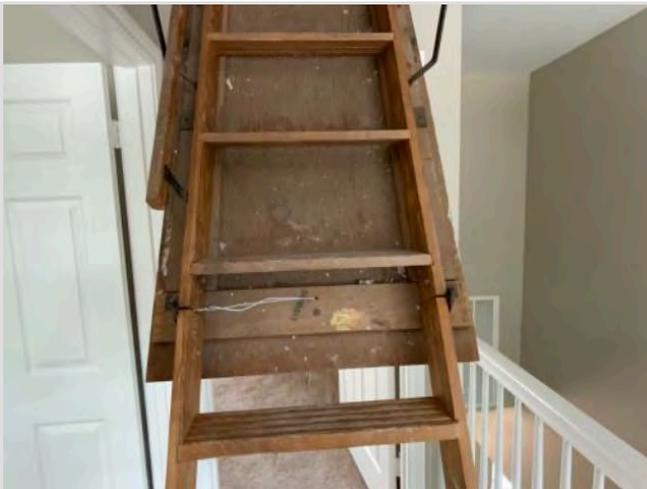
Attic access was installed in the living area via drop down ladder and was not properly insulated and/or did not have weather-stripping installed. Attic doors should be sealed the same as any other exterior door, helping prevent conditioned air from escaping into the unconditioned attic space.

No insulation or weatherstripping at drop-down attic stairs

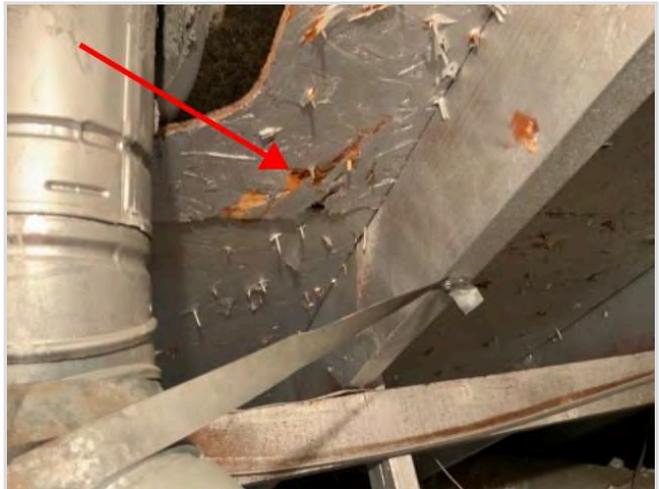
Roof decking was found to be damaged in one or more locations.

Damaged roof decking

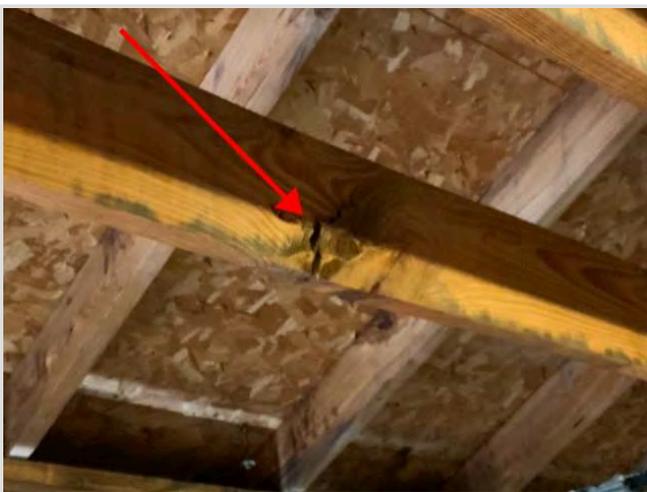
There was a broken or damaged ceiling joist in the detached garage.

Damaged joist (garage)

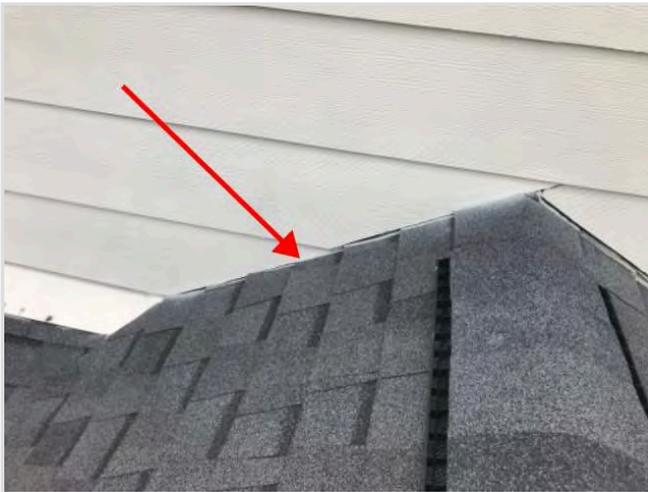
Portions of the exterior wall covering were in contact with the roof. Common industry standard calls for a one to two inch clearance of walls from the roof covering to help prevent water damage to the materials.

Siding in contact with roof covering (rear)

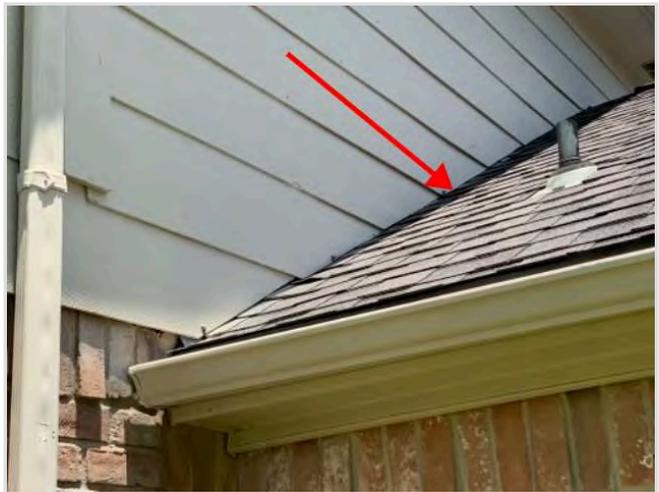
Siding in contact with roof covering (right side)

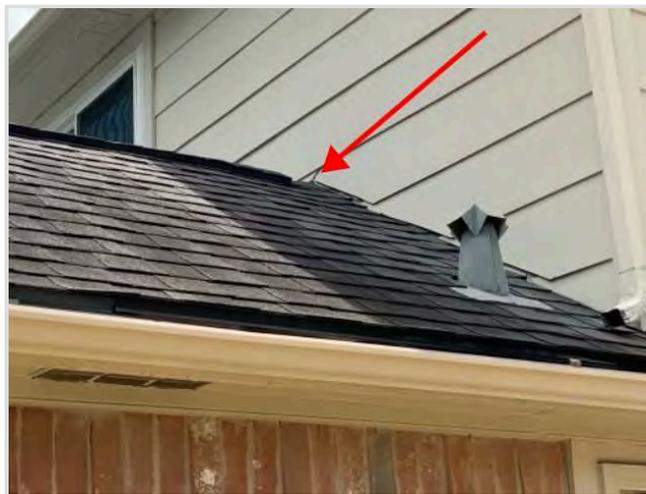
One or more locations on the exterior were in need of routine caulk maintenance (windows, doors, electrical boxes, seams of the siding, etc).

Joint or crack in siding is in need of routine caulk maintenance (rear)

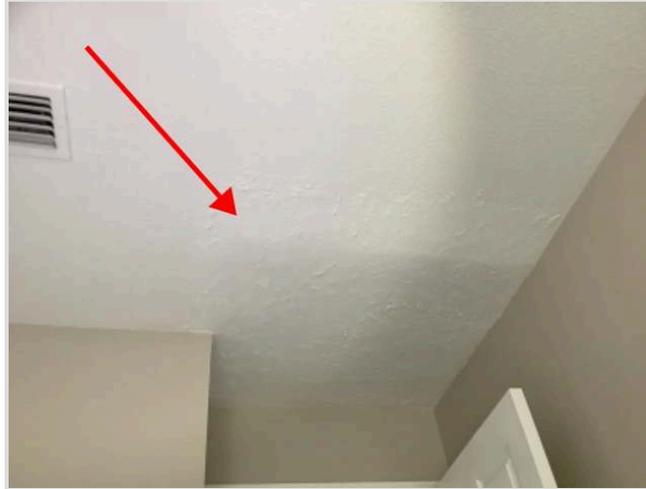
Note: Previous repairs had been made to the sheetrock ceiling in the left front and left middle bedrooms.

Previous ceiling repair (second floor front left bedroom)

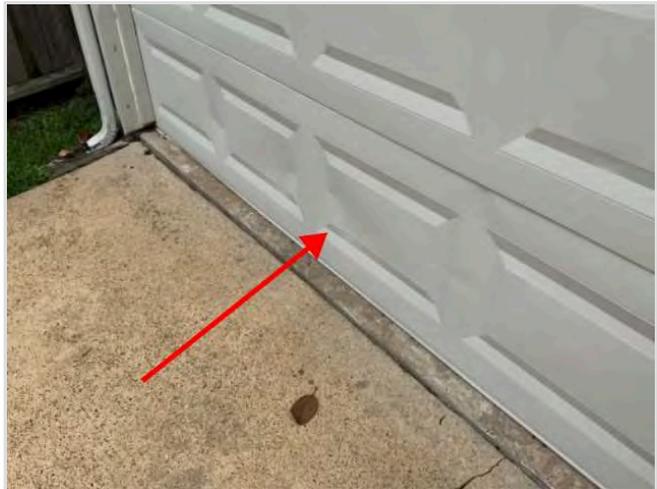
The overhead garage door was damaged.

Damaged garage door

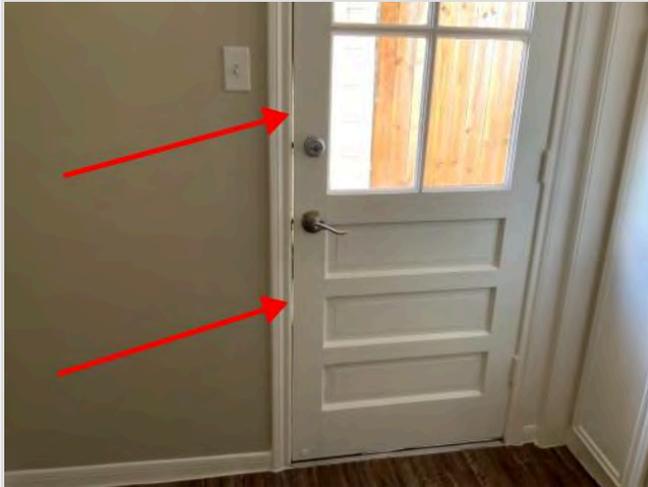
Weather stripping was torn/damaged and/or missing on one or more exterior door(s).

Missing weatherstripping (left back door)

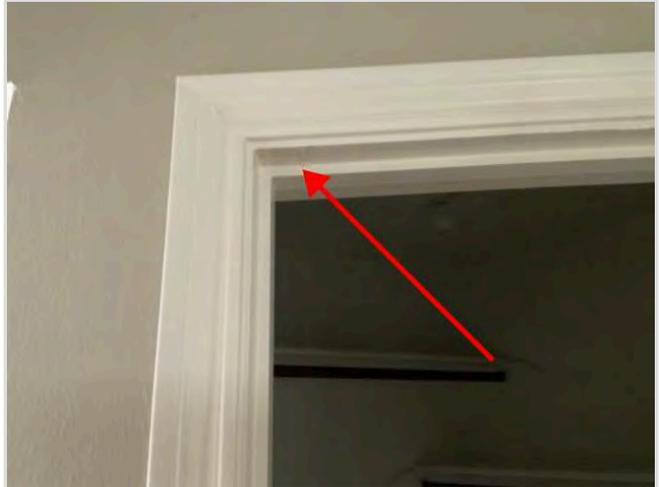
Master closet door sticks

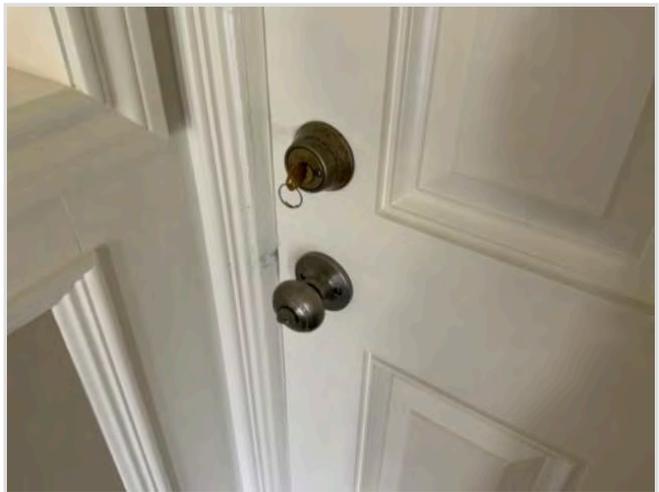
Lock keyed on the inside (back door)

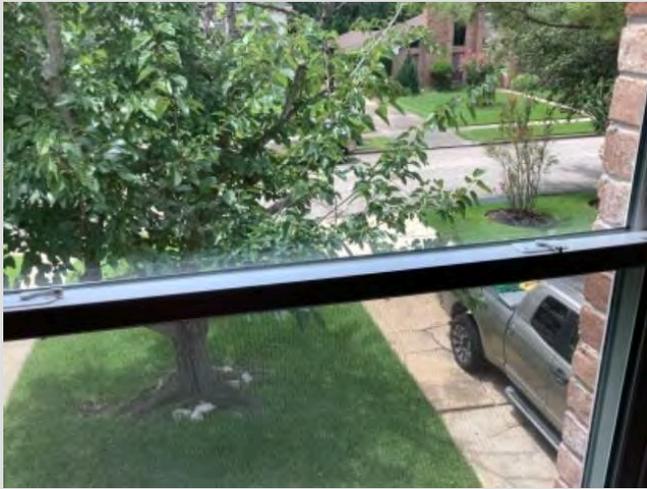
Locking mechanisms were damaged/missing on one or more windows.

Window locks were non-functional (second floor front left bedroom)

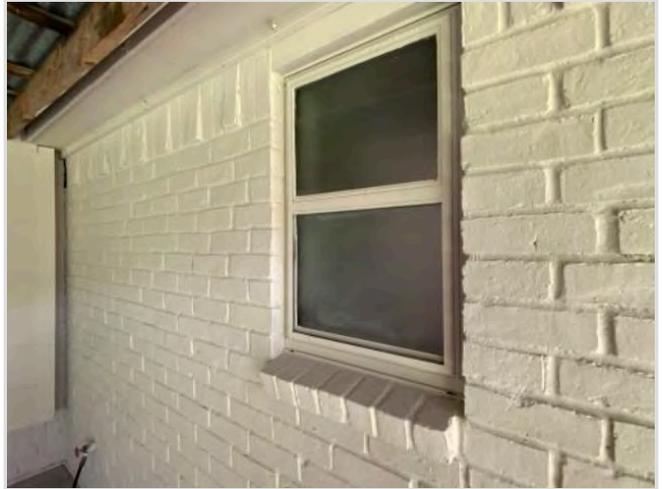
Not all of the windows had screens. In addition, several of the screens present, were damaged. The Texas Real Estate Commission (TREC) considers this to be a deficiency according to the standards of practice (SOP).

Missing screen (back porch)

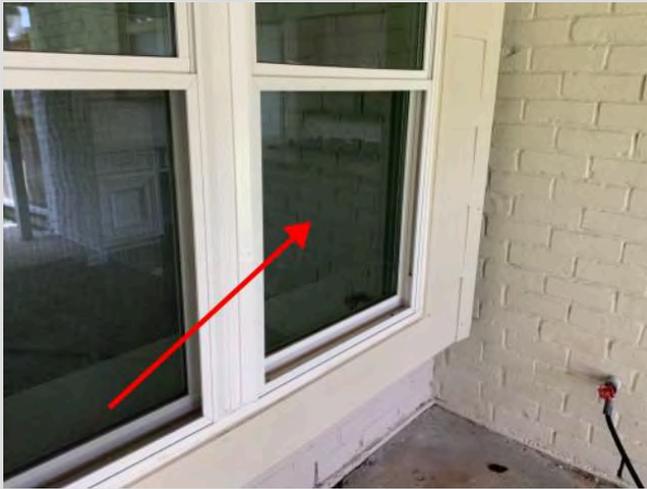
Missing screen (back porch)

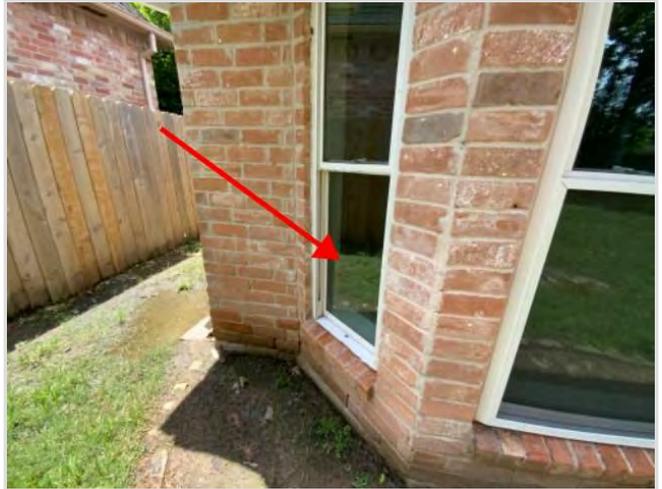
Missing screen (rear)

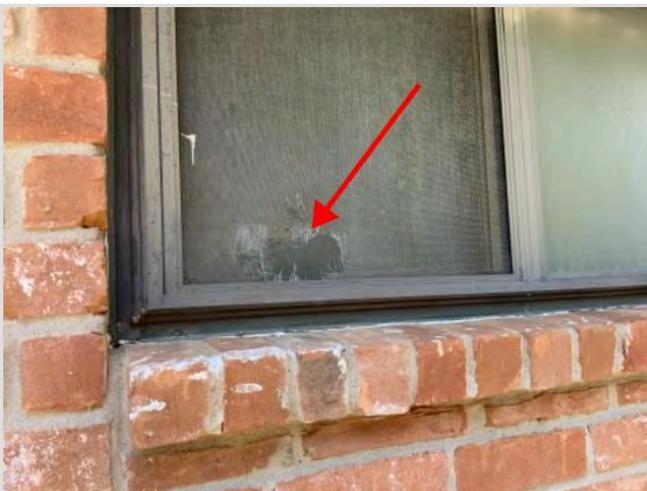
Damaged screen (right side)

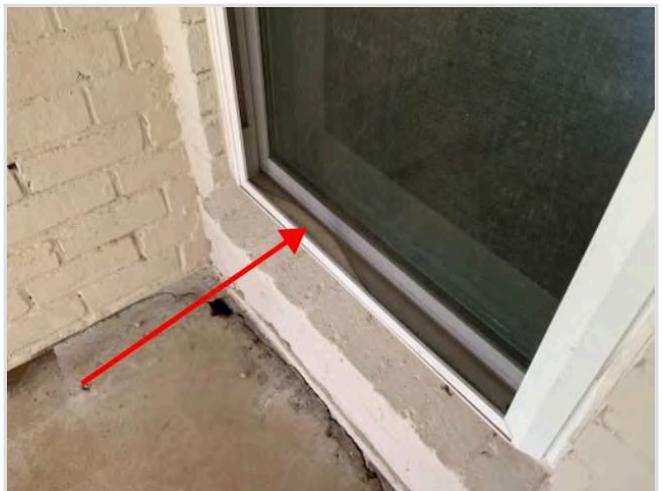
Damaged screen (back porch)

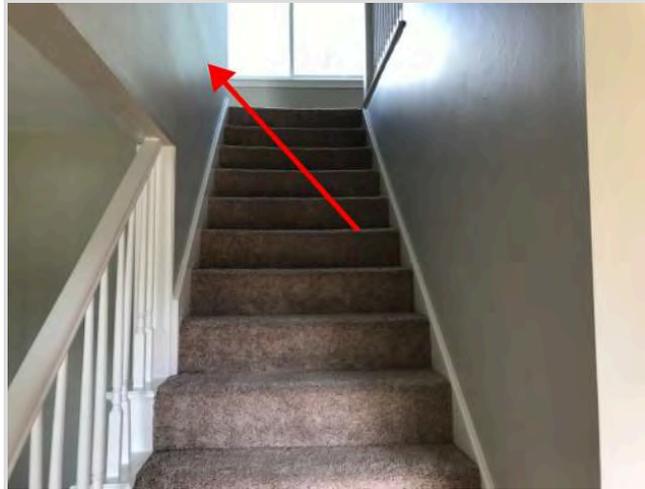
There was no handrail at the upper section of the stairs.

There was no continuous handrail at the upper portion of the stairs

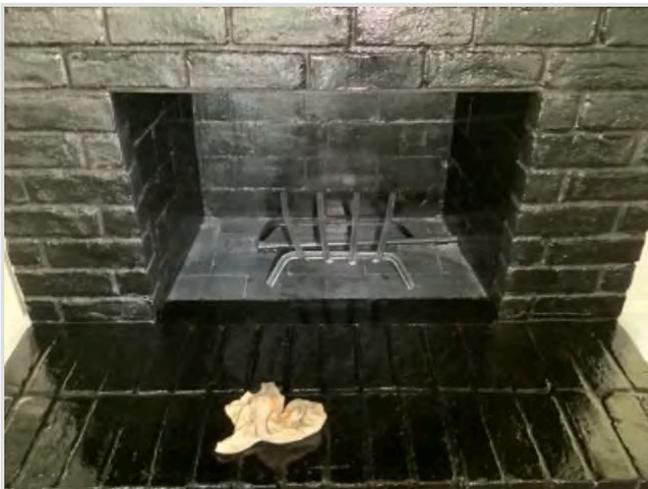
No screen installed at firebox opening

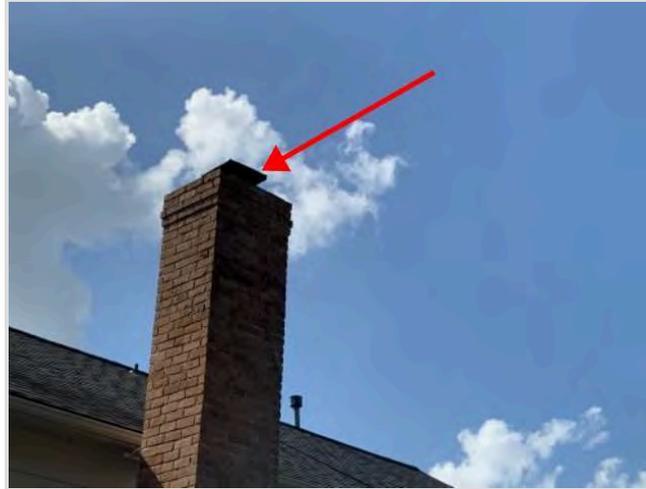
Rust at chimney cap and spark arrestor

The metal chimney cap and spark arrestor were starting to show signs of rust corrosion. These items could be painted to help prevent further rusting.

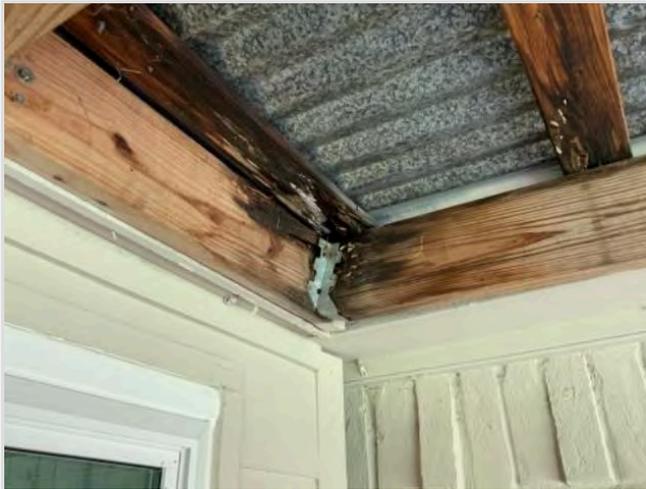
There was water damage/wood rot to portions of the back porch roof joists.

Signs of water penetration and wood rot (back porch joists)

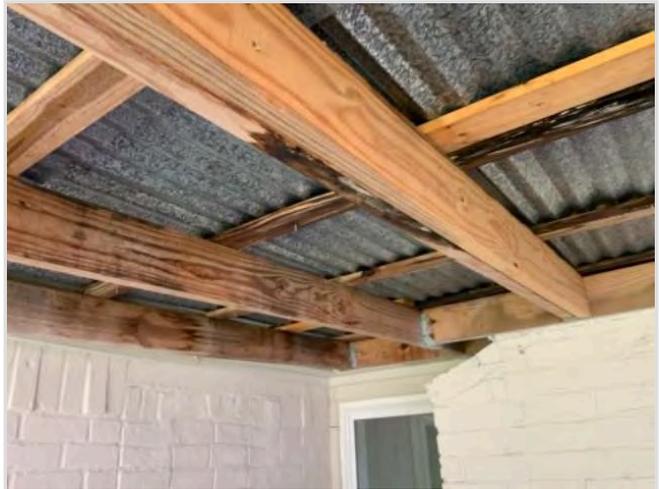
Signs of water penetration (back porch joists)

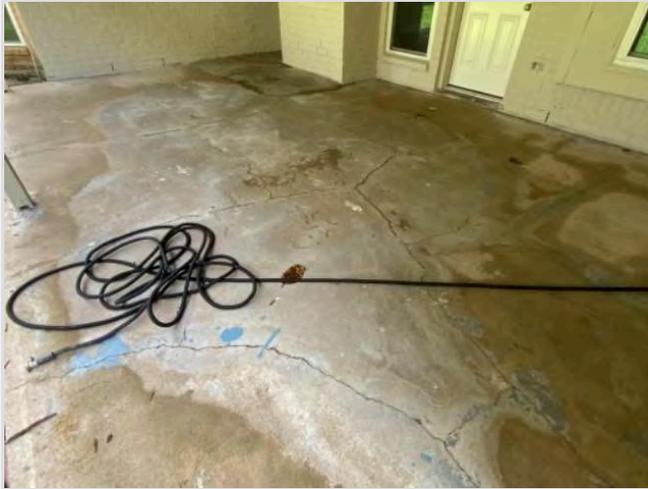
There were cracks/damage to the driveway and rear patio in several locations.

Cracks at non-structural rear patio floor

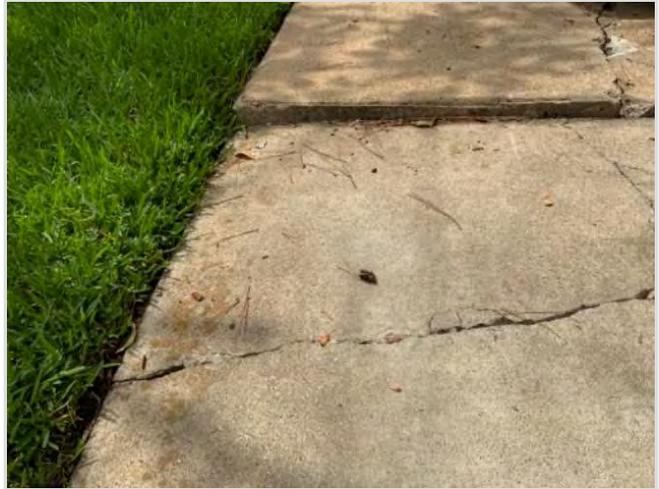
Cracks in driveway

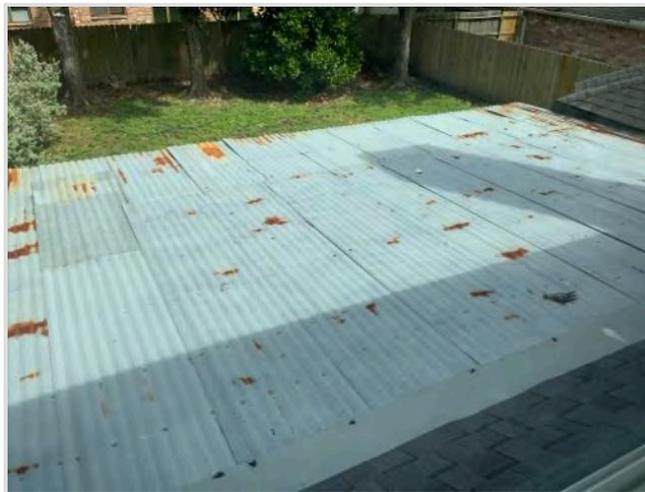
The rear patio metal roof was showing signs of rust.

Rust on metal patio roof

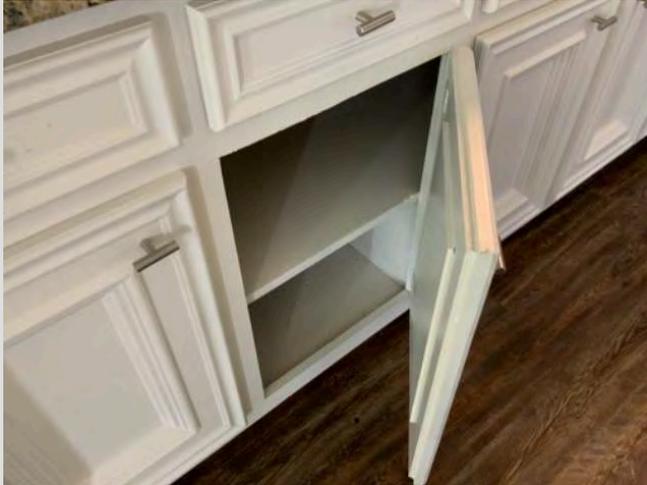
Cabinet doors in several locations would not stay closed.

Cabinet door would not stay closed (kitchen)

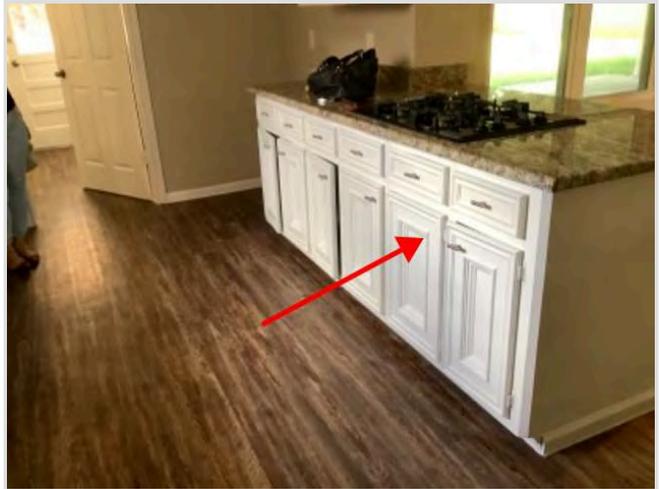
A cabinet door pull was missing in the kitchen.

Cabinet door pull was missing (kitchen)

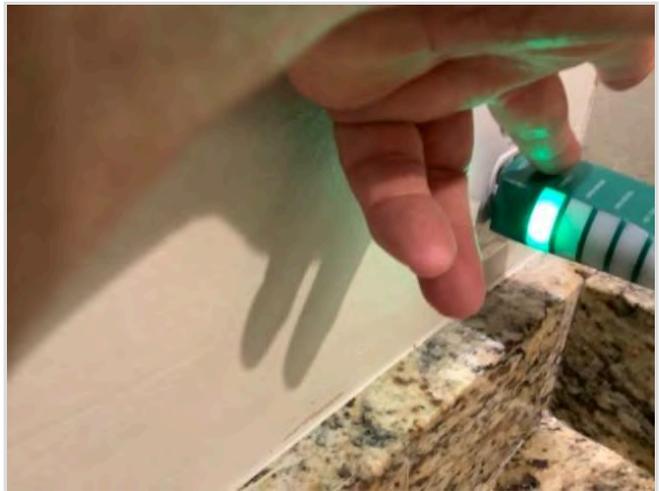
No GFCI protection (bar countertop)

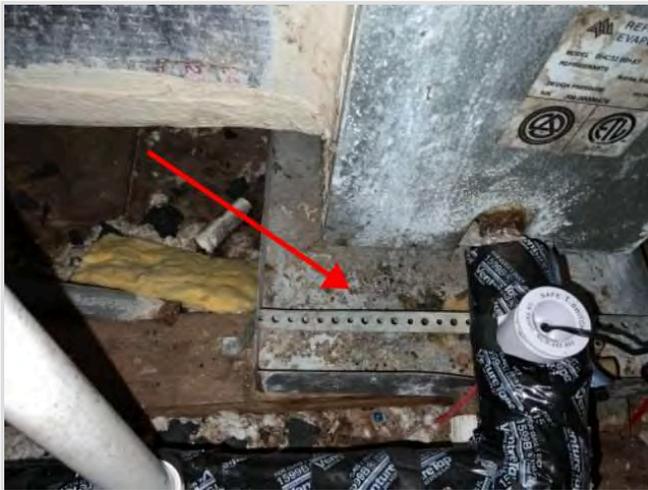
Secondary drain pan was showing signs of rust. Once the galvanized coating is used up and rust sets in, it will continue to rust even without liquid water present.

Secondary drain pan was showing signs of rust

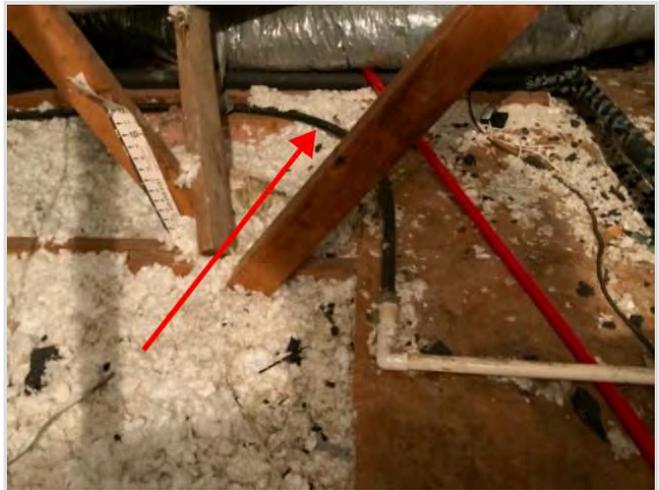
A flexible hose was used for part of the air conditioning secondary drain line in the attic. This is not a proper drain material.

Flexible hose used for secondary drain line

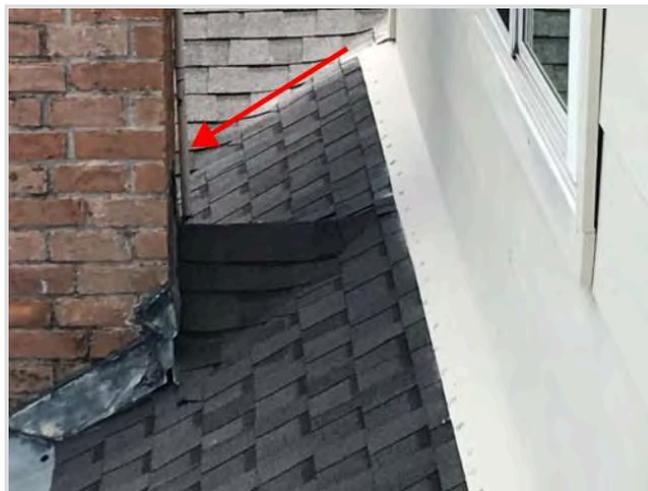
The air conditioning drain line should terminate at a visible location in order to alert homeowners of a clogged primary drain line. However, the secondary drain line was diverted so the dripping drain may not be obvious.

Air conditioning secondary drain line extension

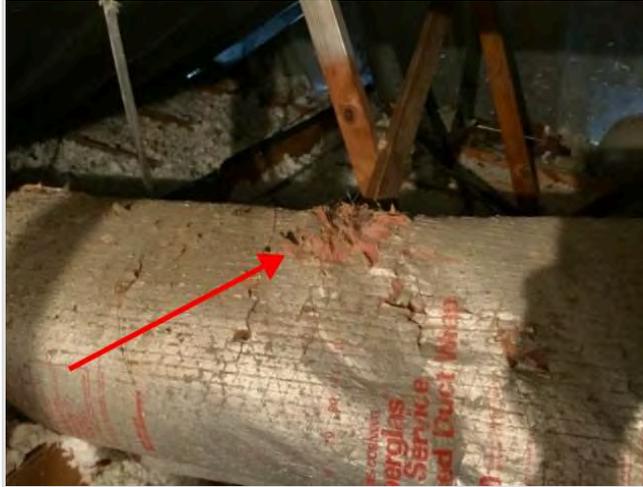
The outside insulation covering was damaged / missing on portions of the duct system in the attic. The covering helps insulate the conditioned air from the attic temperatures.

Damaged duct insulation

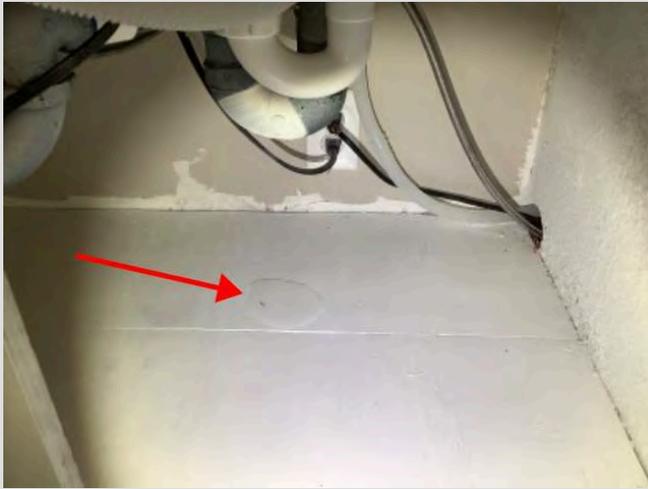
A leak was found beneath the kitchen sink and the second floor bathroom sink.

Leak (kitchen sink)

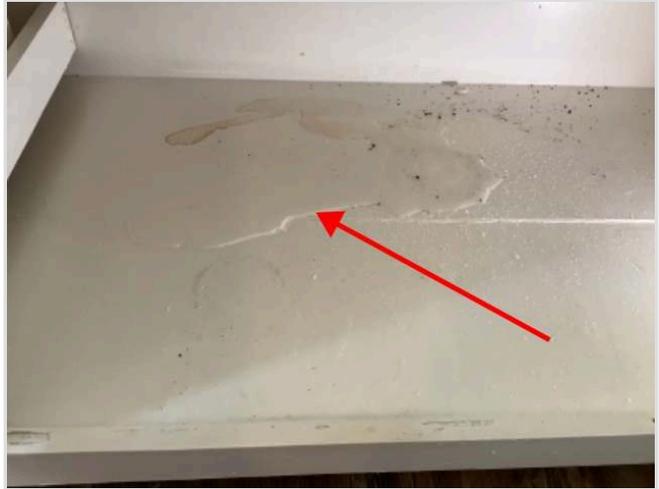
Leak (second floor bathroom sink)

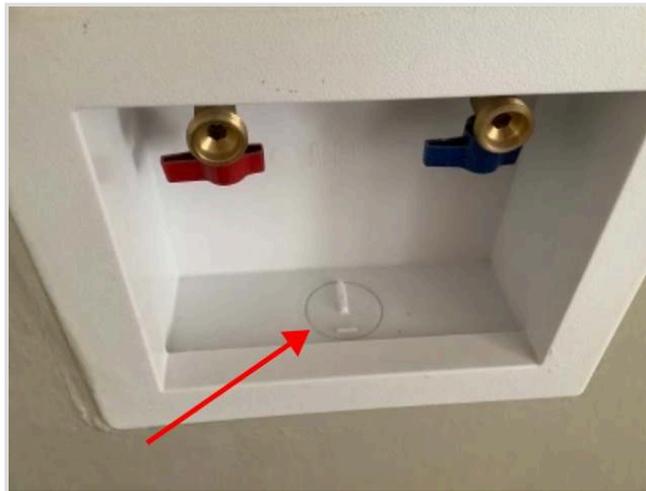
Note: The new washing machine plumbing connection box did not have the drain knock-out removed, so we were not able to view the washing machine drain line.

Laundry drain was not accessible

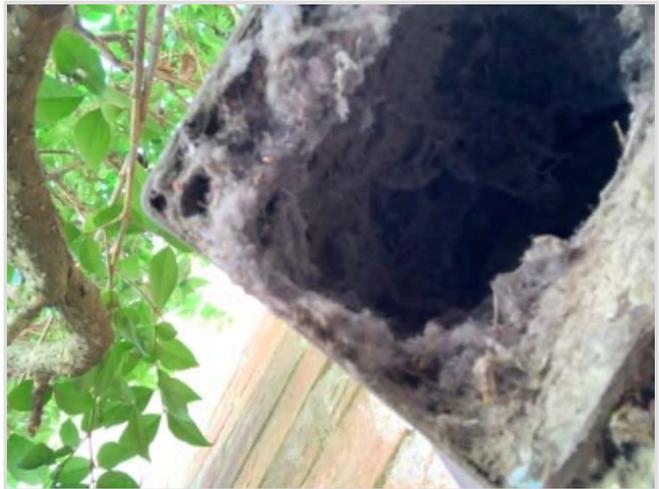
Dryer vent was missing its damper/exclusion cover, which could allow rodent/pest entry into the house.

Dryer exhaust had excessive lint buildup and needed to be cleaned.

Dryer exhaust vent was missing damper and needed to be cleaned
