HOME INSPECTION REPORT

**123 Sample Drive
Anytown, TX 55555**

PROPERTY INSPECTION REPORT

Prepared For:	Bill Sample	
	(Name of Client)	
Concerning:	123 Sample Drive, Anytown, TX, 55555	
	(Address or Other Identification of Inspected Property)	
By:	Inspector 1 Inspector 2	9-29-2017
	(Name and License Number of Inspector)	(Date)
	(Name, License Number of Sponsoring Inspector)

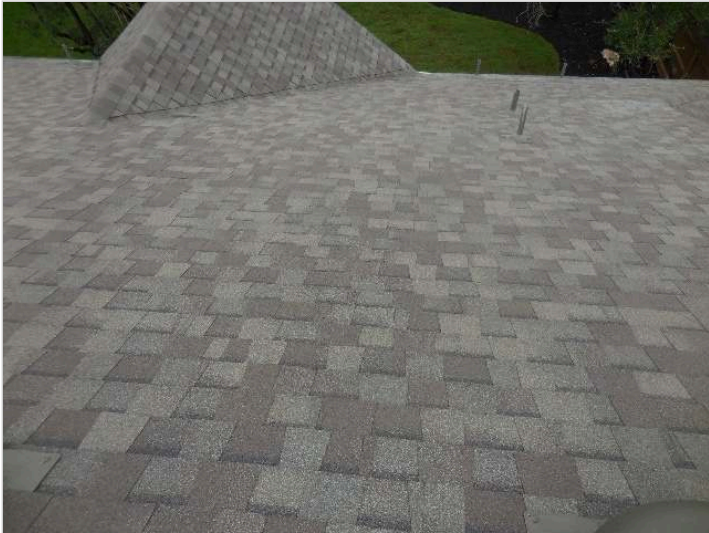
View of roof covering (back).

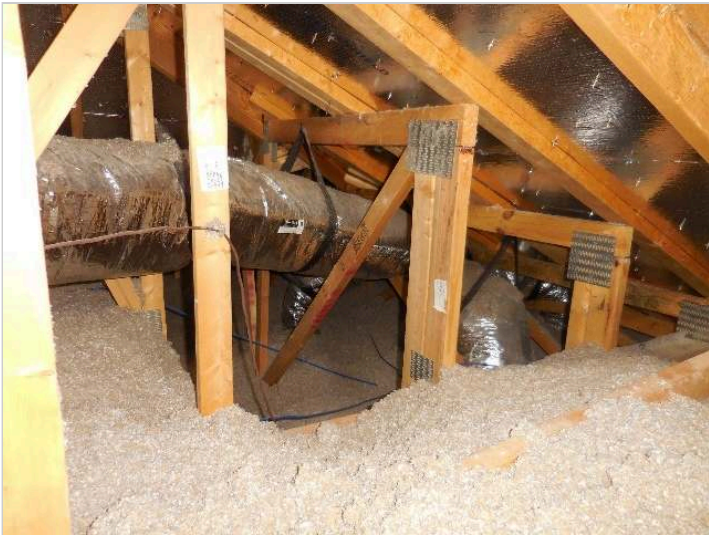
View of upper attic space (over common room).

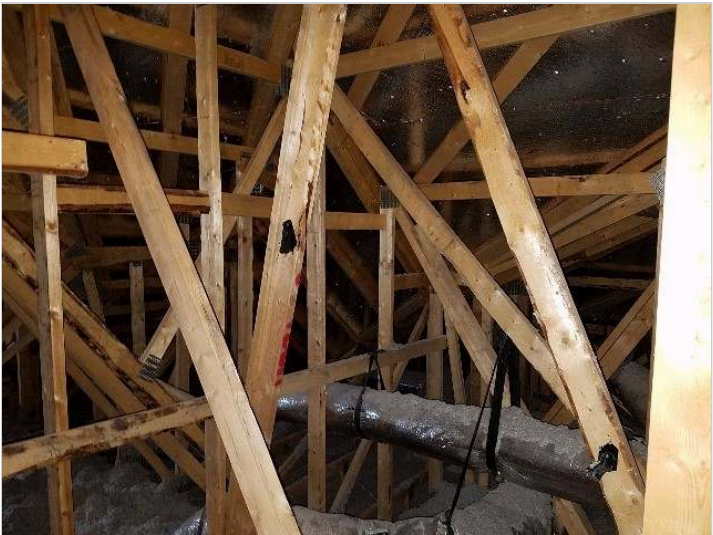
view of Texas attic space (left side).

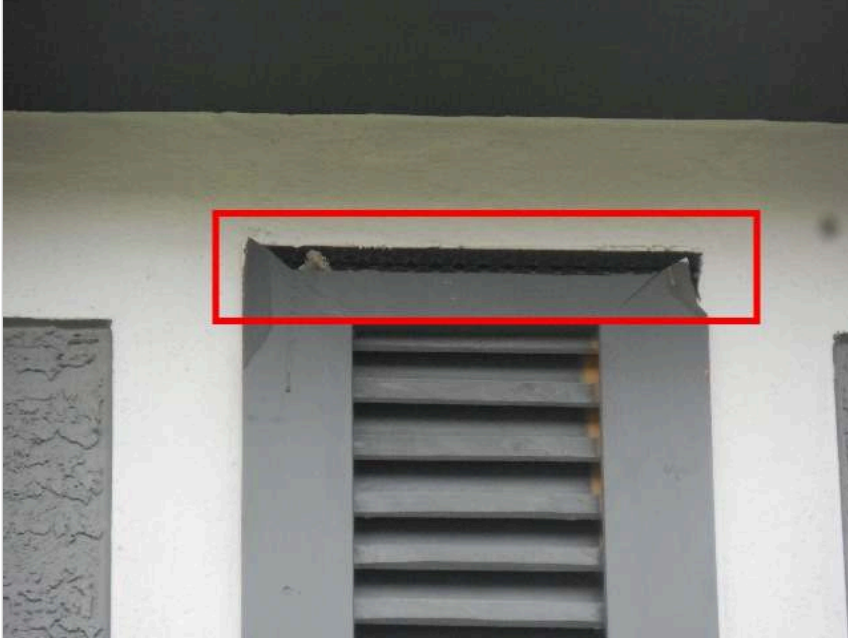
Trim was damaged at the top of the front facing gable vent. Recommend repairing and sealing.

Part of trim damaged/missing at front gable vent.

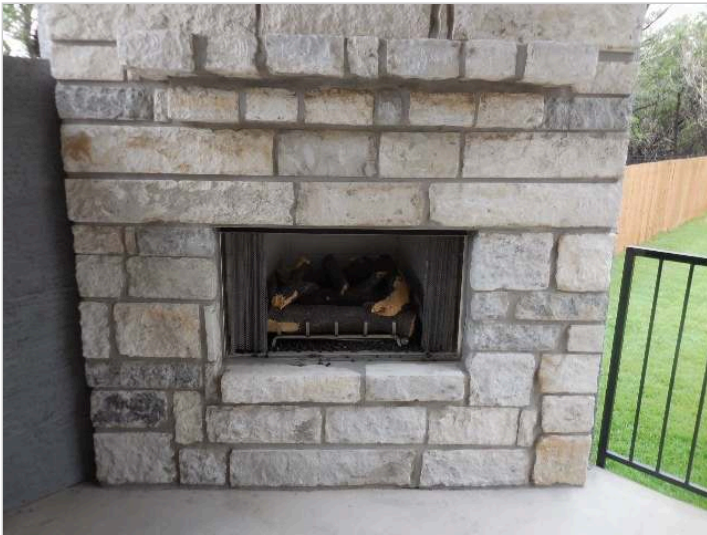
The ventless gas fireplace on the back exterior patio was proper.

View of patio fireplace.

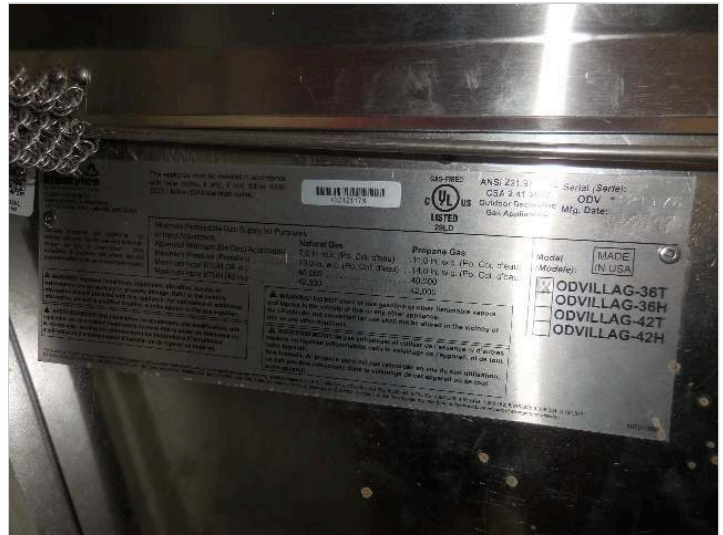
View of fireplace data plate.

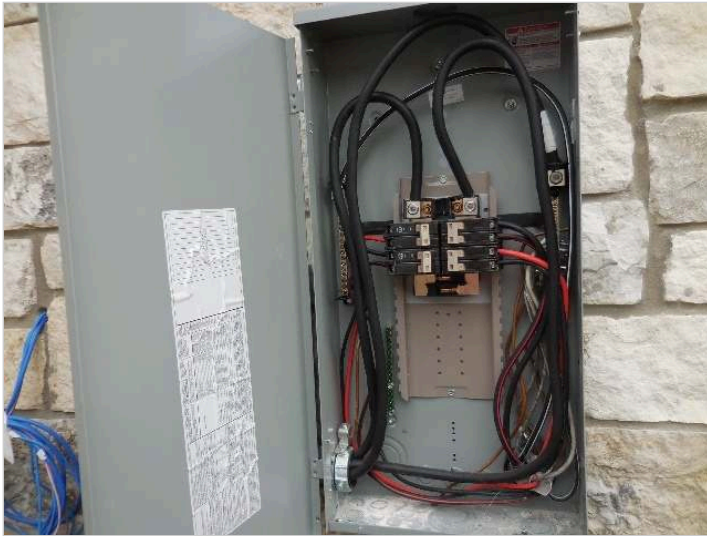
View of main electrical panel.

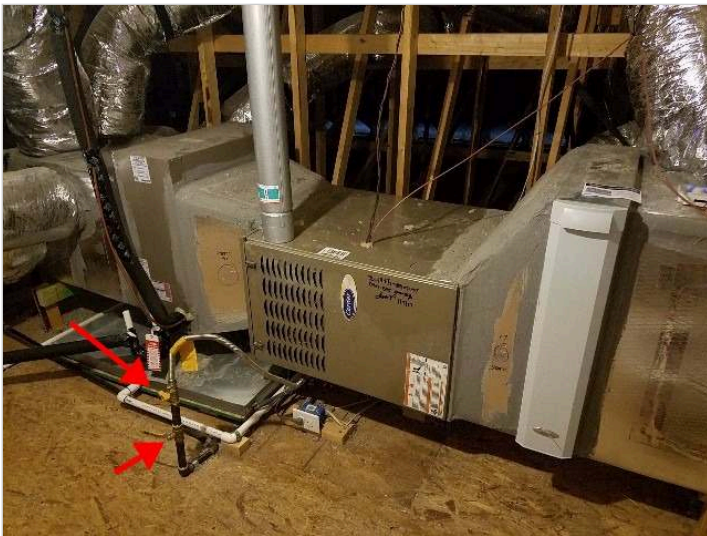
The heating units would not come on. Both unit gas valves and systems were OFF at the time of the inspection (at the units) and did not appear to be activated by the builder. After attempting to temporarily turn on the gas and units for testing they still did not respond. Recommend the builder activated the units (bleed gas lines) and demonstrate operation during final walk-through.

view of lower HVAC unit: gas and heater system off.

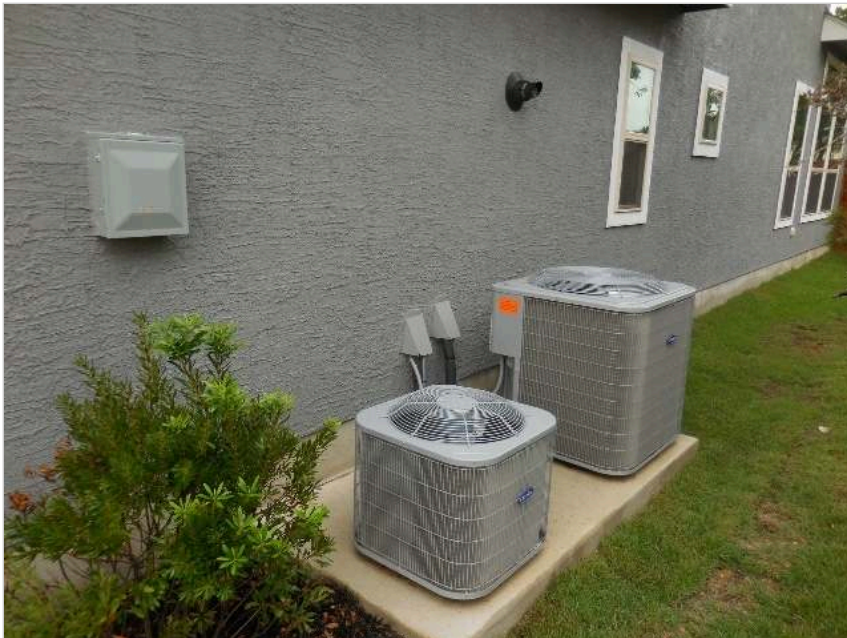
The HVAC exterior compressor and condenser unit(s) were manufactured in 2017 by Carrier.

View of condenser units.

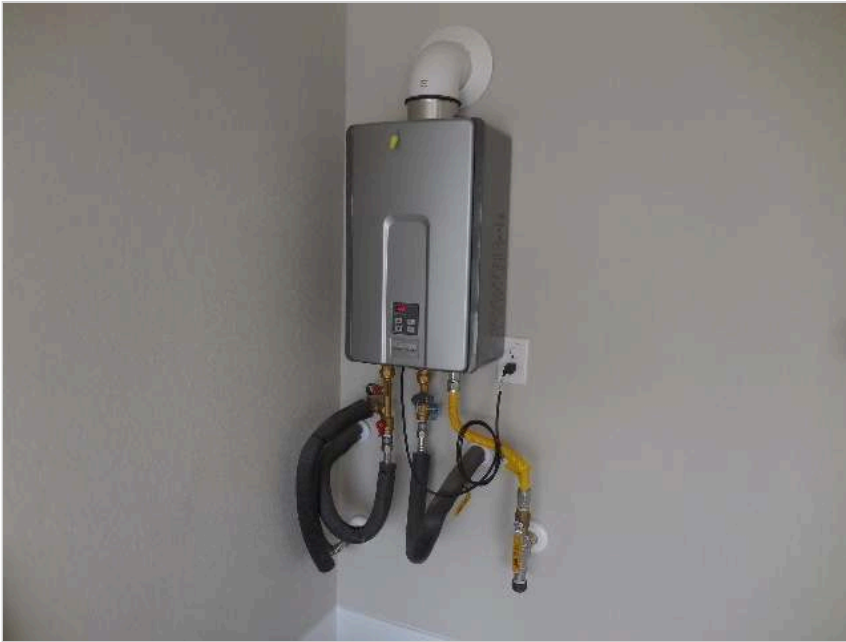
View of tankless water heater in garage.

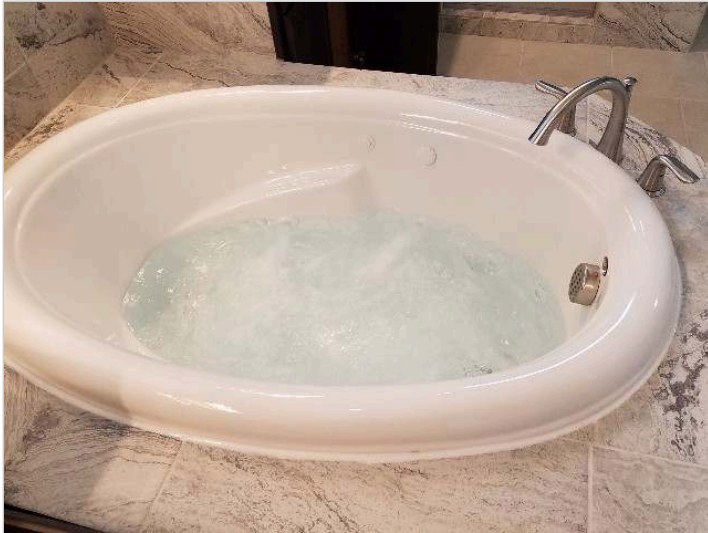
view of spa tub.
