HOME INSPECTION REPORT

**123 Anywhere St.
Topeka, KS 66605
Inspection #: 1234 - 567890**

2718 SE Illinois Ave, Topeka, KS 66605

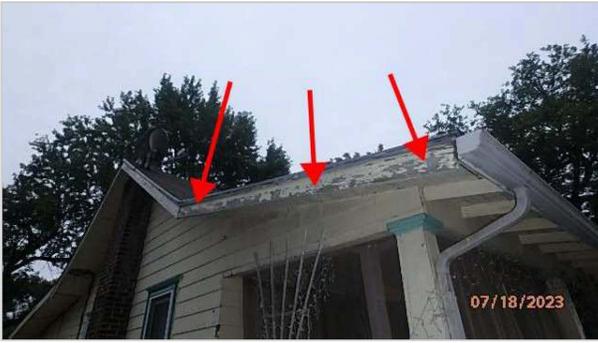
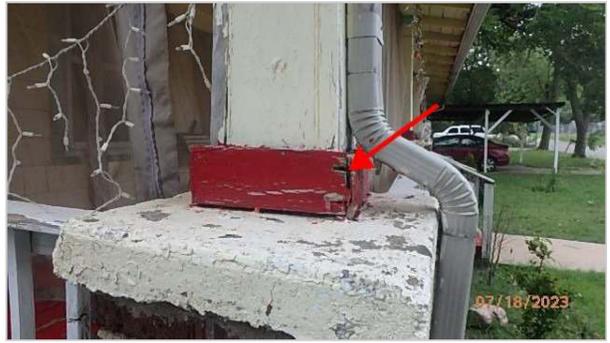
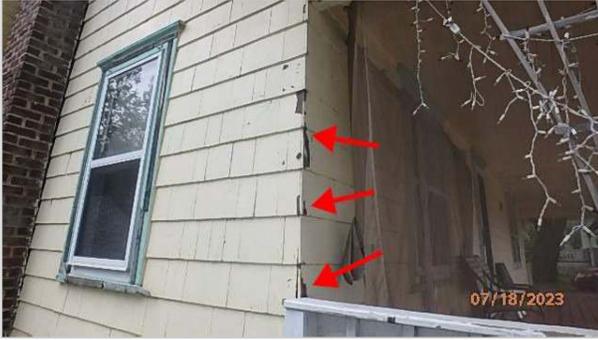
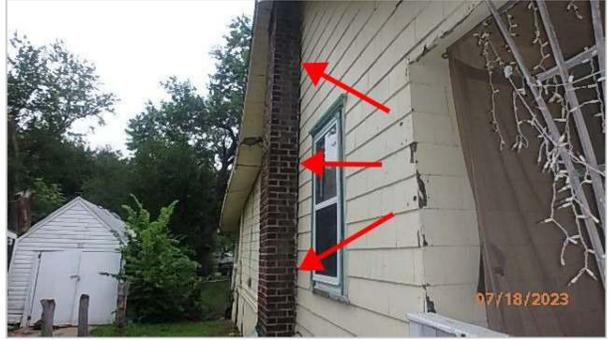
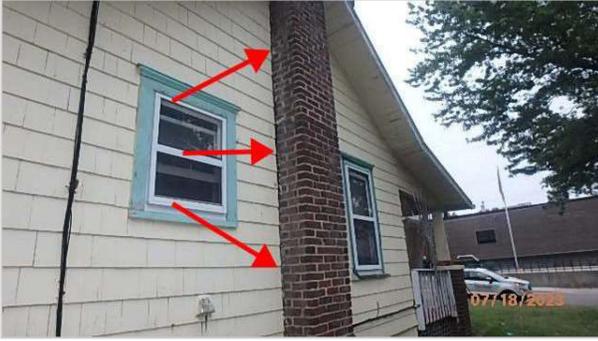
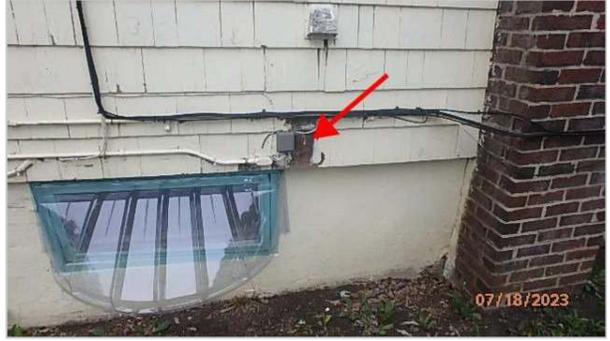
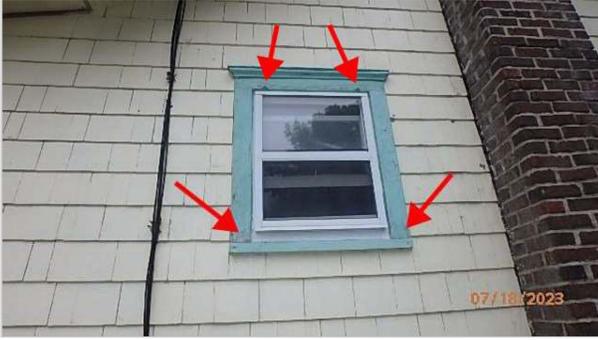
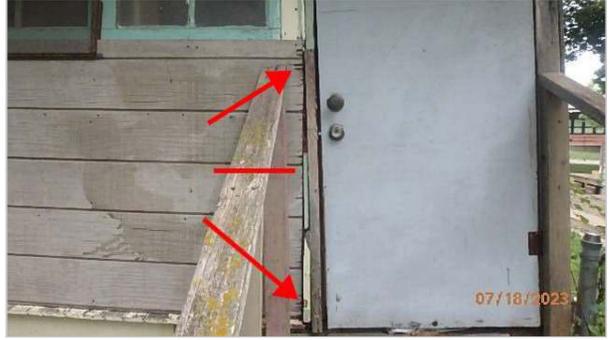
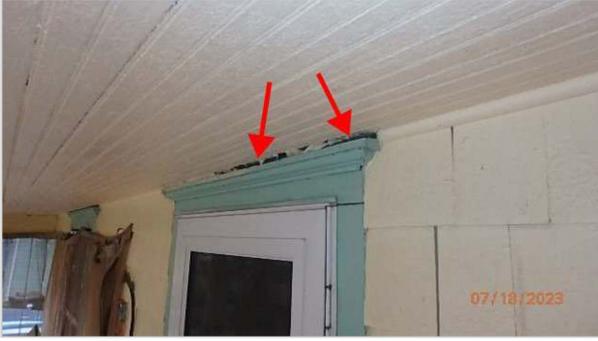
Homeowner maintenance is indicated including caulking, sealing, and/or painting of any areas of the siding and trim that could allow moisture penetration.

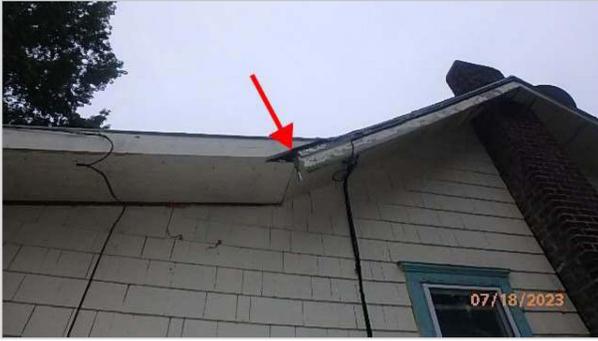
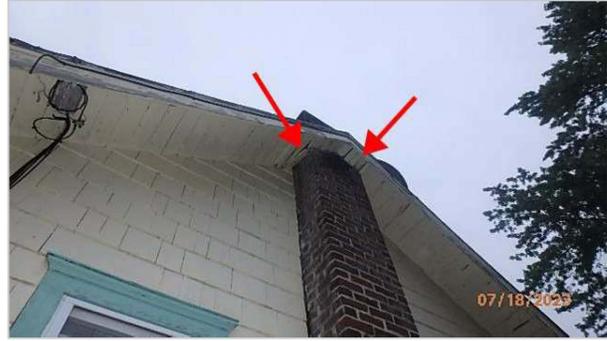
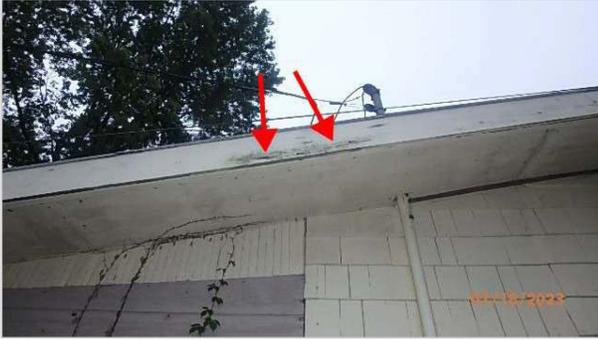
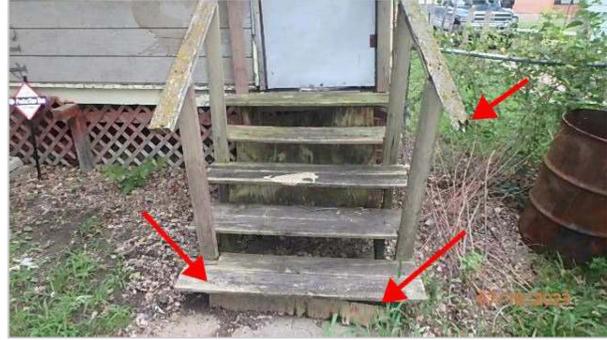
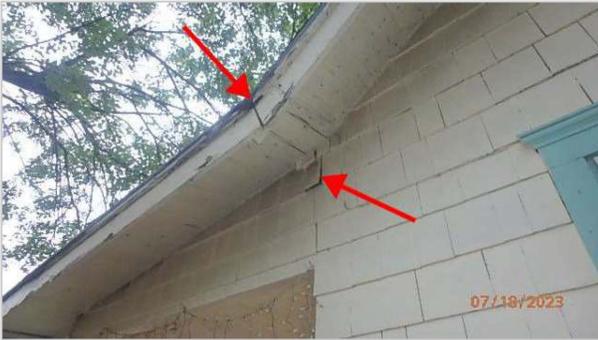
There was some decay observed on the exterior wooden elements in a few places. These are in need of some repair.

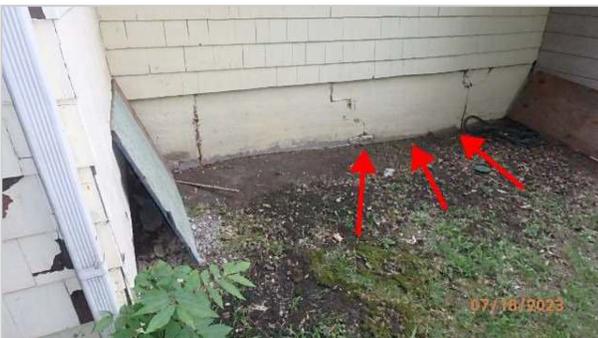
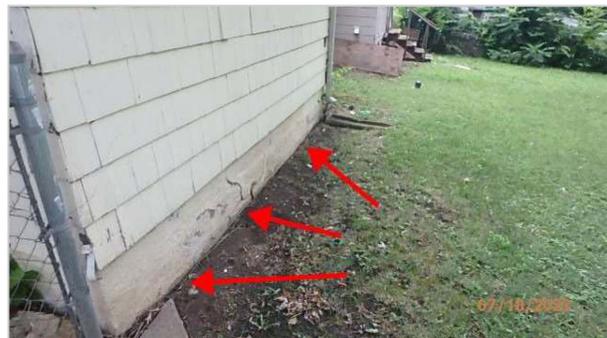
The grade in a few locations is in need of minor correction to improve the drainage and eliminate water pooling or channeling next to the foundation.

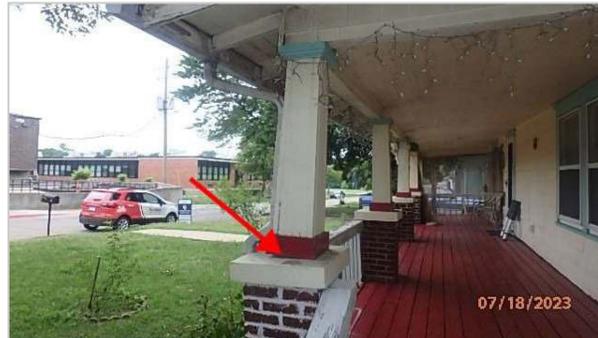
We observed shifting at one of the front porch post piers along with dry rot to the bottom of the inner wooden post. Repair/reinforcement is needed.

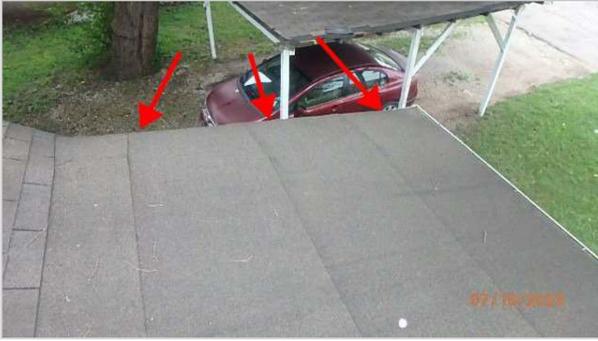
We observed several issues with the roof covering/structure including but not limited to: damaged shingles; significant wear on the asphaltic roll roofing over the low slope areas; damaged/deteriorated flashings; settled and soft areas of sheathing indicating damage to the roof decking. Further evaluation of the roof covering above the roof and to the roof structure in several areas (including in the attic) is recommended to determine the scope and cost of needed repairs/reinforcement.

Settled overhang structure

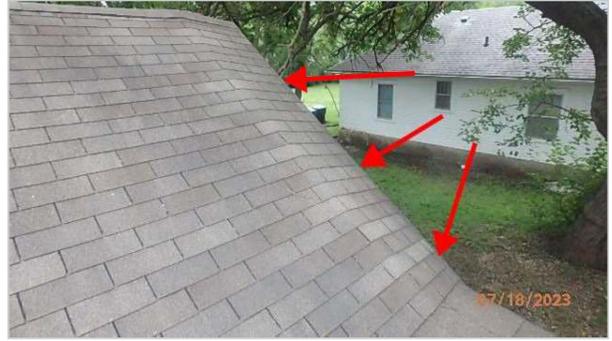
Settled overhang structure

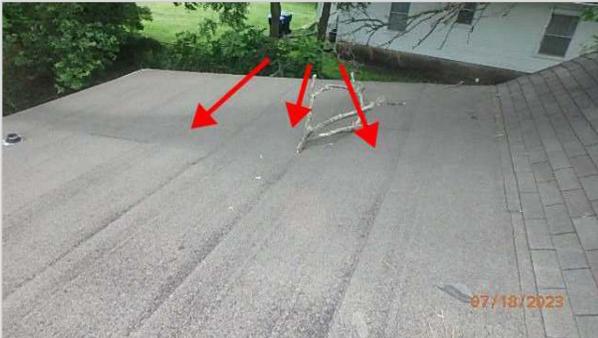
Significantly soft decking

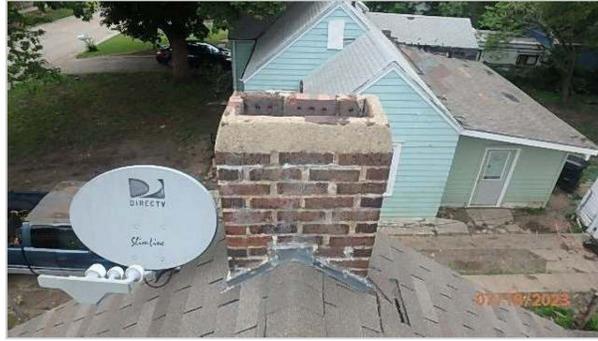
The chimney is in need of service to seal up the flashing around the base, repair the crown, and install a rain cap.

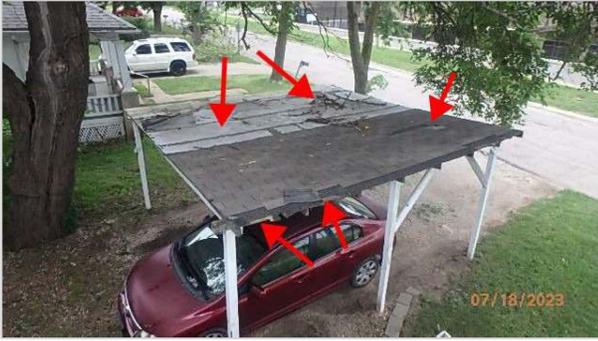
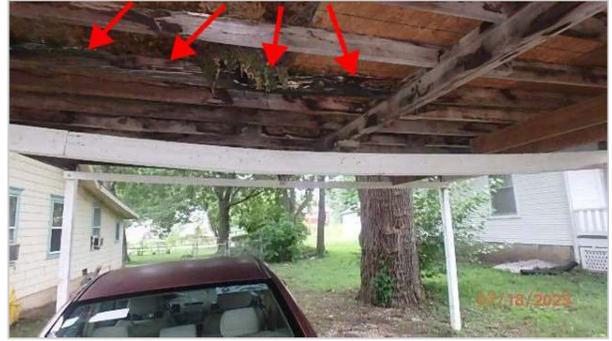
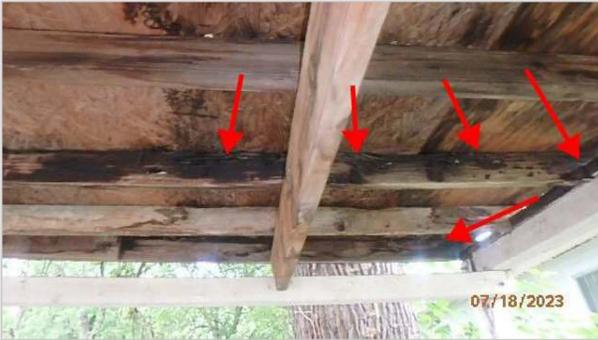
The carport was in marginal condition with significant damage to the roof covering, roof decking, and to the rafters/beams. Significant repair/replacement is needed.

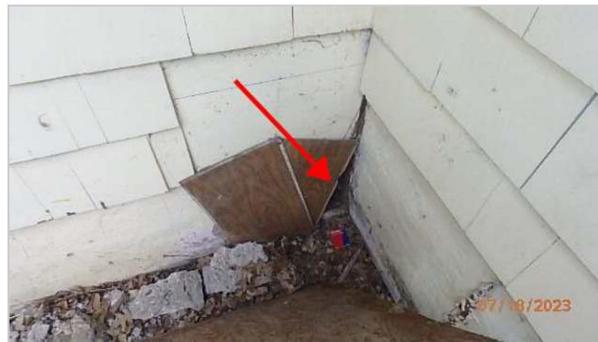
We observed a hole in the foundation in the back in need of repair.

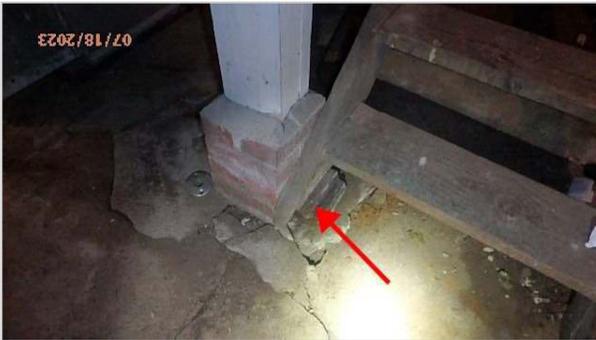
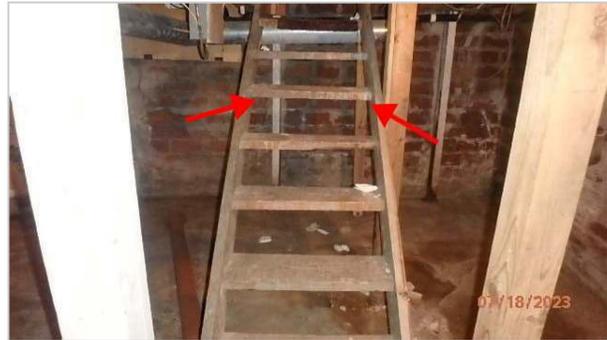
The bottom of the basement stair stringers has been damaged by dry rot and the treads are supported only by nails. Service is needed to repair/reinforced the damaged stringer and to install cleats beneath the treads to prevent and falling hazard.

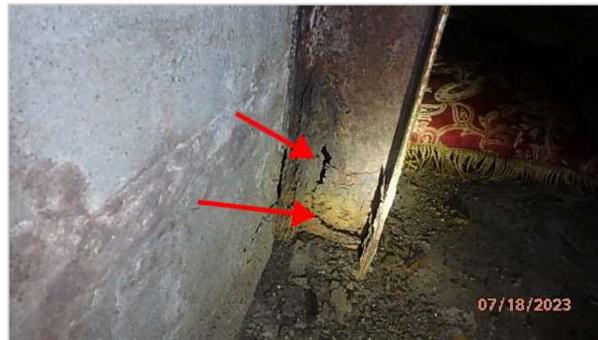
Steel reinforcing beams seen along the basement foundation wall have heavy rusting and corrosion at the bottom of the beam, with some having been rusted completely through. Further evaluation by a foundation specialist is needed to determine the scope and cost of needed repairs to the damaged beams.

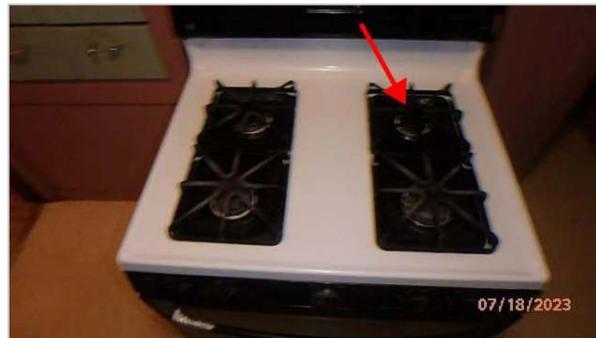
The natural gas range was tested and did appear to be mostly functional, but the rear right burner was not igniting at the time of the inspection. Repair is needed.

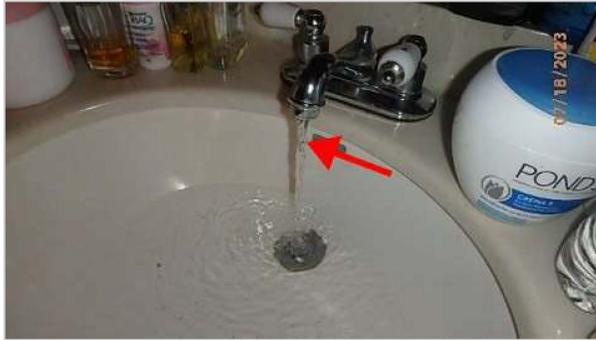
acceptable limits. Any galvanized pipes that may be remaining that were part of the original water pipe system appear to have exceeded their service life. Further evaluation by a plumbing specialist is recommended to determine the scope and cost of needed repairs.

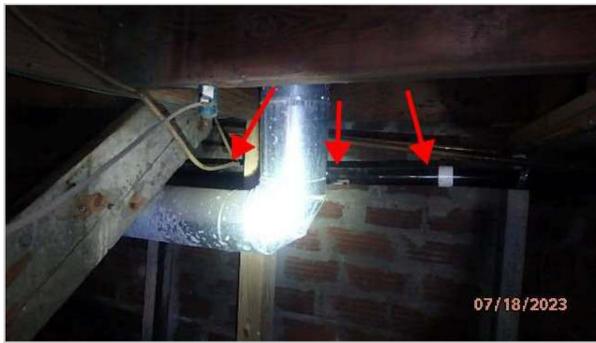
A section of drain piping running behind the stairwell in the basement is incorrectly sloped. Service is needed to correct the slope.

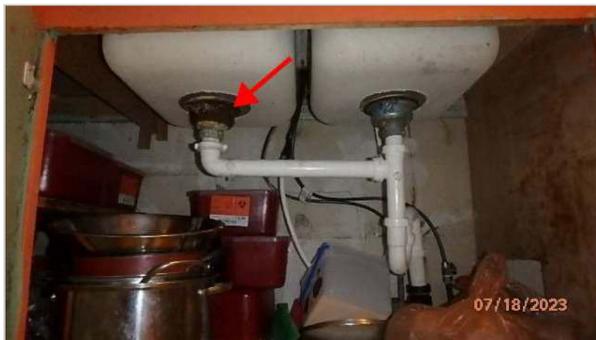
A drain leak located beneath the kitchen sink is in need of some evaluation and repair.

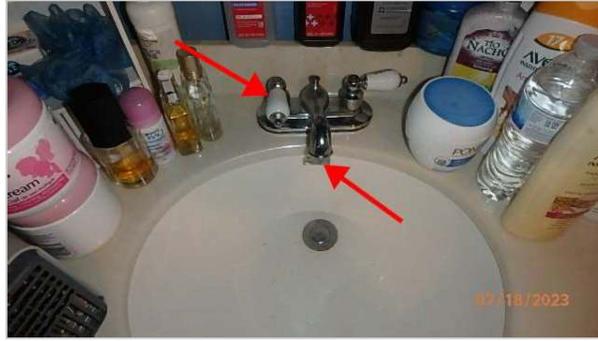
Hot water flow at the sink faucet in the full bath was little to nothing. This may be due to some sediment that has accumulated in the faucet or supply line. This could be an indication that the faucet has exceeded its service life and is due for replacement. Further evaluation and repair or replacement is needed to restore water flow.

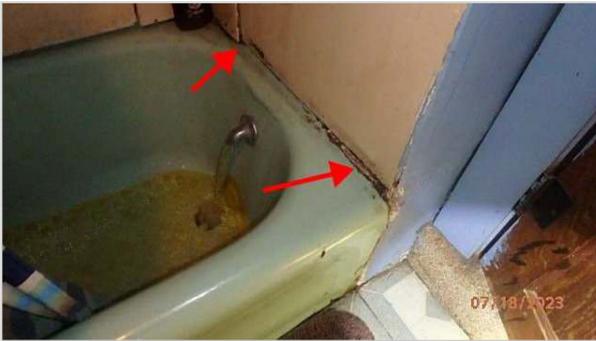
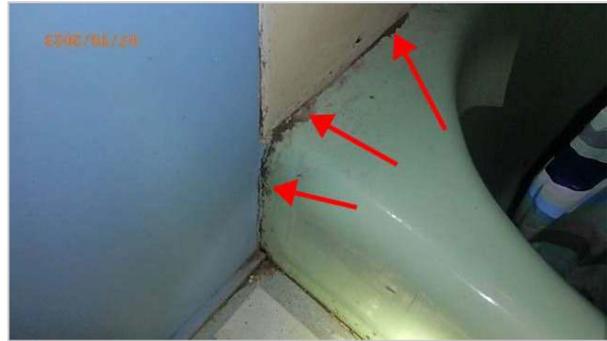
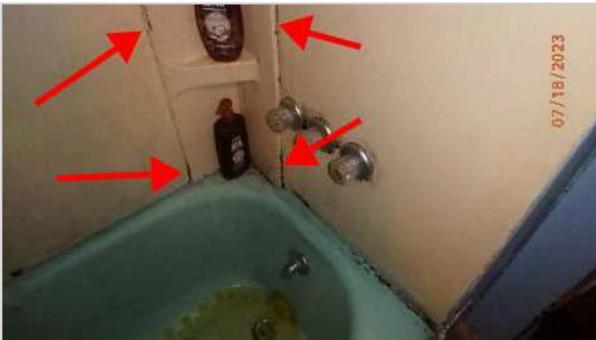
Failure to keep bath & shower walls sealed can lead to moisture damage which may include deterioration and decay of underlying structural elements and can promote mold growth on or within walls, which is not always visible at the time of the inspection. **The caulk was missing or damaged at several of the shower enclosure joints. These areas should be sealed and or repaired as needed to prevent moisture penetration.**

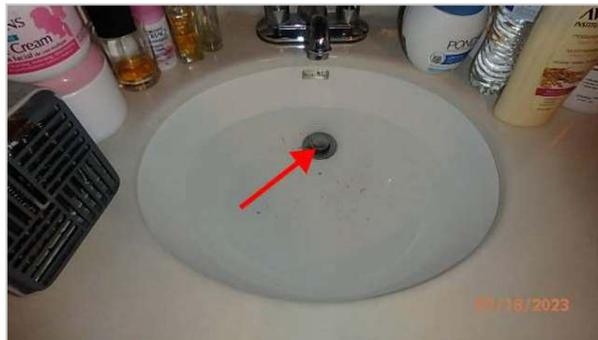
The sink drain in the full bath was mostly obstructed and in need of service.

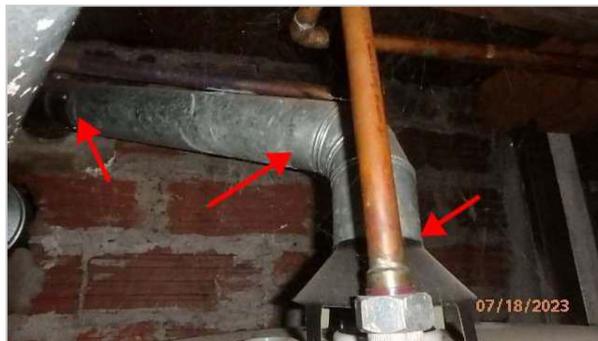
The flue pipe to the water heater was inspected and found to be in need of some adjustment.

Joints in flue pipes are required to be joined with screws to prevent incidental separation at joints. The water heater flue joints need to be secured with screws.

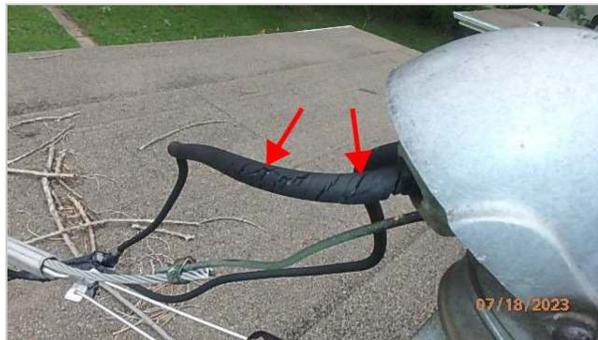
The electrical service wires located just outside the weather head have damage to the insulating jacket caused by age. These wires are in need of replacement from the overhead connection to the meter to eliminate potential short circuiting or accidental contact.

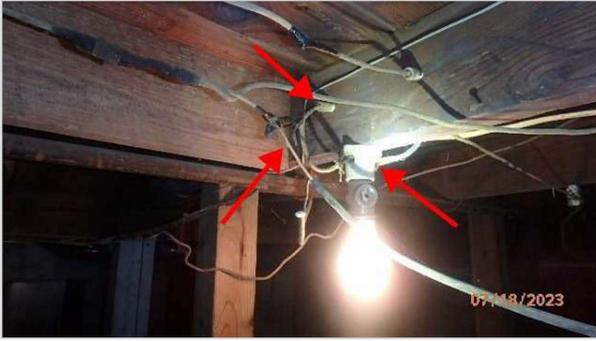
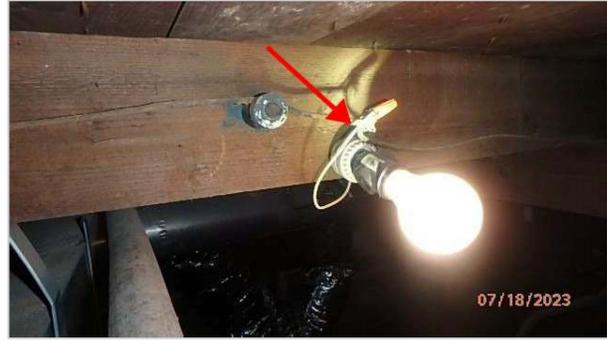
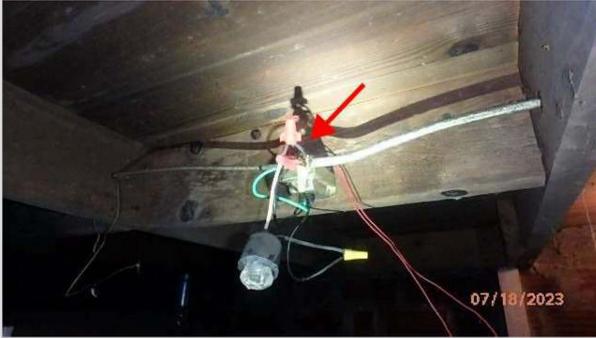
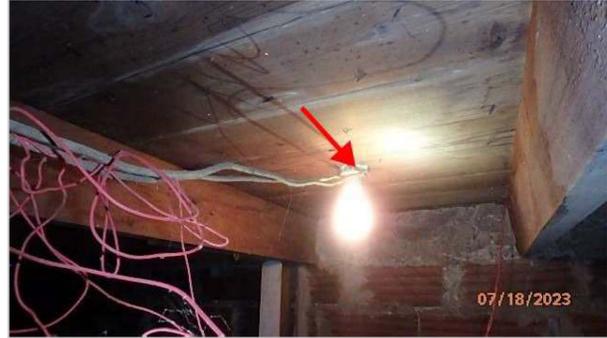
The remaining knob and tube wiring in the basement is in poor condition, with numerous open splices and several open terminal light fixtures. The remaining knob and tube that is visible should be rewired with newer jacketed cable and with safe fixtures.

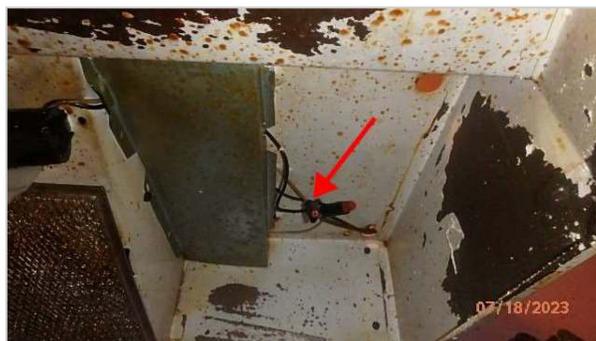
The range hood is wired with light duty lamp cord and with an open splice. Service is needed to rewire the range hood with proper materials and methods.

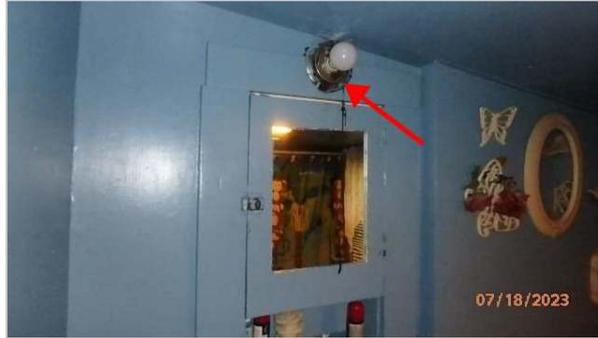
The light above the full bathroom sink was not functioning properly. Repair or replacement is needed.

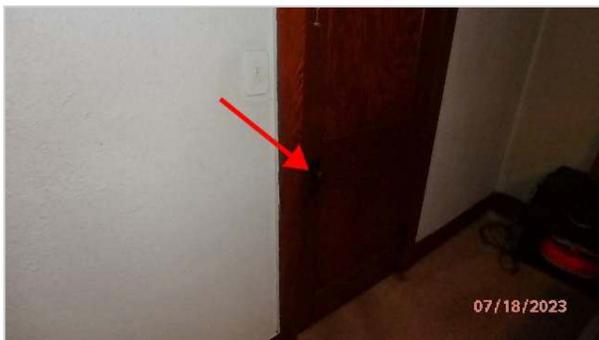
Some of the interior doors are in need of some adjustment/repair to allow them to close and latch properly.

Rear bedroom door (latch and strike plate alignment)

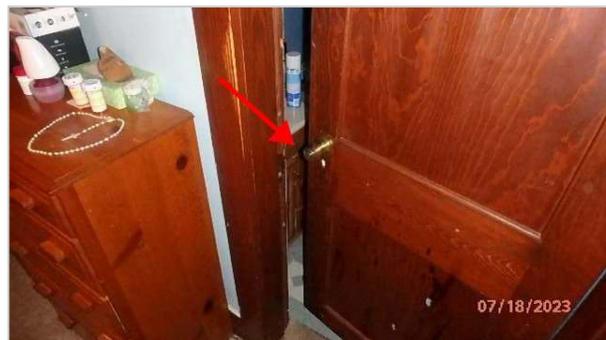
Full bathroom door (latch and strike plate alignment)

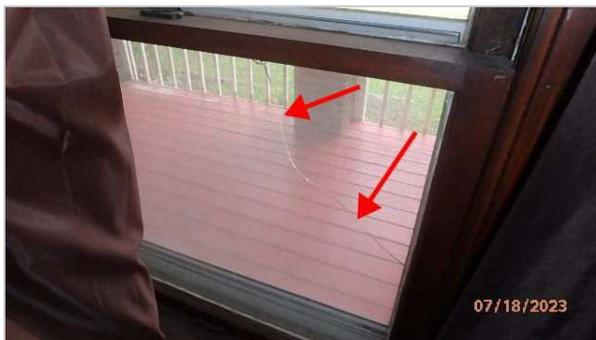
A window located in the living room has a cracked pane of glass in need of repair.

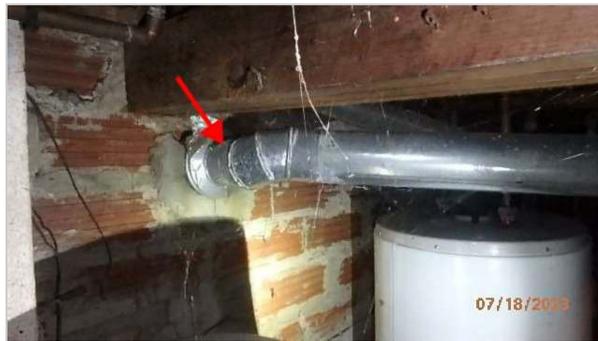
The furnace flue takes a downward slope right before entering the chimney. Service is needed to correct the downward slope to help prevent back wash of flue gases into the basement.

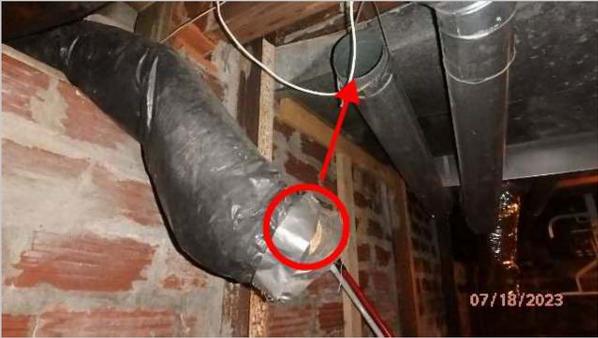
One of the supply ducts located in the basement has come loose and needs re-attaching.
