HomeTeam[®]
INSPECTION SERVICE

Joe Client
1313 Mockingbird Lane
Mayberry, NC 12345

On 6/30/2021, HomeTeam Inspection Service made a visual Pre-drywall inspection of the property referenced above. Enclosed please find a written, narrative report of our findings in accordance with the terms of our agreement.

PDW - PHASE II - PRE-DRYWALL

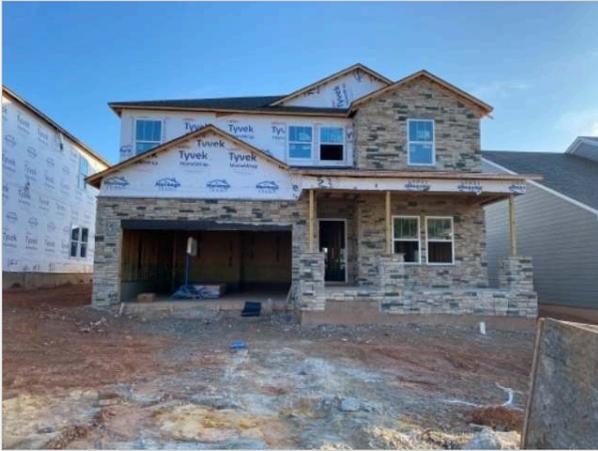
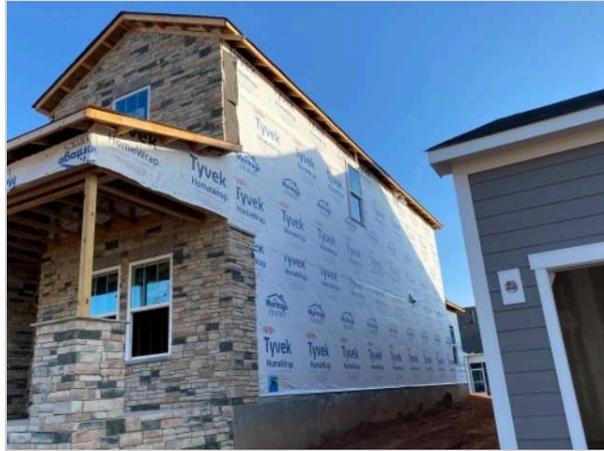
At the roof, the two plumbing vents have no boots installed. This allows water penetration to the interior. Have the builder complete this work prior to insulation and drywall work.

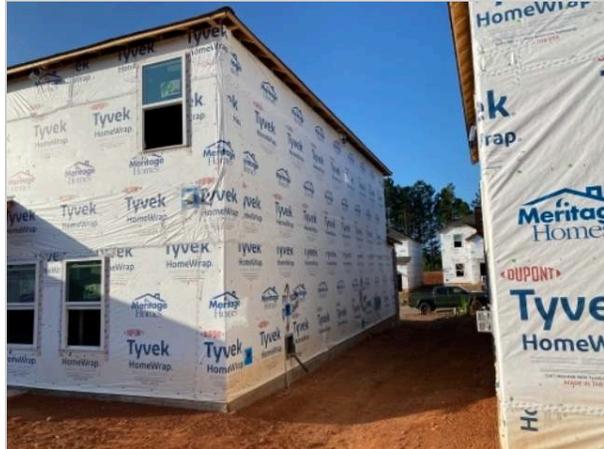
At the front porch, the final roofing is not installed. This may be awaiting standing seam metal roofing. Prior to installation of insulation or drywall, have the builder complete this roofing work.

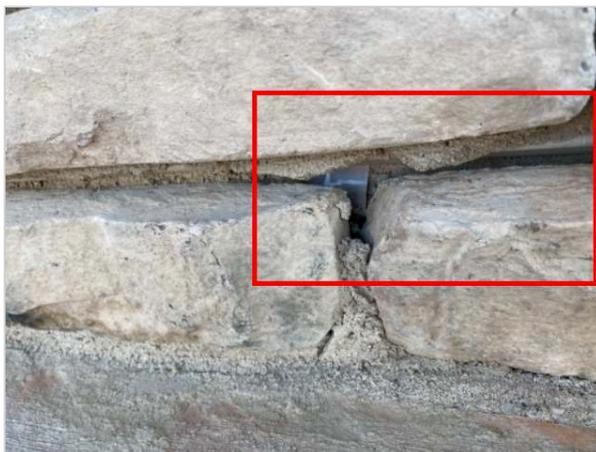
At the stone veneer around the home, there is at least one area where the mortar is incomplete. This can allow moisture and pest intrusion. Have the builder repair everywhere needed.

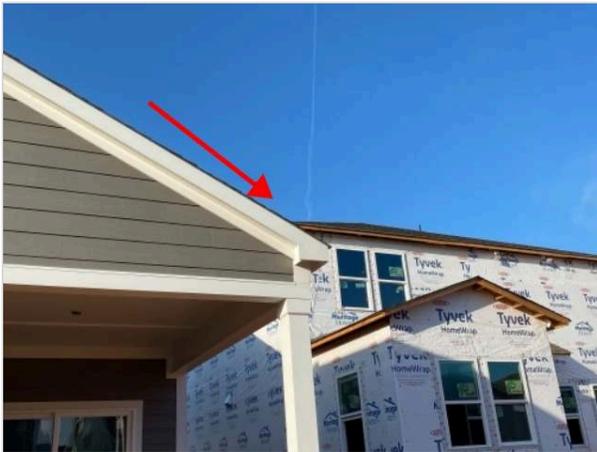
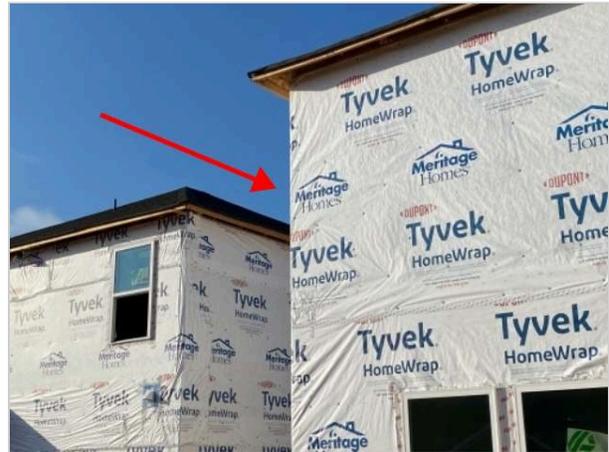
Due to the proximity of neighboring houses, the roof inspection was limited. The roof is not fully visible from multiple sides of the home.

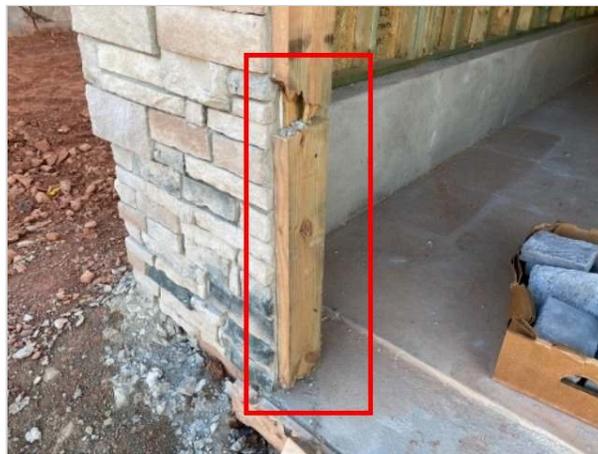
At the garage door, the framing on the left side is defective. Have the builder rework/repair as needed.

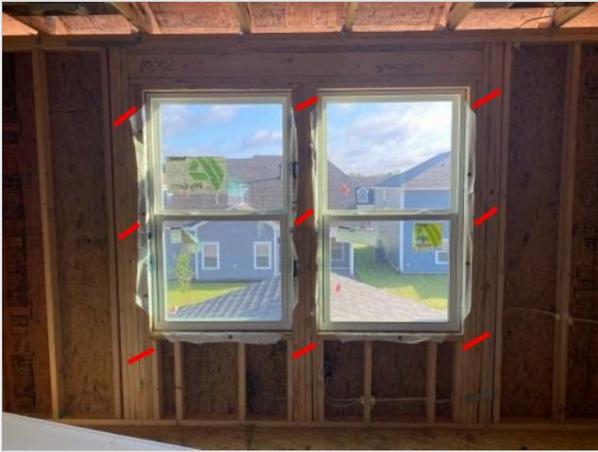
At the owner's suite rear window, the frame strapping is missing. Have the builder install this strapping prior to drywall installation.

Strpping missing

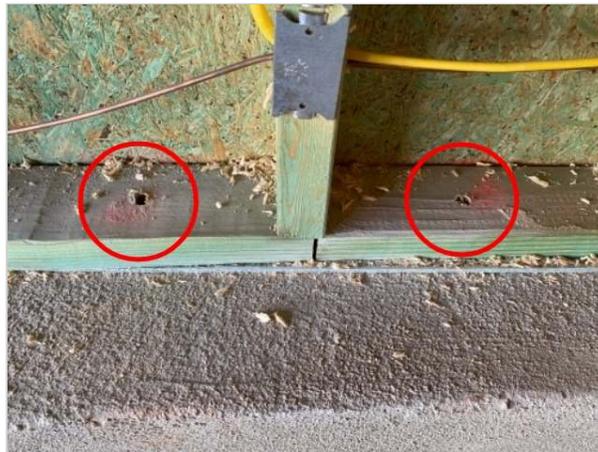
Around the structure, there is one place where the sill bolts are missing. These are vital for holding the structure to the foundation. Have the builder install sill bolts as needed.

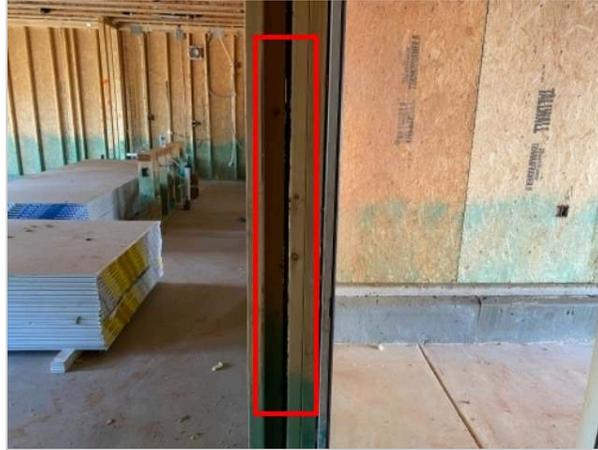
At the family room/garage perimeter wall, there is a gap where daylight is visible. Have the builder seal all gaps and holes in the perimeter walls prior to interior finish work.

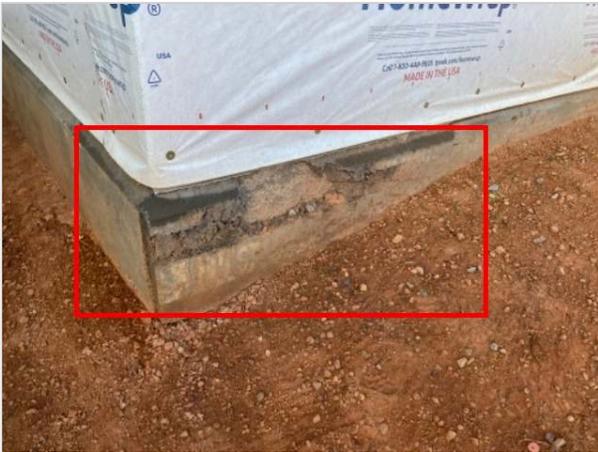
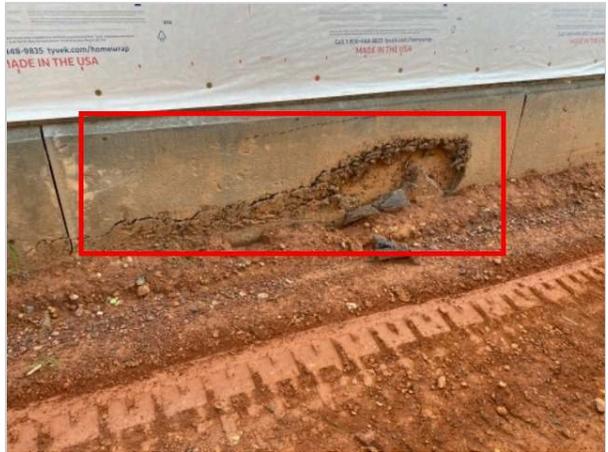
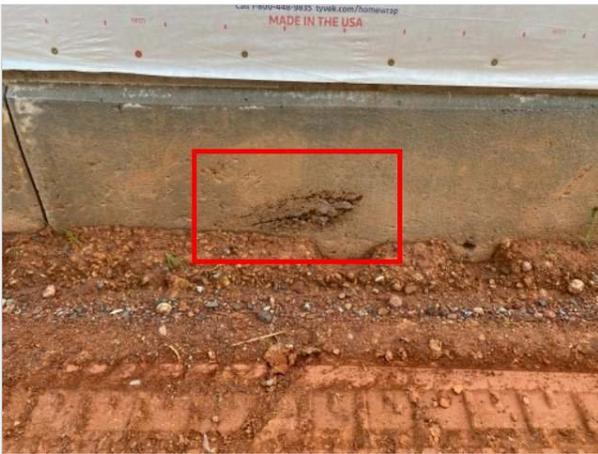
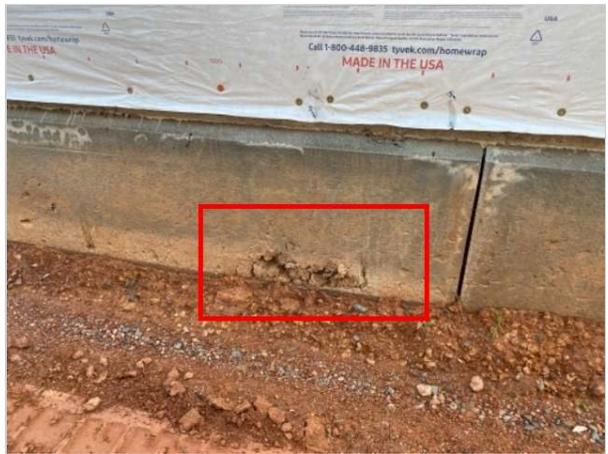
Around the foundation, the foam insulation panels are damaged. The purpose of the insulation is to knock down heat gain or loss from the home through this concrete and help keep the floor temperature more stable. Hve the builder repair the panels as needed.

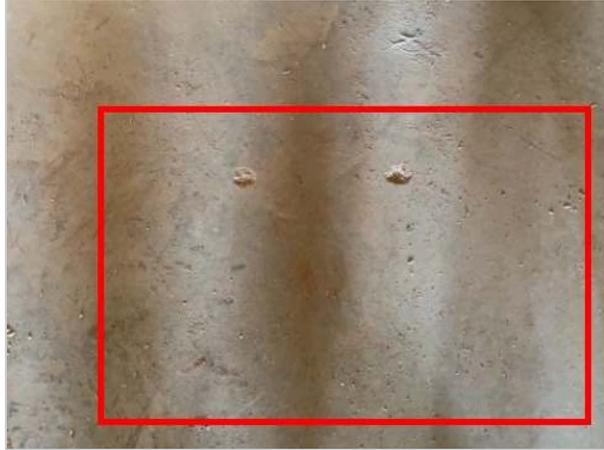
At several places, the concrete slab is damaged. Have the builder repair the slab as needed prior to interior finish work

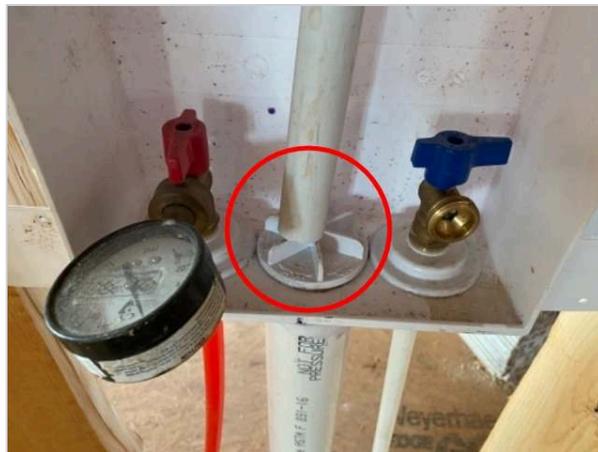
At the laundry room, the HVAC primary condensate drain line is run to the washing machine drain outlet box. While this is typical in modern home construction, it requires a double drain box while this is a single drain box. Further, when installed to its own drain, the HVAC condensate pipe should extend into the drain pipe in order to prevent leaks and reduce the drainage sound. Have the builder rework as needed.

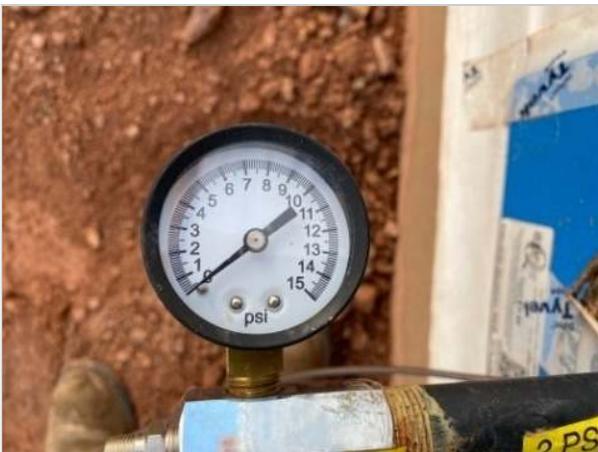
At incoming

At the incoming gas line, the test gauge is reading 0 psi. This may mean the static pressure test has failed, indicating a leak in the system. Also, the gauge at the kitchen gas pipe reads 5 psi. Both gauges cannot be correct, but either reading indicates a possible test failure. Prior to insulation and drywall work, have the builder ensure the gas piping is properly installed and passes the static pressure test.

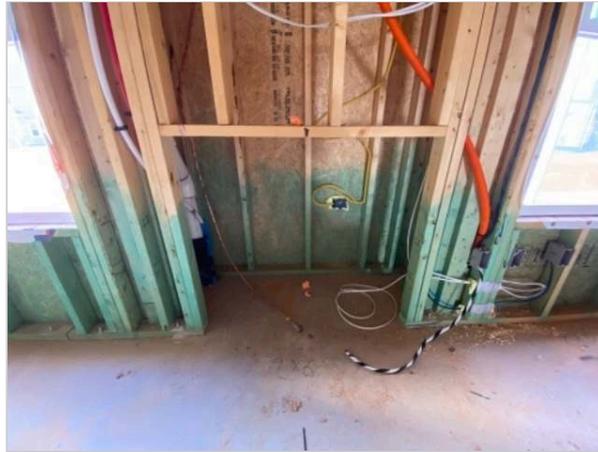
There is what appears to be framing and gas line for an unvented fireplace in the family room. Typically, at this stage, the unit is installed and ready to be closed in. Have the builder complete the fireplace installation prior to drywall installation.
