**HomeTeam**<sup>®</sup>  
INSPECTION SERVICE

February 19, 2013

**123 Sample Rd.  
Leland, NC 28451  
Inspection #: 123456**

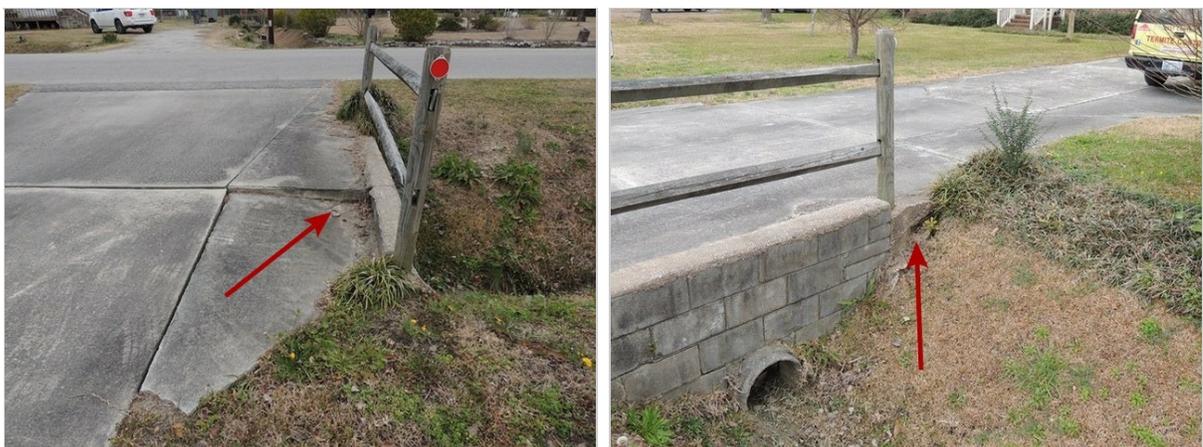
- ***The following defects were noted in this section:***
- There was severe settlement of portions of the concrete driveway over the drainage ditch and culvert near the street. The retaining wall on one side of the driveway was cracked and has begun to bow out. There was erosion of the soil under both sides of the driveway. Further erosion can lead to failure of the driveway and retaining walls. The settled portion of the driveway can also lead to damage to low profile cars.

- Recommend a qualified contractor be consulted for repairs needed.

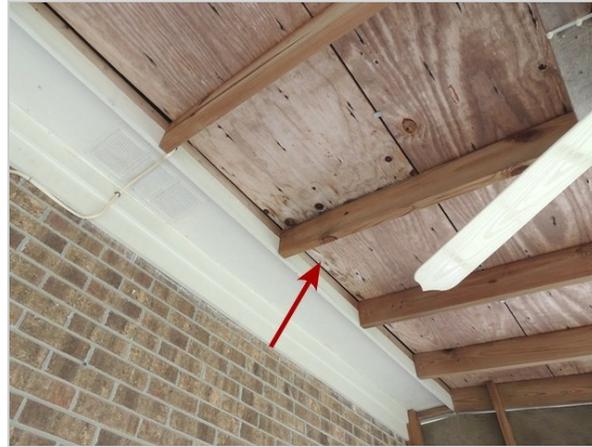
**PATIO:** There was a covered and screened in concrete patio located at the rear of the home. NOTE: The roof over the patio was attached only to the fascia board of the roof boxing. This is not a structural connection for the roof.

However the roof over the patio has been in place for several years and has stood the test of time. NOTE: There were a few stains in the roof sheathing of the patio. This is an indication that there has been a leak at one time, possibly due to wind driven rain. The stains were tested with a moisture meter and found to be dry. It was raining at the time of the inspection.

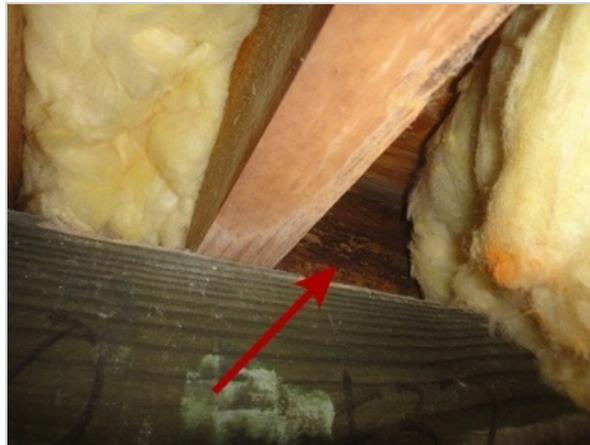
NOTE: There was moderate fungal growth on the band joist behind the front stoop. Sealing any gaps in the dirt filled concrete and brick stoop can help to reduce moisture. The area was tested with a moisture meter and found to be dry at the time of the inspection.

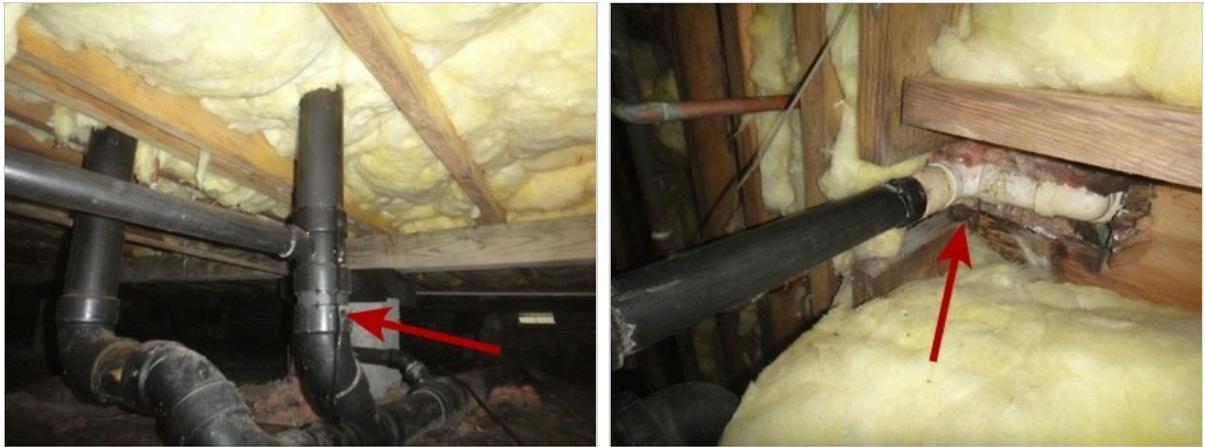
- ***The following defects were noted in this section:***
- The commode in the hallway bathroom was loose at the point where it attaches to the floor. This can lead to a leak due to the failure of the wax seal below.
- There were two leaks in the waste and drain plumbing under the hallway bathrooms. The leaks were observed in the crawlspace.

- Recommend a licensed plumber be consulted for evaluation of the plumbing system and for repairs needed.

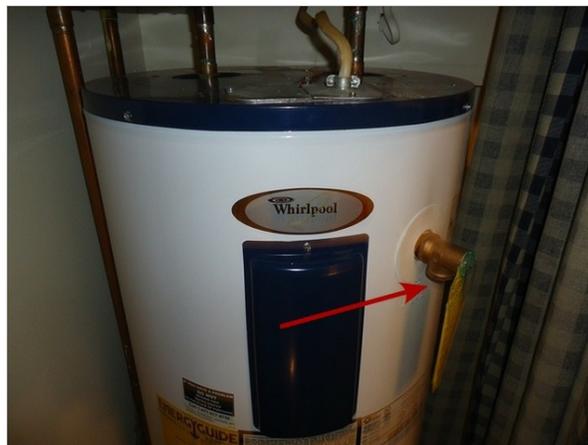
- *The following defects were noted in this section:*
- There was no drip leg on the temperature and pressure relief valve. A drip leg should be installed to prevent injury in the event of the valve tripping.

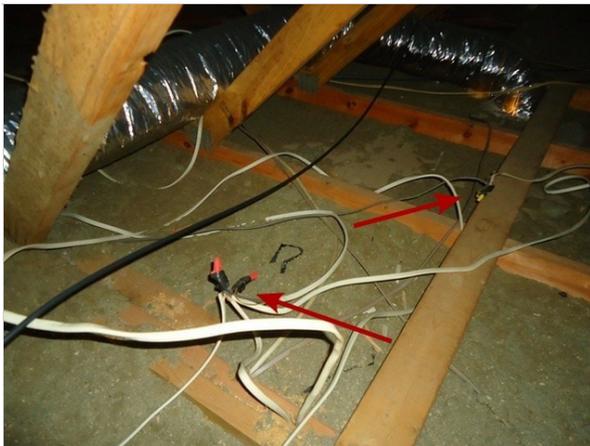
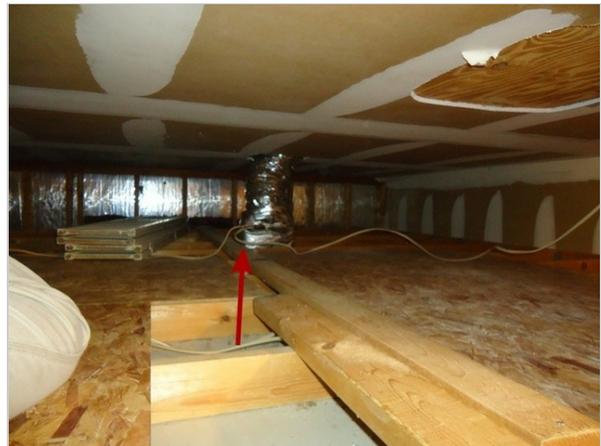
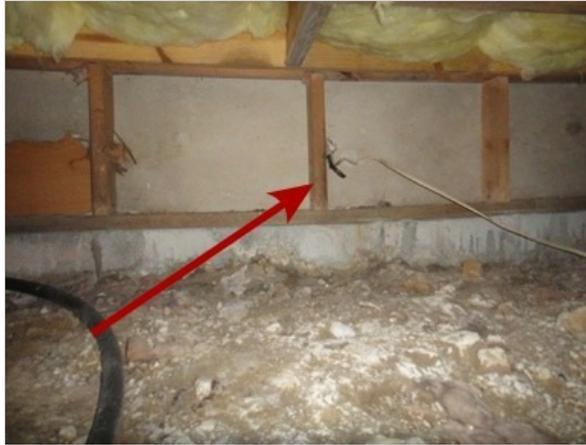
- ***The following defects were noted in this section:***
- There were several (more than 5) open splices, junctions, and improper wire terminations throughout the house and shed. They were located in the crawlspace, attic, above the drop ceiling in the family room/converted garage, and under the shed at the electrical service entry point. Any exposed live wires are a safety and potential fire hazard. NOTE: There was evidence of periodic standing water under the house. One of the open splices and connected Romex cable was lying on the ground at the right side of the crawlspace.

- The GFCI receptacle in the hallway bathroom was inoperable when tested. It would not trip when tested.
- The vent fan in the hallway bathroom was inoperable when tested. A operable vent fan is required for moisture control.
- The hot and neutral leads were reversed at several receptacles in the family room/converted garage. This is a safety hazard.
- Recommend a licensed electrical contractor be consulted to determine the cause and for repairs needed.

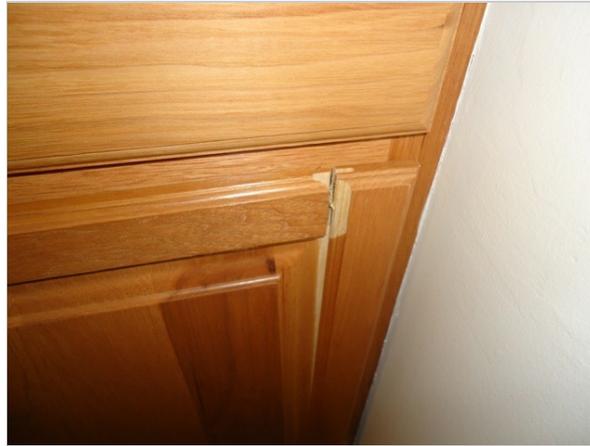
- The face frame on a cabinet to the left of the range was loose. This can lead to damage to the cabinet box.
- The glue joint on a cabinet door in the kitchen was loose. This can lead to damage to the door.

- Recommend a qualified contractor be consulted for repairs needed.
