HOME INSPECTION REPORT

The HomeTeam Inspection Service made a visual inspection of 123 Anywhere St., City, ST 12345. Enclosed please find a written, narrative report of our findings in accordance with the terms of our Inspection Agreement.

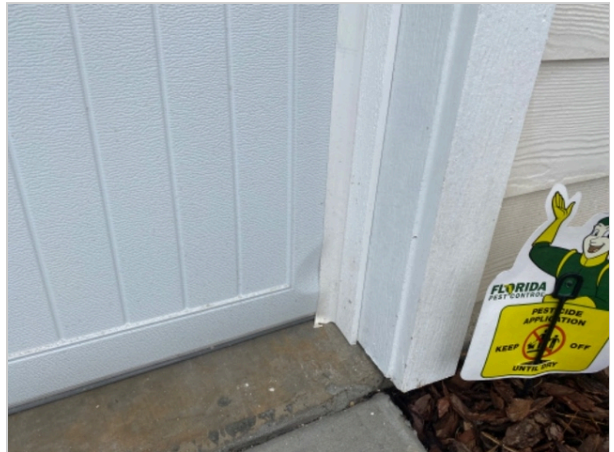
Photo 25

The garage door is dented from what appears to be impact. The door was operating correctly at the time of the inspection. Care should be exercised to ensure that the door is not subjected to further impact, as the door may crack or fail.

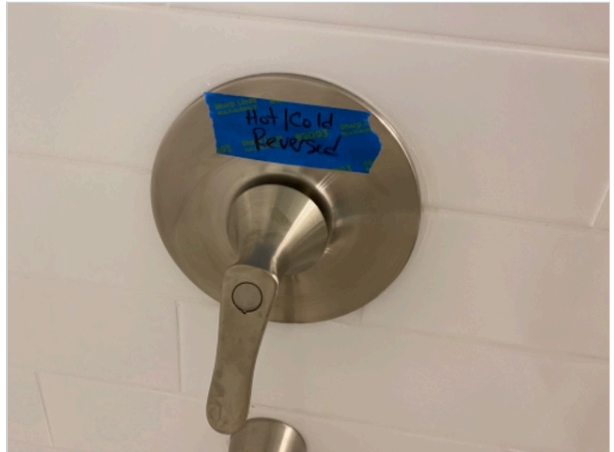
Photo 48

The shower controls in both guest bathrooms had the hot/cold reversed, which is a possible scald issue and should be corrected.

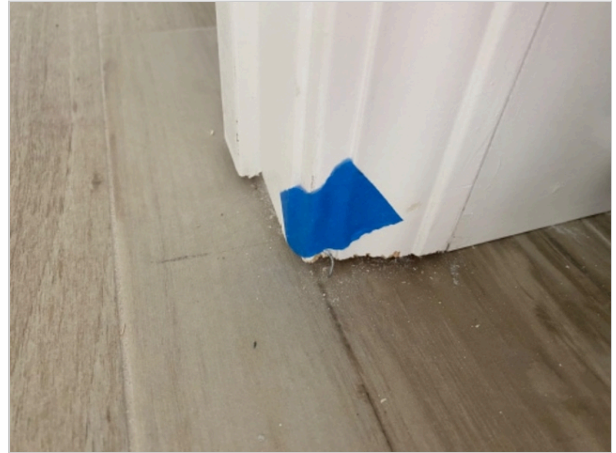
An exposed nail was observed at the guest bedroom/ jack & jill bathroom door frame that should be removed

and has been marked with blue tape to help the builder and contractors identify said issues.

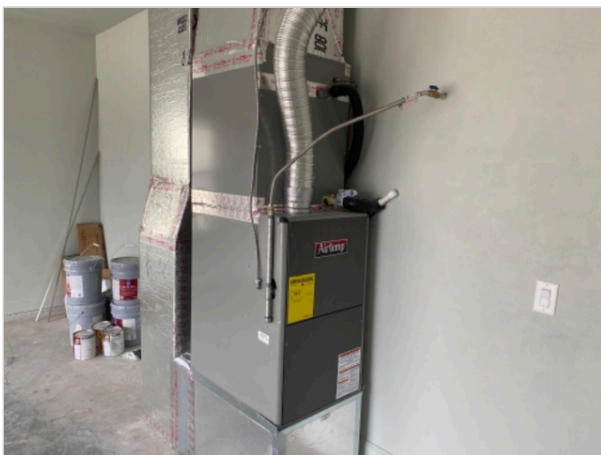
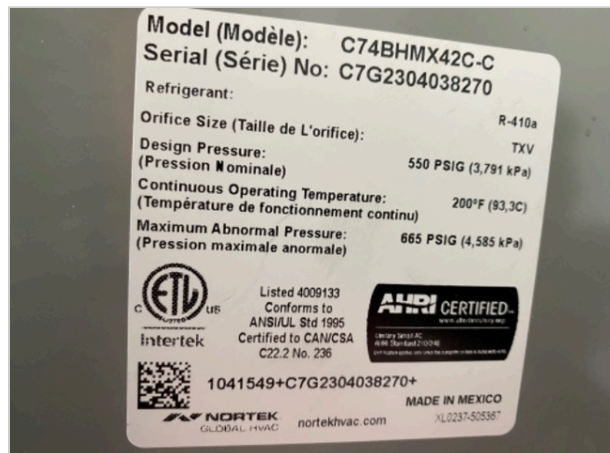
The HVAC condensate line was raised above the floor drain or drain inlet. The condensate line was trapped. The HVAC condensate line must be trapped and not in contact with wet drain inlets to prevent the possible migration of bacteria and mold into the air-handling system. The heating system was found to be functional.
