HomeTeam[®] INSPECTION SERVICE

HOME INSPECTION REPORT

On Thursday, March 14, 2019 HomeTeam Inspection Service made a visual inspection of **Service Service**, Wyoming, MI 49509. Enclosed please find a written, narrative report of our findings in accordance with the terms of our Inspection Agreement.

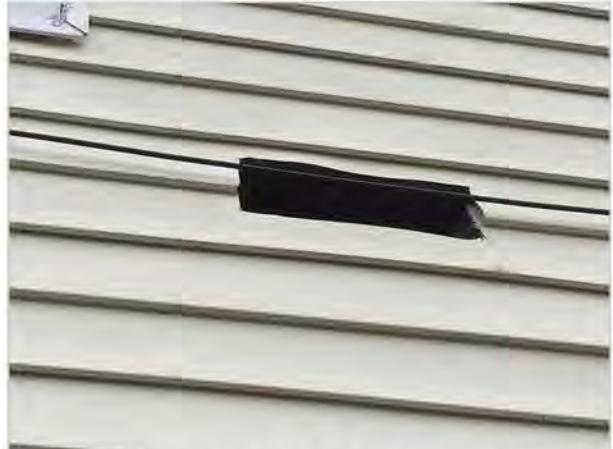
Right wall of house

A hole was noted on the right side of the structure's exterior. This condition does not have any effect on the structural integrity of the building. The areas should be repaired to prevent water intrusion.

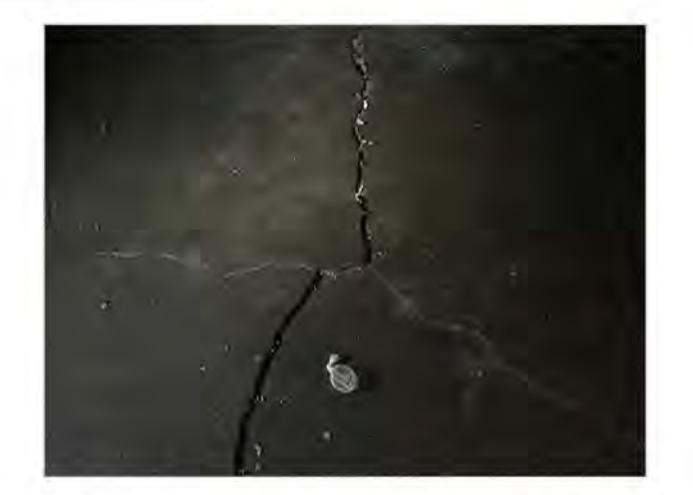
A crack was observed along the center of the garage floor. While this may be from years of normal settling, the width of the crack was greater than 1/4-inch. HomeTeam recommends that a professional contractor be consulted to assess the integrity of the garage foundation and underlying soil.

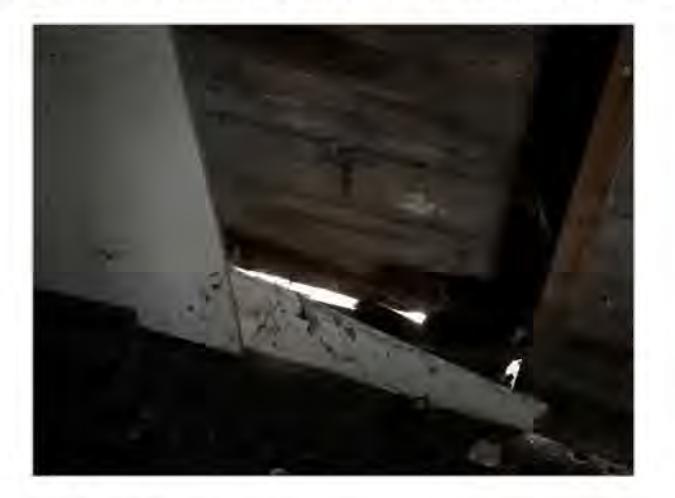
The rear garage wall is bowed outside the perimeter of the garage foundation. This wall appears to have been the automobile entrance door at one time and therefore not providing load-bearing support, but HomeTeam recommends a professional contractor be consulted to assess the stability of the garage structure.

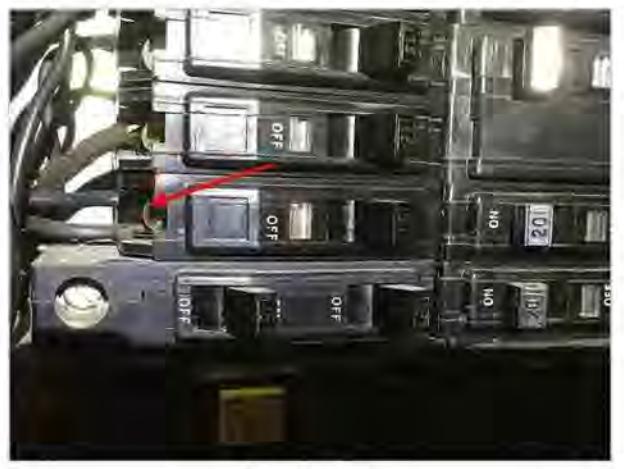
Breaker "7"

A circuit breaker in the electric panel had two attached circuits (wires). Each circuit should have its own dedicated breaker to prevent nuisance tripping and ensure good terminal contact, which may help prevent overheating. This situation is commonly referred to as a "double-tap". An electrician should repair this condition and further assess the panel for any additional required repairs.

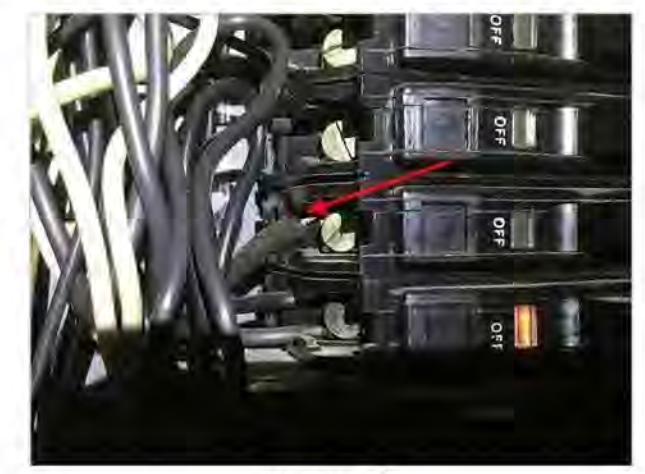
Breaker "5"

A 120-volt branch circuits in the structure has single strand aluminum wiring. Single-strand aluminum wiring was used extensively in the late 1960s and early 1970s but may have safety problems associated with it. Aluminum wiring in the structure should be evaluated by a qualified electrician who is experienced in evaluating and correcting aluminum wiring problems.

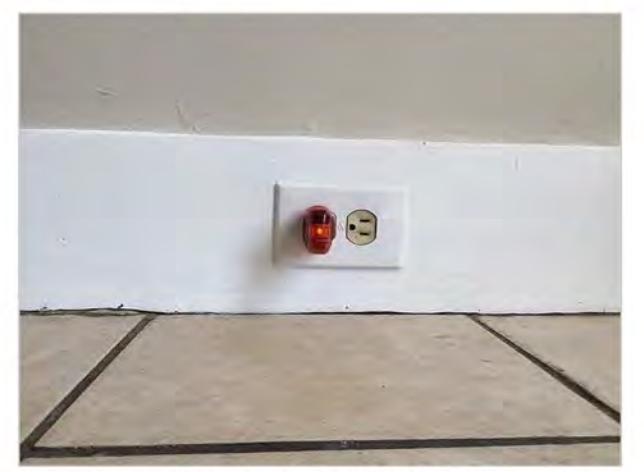
Example from dining room

Multiple three prong type outlets in the structure had an open ground. The affected outlet(s) should be grounded, replaced with two-prong outlets, or connected to GFCI circuits to improve safety. This condition means that the third prong, also known as the ground prong, is not doing its job. This is often caused by a missing or disconnected ground connection at an electrical device in the circuit. Consult with an electrician for the best course of action.

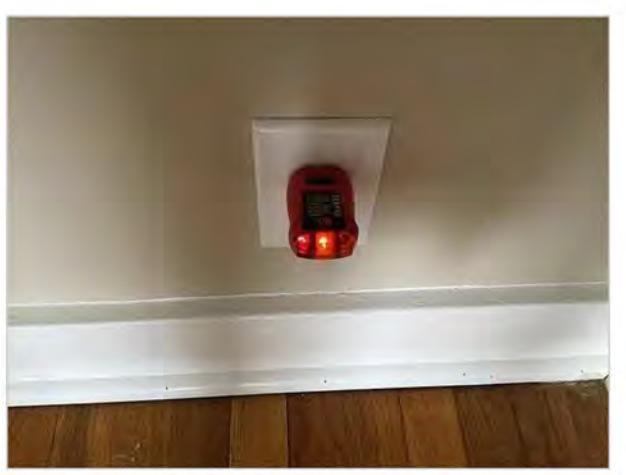
Example from upstairs front right bedroom

Multiple receptacles have hot and neutral wires reversed. This is a safety concern and should be repaired and further assessed by a licensed electrician. Please note that we only test outlets that are visible and readily accessible at the time of the inspection.

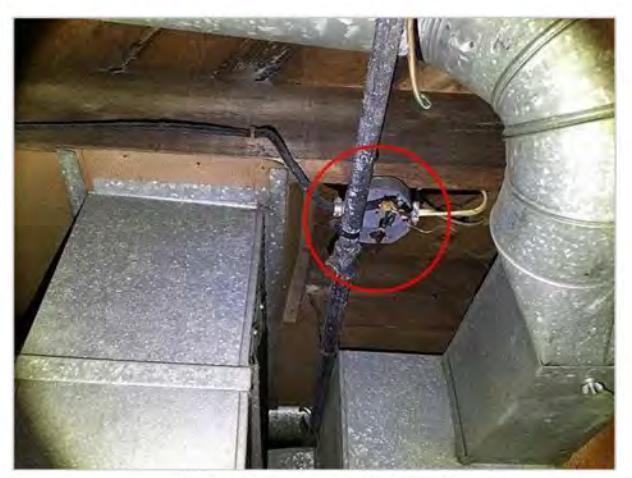
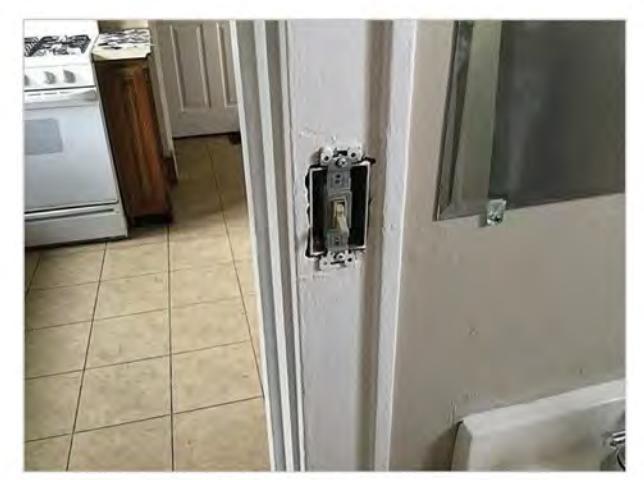
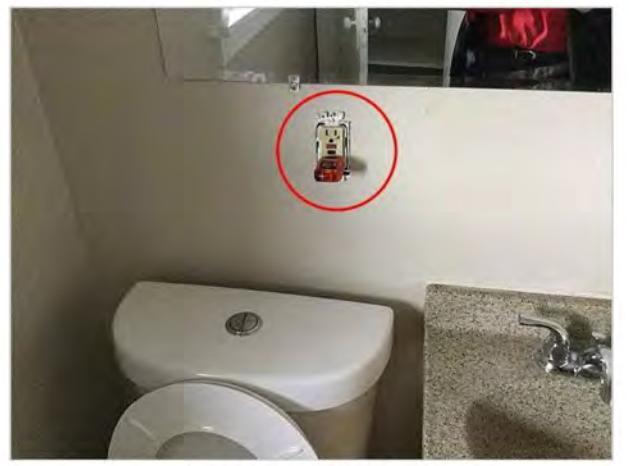
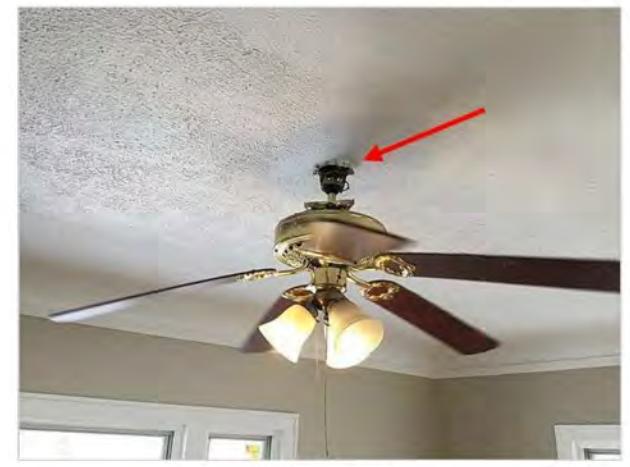
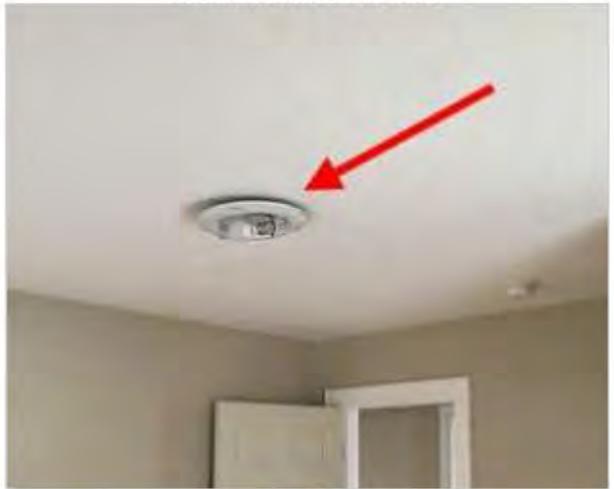
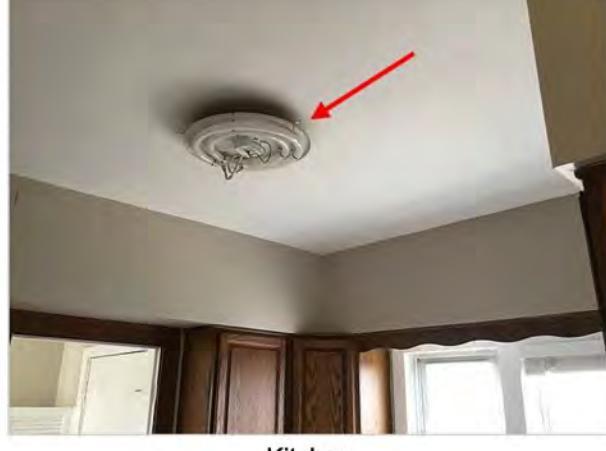
Missing light fixture, switch or outlet covers were observed throughout the home. All switch and outlet boxes should be properly covered to avoid a shock hazard. Electrical repairs should be performed by a qualified electrician.

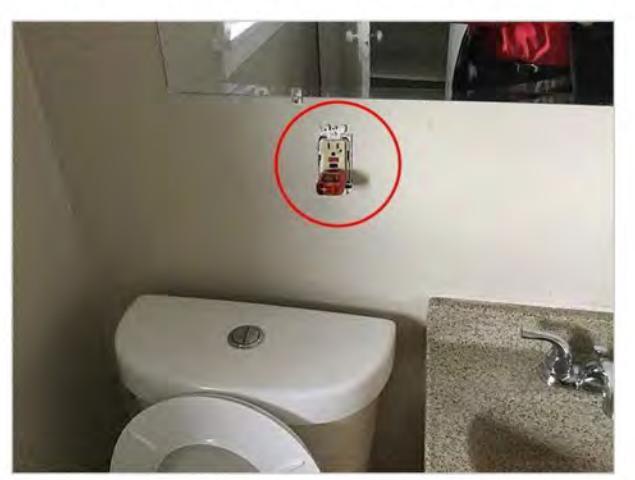
Upstairs bathroom

The GFCI outlet located in the second floor bathroom is defective and should be replaced.

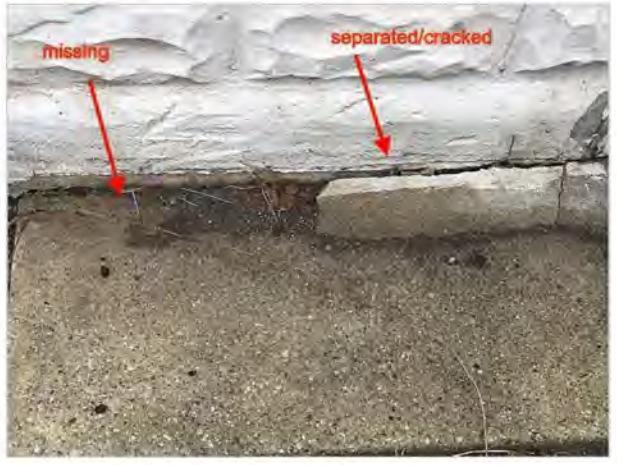
Left side of house along driveway

Cement parging is cracked and should be sealed. The parging is a covering for the foundation; it is important to keep it sealed in order to prevent further deterioration.

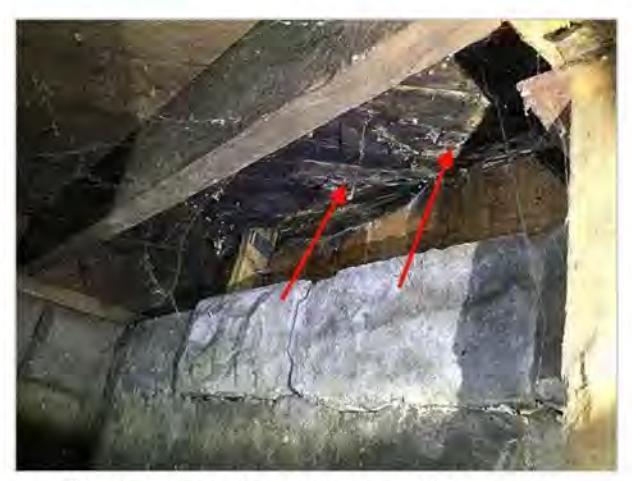
Crawlspace below stairs on right rear corner

Daylight and evidence of moisture intrusion was visible in the crawlspace under the right rear entrance door. This is most likely being caused by the sagging of the concrete staircase outside that door. We recommend a professional contractor be consulted to assess the cause of the sagging and effect repairs.

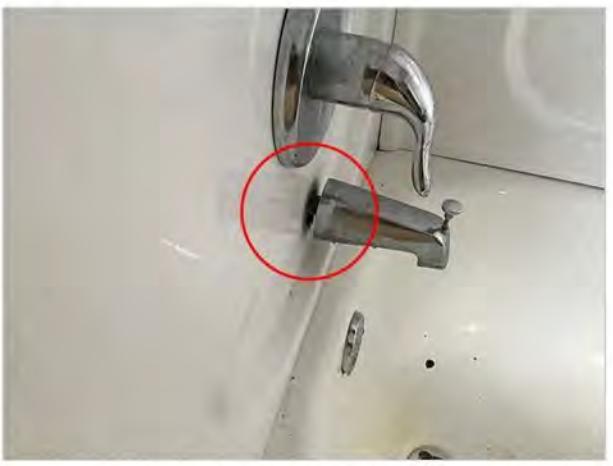
Upstairs bathroom bathtub faucet

The faucet in the main bathroom is loose and should be secured.

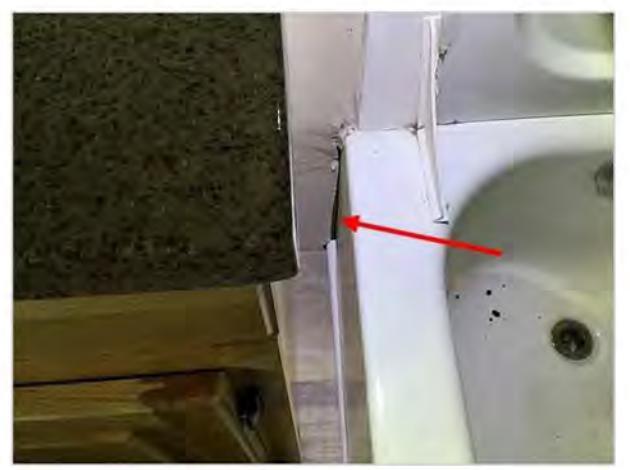
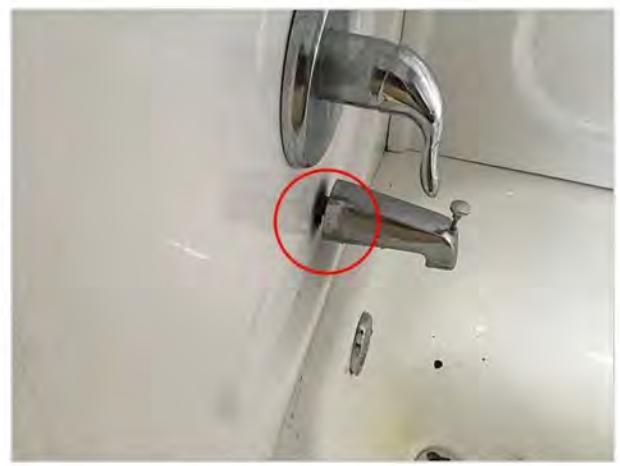
Some of the caulk or seal was missing from around the tub in the second floor bathroom. These areas should be sealed to prevent moisture penetration. Failure to keep walls sealed can cause deterioration and extensive moisture damage including mold growth to the interior walls, which is not always visible at the time of the inspection.

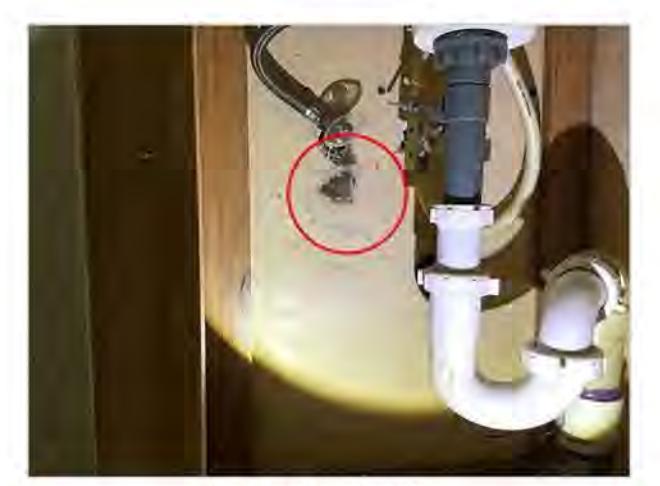
Half bath under sink

Mold-like growth is visible in the structure. The EPA has helpful information that may assist the buyer. HomeTeam recommends having the areas tested to determine presence, type and relative concentration of mold spores, and professionally remediated by a reputable mold remediation company, which may include removing and replacing affected segments. A mold remediation company may uncover additional areas or issues requiring repair or

remediation.

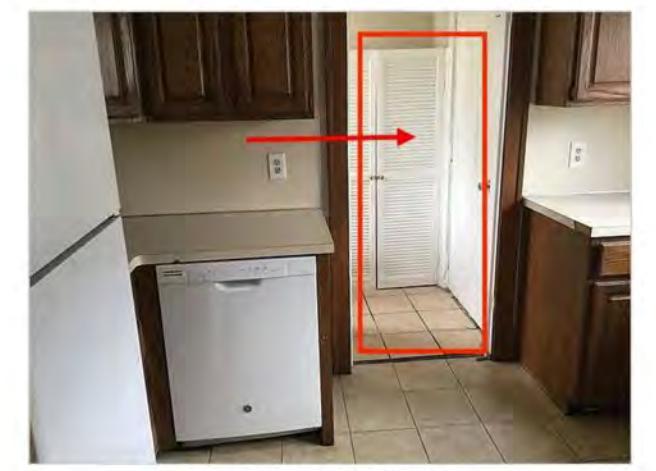
Door to half bath off kitchen

The door to the half bath off of the kitchen is missing.

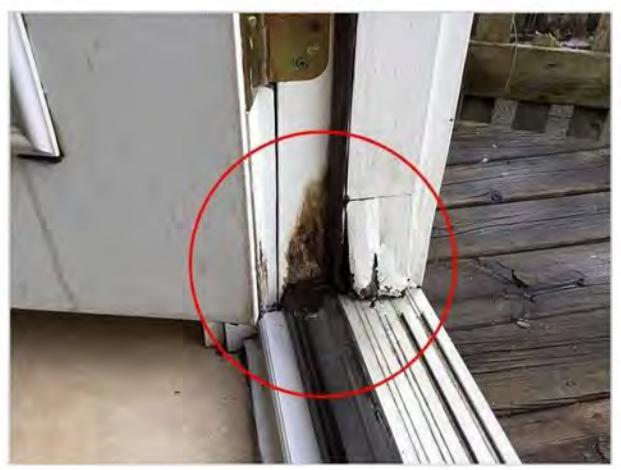
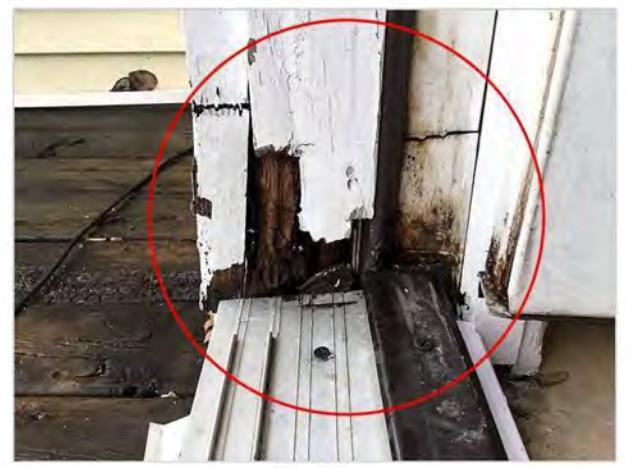
The base of the door and door frame to the rear of the home was damaged from apparent moisture exposure. The door and frame should be repaired and the surrounding area should be further assessed at the time of repair for any additional damage.

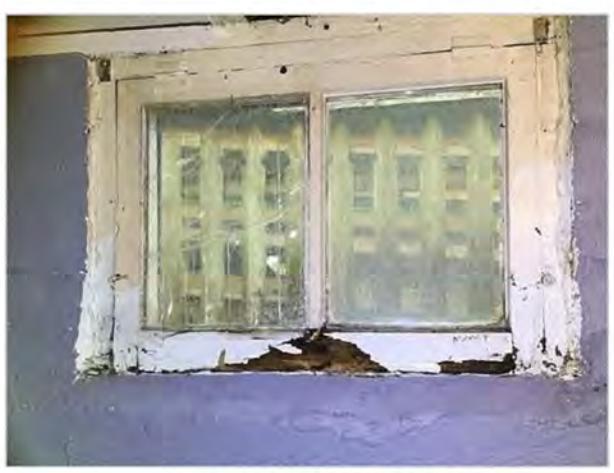
At base of basement stairs

The frame of a basement window was also damaged from apparent moisture exposure. The frame should be repaired and the surrounding area should be further assessed at the time of repair for any additional damage.

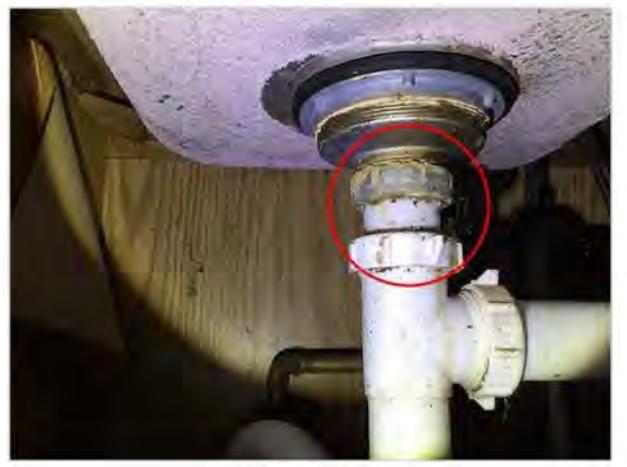
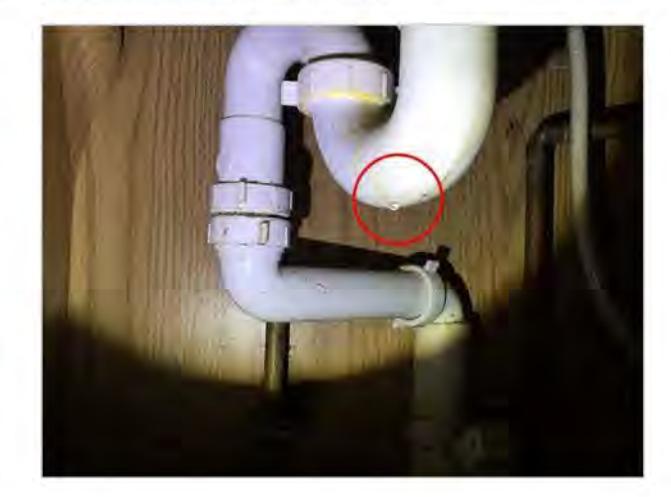
Kitchen sink

A leak was observed at the drain line under the kitchen sink. The drain line or seals should be repaired or replaced to prevent further water intrusion. At the time of repair, all drain lines should be further assessed.

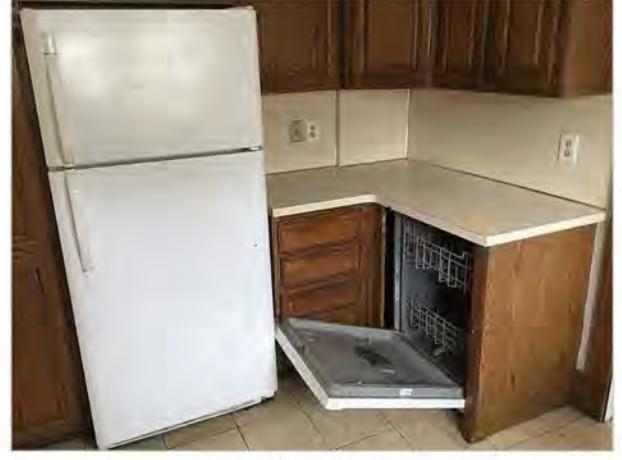
Kitchen

The General Electric dishwasher was tested and did not appear to be functional.

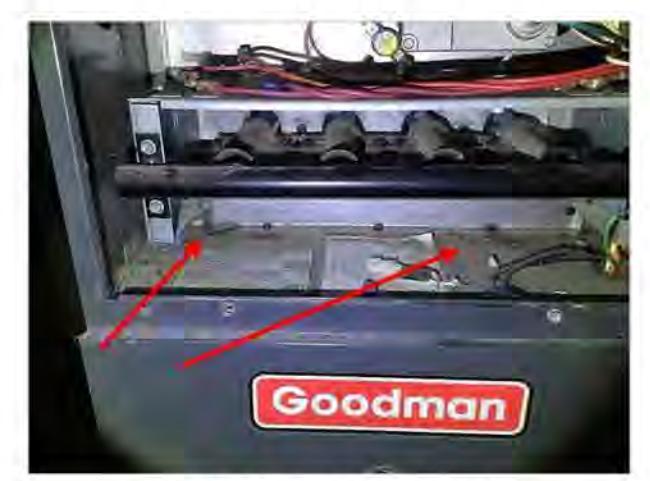
Furnace burner compartment

The furnace requires maintenance due to dirt and dust in the burner compartment. Having the system maintained will increase the life of the equipment and also reduce unneeded service calls.

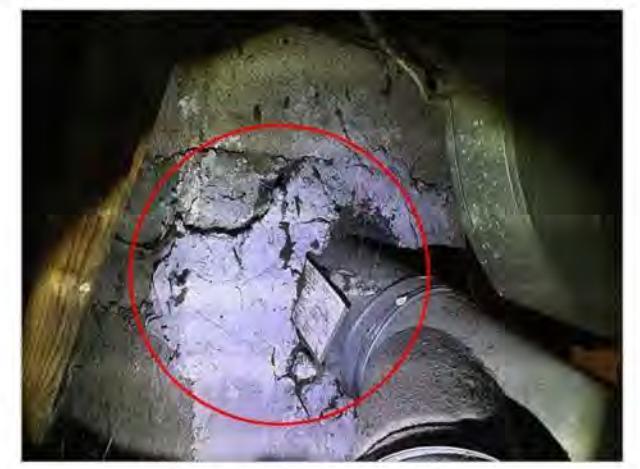
Basement furnace venting

The furnace flue pipe is not sealed where it enters the chimney, possibly leading to exhaust gases entering the structure. In order to ensure proper venting of the flue gases, the chimney should be properly sealed around the flue pipe. Consult with a qualified contractor for repair.

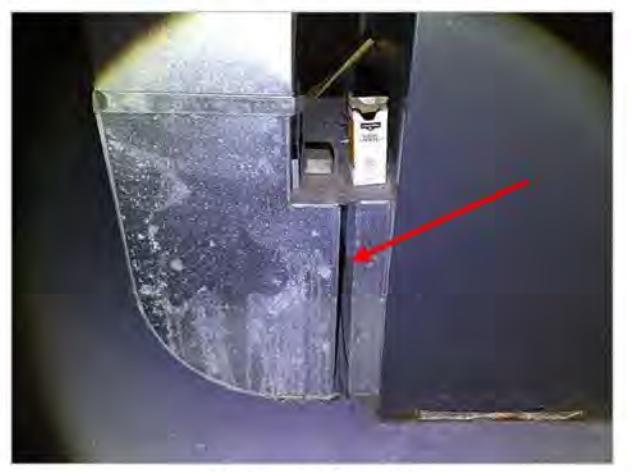
Furnace filter slot

NOTE: A furnace filter was not installed The filter size mentioned above is approximate. Please refer to the furnace manual or a licensed HVAC technician to determine the correct filter size and placement.

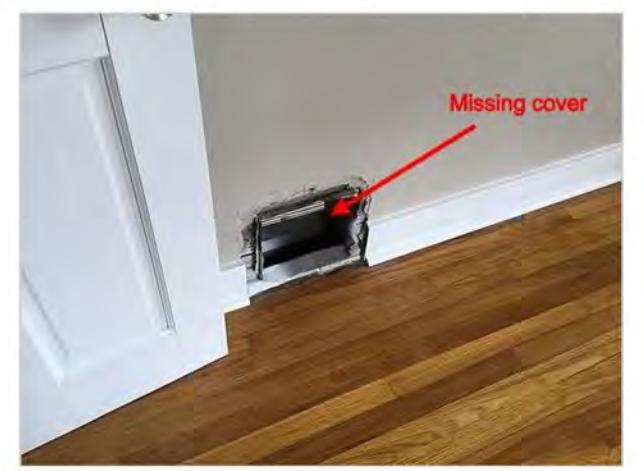
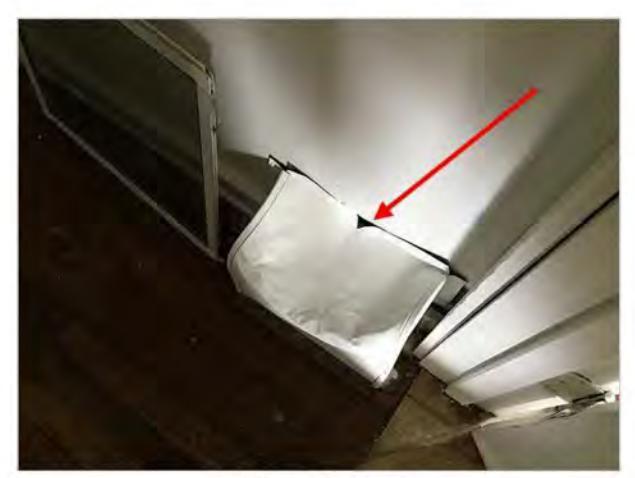
Damaged ductwork was observed.
